The Exterior Conservation Project of the Tower of Belem and its Sequel

ABSTRACT

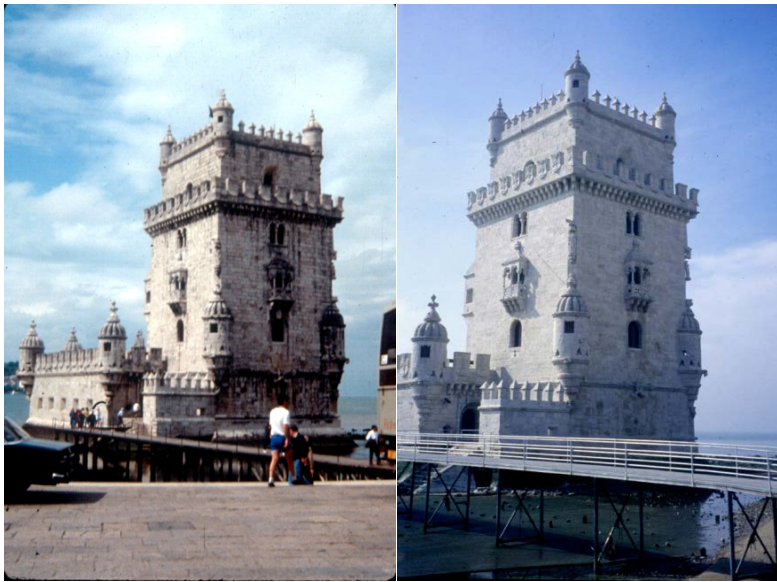
The main reason for the heavy soiling of the north façade was the presence of a coal gas manufacturing plant —from the end of 19th to mid 20th century— located in front of the Tower, where the plaza and gardens are now. Since then, the exhaust fumes of cars and tourist buses that were allowed to park right on the plaza also contributed to it and prompted the decision to no longer allow parking there.

Figure 1. View of the east-north façade of the Tower before (1993) and after the intervention (1998). Please note in the earlier photo the end of a car and a bus parked close to the walk-way to the Tower. Photos A. E. Charola, WMF-P.

The actual intervention, Phase II of the Project, focused on these issues and also can be subdivided into the following main categories: 1) addressing structural issues; 2) sealing and repointing joints⁷; 3) cleaning⁸; 4) application of consolidants where the stone surface was in poor condition⁹; and 5) localized application of a water repellent or lime water-wash, the latter to provide a uniform color. Figure 1 shows the appearance of the Tower before the intervention and after it.

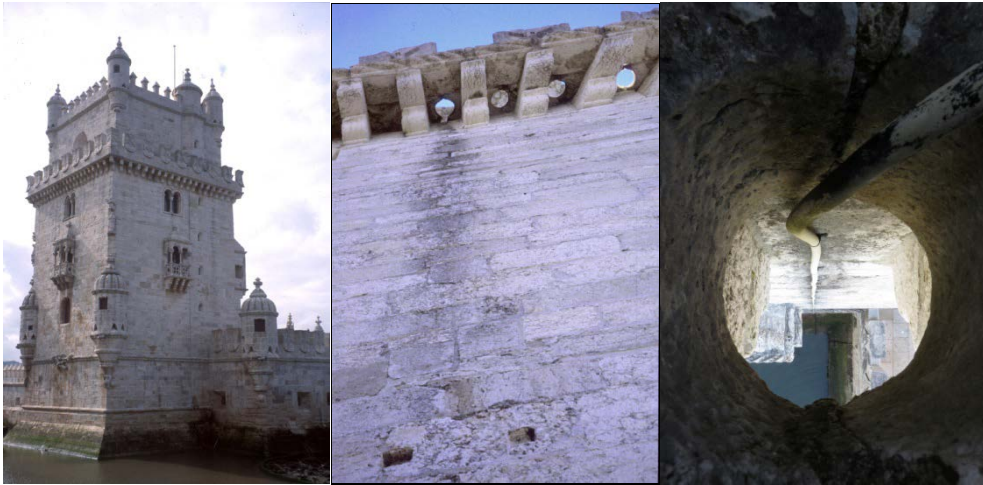
even so, it became evident that some problems still existed. For example, on the west façade, a dark streaking was evident towards the south end that could be traced a broken spout of the drain from the round-walk terrace (Figure 2). This feature funnels water along the wall of the tower so that both soiling and biocolonization is enhanced along the water path. Also visible towards the center of this facade is the pipe that grounds the lightning rod passing through a hole in the round-walk. By 2015, similar staining was observed (Figure 2 right). Both these problems, which have relatively easy solutions, have as yet not been addressed but in the meantime further soiling has accumulated over the seventeen years that have gone by since the intervention (Figure 3).

Figure 2. View of the north-west façade of the Tower in 2003 (left). A stained strip towards the south originates from a broken drain spout of the round-walk terrace (center). A lesser line closer to the center results corresponds to the pipe that grounds the lightning rod (right) and that by 2015 shows increased staining. Photos left and center, A.E.Charola, WMF-P; right, Angelo Silveira, DGPC – DEPOF archive.

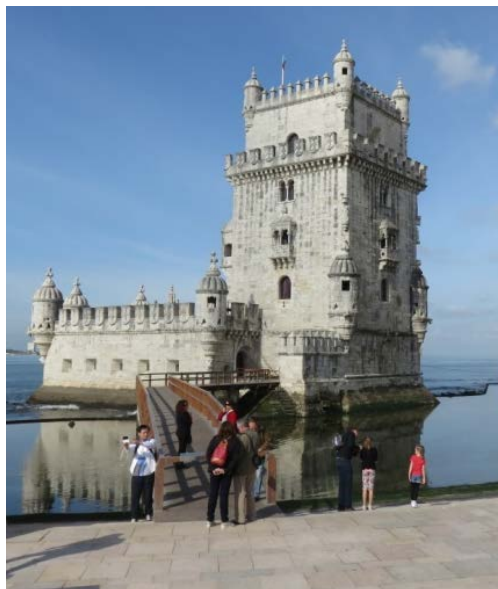
When comparing the soiling shown in Figure 3 to that in Figure 1 it is evident that the east façade accumulated far more soiling than it had before the 1997 intervention and the reason can be found in part by the actual intervention. During Phase I of the project, structural problems were identified in the covered balcony on the south façade, such as cracks in four of its six columns and in eight of the twenty corbels supporting it. Furthermore, this balcony, as the round-walk terrace, had round holes in the floor that originally had served as defense for shooting arrows down to the enemy should they reach the bulwark terrace. In a previous intervention, these holes had been covered by wooden round blocks, which over the years, through expansion-contraction during wet-dry cycles, induced major or minor cracks in the surrounding stone. A monitor was installed on one of the most affected corbel and it was found that the crack was still active three years later. Therefore, to prevent further damage, the wooden blocks were removed from this balcony as well as from the round walk terrace. In the case of the balcony, the holes were sealed with round Lioz stone.

Figure 3. View of the east and north façade of the Tower de Belem in 2015. Note the regular soiling pattern that developed from water running down the holes in the round walk terrace. Photo Angelo Silveira, DGPC – DEPOF archive.

It is interesting to note that the north façade is still the one showing most soiling, which can be attributed to the vehicular traffic beyond the railway tracks though it appears to be less than it was before, owing to its restriction close to the Tower. This is followed by the east façade, where a streaking pattern developed from water flowing through the holes of the round-walk terrace, which was not evident previously (Figure 1). The west façade shows an intensification of the two previously mentioned streaks, while the south one is still the cleanest as these façades benefit from the regular cleaning from SW driven rain. This same soiling pattern had been originally found as previously reported¹³.

Another one is the mentioned sealing of the terraces, starting with the more urgent Tower terrace that is currently being planned for quick implementation so as to minimize the time it will be closed to the public. This hopefully will be followed by addressing the drainage of the round-walk, while the bulwark terrace appears to have less problems.
