REPAIR OF A SIDE CHAIR WITH PERFORATED PLYWOOD SEAT

Walter Angst

Abstract—The repair of a mahogany side chair with a perforated, bent plywood seat is detailed.

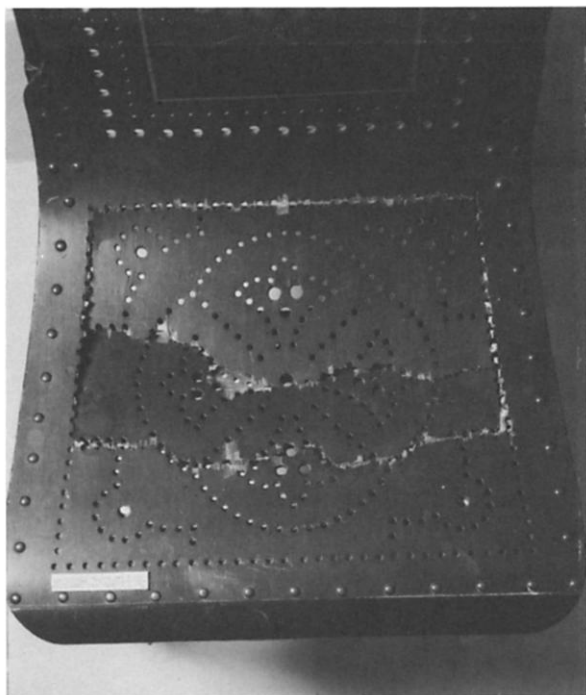
As viewed from the top, the seat appears to be broken along the outermost row of holes in the back, along both sides, and across its width; one irregularly shaped oblong, about 55-95 mm in width, is actually separated. The back-part of the seat, ca. 320 × 200 mm, is still partially attached but has caved in along a jagged central fracture line, forming two separate pieces. Obviously, the seat has been pushed downwards with great force (Fig. 1). The two pieces of plywood are now arranged in two separate planes and need to be aligned before they can be rejoined. The plies have separated and some 25 areas of the top layer, varying from 10 × 5 mm to 20 × 15 mm, are splintered-out and are missing. Two roughly triangular areas, 20 × 6 mm and 40 × 25 mm, respectively, are completely broken through and missing. The outermost rows of holes in front and back are only cracked.

FIG. 1 Top view of caved-in seat with a support piece beneath it. The light area near the center is actually a broken-through piece that is missing.

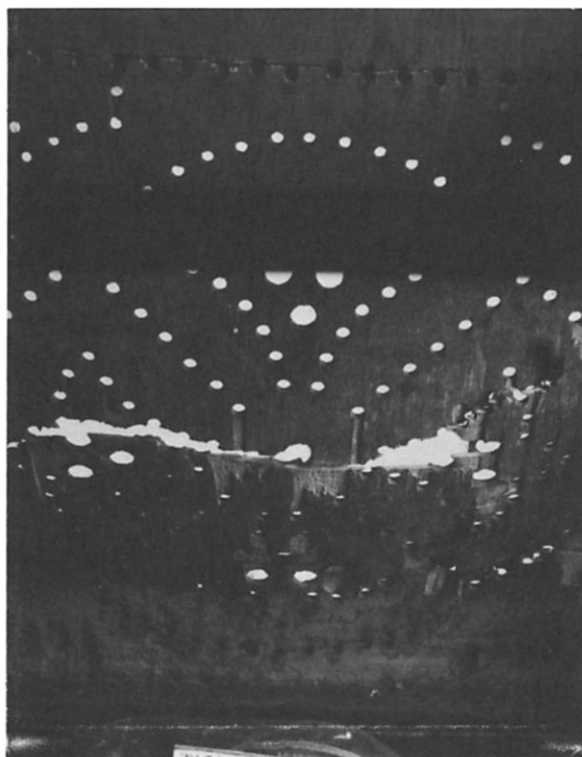
As seen from underneath, (Fig. 2) it appears that the seat has been previously repaired. Originally attached to its underside with moldings and brads, but now torn loose, is a second piece of perforated plywood which extends the width of the seat inside the rails, and reaches ca 200 mm in the other dimension. This sheet of plywood is now bulging in a tented curve. Of the moldings, only a few broken parts remain. By noting differences in color of the stain on this piece, on the back side of the back, on the underside of the seat, and on the inside of the rails, it is concluded that this added section of plywood never extended over the entire seat. It could have been an

The underside of the actual seat is rough, water stained, having many patches and runs of what appears to be hide glue, and is variously discolored with wood stain. Some of its missing segments are stuck to the corresponding surface of the removed reinforcement piece. The surface of the underside of the actual seat, where it has not been covered by the reinforcing piece, is markedly lighter, with a quite different texture, as if it had been scratched in a regular cross-hatching pattern, possibly in preparation for applying adhesive to that surface.

FIG. 2 Seat as seen from beneath, with the reinforcing piece removed. Note the numerous torn-off and missing parts of ply.

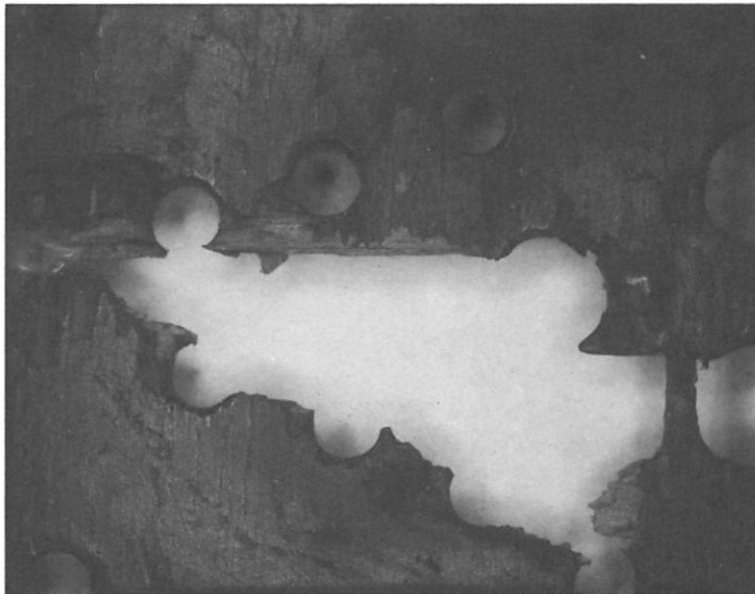
Fig. 3a Detail, loss in seat, seen from above.

It was decided not to chamfer the underside of the fills to fit the plywood residue within the torn-out area, which would take approximately three times as long and would not appreciably change the appearance of the patch. It was also considered justified to cut away a very small amount of the original ply in order to obtain obtusely angled joints, rather than allowing the joints to run at right angles to the grain (Fig 3a and b).

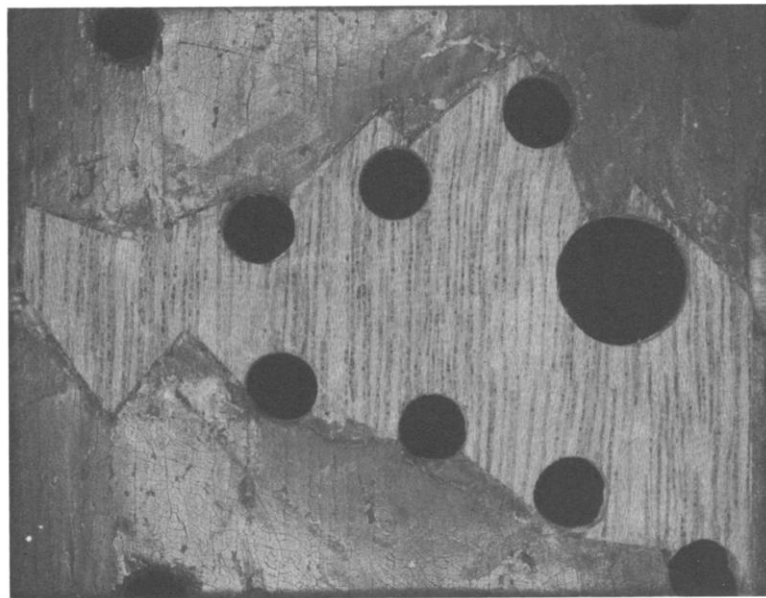
FIG. 3b Detail, replacement piece, a mahogany veneer, glued into place.

Since the curator wanted the repairs finished in mahogany, the top layer of the glued-in plywood was removed by chisel and replaced with mahogany veneer. To ensure good joints, some segments of the splintered top layer of the original ply were also removed.

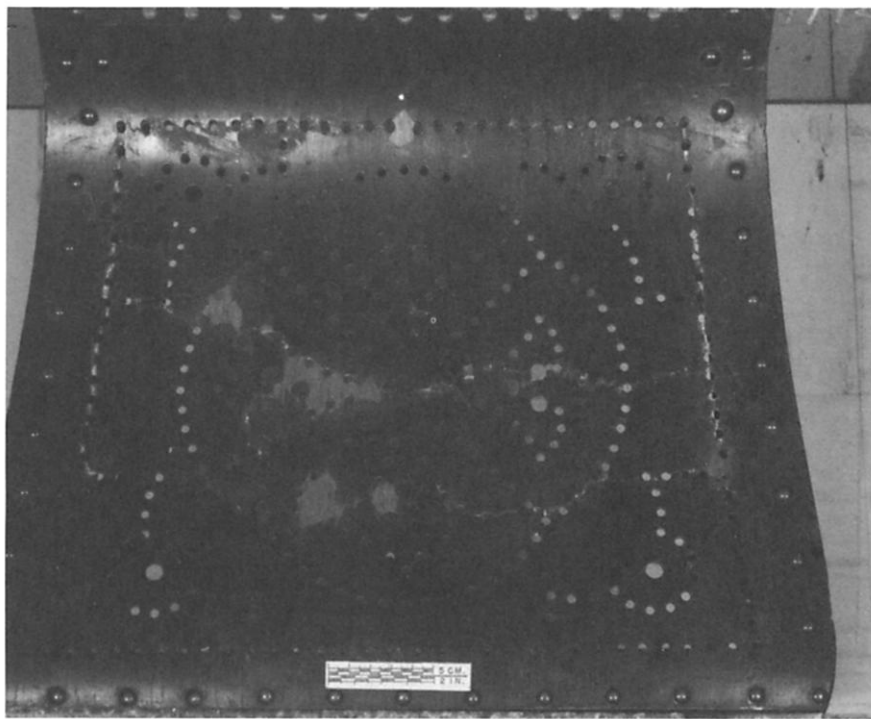
FIG. 4 Patches of veneer glued in place and stained, before finishing.

All seven of the larger areas of broken-out and missing top plies were thus repaired with set-in veneer. They were sanded with finishing paper No. 240 A. Several tests were made with alcohol stains, on pieces of the same kind of veneer. It was found that all colors tested were too intense, and would probably turn out too dark when finished.

Therefore the patches were brushed with a mahogany filler (a pigment suspended in a light drying oil of very low volatility) and immediately wiped off against the grain, with a rag. This was repeated four times, to fill the pores of the mahogany and to color the wood. Upon drying, the filler turned grayish, but when later covered with finish, it closely matched the color of the chair. To further improve the match, each patch was touched up by transferring the dye of a Behlen-Beetsol Touch-up Marker No. 104, light walnut, to the wood, via the tip of a rag (Fig 4). When this had dried, three thin coats of white shellac cut 50% with denatured alcohol were wiped onto the patches with a French polish rubber.¹³

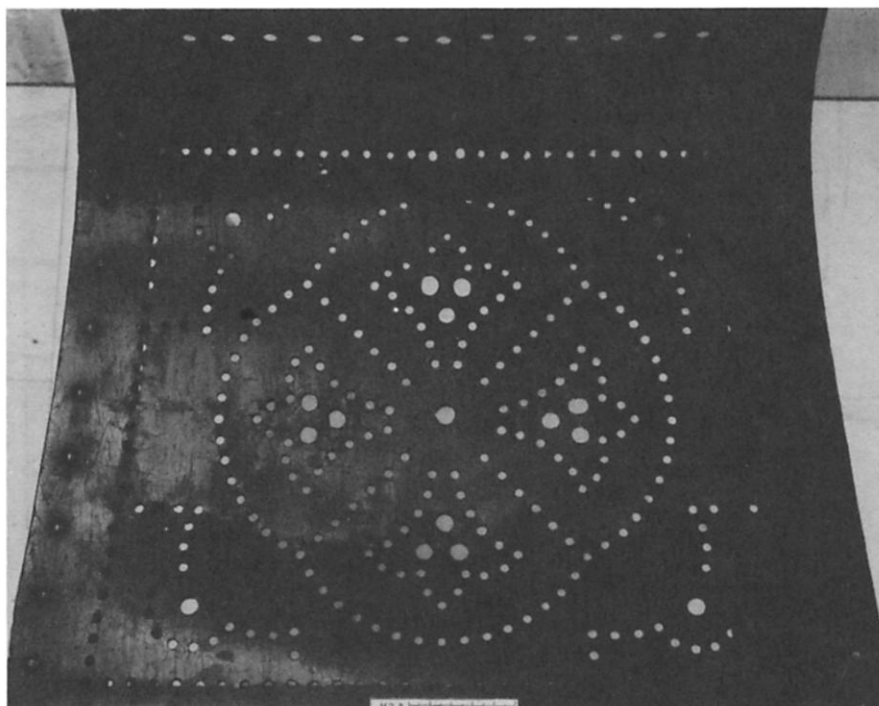
FIG. 5 Patches after finishing and waxing.

The many small lacunae in the top ply of the seat were then filled with melted wax from a Patchal Pencil No. 256 (synthetic ester wax with appropriate pigment, test CAL 2921), applied with a hot spatula, and the whole seat was repeatedly wiped, after a very light coating of paraffin oil had been applied with a rag (Fig 5).

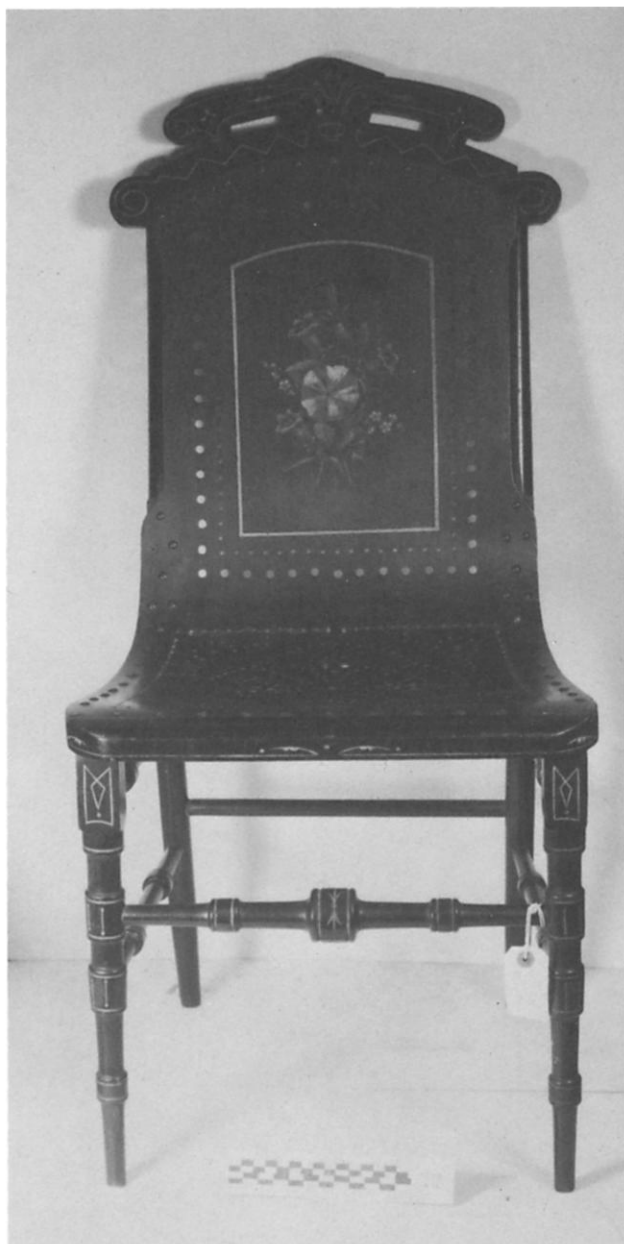
FIG. 6 Chair after treatment.

According to the curator's wishes, no attempt was made to stabilize the chair, which has loose joints. An abraded area on the highest point of the back's crest was, however, touched up with Lucite acrylic lacquer, No. 407-L, jet black (Fig 6).
