## **THE RUINS OF SAN IGNACIO MINI, MISIONES, ARGENTINA - CHARACTERIZATION OF THE STONE USED IN THEIR CONSTRUCTION**

**P. L. BIANCHETTI**

**A. E. CHAROLA**

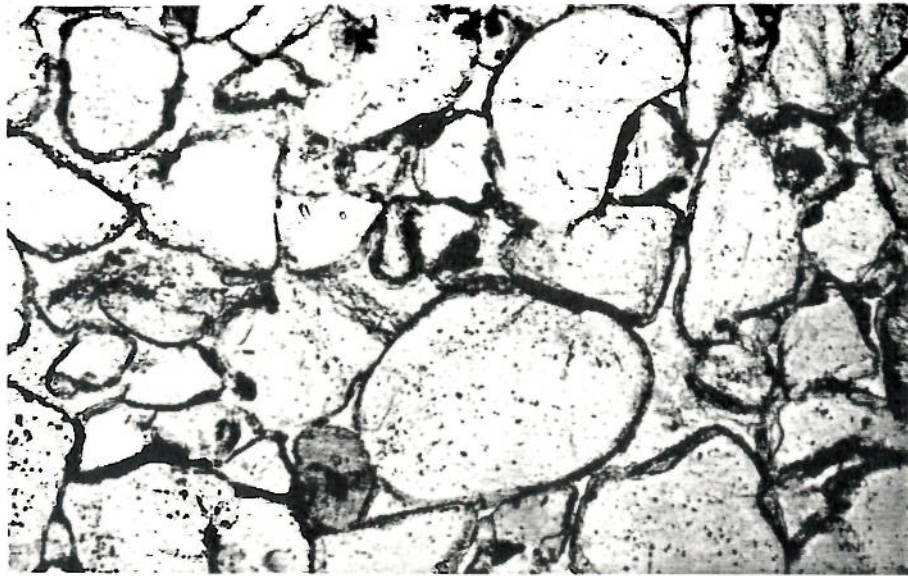
The slate-like variety (Sample #2) does not differ in microstructure from the previously described arenite. Figure 1 shows a thin section of this stone.

Figure 1. Photomicrograph of a thin section of the slate-like arenite (78 x, N //). Note the well-rounded and well-sorted quartz grains which are coated with haematite giving this stone its red colour.

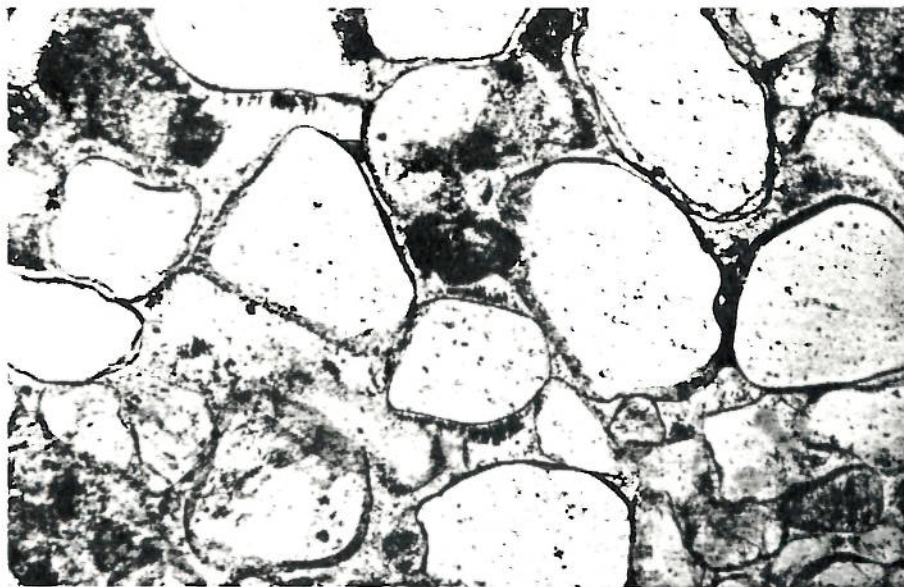
The compact variety of this sandstone (Sample #3) gives a nearly conchoidal fracture. It is much harder and is cemented by quartz overgrowth or precipitated around the sand grains coated by the haematite. Figures 2 and 3 show scanning electron photomicrographs of the typical arenite and the compact variety.

Figure 2. Photomicrograph of a thin section of the compact variety of the Asperón Rojo (78 x, N //). The quartz crystals are partially coated by hematite and cemented by quartz overgrowth.

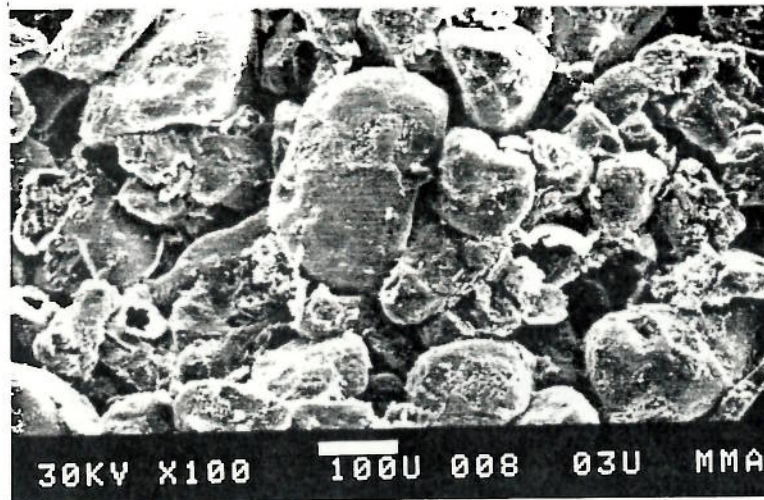
Figure 3. Scanning electron micrograph of a fracture surface of the Asperón Rojo sandstone. Note the coating of haematite on the quartz grains and the open pocket of amorphous haematite in the lower left side of the picture.

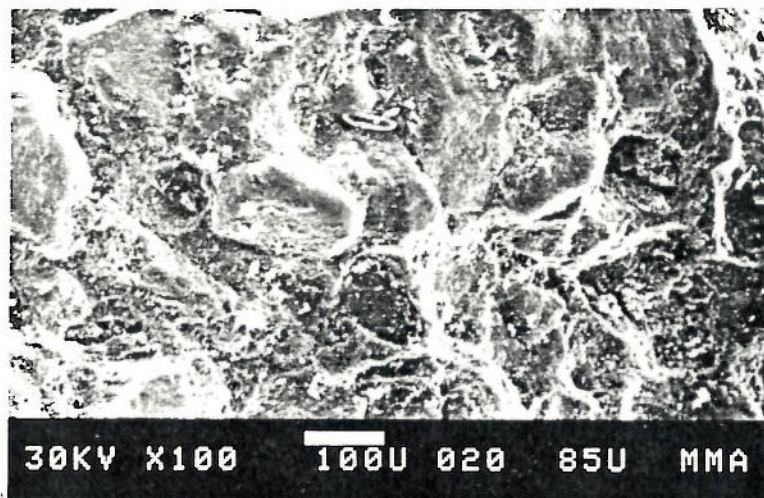
Figure 4. Scanning electron micrograph of a fracture surface of the compact arenite variety. Note the silica cementation between the quartz grains.

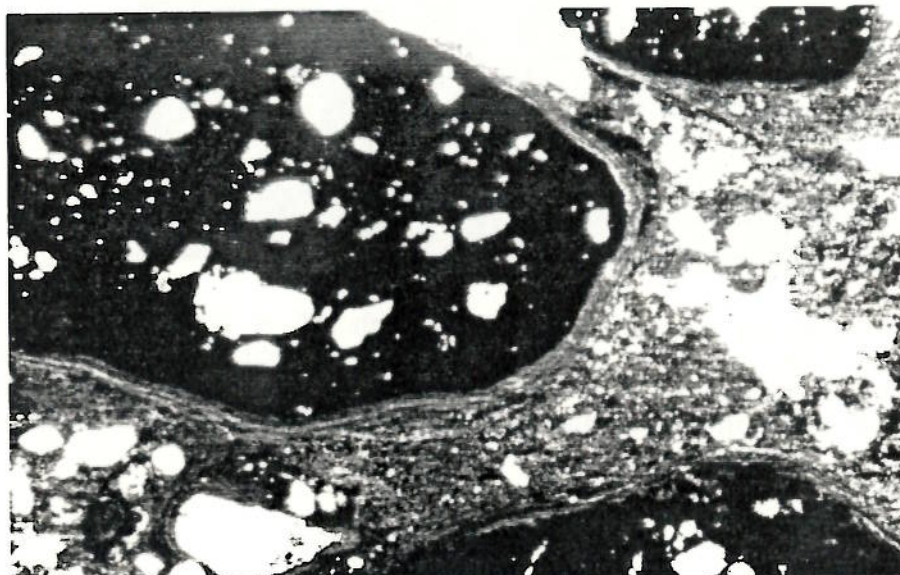
The goethite and limonite, which cover a range of mixtures of iron oxides and iron hydroxides, appear to be the weathering product formed by hydration of haematite. In thin section the goethite-limonite is yellow to brown and generally appears isotropic and is present as thin beds and laminae around the massive red haematite. Figure 5 shows a thin section of this stone.

Figure 5. Thin section of the Ita-Tacurú stone showing its pisolitic structure (31 x, N //). Note the masses of goethite-limonite around the haematite oolites.
