AN ANALYSIS AND TREATMENT OF THE FIRE-DAMAGED MARBLE PLAQUE FROM THOMAS JEFFERSON'S GRAVE MARKER

Abstract

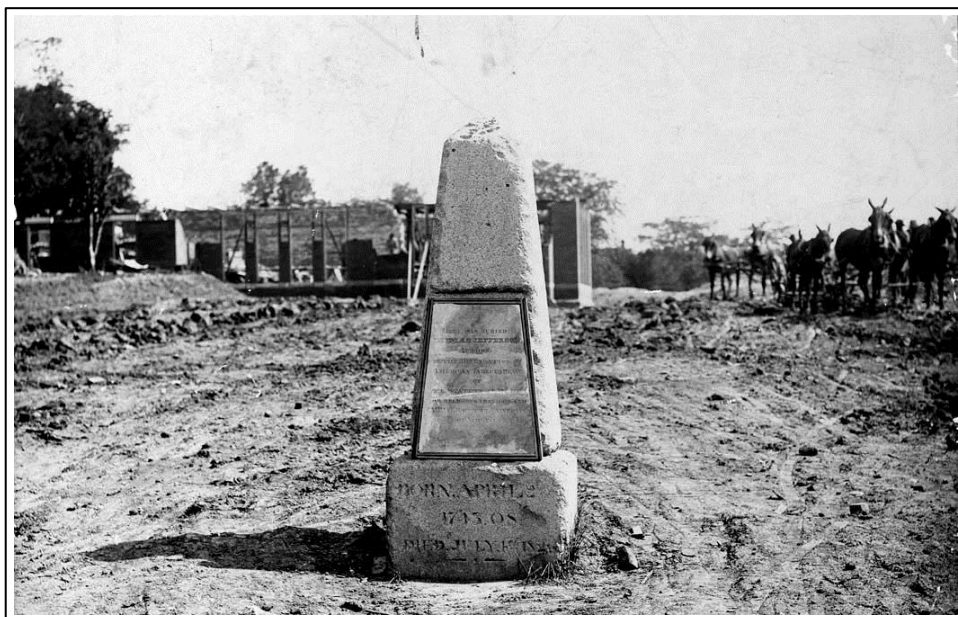
Fig. 1: Thomas Jefferson's grave marker displaying the repaired plaque in a frame following the 1892 fire, on the grounds of the University of Missouri. Courtesy, University of Missouri Archives.

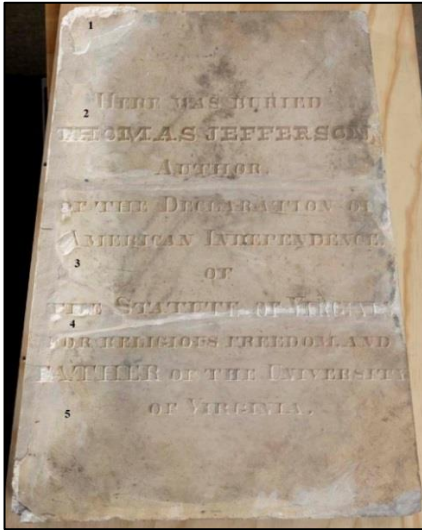
Examination of the plaque at the Smithsonian revealed considerable fire-induced damage, including breakage into five pieces, numbered in Fig. 3. After disassembly, break edges were found to have the convex shapes characteristic of fire damage, known as conchoidal fracture (Steiger *et al.* 2014, p 227-228). Disaggregation along broken edges suggested that fragmentation occurred from simultaneous expansion and contraction of anisotropic calcite crystals, which can induce strain in marble at temperatures as low as 60° C (Siegesmund and Dürrast 2014, p 149-150). The rate of transmission of heat through the 5-cm-thick block would have been highest at corners, consistent with detachment of the small triangular pieces designated 1 and 4, as well as the formation of oblique cracks across the lower left corner visible in Fig. 4. Losses can also be readily seen in Fig. 4 because of the irregular surfaces of fills that replaced them. They are significant along broken edges, particularly at the left edge, where as much as 3 cm of the plaque is missing (apart from small areas at top and bottom corners) and may indicate the direction of the fire. Adjacent to this loss, a layer about 1-cm thick is missing on the back face, suggesting that the plaque may have been in a wooden case that burned in the fire. The plaque is slightly convex on

the back, probably from residual expansion caused by greater exposure to the fire; concomitantly, it is slightly concave on the front. Front surfaces at the left and bottom are partially calcined, distinguishable by whitening (Fig. 3). Expansion of these areas can be felt where they intersect sound stone. Partially delaminated areas with voids below were also found to have expanded, preventing readhesion; during treatment, the voids were filled instead. Since the historic photograph was taken in the 1890s, lettering has been lost at the left edge, visible as bright areas, e.g., where the first letter of “AMERICAN” is missing.

Fig. 3: The tombstone plaque before treatment; fragments are numbered at left. Height = 74cm. Photo by Don Hurlbert

upper right to lower left (Fig. 3) but were sometimes difficult to differentiate from surfaces soiled by smoke. Scanning XRF confirmed locations of veins by finding silicon and potassium in them, consistent with quartz and feldspars. No elements, other than calcium, were found in areas that appeared more likely to be darkened by smoke. This finding does not rule out the presence of carbon deposited from smoke, however, since this element is

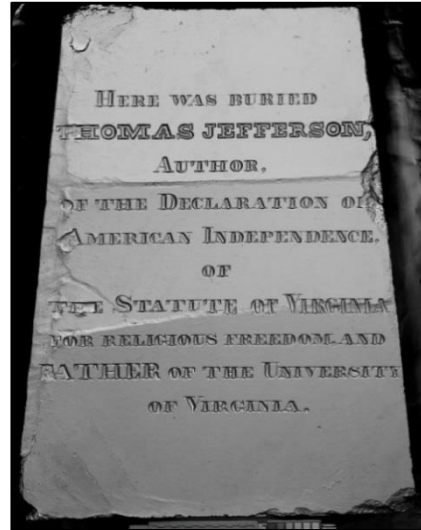
Fig. 4: RTIViewer screenshot in the specular enhancement mode shows surface irregularity of the plaque before treatment. Photo by E. Keats Webb

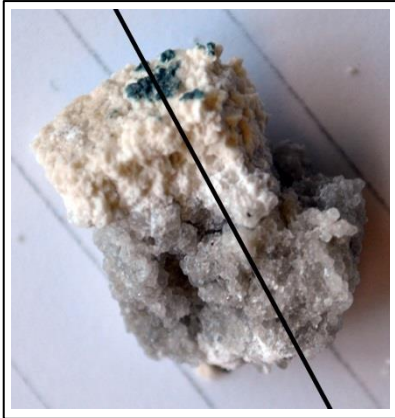
Decomposition of calcite (CaCO_3), or calcination, occurs at temperatures above 700°C ; carbon dioxide (CO_2) evolves, leaving calcium oxide (CaO) behind. The CaO can subsequently recarbonate in air to form poorly cohesive calcite. The calcined upper part of a marble sample from the plaque appears chalky white to the naked eye (Fig. 5), and a thin section shows that the marble's granular texture there has been replaced with an opaque material (Fig. 6), which is very fine. Micro-X-ray diffraction analysis of samples from such areas found both calcite and calcium hydroxide [$\text{Ca}(\text{OH})_2$], and preliminary thermogravimetric analysis (TGA) indicates about 95% calcite and 5% $\text{Ca}(\text{OH})_2$. In the intermediate zone between calcined marble and smoke-darkened marble grains below (Fig. 7), hyperspectral energy dispersive analysis using the SEM indicated that rims of grains had calcined and recarbonated. Below this zone, smoke-darkened marble retains its structure but is disaggregating (Fig. 5 and Fig. 6), presumably because of the heat-induced residual stresses in calcite grains.

Fig. 5: Damaged sample from the plaque. The calcined surface is opaque and white, with a dark blue spot on top; below, smoke-darkened marble grains are disaggregating. The black line marks the plane of the thin section in the next image.

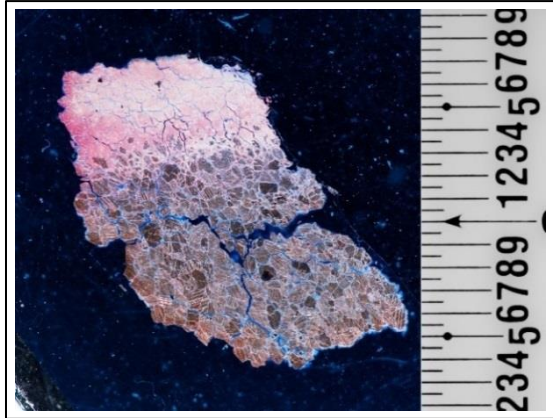
Fig. 6: Thin section made from the previous sample in darkfield illumination, with mm scale at right; stained red for calcite. The calcined upper surface has lost its marble texture, while grains and cleavage planes can still be seen in the smoke-damaged disaggregating marble below. The partially calcined zone in between is shown at higher magnification in the following figure.

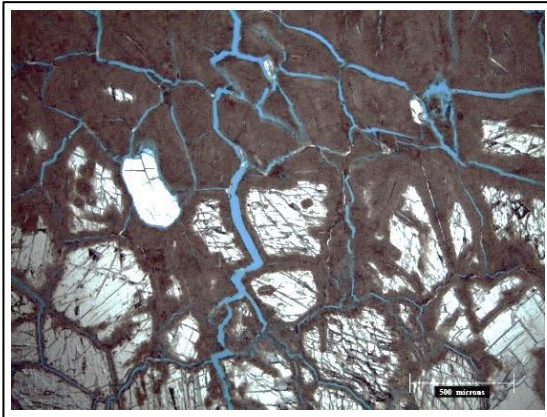
Fig. 7: An area in the intermediate zone of the previous thin section, at higher magnification in plain polarized light. Completely calcined marble (above) is dark. Calcite grains (below) are bright, except where calcined at rims and at cleavage planes. The brightest particle at center left is quartz. Blue epoxy medium can be seen in cracks, which to some extent follow grain boundaries. Bar = 500 μ m.

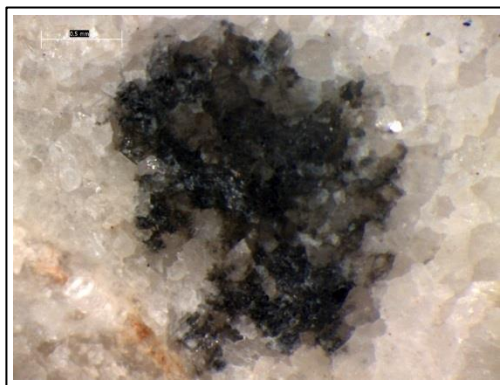
not detectable by the XRF instrument. Cleaning tests found reduction but not elimination of soiling from smoke, apparently because smoke had penetrated the disaggregating stone. Disfiguring black spots and streaks of a type seen in Fig. 8 were found to contain copper, tin, lead, and sulfur as the main elements, confirmed by SEM EDS; they are probably metal sulfides derived from plumbing or other building materials burned in the fire. Microscopic examination of these accretions indicated that they were so intimately mixed with the stone that they could not be removed mechanically or by laser ablation without damaging the stone. Scanning XRF identified mainly sulfur and calcium in dark blue spots atop calcined areas (Fig. 5) but also small amounts of lead, confirmed by X-ray micro-analysis of a dark blue spot on both the thin section (Fig. 6) and a second fragment; this result suggests that lead sulphide may have provided the blue color. A sticky material on the surface of the plaque was analysed by Fourier transform infrared spectroscopy (FTIR) and found to have a spectrum similar to parchment. This would be consistent with application of a material such as animal glue during the 1890s restoration and its removal with an aqueous solution during the 2013 treatment.

Fig. 8: Copper, tin, lead, and sulfur were the main elements found in the black spot using scanning XRF and SEM EDS analyses. Bar = 0.5 mm.

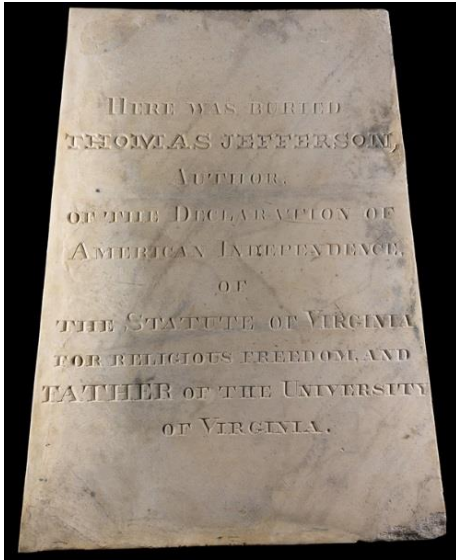
Fig. 9: Plaque front after treatment. Lighting is even; hence, lighter areas at left and bottom reflect calcination. Photo by Brittany Hance.

The front surface of the plaque was initially cleaned using mineral spirits, acetone, and an aqueous solution with a surfactant. Areas in good condition were further cleaned with methyl cellulose poultices; to prevent detachment of calcite grains, the poultices were bulked with silica and calcium carbonate powders and removed before dryness. Cleaning was limited on calcined areas at left and bottom edges because of their fragility. Treatment was completed with retouching of fills using watercolor and gouache paints to match the stone on the front (Fig. 9). Fills on the back were left lighter in color than the stone (Fig. 10).

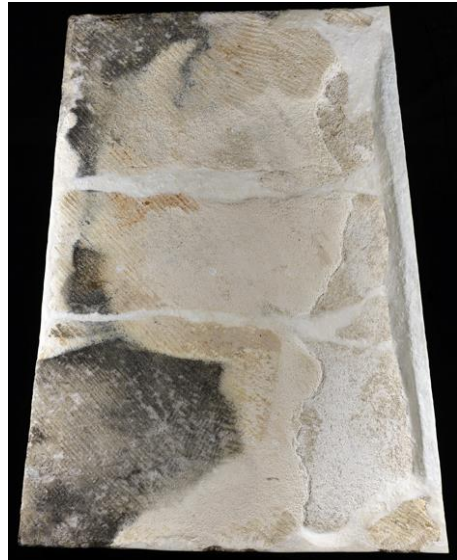
Fig. 10 Back of plaque after treatment. At the right, a structural fill completes the edge; next to it is an area missing a cm-thick layer of stone. In the light-colored central area, a thick layer on the surface has been calcined but remains. At the left, the marble is smoke damaged but more or less intact. Photo by Brittany Hance.
