CHARACTERIZATION AND TEST TREATMENTS OF CAST-STONE MEDALLIONS AT THE SMITHSONIAN

C.A. Grissom^{1*}, E. Aloiz², E.P. Vicenzi¹, N.C. Little¹ and A.E. Charola¹

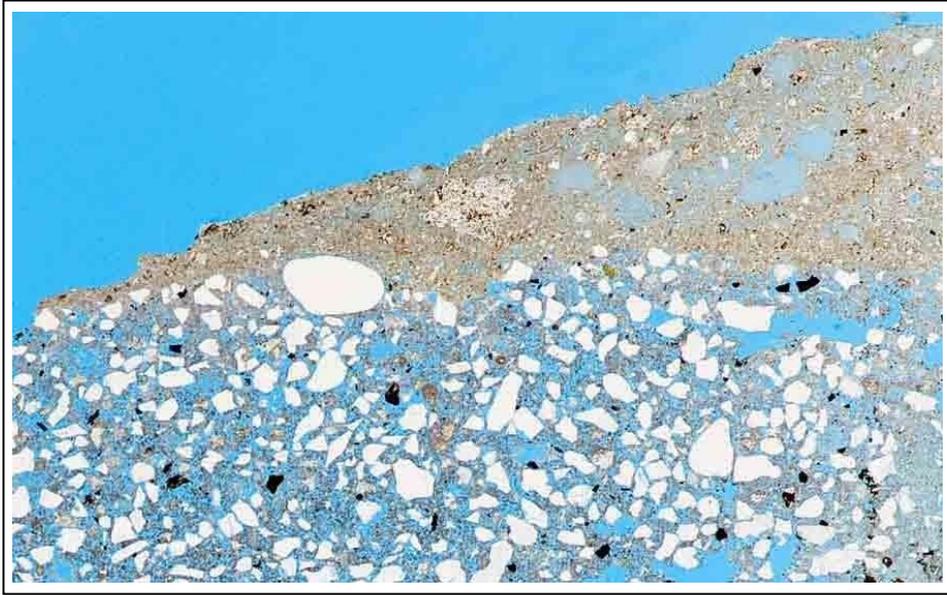
Fig. 2: Thin section from a well-preserved, smooth-surfaced area on N5 in transmitted light; calcite is stained yellow and the epoxy medium, blue. The cross-section shows two layers: a dense surface layer and a more porous lower layer with large quartz aggregate (white in this image) and small black ilmenite particles. Width of sample is 11 mm. Photo by Mel Wachowiak.

The cause of surface loss was investigated in cross-sections. Deterioration in the form of conversion of calcite to gypsum following uptake of atmospheric sulfur oxides was found even where the surface layer is still present, as in Fig. 2. An SEM image of that sample shows sulfur to a depth of ~50 μm from the surface (Fig. 5). On a sample from medallion S9 taken from an area that has lost most of the surface layer, in contrast, calcite was found to have converted to gypsum to a depth of ~250 μm (Fig. 6); below that, an even thicker zone of mixed gypsum and calcite was present. Thus, it appears that loss of the surface layer has increased the depth of conversion to gypsum, probably in part because of the porosity of the lower layer. A major source of sulfur was almost certainly coal, used to heat the Arts and Industries building until around 1910. The amount of airborne sulfur in the vicinity of the building has been limited since then, and the current rate of sulfation of the medallions should be minimal. Deterioration, however, is likely ongoing because gypsum is approximately one hundred times more soluble than calcite. Several observations underline the key role that rainwater plays in deterioration. Greater water absorption during rainfall and slower drying afterward were observed on high-relief areas, in contrast to low-relief areas (cf. Fig. 7 and Fig. 8). Moreover, high-relief areas invariably appear clean and light,

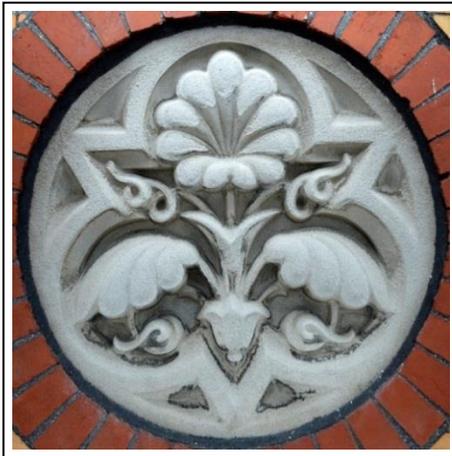
Fig. 3: Medallion W10, before treatment (January 30, 2013).

almost certainly from ongoing dissolution of gypsum by rainwater; while recessed areas are dark and smooth, with soiling retained by relatively intact surface layers (Fig. 3). Visual comparison also indicated that predominant rain directions play a role in greater surface-layer loss on west and north façade medallions compared to those on east and south façades. An unexpected finding was that both thin sections showed thin surface layers (~5-7 µm thick) enriched in fluorine (Fig. 5). This is attributed to past hydrofluoric acid or ammonium bifluoride cleaning of the building.

Concern about deterioration of the medallions has been limited, because they remain readable from a sculptural standpoint on account of relief areas being light in value and background areas dark (Fig. 3). Substantial loss of surface layers and conversion of calcite to gypsum, however, led to a proposal for test treatments. The relatively good condition of the cast stone and limited experience and literature in treating similar problems also rendered test treatments a sensible option.

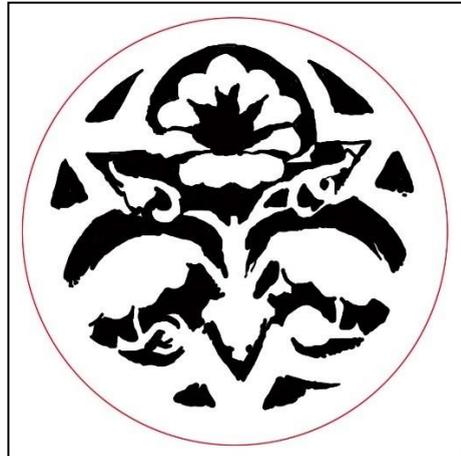
Fig. 4: Drawing after the previous, with areas retaining the surface layer marked in black; such areas are invariably lower in relief.

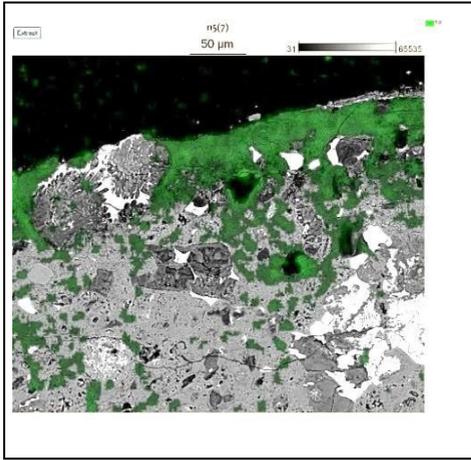
Fig. 5: SEM backscatter electron image of the fine-grained upper layer of thin section N5 (cf. Fig. 3) shows raw sulfur x-ray counts at the surface in green false colors to a depth of ~50 µm. The thin bright line at the upper right surface is enriched in calcium fluoride.

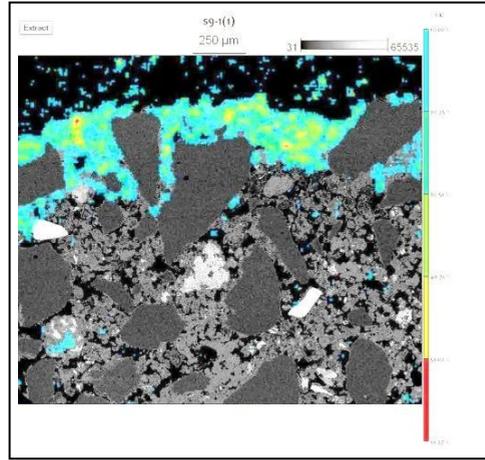
Fig. 6: SEM backscatter electron image of thin section S9, which has lost nearly all of the fine-grained upper layer, shows sulfur to a depth of ~250 µm in false colors. Only sulfur above 10 atom per cent (blue on the bar at right) is displayed, ranging up to 61% (red on the bar). Large dark gray particles are quartz.

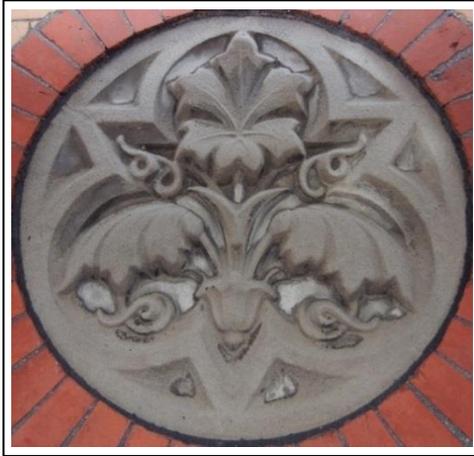
Fig. 7: Medallion W9 after rainfall, before treatment (September 28, 2012). Low-relief areas are dry, indicated by their relative lightness; in contrast, when the entire medallion is dry, low-relief areas are darker than high-relief areas (cf. Fig. 8).

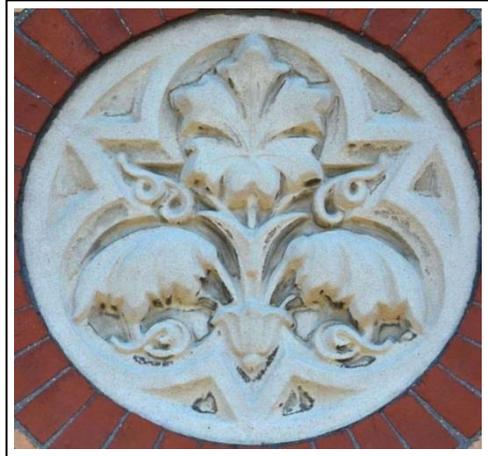
Fig. 8: Medallion W9 two-and-a-half years after treatment with ammonium carbonate, $\text{Ba}(\text{OH})_2 \cdot 8\text{H}_2\text{O}$, and ammonium oxalate (July 16, 2015).
