CONDITION SURVEY OF AQUIA CREEK SANDSTONE COLUMNS FROM THE U.S. CAPITOL RE-ERECTED AT THE U.S. NATIONAL ARBORETUM

Emily Aloiz,^{*1} Carol Grissom,² Richard Livingston,³ and A. Elena Charola⁴

Abstract

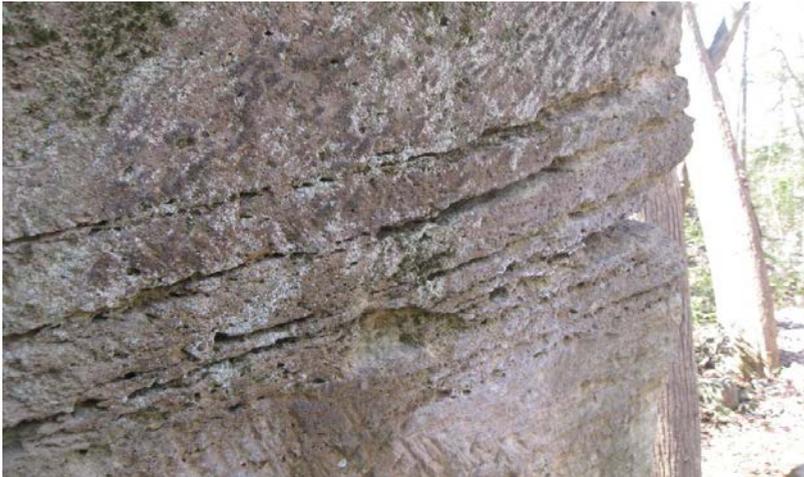
Figure 2: Quarry face on Government Island, a state park where Aquia Creek sandstone was once quarried, with horizontal voids indicating stone unsuitable for buildings (2013).

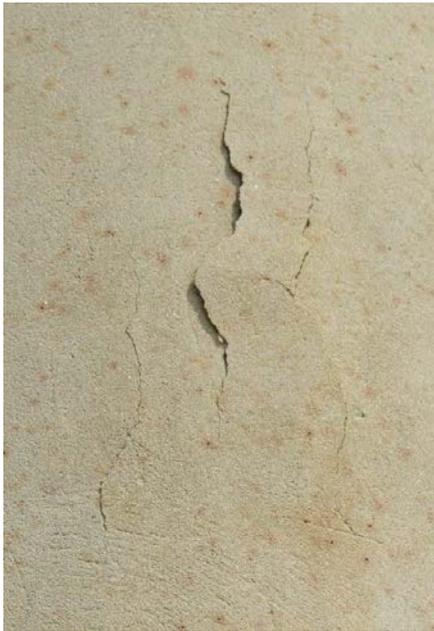
Pervasive surface delamination was identified during the condition survey. Contour loss, where the delaminated surface has completely detached, was found on 18 of the 22 shafts during this study, mostly around the bases of the shafts, but also around shaft repairs and isolated areas higher up on the shafts. Figure 3 shows an area of detachment, and Figure 4

shows an example of contour loss at the base of a shaft. The detached crusts range up to 13 mm in thickness. The same type of deterioration was found on many of the pedestals, although the thickness of the crusts (1-2 mm) was much less than the surface crusts on the shafts. The crusts are well cemented on their surfaces, where McCarthy and Ginell (2001) found a higher quartz to feldspar ratio based on X-ray diffraction intensities and lower porosity by both image analysis and mercury porosimetry.

Figure 3. A detachment on the shaft of column L20, which is has not progressed to contour loss.

The breakdown and redeposition of minerals on the surface of Aquia Creek sandstone is inevitable outdoors, but loss of surface crusts may be hindered. Grouting is recommended in voids behind detached crusts to reestablish adhesion and stop water from pooling. Where the crusts have already been lost, consolidation can strengthen the fragile surface. Voids were filled on two columns behind detached surface layers. Use of a pozzolanic lime-based grout is recommended as it sets with moisture and chemical reactions to form vapor-permeable solids that have properties similar to Aquia Creek sandstone. Voidspan's CG-70 was tested in four areas of detachment; a year and a half later the surfaces are still intact. Monitoring will determine the long-term effectiveness of the treatment. Applying a surface coating such as paint would not stop void formation and might even encourage it by making the surface layer less permeable. Furthermore, the application of Conservare H in 1988 does not appear to have stopped contour loss on the two columns to which it was applied, but left visible glossy streaking that is still visible today.

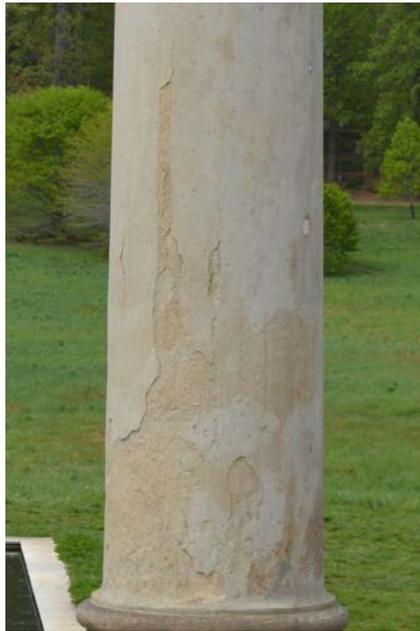
Figure 4. The lower shaft of column L20 has the highest contour loss, extending more than six feet; a detached area reaches even higher. The area of detachment can be seen on the left.

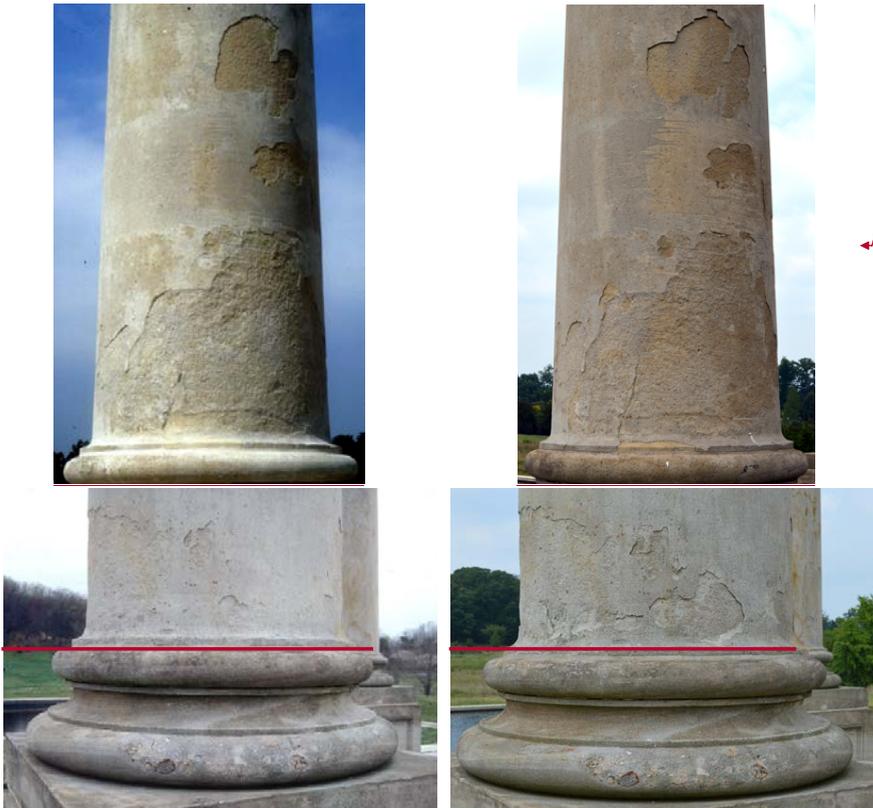
Washington D.C. has a humid, subtropical climate with multiple wet/dry and freeze/thaw cycles that would continually stress weaker areas, eventually leading to contour loss, although the exact driving mechanism remains a matter of discussion. Detachment was likely occurring early in the columns' existence while still on the U.S. Capitol or in subsequent storage, since significant contour losses were documented by the architectural firm Oehrlein and Associates just before the columns were erected in the Arboretum (EDAWinc. *et al.* 1987, A2-A7). The earliest photographs that could be obtained showing contour losses were taken by the second author in 1988: comparison to current condition suggests about 10-15% additional loss over the 25 years since then (Figures 5 and 6).

Figure 5. Contour losses on column L53 in 1988/2000 (Grissom).

Figure 6. Same location as the previous in 2013, showing an estimated 10-15% additional contour losses after 25+4 years (Grissom 2013).

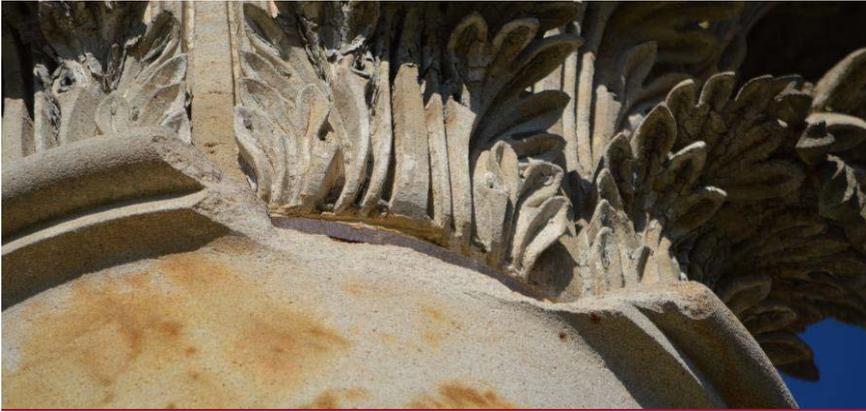
Wrought-iron rings set in lead at the top of each shaft present a second instance of inherent vice. Since the rings are covered by the capitals, it is almost certain that they were installed at the time of original construction, although their purpose remains unclear. Corrosion of the iron has resulted in cracking or loss at 13 of the 22 astragals, as seen in Figure 7.

Figure 7: Detail of stone loss from L13's astragal, revealing its iron ring directly below the bottom edge of the capital.

The astragals present the most complex and difficult problems for the columns, since the lead-bedded iron rings set into the top of column shafts are covered by the capitals. The only means of completely halting deterioration would be to remove the rings. This would be nearly impossible to do without harming the stone, since the capitals are fixed to the shafts with epoxied steel dowels and mortar. In lieu of removal, a method to slow water entry is required such as flashing to top surface of the astragals.

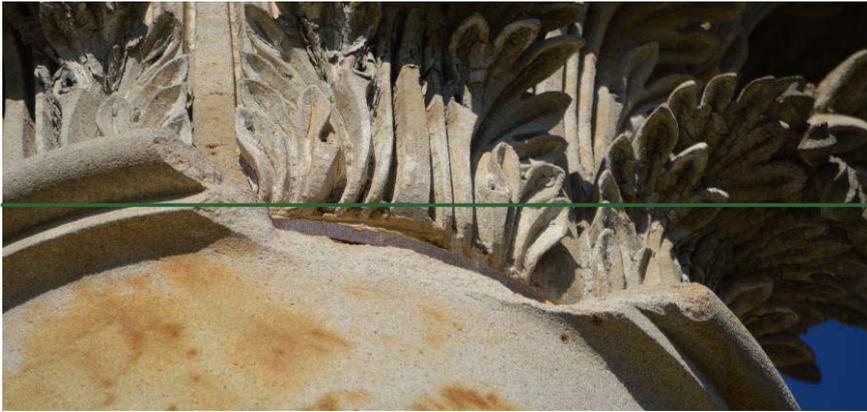
Figure 7: Detail of stone loss from L13's astragal, revealing its iron ring directly below the bottom edge of the capital.
