## **Conservation and restoration of the Don José I Monument in Lisbon, Portugal. Part II: Metal components**

### **Abstract**

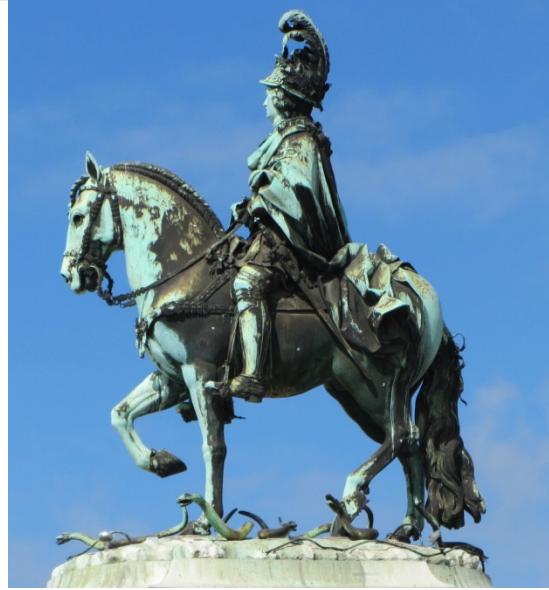
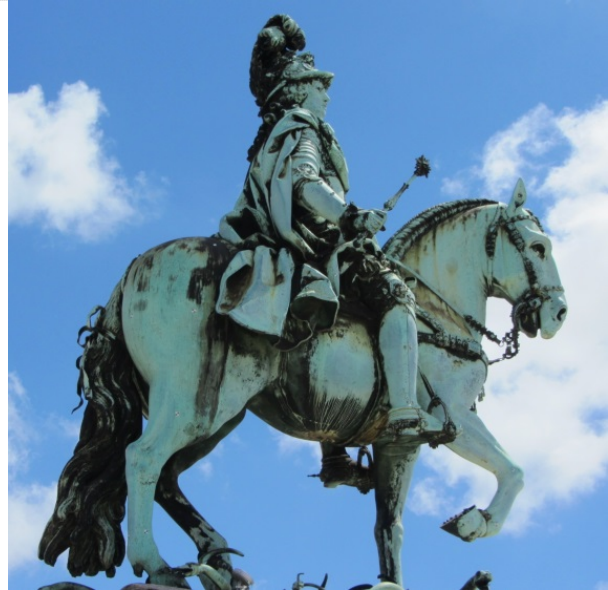
The main direction of rain and winds is from the SW, thus the south and west sides of the statue are subjected to more rain and wind than the north and east sides. The former, rain exposed sides show a green patina, while the latter have mainly a black patina covering them. Large areas of the statue are covered with a dense black patina, extremely adherent to the substrate. This fairly uniform patina forms alternating stripes with the underlying green patina in areas with intermittent water run-off. In others, small minuscule black islands appear in the green covered areas. The black color is mainly due to air pollution particles deposited on the surface. The spatial distribution of these patterns, their composition and stratigraphic layering have determined the approach to be followed in the intervention as discussed below (Figure 2).

Figure 1. D. José I statue in Lisbon. East view (left) shows the prevalence of dark patinas, while in the west side (right), more exposed to the marine winds and rains, green patinas prevail.

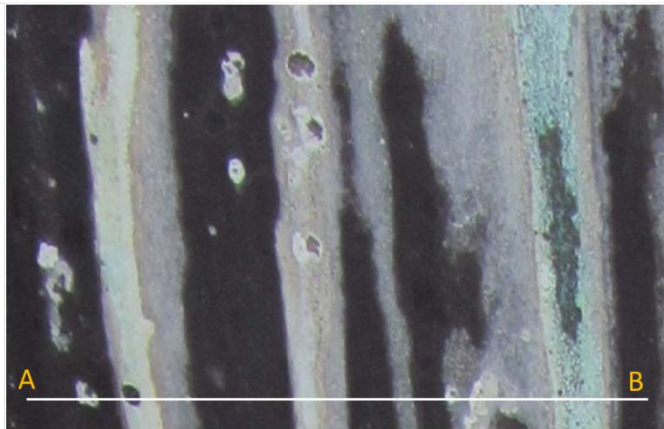
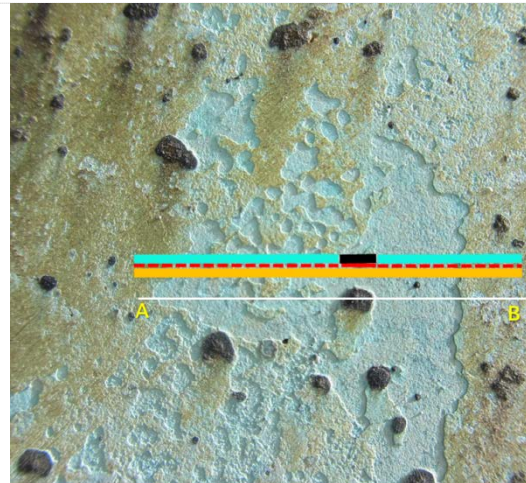
Figure 2. Sequence of black and green stripes in areas affected by intermittent runoff water (left figure-width 20 cm) and the typical green deposits where some black “islands” remain (right figure-width 5 cm). The colored bands are schematic representations of the stratigraphic sequence across lines AB in each picture. The greenish pustules in the black stripes in the left are eruptions caused by the formation of nantokite.

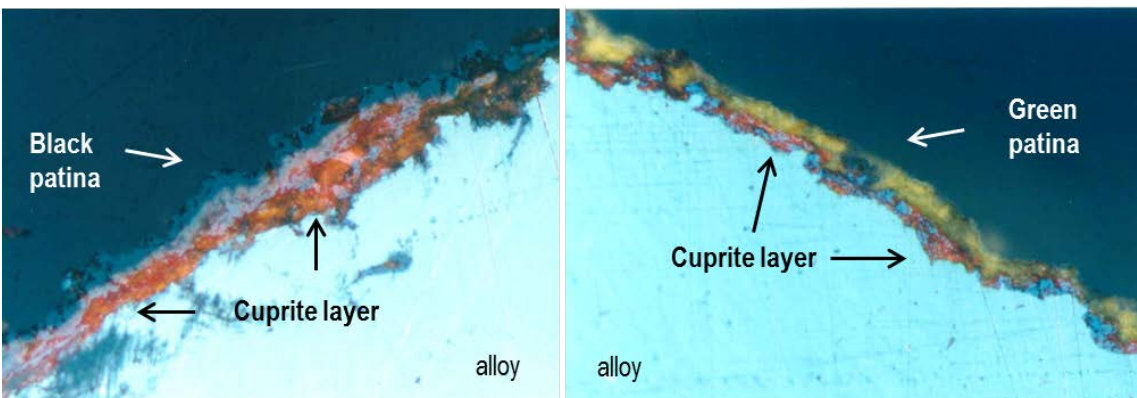
Figure 3. Microphotographs of cross sections in polarized light with Normarski interference contrast. The cuprite layer in red is more or less continuous under a dark patina (left) while it is clearly discontinuous under the green patina (right). The width of each figure is about 1.2 mm.

Figure 3 shows microphotographs of cross sections showing the two typical situations encountered: dark patinas on the left; green patinas on the right. It can be seen that under the dark patinas, there is a fairly continuous red layer, which analysis has shown to be cuprite, the cuprous oxide ( $\text{Cu}_2\text{O}$ ). Contrariwise, the green patinas, —mainly composed of brochantite, a basic copper sulfate ( $\text{Cu}_4\text{SO}_4(\text{OH})_6$ ), and mushitonite, a copper tin hydroxide ( $\text{CuSn}(\text{OH})_6$ ), — only have a discontinuous cuprite layer underneath them. The hydrated basic copper chloride ( $\text{Cu}_7\text{Cl}_4(\text{OH})_{10}\cdot n\text{H}_2\text{O}$ ), as well as a basic lead, iron copper sulfate ( $\text{Pb}(\text{Fe,Cu})_3(\text{SO}_4)_2(\text{OH})$ ) were also identified in association in the green areas not fully exposed to direct washing rains [1].

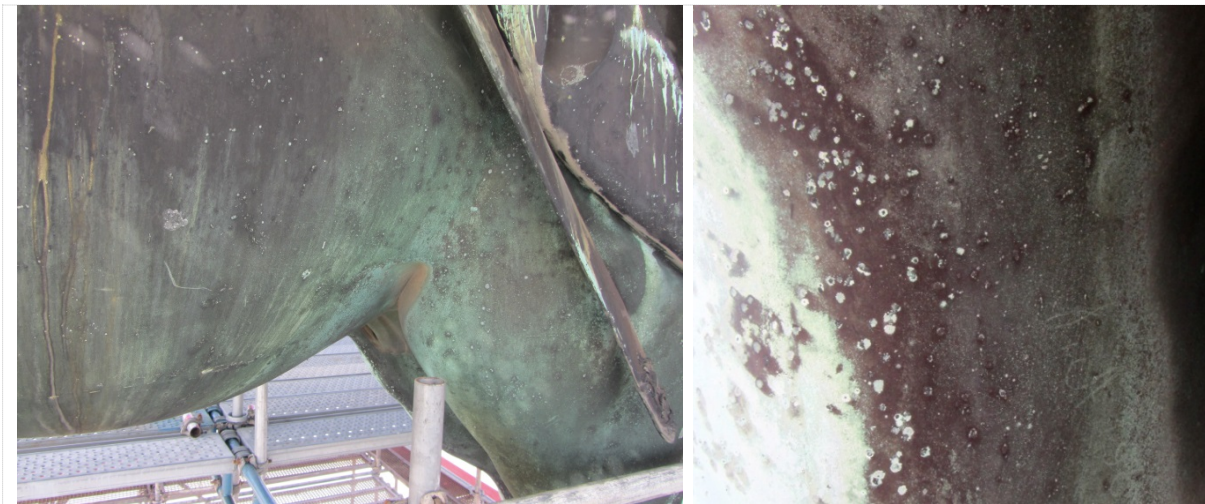
In some sheltered areas, a blackish patina occurs over a green patina with frequent presence of greenish pustules and other similar surface disruptions (Figure 4). In these areas, the superficial alteration products are constituted mainly by the hydrated basic copper chloride mentioned above, with some quartz ( $\text{SiO}_2$ ). In green areas below the black patina, a basic copper chloride

was found, atacamite ( $\text{Cu}_2(\text{OH})_3\text{Cl}$ ), as well as cuprous chloride, nantokite ( $\text{CuCl}$ ) [1, 4,]. Contrarily to the basic copper sulfates, nantokite is unstable and it doesn't offer any protective action to the copper alloy. This circumstance implied the need to address the areas with nantokite as requiring specific measures to stop or at least to drastically reduce the impact of this alteration mechanism in the overall condition state.

Figure 4. Aspect of the green patina covered with a blackish layer (left), and a detail of the surface pustules and disruptions (right).

In the zones where nantokite was forming, a specific treatment was necessary since corrosion by sodium chloride is an auto propagating process because the chloride ion from the cuprite is released once this cuprous chloride is transformed in other less soluble compounds such as brochantite, other sulfates, or carbonates. The traditional process to attack this problem is the application of corrosion inhibitors, such as benzotriazole. Since most of these products are toxic

and may even be mutagenic, a different approach was followed, such as applied in the case of the copper roof of the Santa Maria delle Grazie, in Milan. In this intervention, a sodium oxalate solution (5% w/v) was used with a very positive outcome [7]. A similar approach was used on several bronze sculptures in Milan, with excellent results [8]. Therefore, this same approach was used on the “cleaned” statue of D. José I statue. The positive results can be explained by the reaction that occurs during the treatment:

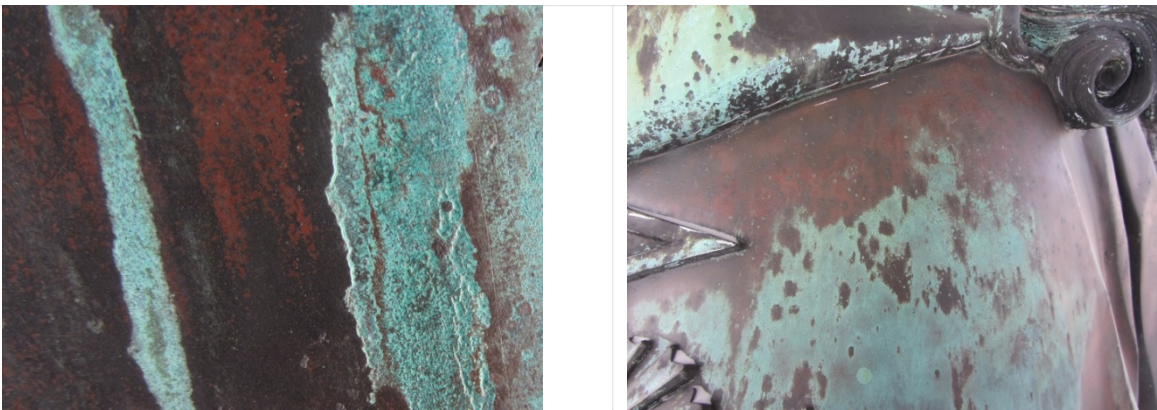
Figure 5 illustrates the first steps of the progressive disruption of the original protective cuprite layer. On the left, the cuprite layer is still perceived through the relative transparent black patina while the green stripes are at a lower topographical level, as a result of the erosion of the upper cuprite+black layer. On the right, the surface during a cleaning test is shown to illustrate the presence of a continuous cuprite layer after removal of the overlying black patina, as well as several dispersed “islands” of cuprite in the prevailing green areas. Also to be noticed is the reddish colour perceived as an underlying layer seen by transparency through the green cover.

The continuity of the cuprite layer in both situations is highly contrasting, as seen in cross section (Figure 3), but also perceived in superficial shots (Figure 5, right). These differences in the cuprite layer occurrence may correspond to two different genetic stages: initially, when a continuous layer could be formed, and subsequently, when cuprite no longer could form because of changed conditions so that it only developed discontinuously and was therefore far less protecting. The occurrence at two clearly distinct topographical levels, as seen in Figure 5, may constitute a significant evidence for this process.

Figure 5. Aspects of the cuprite covered situation (coloured reddish) and its transition to the copper green compounds. Left: Cuprite is the underlying layer of the black soiling; the green stripes have formed along the water runoff paths and stay at a lower topographic level showing that erosion has already taken most of the cuprite layer. Right: During a cleaning test the black soiling was removed leaving an almost continuous cuprite layer. The green compounds encroach on the cuprite layer leaving behind some residual cuprite islands.

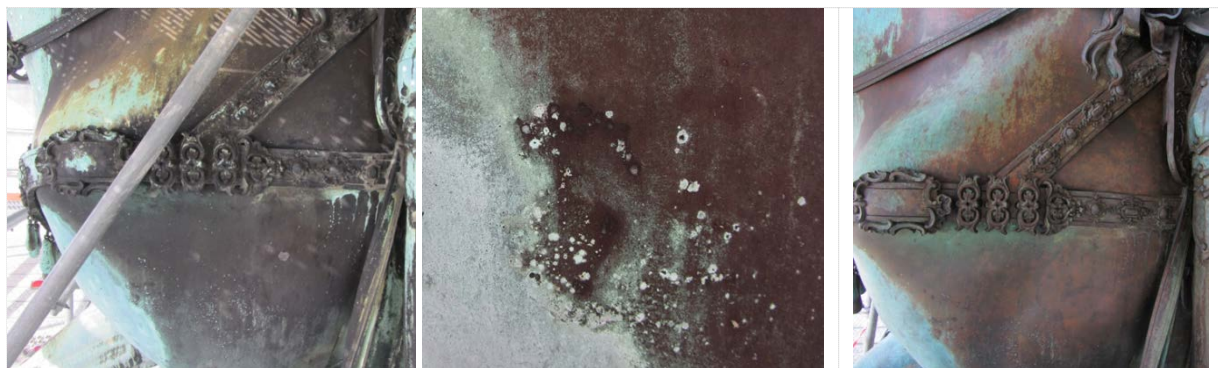
Figure 6. Aspects of a transition zone between the black and green patinas (left). The small bright dots of nantokite identified in the detail (center) show that they are in fact pustules protruding through the black cover thus acting as an entrance window of the corrosion agents to the underneath copper alloy. The same area after cleaning (right).

Areas with nantokite pustules represented the worst scenario for conservation. The soft products had to be eliminated and the existing chloride ions removed as far as possible. To avoid a repetition of this alteration mechanism, other measures were implemented as discussed subsequently.

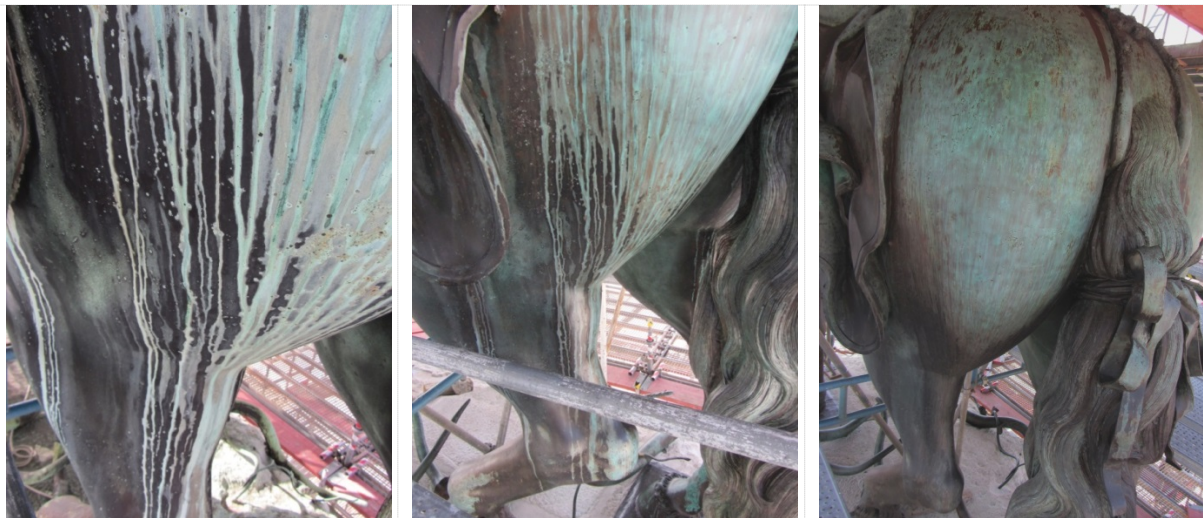
Figure 7. Aspect of a zone with highly a contrasting colored pattern before (left), after cleaning (center) and after cleaning and artificial patination (right).

Cleaning was one of the major operations required for the preservation of the statue. The memory values associated with it and its current impact in the popular iconography, required that the color contrast of the sculpture should be minimized. To balance the iconographic objectives with the conservation needs constituted a major challenge for the intervention team. Loose dust and soiling concretions were eliminated with water and soft brushing. Alteration deposits and the more adherent black ones were cleaned with controlled particle jets. To remove these deposits, a micro-jet sprayer at low pressure was used to spray spherical glass particles perpendicularly to the surface to clean as well as and to improve compaction on the irregular metallic surface. The experience obtained during the cleaning tests corroborated the patina development models, however a uniform clean level could not be attained, since the surface no longer is homogeneous. In areas where highly contrasting patterns coexist side by side (Figure 7), a balanced cleaning level was quite difficult, if not impossible to achieve, and only artificial patination applied at the time of the final protection solved the problem of disfiguring colored stripes.

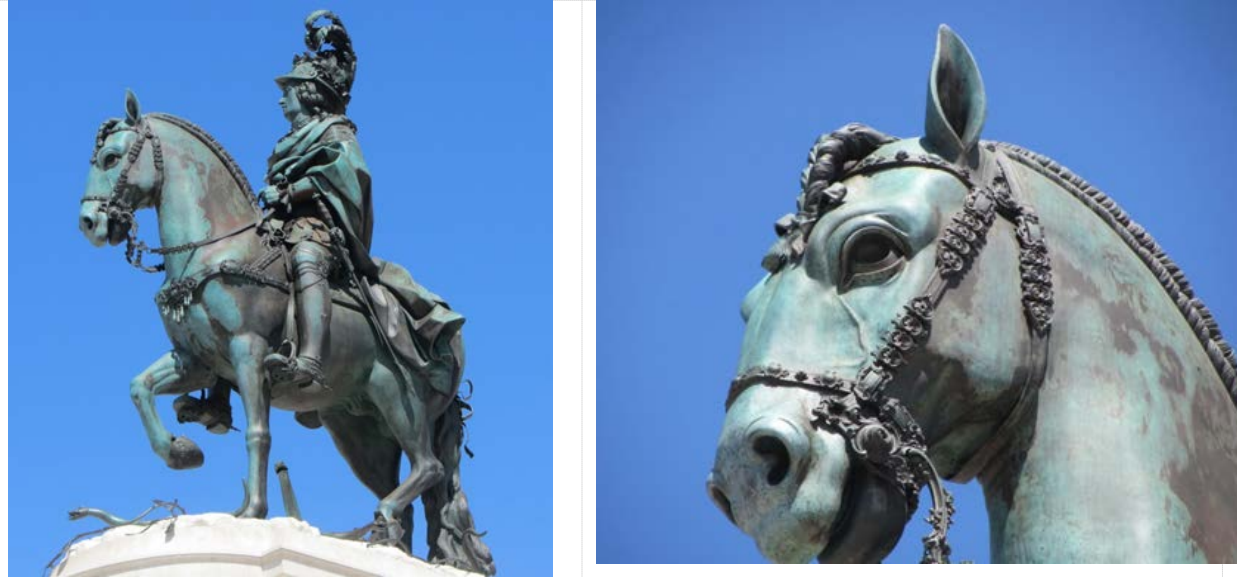
Figure 8. View of the statue after the intervention (left) and a close up detail (right).

The final treatment consisted of the application of several layers of protecting resins, such as Paraloid B44, and microcrystalline wax. During this phase, the areas with higher contrasting appearance were retouched with watercolor paints to achieve a more homogeneous appearance consistent with the iconographic value of this masterpiece sculpture (Figure 8).
