Conservation and Restoration of the Don José I Monument in Lisbon, Portugal. Part I: Stone Components

J. Delgado Rodrigues^{1*}, A. E. Charola², and F. M. A. Henriques³

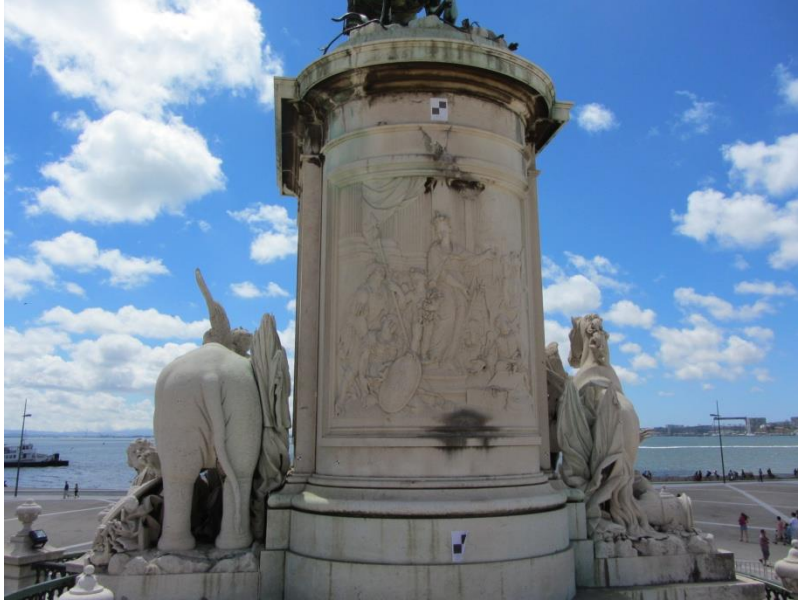
Figure 1. North view of the plinth and the adjacent sculptured groups before the intervention. The bas-relief depicts the allegory “Royal Generosity”.

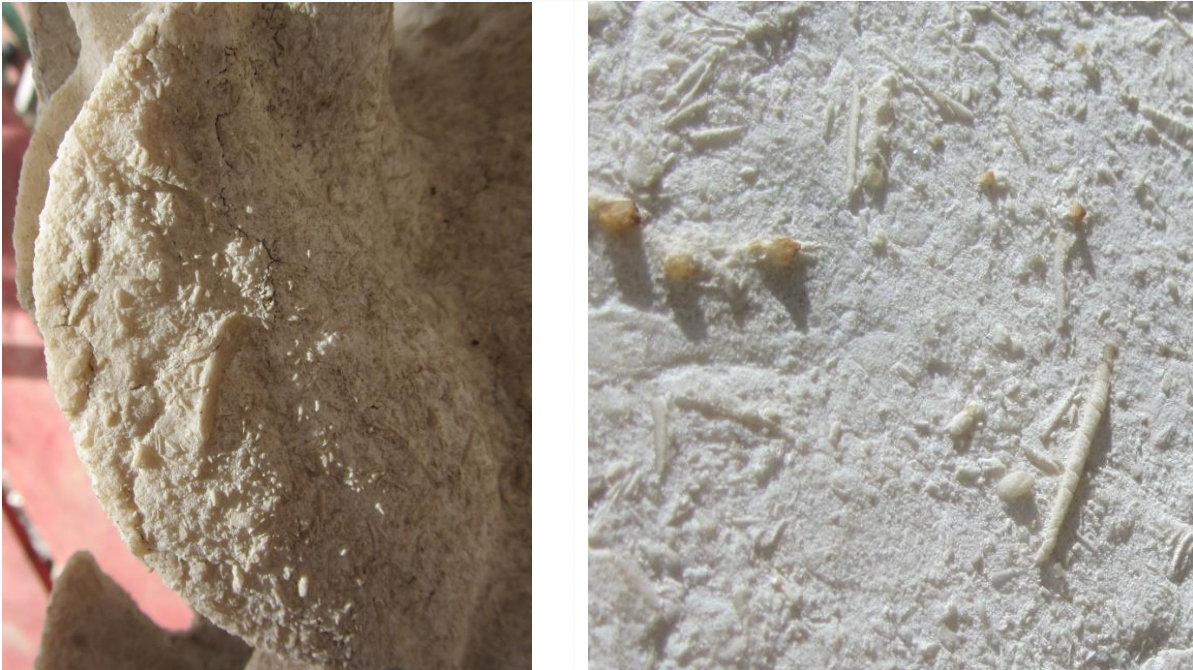
Figure 2. Differential erosion caused by the acidic run off waters (left). Fossil remains and some silica grains stay in relief on the stone surface (right).

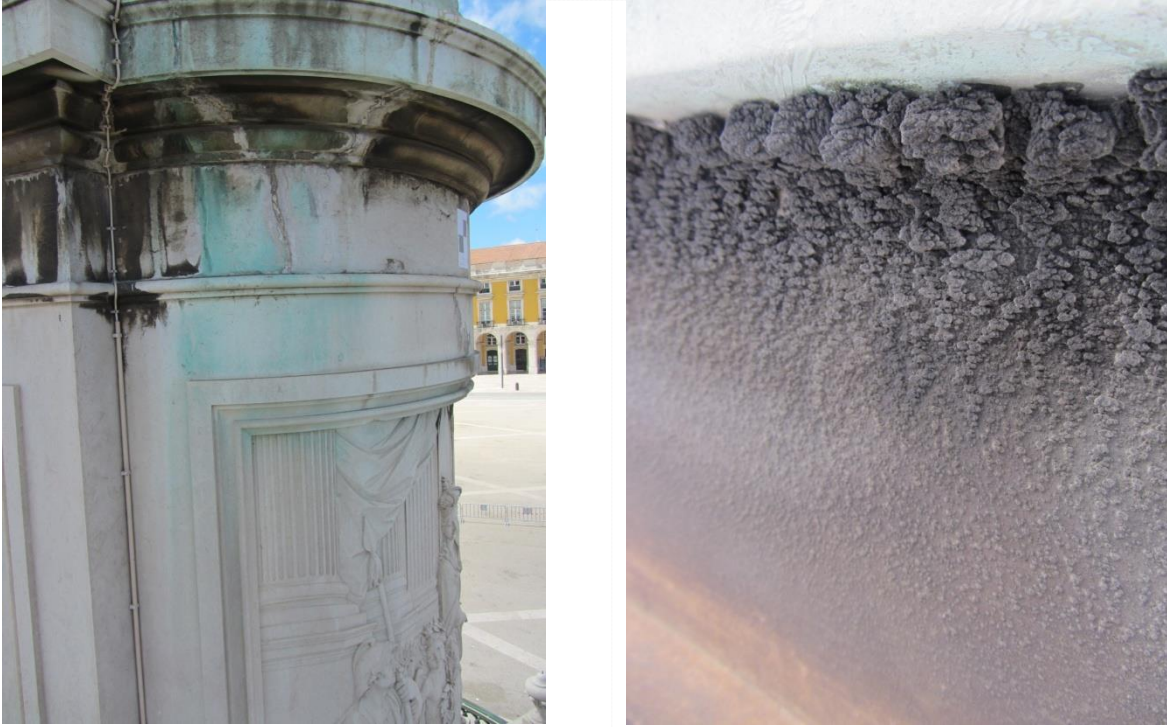
Figure 3. Aspects of the sheltered areas where black crusts are formed and the deposition of copper ions originated green staining (left). Black **gypsum** crusts developed thick deposits in the most protected areas (right).

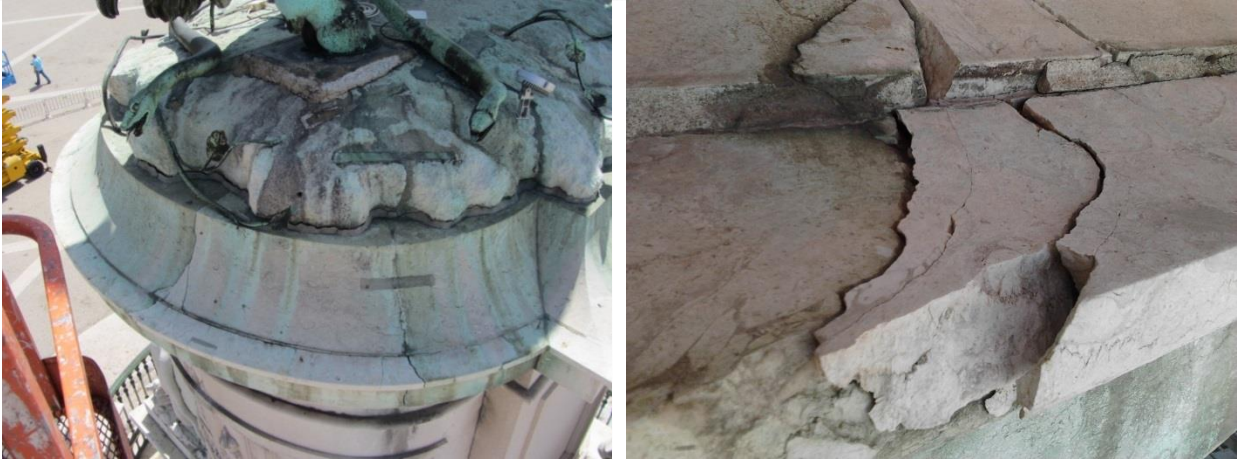
Figure 4. Details of the top and upper part of the plinth showing some fractures. Some of them were stabilised with bronze rivets during previous interventions (left). Detail of the fracturing pattern (right).

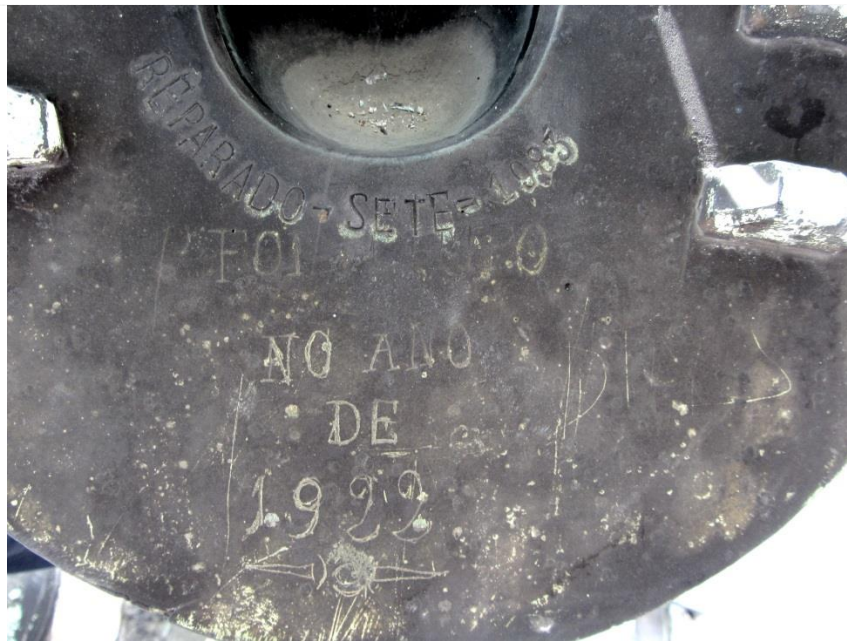
Figure 5. Incisions made in Detail of the horseshoe of the statue indicating incisions stating the date when that interventions were made in (1922 and 1983) were made.

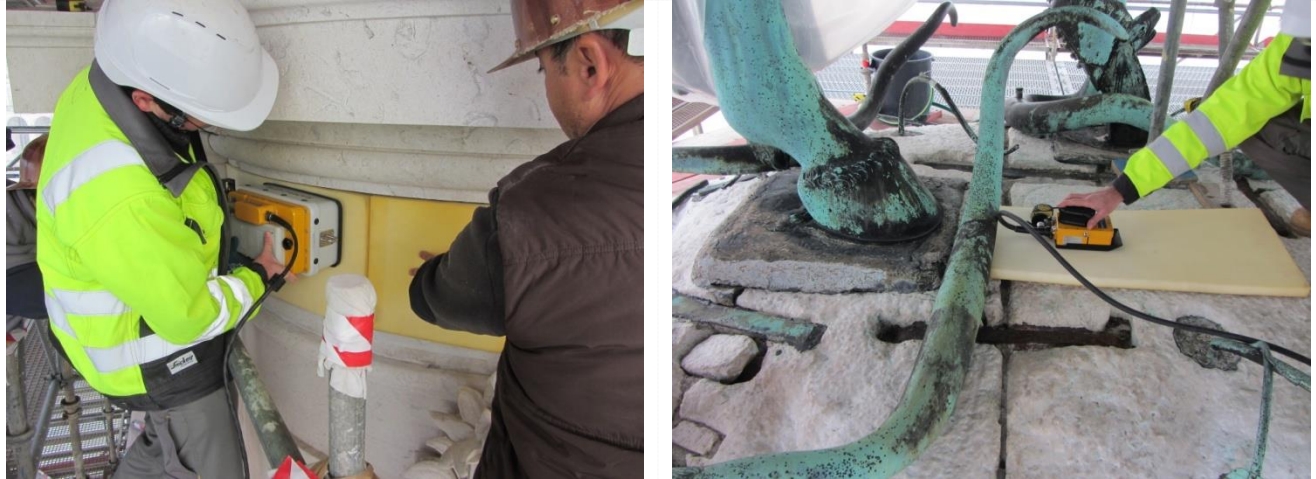
Figure 6. Survey with geo-radar in the upper part (left) and top of the plinth (right).

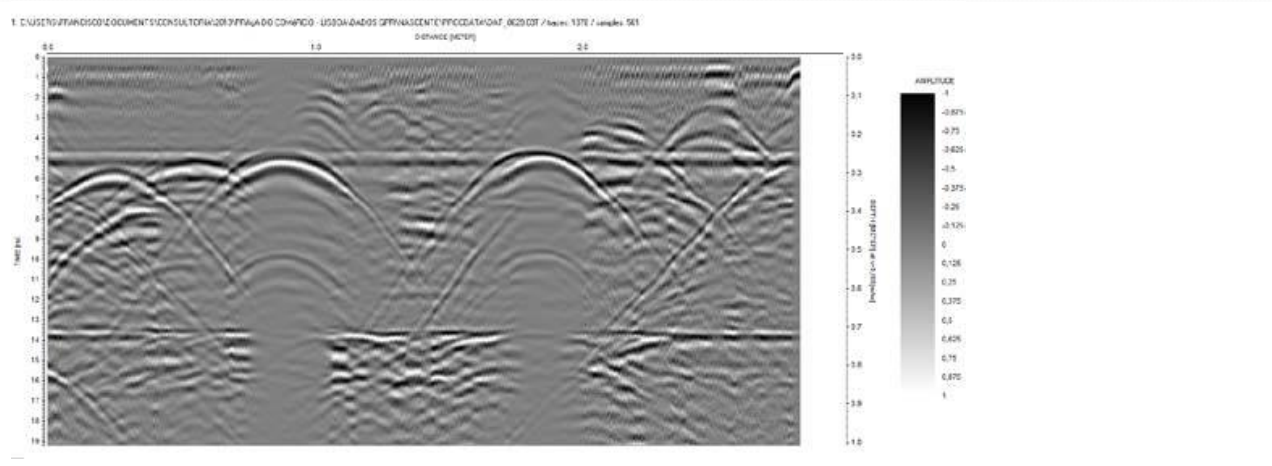
Figure 7. Example of a radargraph. The hyperboles are echoes from the connecting iron rods inside the plinth [8].

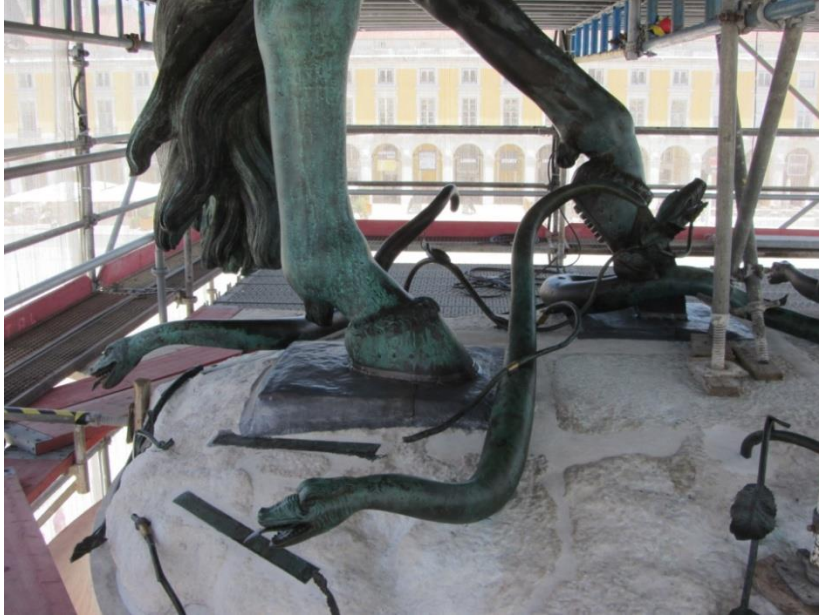
Figure 8. Aspect of the top of the plinth showing the fractures sealed and the visible bronze clamps treated.

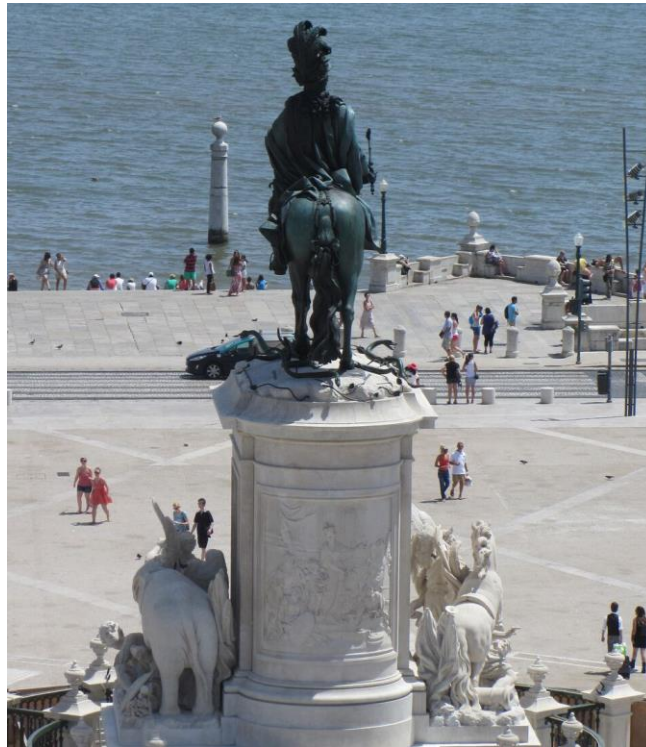
Figure 9. North view of the monument after total completion of the conservation intervention.
