EXTERIOR MASONRY CLEANING AT SAINT THOMAS CHURCH  
NEW YORK, NEW YORK

Frances Gale, Robert J. Koestler, Norman R. Weiss, A.E. Charola

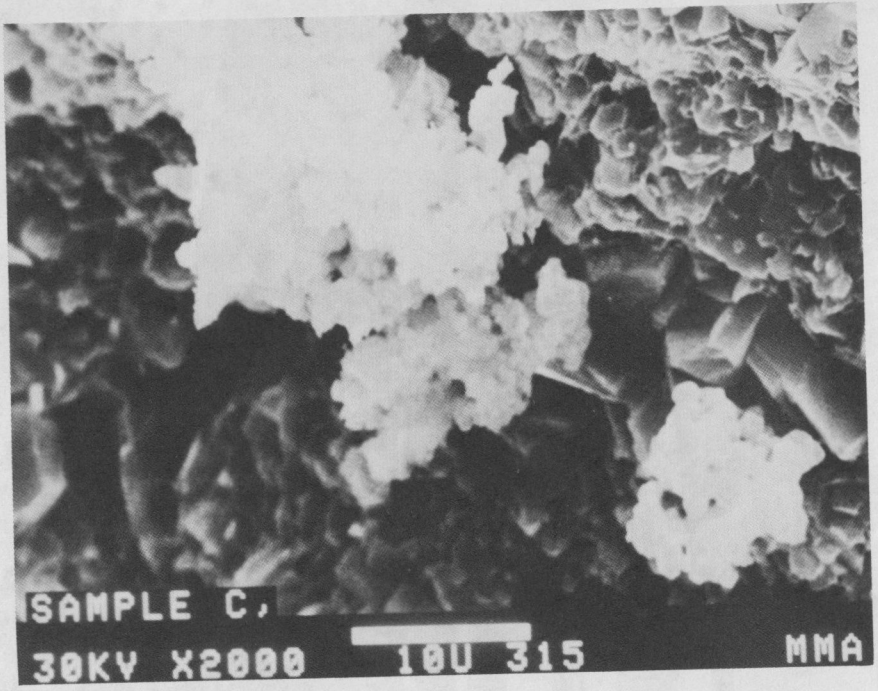
Fig. 2

Residue of the fluorosilicate treatment was found in all areas as evidenced by the spongy  $\text{SiO}_2$  masses resulting from the treatment (fig. 2), and the  $\text{CaF}_2$  deposits on the calcite crystals (fig. 3). These types of deposits have been described in other studies [10] as being characteristic of the fluorosilicate treatment of limestone.

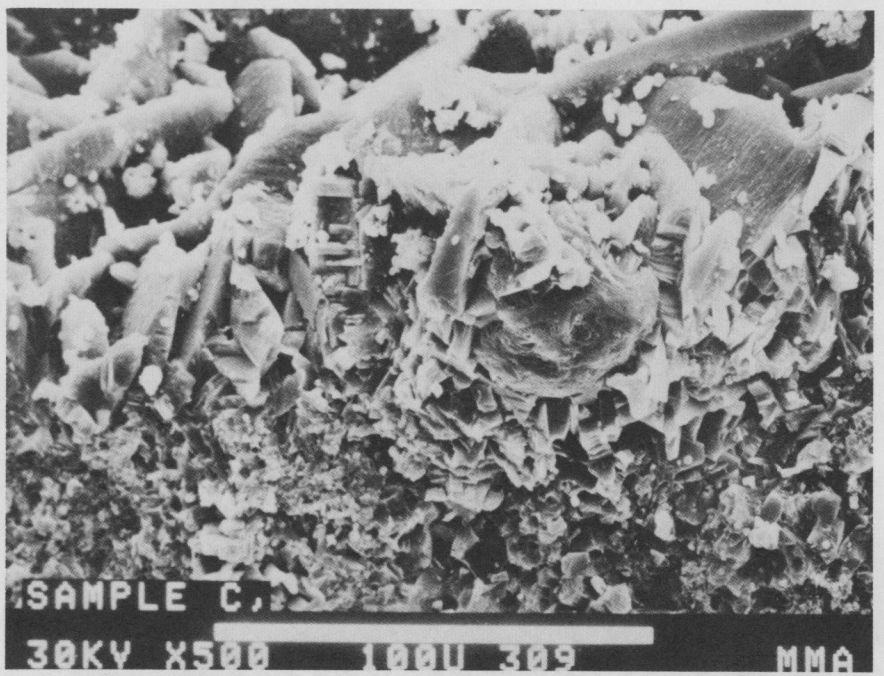
Fig. 4

In one area sampled, a black gypsum crust, typical of a limestone exposed to acidic air pollutants, was observed. The crust was covered with amorphous masses of silica and calcium fluoride crystals (fig. 4), indicating that the crust was not removed before application of the fluorosilicate treatment. Fly ash particles were also found on top of this layer (fig. 5). It is anticipated that there may be problems in cleaning areas of the church that have a black crust because it appears that, in some areas, the crust may be locked under the fluorosilicate treatment. Where this is the case, water washing may only remove surface dirt and fly ash.

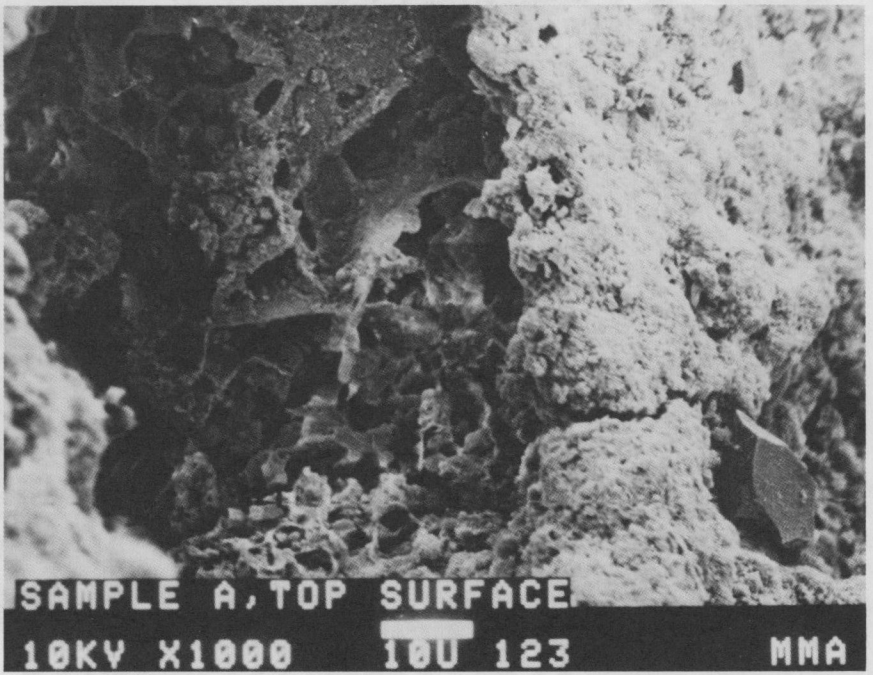
Fig. 6

Of the three locations examined for evidence of previous treatments, the polyester/acrylic residue was found in only one area (fig. 6). Here the surface film is apparently holding gypsum crystals in place. That the organic resin has not protected the stone beneath is evidenced by the gypsum crystals seen underneath the film. This factor and the absence of resin in other areas indicates that the treatment was not applied evenly or properly to the stone to create a protective layer. In the long run, however, the poor application of this resin may have been fortuitous: if it had sealed the surface completely, condensation might have occurred beneath it resulting in massive flaking of the surface. This application might have resulted in considerably more damage to the substrate [11].
