AIR-COUPLED ULTRASONIC SYSTEM FOR DETECTING DELAMINATIONS AND CRACKS IN PAINTINGS ON WOODEN PANELS

A. Murray¹, E.S. Boltz², M.C. Renken², C.M. Fortunko²,
M.F. Mecklenburg³, and R.E. Green, Jr.¹

ABSTRACT

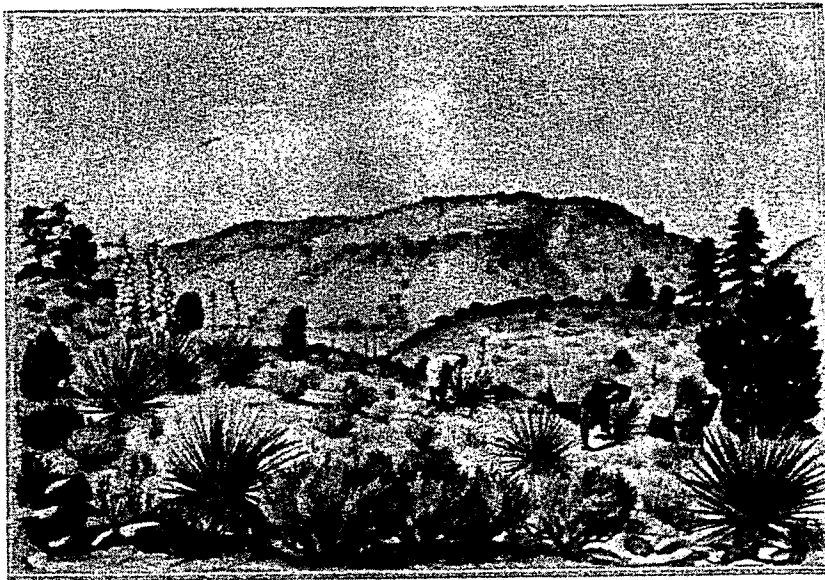
Figure 2. Photograph of the painting *Women Gathering Yucca Plants*, National Museum of American Art, Smithsonian Institution, transfer from the U.S. Department of the Interior

was painted by an unidentified artist in the 20th century and is shown in Figure 2. It is a watercolour and ink painting on illustration board (laminated paper board with paper layers glued to its surface) mounted on hardboard. The painting was approximately 6 mm (0.24 inches) thick. The illustration board had delaminated from the hardboard in certain, hard-to-determine areas.

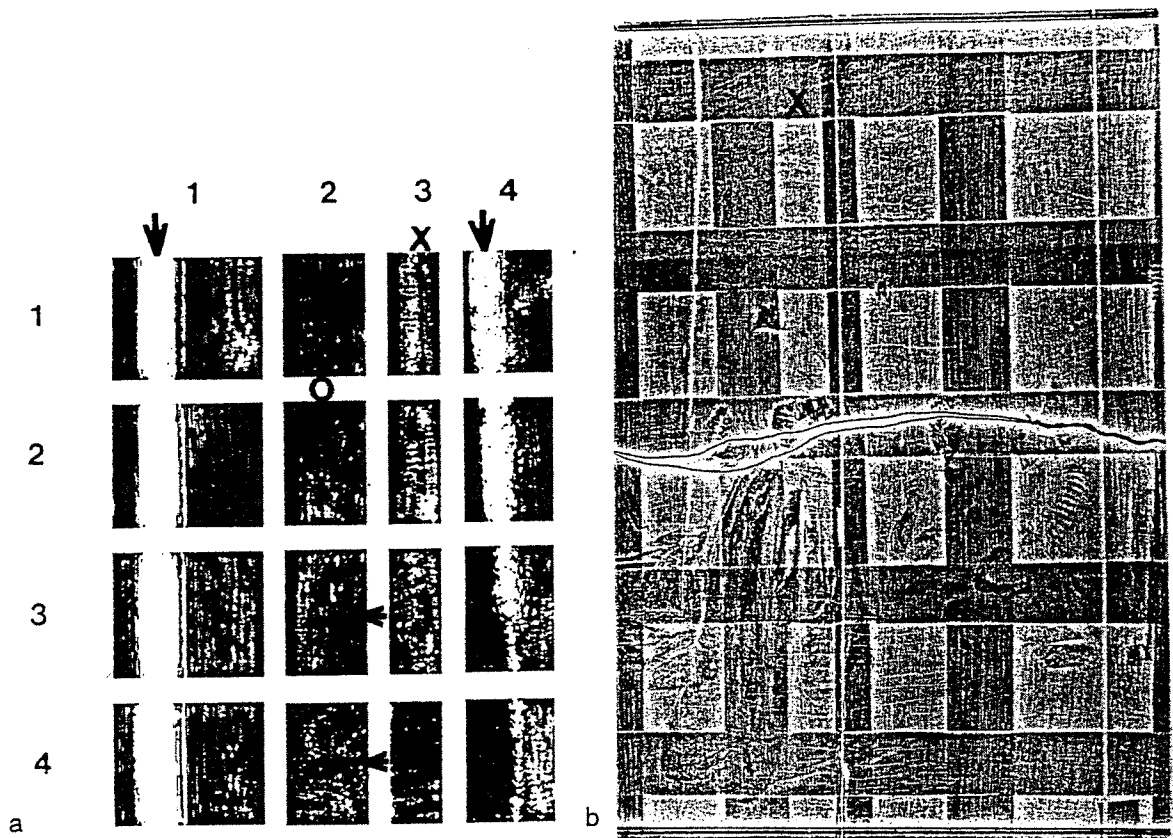
Figure 3. (a) Amplitude results from ultrasound scan of painting *Parental Admonition*, (b) xeroradiograph of the painting *Parental Admonition*: X is near closed crack which is hardly visible, and other features seen are the open cracks, the cradle, the hanging wire, and the image from the paint layer (x-ray tube was 130 cm or 51.2 inches above film, settings were between 40 and 60kV, 5 mA, and exposure time was one minute)

Investigations were made of the cradled painting *Parental Admonition*. In this case, the cradle on the painting had not adhered well to the panel so that the signal-to-noise ratio was insufficient to allow an investigation of the entire painting. Thus ultrasonic scans could be performed only in the 16 areas between the battens of the cradle. A variety of artifacts can be seen in the ultrasonic C-scan of the amplitude results shown in Figure 3a.

Two types of cracks exist: open cracks, where there is a visible opening to the other side, and closed cracks, where this is not the case. The open cracks appear as white lines (indicated by large arrows) and are larger on the ultrasonic image because of diffraction effects. Open cracks may mask other nearby artifacts, such as other cracks or paint craquelure. The closed cracks are dark lines (one is indicated by an "X").

Many of the vertical lines correspond to grain and closed cracks in the wood. Using the ultrasonic data only, it is difficult to distinguish the lines due to grain and those due to cracks. For example, in the two areas located in the second column and first and second rows, the lines could be indicative of either grain or cracks (adjacent to the circle).

The horizontal lines in the two areas in columns two and three and rows three and four are the craquelure running perpendicular to the grain. Some of the craquelure is identified by small arrows. Knots can also be seen in the first column, first row.

The closed crack marked by the X is detected with the ultrasound, but could not be detected visually or by xeroradiography (Figure 3b). In the positive xeroradiograph, the high density areas appear dark and those of low density appeared light. Visually it is very difficult to determine if the line indicates a crack running all the way through the panel, or merely an indentation in the wood.

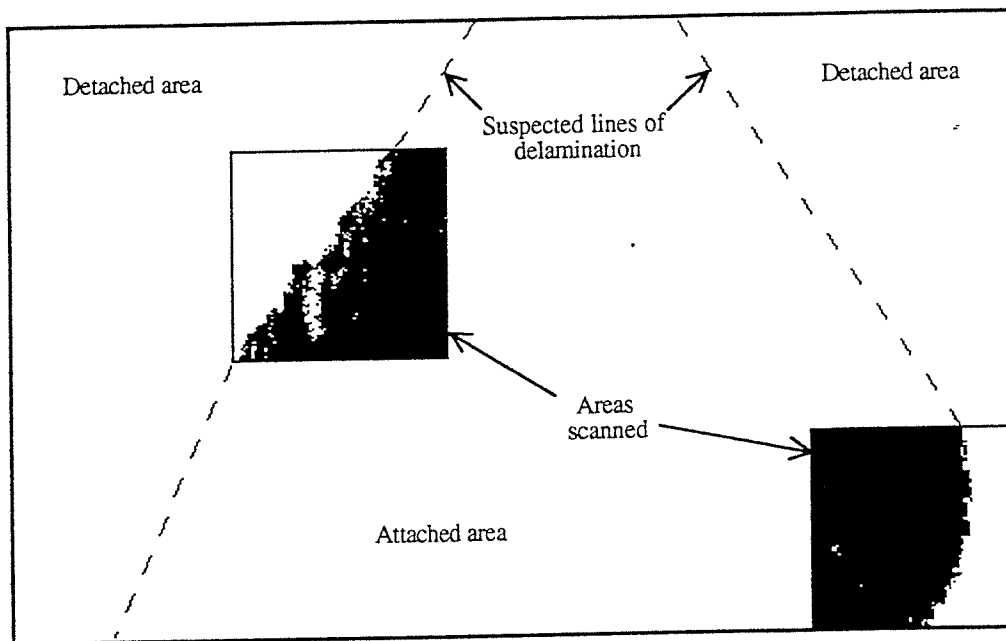
Figure 4. Outline of the front of the painting *Women Gathering Yucca Plants*, showing processed amplitude ultrasonic results from scanned areas (dotted lines show places at which it is suspected that the paperboard has become delaminated)

Figure 4 shows the outline of the painting *Women Gathering Yucca Plants* (Figure 2), and the results from ultrasonic imaging of two areas within the painting. The processed amplitude scans are used as they show the delaminations most clearly.

The regions where the paperboard is detached from the hardboard are white. The dotted lines show the places at which it is suspected that the paperboard has become delaminated. The entire painting would need to be scanned to validate these lines. As expected, the xeroradiography (which is not shown) does not detect any delaminations.
