## Examination of the Ardagh Chalice—A Case History

In June 1961 the chalice was taken to the Research Laboratory of the British Museum for repair because it had become loose at the joint between bowl and foot. This necessary work was also to provide a convenient occasion to study the chalice, both in order to discover how reliable for modern usage Dunraven's account had been and also to analyze its materials and construction.

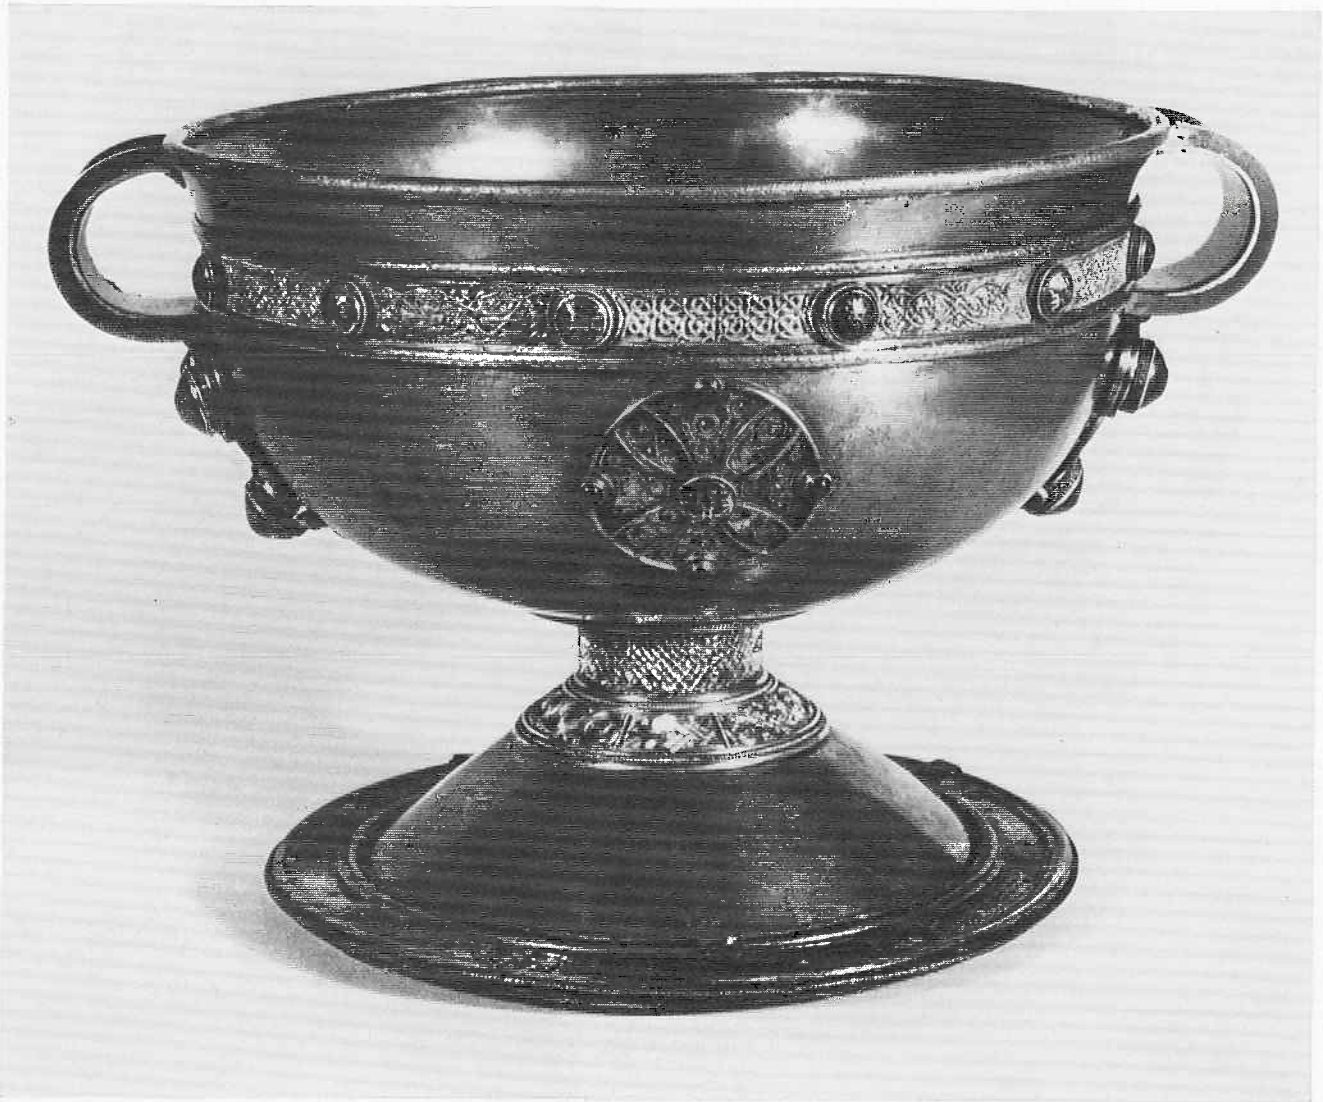
Fig.1 shows the chalice as received. It consisted essentially of a silver two-handled bowl joined to a silver foot through a gilt-bronze neck. The bowl is decorated with a rim, with two handle-escutcheons beneath the handles and with two roundels, one quite clearly visible at the front. It was decorated

1. The Ardagh chalice as received.

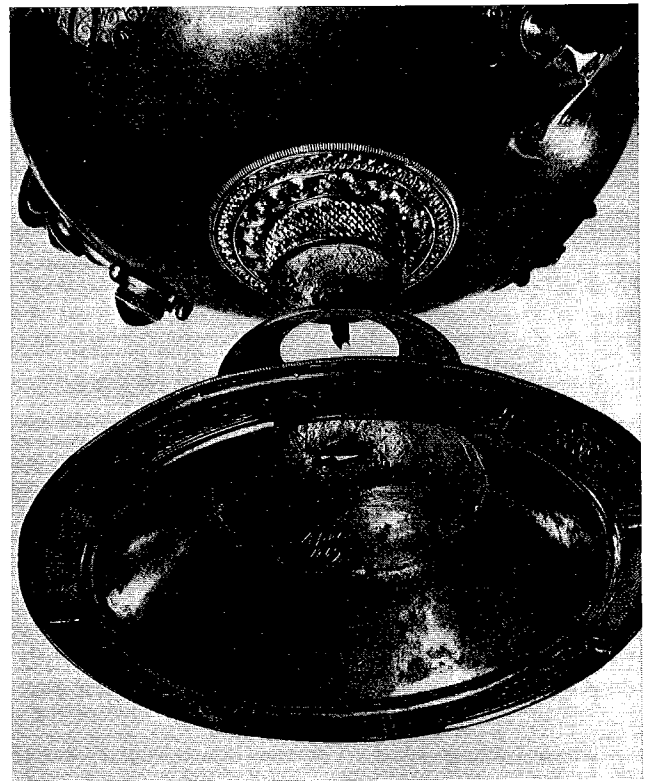
4. Removal of the foot-cone and the lower neck ring to reveal a mass of lead cast into the neck.

The next stage of exploration was to lift away the foot-cone. This revealed the lower of the three rings of the neck assembly and also exposed a mass of lead, fig. 4, that locked the bolt into the central ring of the neck. A loose stud that fell out of the foot-girdle during this work was immediately taped on to the appropriate position of the bowl, using pressure-sensitive tape, as a short-term precaution against loss or damage (see upper right-hand corner of fig. 4).

At this stage of examination it was believed that the lead in the neck had been inserted by Johnson, the jeweler who first examined and cleaned the chalice, and that it could therefore be removed if need be because it was not original. In fact it was shown later to have been original, but removal now was essential, whatever its origin, because it was endangering the stability of the chalice: the lead had corroded — the crust of corrosion products on it is visible in the photograph — and had been forcing the foot away from the bowl. This turned out to have been the source of weakness in the neck that had initiated the work.

The lead was removed very carefully. It was first channelled annularly with a rotary file with care that the file did not approach any part of the chalice. Then the thin wall of lead that had been left against the central bolt was carefully levered back into the annular space made by the file. The neck could then be lifted away from the bowl. In fig. 5 it can be seen with its lead still within it, turned over and laid down alongside the place from which it came. Looking at the inside of the neck you may note that the lead that had lain against the silver bowl is white with corrosion products. Circular turning-marks in these suggest that a lathe had been used. In the periphery of the disc there is a greenish-white deposit that actually represents corrosion products from the bronze of which the disc was made. On the silver bowl may be seen a circle of untarnished silver. This had been protected from the tarnishing gases in the atmosphere by the seal of corrosion products around the periphery of the disc. Toward the center of the clear circle of silver one or two patches of white material adhere firmly. These provide evidence that the expanding corrosion products of lead had been forced tightly against the silver at these places.

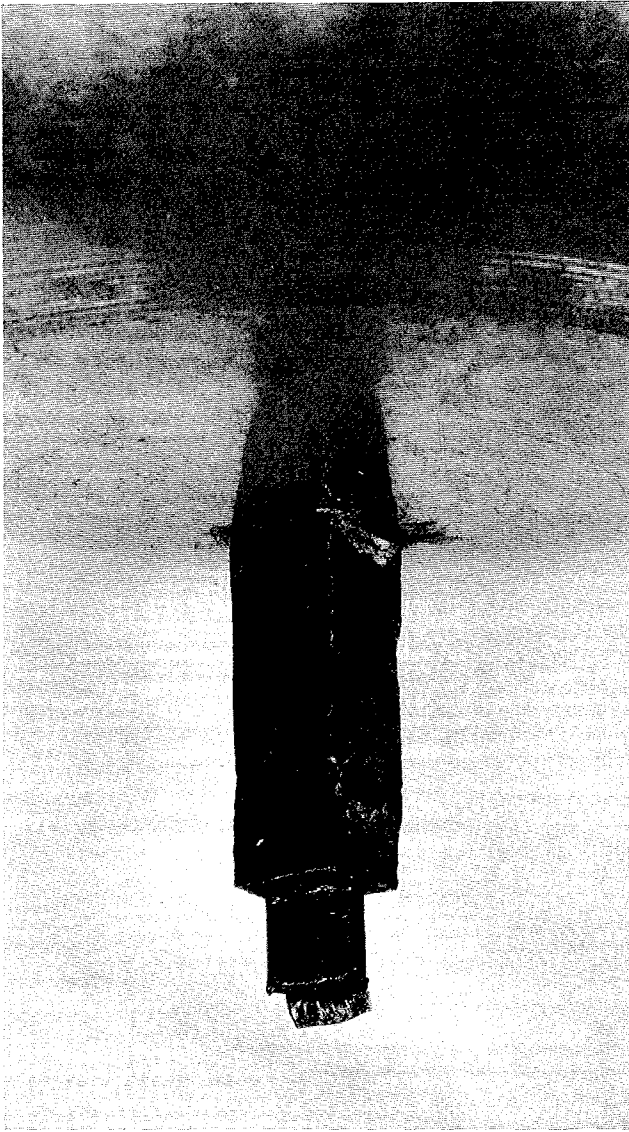
Now, although the copper bolt observed was not the iron bolt noted by Dunraven, an iron key was found that actually passed through the slot in the copper bolt and lay in the two additional slots found cut across the central square. The iron key lay there quite loose and served no useful purpose whatever. By close reasoning from a number of observations it was deduced that this was not the original key. On the bases of this theory, most important for the reassembly, a search was made for evidence that it was correct. Confirmation hinged on the fact that if the original key had been made of iron it should have rusted extensively because it would have lain underground in contact with a nobler metal, silver, for over 1000 years. The product of corrosion would have been iron oxide, of greater volume than the iron. This should have resulted in expansion of the key against the top of the foot-cone. Some evidence of such an expansion might have been preserved as a deformation of the silver at areas of contact with the key. Evidence of deformation was therefore sought on the flat top of the foot-cone. It was in fact found. We were next faced with the problem of recording this deformation in a form that would carry greater weight for posterity than mere words.

17. The copper bolt found in the neck. One of the two end tags has broken off.

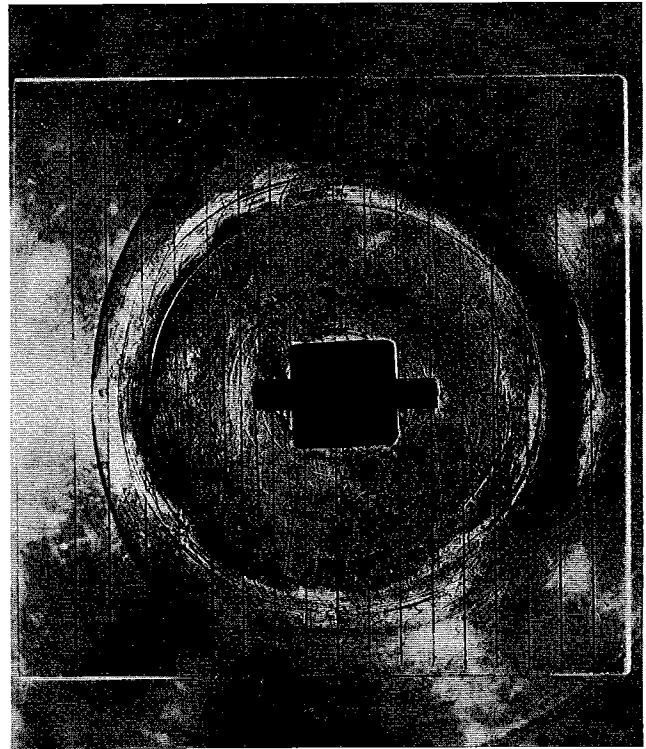
19. The deformed flat top of the foot-cone, illustrated by a family of curved shadows cast from a grid of straight lines.

both the straight lines of the grid and, between these, their shadows. The curves of these shadows indicate quite clearly that the slightly concave top has been deformed along the axis of the two side slots in which the iron key was discovered lying loose. It was also observed, in confirmation of this finding, that the whole foot-cone had been distorted slightly along this same axis. It had been "squeezed in." In fact, at the time when the chalice was reassembled temporarily for exhibition at the British Museum, at a time when the significance of this distortion was unrecognized, a pair of tiny pads had to be inserted between foot-cone and lower ring mounting in order to compensate for the distortion and to obtain a rigid structure. Those pads may be seen in fig. 25.

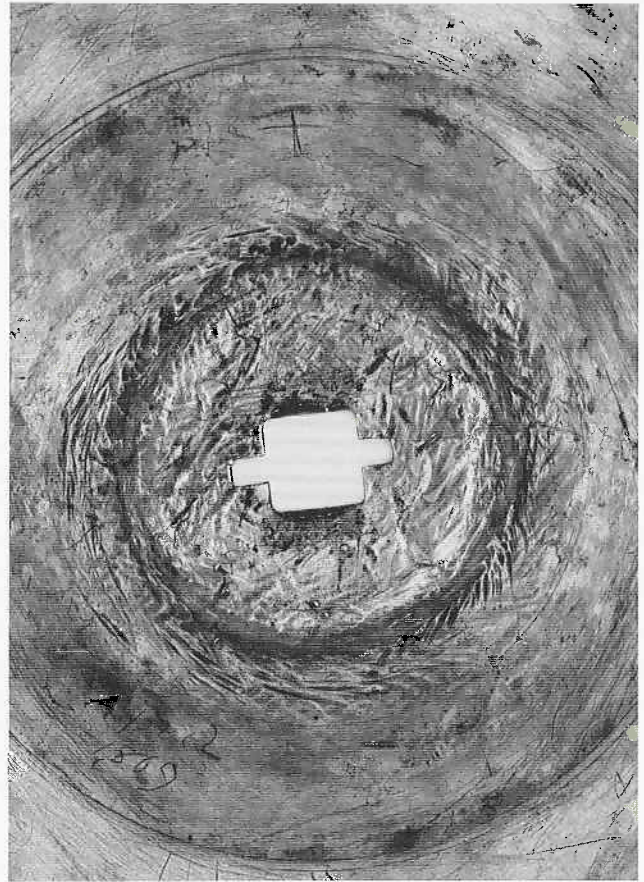
Fig. 20 shows the inside of the foot-cone. On the axis of the side slots, at the right-hand side, is a rather ragged line. It is believed that this was made at the time when Johnson was struggling to insert his key. The key slid down the side of the foot-cone, marking it because of a rough corner at its rear edge, and was then wiggled side to side in an endeavor to force it further. The impossibility of inserting such a key was checked by making a key and attempting to insert it. The fact that this experiment was made may suggest that the test caused the mark. Actually, photographs made of the inside of the foot-cone before the time of the theory revealed the mark already present, although it had not been noticed at that time. This alone was justification of the policy of taking careful photographs at all stages of the work. To summarize: there was now evidence to support the theory that Johnson cut away the rusted original key and replaced it with a new key and that he cut out the side slots in the top of the foot-cone in order to insert this new key.

20. The interior of the foot-cone. The central area, normally hidden by the under-foot disc, remains marked by the silversmith's hammer and bears the date of Johnson's examination.

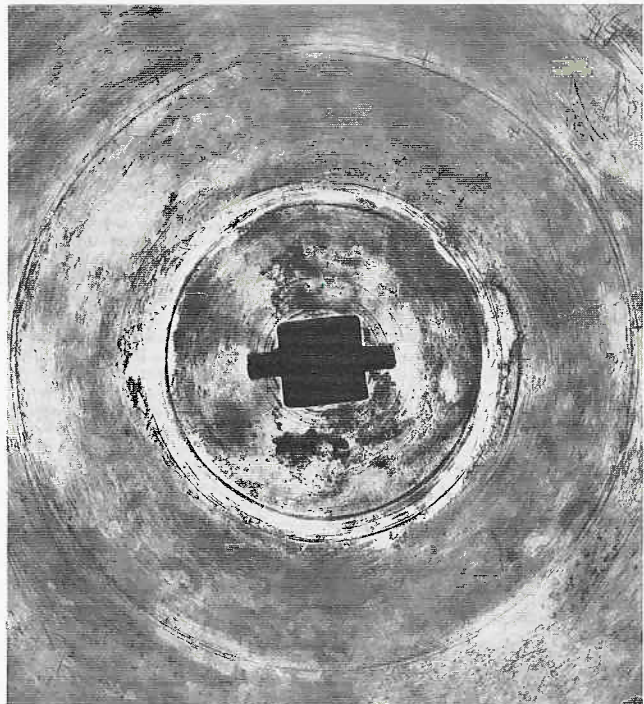
Additional evidence was found that the side slots are actually different from the central aperture. Fig. 21 shows the central square aperture outlined in white lines because there is a burr on the edges. The two side slots are not outlined in white because they were made with a different tool at a different time, in accordance with the theory.

21. The exterior of the foot-cone in the uncleaned condition.

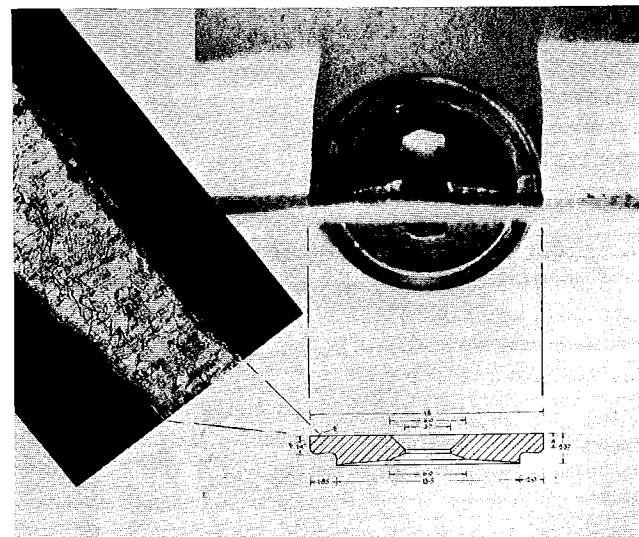
24. Scale drawing of cross-section of the catch-disc, derived from shadow casting, indicating the location of a metallographic section.

The second method of examination involved making a minute metallographic cross-section along the line BB' marked on the drawing. The cross-section reveals two thin broken white lines on the two surfaces of the disc. The lines represent gilding about 0.002 mm (less than  $\frac{1}{10,000}$  inch) thick. It is believed that this gilding was applied at the time of Johnson's restoration because similarly thin gilding has been observed elsewhere on the chalice. This thin gilding was absent from the lathe-turned surfaces of the disc. From this it may be deduced that the lathe-turning followed gilding. Furthermore, the plane of turning has not been squared off nor has the tool been traversed fully before being withdrawn. This suggests that the work was being carried out in a great hurry — the ridge could have been removed in a matter of seconds by a few strokes of a file but it was not, and it may well have been carried out at the last moment of reassembly in order to make the crystal fit.

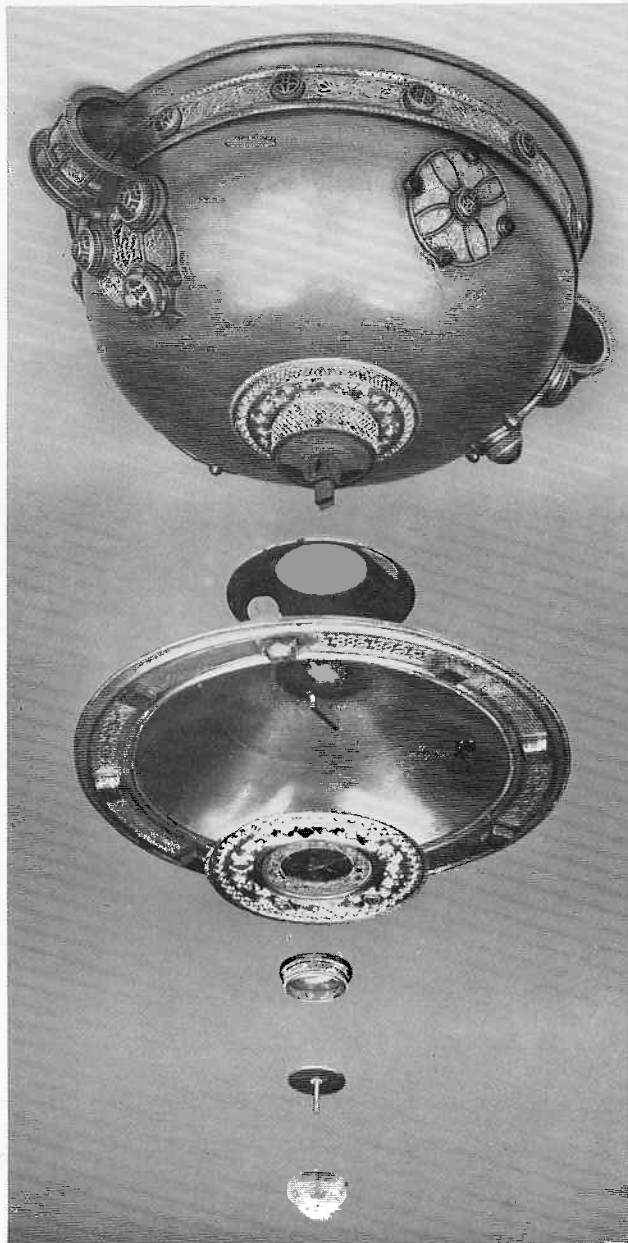
25. An exploded view to show how the components of the chalice were reassembled temporarily in 1962.

When the chalice was finally reassembled at the British Museum, the lead which, corroding, had endangered the security of the assembly was taken out of the neck and replaced by a spacer made of polymethyl methacrylate. This is obviously a 20th century fitting and could not be mistaken at some date in the future for work of the 8th or 9th century. An iron key was not replaced through the bolt because experiment had shown that one long enough to be secure beneath the slotted foot-cone could not in actuality be inserted. Instead a pair of brass wedges were inserted. These together ensured that the bolt remained perpendicular to the flat top of the foot-cone. Instead of allowing the whole weight of the under-foot mounting to be suspended on the two small tags of metal an 8 B.A. brass screw was inserted and a substantial brass disc was added beneath the crystal in order to support the load. The one completely detached tag was refitted with epoxy resin. Fig. 25 illustrates how the chalice was assembled temporarily in 1962.

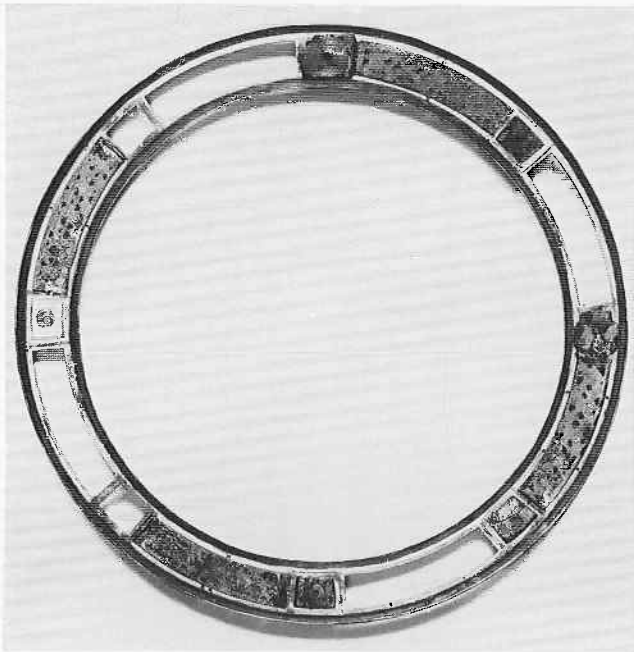
34. View of the interior of the upper foot-girdle after reassembly.

In the British Museum reassembly, fig. 34, the foot was arranged more or less as the designer must have intended. The missing rivets were replaced by epoxy resin and the stud back-plates that were lacking were replaced by obviously modern transparent plates of cellulose acetate of similar thickness. In the photograph, at 12 o'clock and 3 o'clock, there can be seen all that remains of the original plates. A modern transparent replacement can be seen clearly at about 1:30 o'clock.

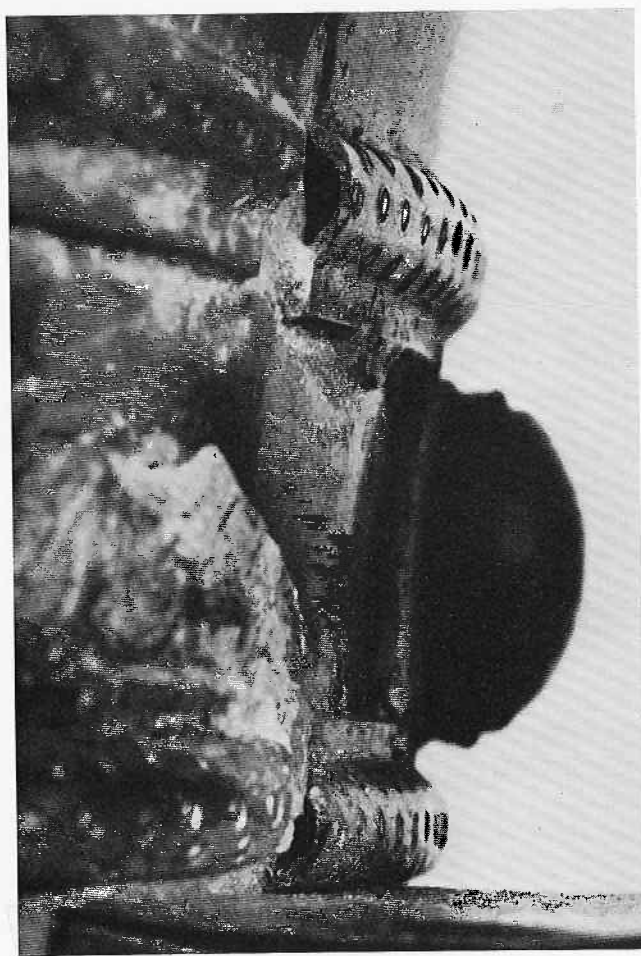
36. The ends of the bowl girdle, which do not meet, secured by means of soft solder beneath handle I.

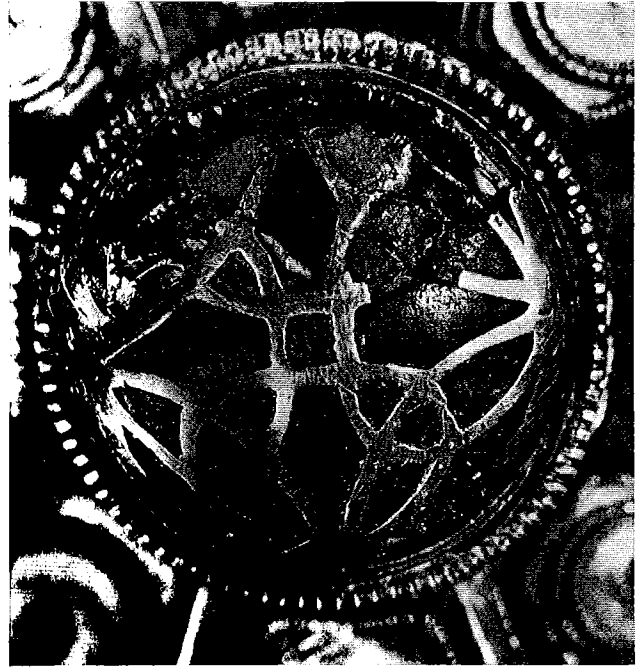
50. The central stud in the other one of the two roundels.

Fig. 50 illustrates the central stud in the roundel on the other side of the bowl. A certain amount of damage had been done here, with the result that where the central silver grille had been torn away the glass of the stud had been exposed. The stud contains both red and blue glass. It could be seen that the red glass has been inserted into spaces in the grille and that the blue glass in a plastic condition has been pressed in behind it in order to fill all of the remaining cavities.

The damage here appears to have been done by someone in search of information. A less destructive method of examining a stud would have been to push it slightly forward in its mount so that the edge of the silver grille was exposed. The thickness of the exposed edge could then have been measured by means of a microscope. In fact, on preliminary examination a stud was found that had been pressed forward in this manner. Advantage was taken of this to measure the thickness of the grille, 0.1 mm ( $1/250$  inch). There does exist, however, a general method of examination that is completely nondestructive. The next photograph, fig. 51, illustrates another stud, photographed while it was immersed in toluene so that the glass can be seen clearly without the confusion introduced by surface scratches. Here the actual thickness of the peripheral
