A Question of Technique: Condition Issues Associated with Layering Structure in Richard Diebenkorn's Ocean Park Series

ABSTRACT

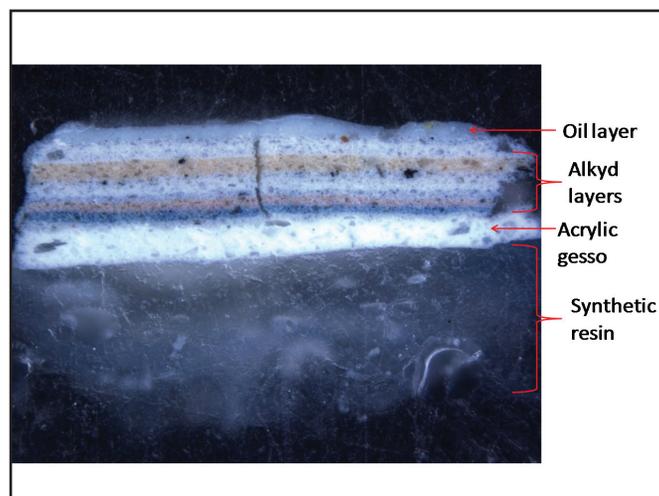
When *Ocean Park No. 111* was requested for loan, a preliminary examination revealed an extensive system of lifting cracks that appeared to have become more severe than when the painting was last examined. Examination also revealed drips of clear polymeric resin along the tacking margins. This resinous material which the artist applied directly to the raw canvas overall and beneath the ground and paint layers is soft and malleable. Samples removed from the tacking margins are noticeably porous, as evidenced by air bubbles. Under magnification, the resin is readily visible at the bottom of crack openings and is evident in paint cross sections (fig. 2). As seen in this cross section, the resin is as thick as the combined paint and ground layers above.

Figure 2. Cross section from *Ocean Park No. 111*. Darkfield 200x.

The cross section illustrated in Figure 2 may be indicative of what is happening structurally to the Ocean Park paintings that are in poorer condition. An internal vertical fissure is visible through the center of the sample. Significantly, the alkyd paint layers have cracked preferentially to the oil paint layer on the surface and the acrylic gesso layer beneath. Many of the cracks now visible on the surface of these paintings may have started in the alkyd paints and with time migrated to the softer artist's oil and ground layers. Moreover, it is likely that the inherent flexibility of the acrylic size layer would have magnified any stresses placed on the paint layers, causing smaller fissures and flaws in the brittle alkyds to propagate to the surface and into the ground. As previously noted, the paint layers in most of the cross sections from *Ocean Park No. 111* and *Ocean Park No. 96* measure about 100 microns on average, while the clear synthetic resin of both paintings is twice as thick. In these examples, brittle and excessively lean alkyd paints were applied to a heavy layer of flexible resin size that provides inadequate support. Moreover, Rhoplex has been found to maintain rubbery flow over many years (Michalski 1991). This potentially means a longer period of vulnerability these paintings might experience. With any cause of stress whether it be mechanical or environmental, and little resistance from the support, cracks form freely and propagate. A particularly interesting study by Young et al. (2006) found that alkyd paint layered over an acrylic gesso increased the overall stiffness of samples and caused premature failure of the acrylic during stress tests. These paintings illustrate this in a real, natural setting.

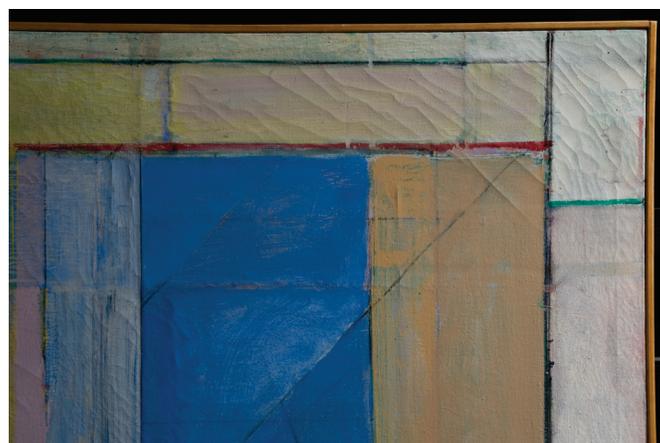
The surface of *Ocean Park No. 111* is riddled with a complex network of cracking patterns (fig. 5). There are extensive linear cracks located at the corners of the painting. Additionally, isolated areas of branched crackle are associated with specific

Figure 5. Detail of *Ocean Park No. 111*, raking light, upper right quadrant.

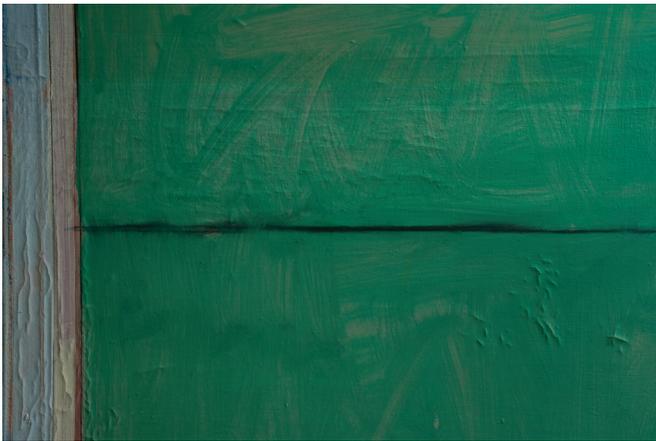
color areas and appear to correlate with changes that the artist made to his composition. For example, near the center of the left side of the painting there is an isolated rectangular area of cracking within the larger green area (fig. 6). This seems to be associated with a design area that the artist scraped and subsequently reworked. Also visible is a system of distracting rounded cracks with cupped edges that extend along the left side of the painting. These cracks appear to coincide with vertical charcoal lines on the paint surface as well as charcoal lines that are concealed beneath the upper paint layers (fig. 7). Under magnification, additional smaller cracks and fissures can be seen in close proximity to these larger rounded cracks.

Figure 6. Detail of *Ocean Park No. 111*, raking light, left edge, center.

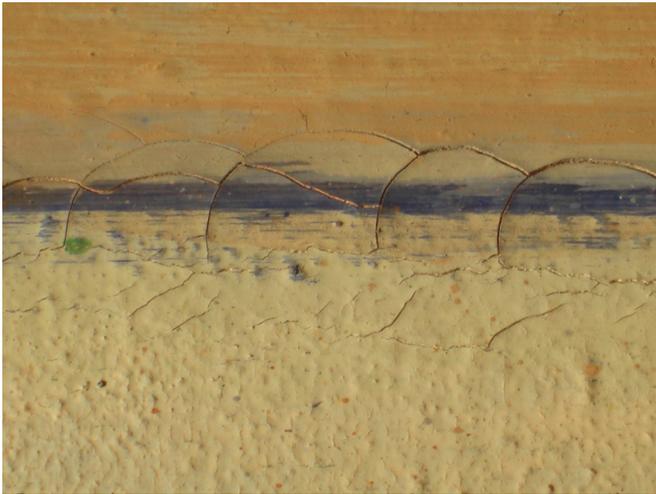
Figure 7. Cracking related to drawing on dry paint in *Ocean Park No. 111*, detail, along left edge.

Both cracking patterns appear to propagate from charcoal lines in the composition and were likely caused when the artist drew with charcoal into already dried paint layers. Diebenkorn was known to have worked on his paintings over long periods of time, sometimes repainting entire surfaces (Bernstein 2009).

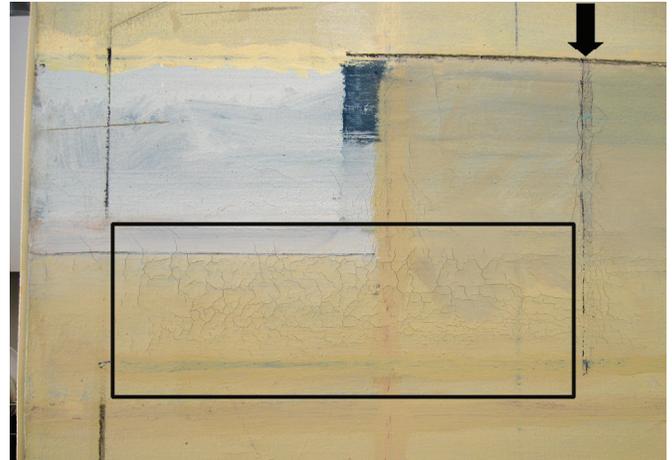
Figure 8. Detail of *Ocean Park No. 96* in an area exhibiting both widespread cracking and cracking following a drawn line as indicated by the square and arrow.

No. 111, show localized areas of dense cracking associated with reworked design areas and areas along drawn charcoal lines (fig.8).

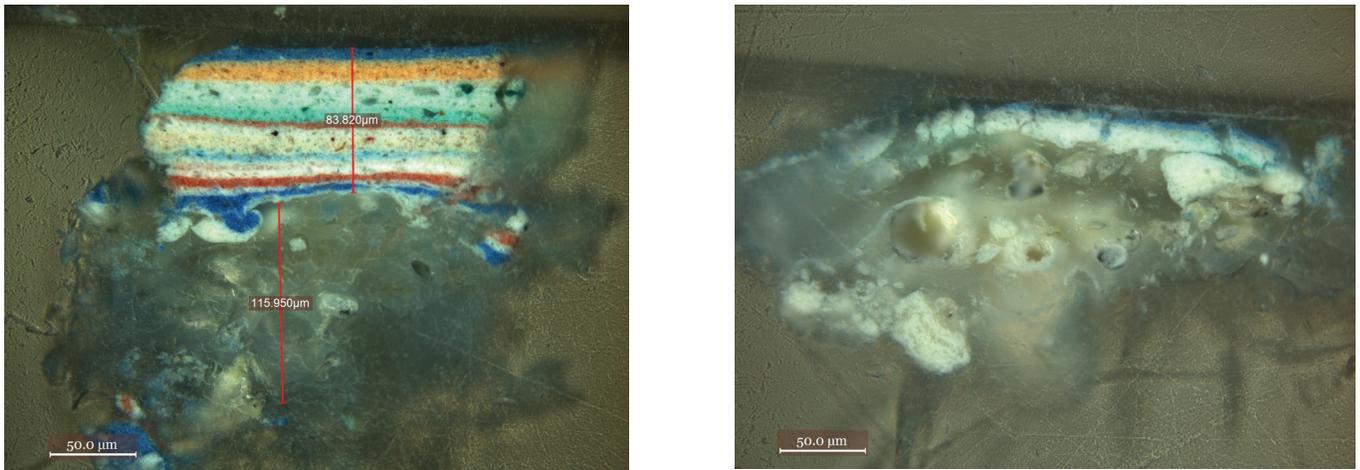
Two cross sections were taken from the blue square located in the upper left quadrant of the design, half of which exhibited cracking and half of which did not. One sample was taken from each half. In both cross sections, the unpigmented acrylic resin layer is clearly visible and is as thick as, or thicker than, the combined thickness of the overlying paints layers. Significantly, the cross section taken from the half that exhibits cracking reveals a surprising buildup of paint layers measuring almost 83 μm thick (fig. 9a). The cross section from the non-cracking portion contains only 2-3 layers of paint and measures less than 50 μm in thickness (fig. 9b). Moreover, several of the individual paint layers in Figure 9a measure less than 10

Figure 9. Comparison of two cross sections from *Ocean Park No. 96*, 200x, darkfield. The cross section on the left (a) was taken from an area that exhibited cracking while the section on the right (b) was taken from an area that did not.

μm thick, which suggests that the artist diluted his paints to an almost wash-like consistency before applying them. As seen in *Ocean Park No. 111*, the filler content in both of these cross sections is consistent with a commercial paint, probably an oil-based alkyd. The difference between these two samples seems to indicate that artist layering and manipulation of his paint may play a large role in how much cracking occurs. Inconsistency of thickness in some of the thinner layers also suggests that the artist scraped down his paints once they were applied.
