MICRO CLIMATES AND MOISTURE INDUCED DAMAGE TO PAINTINGS

MARION F. MECKLENBURG

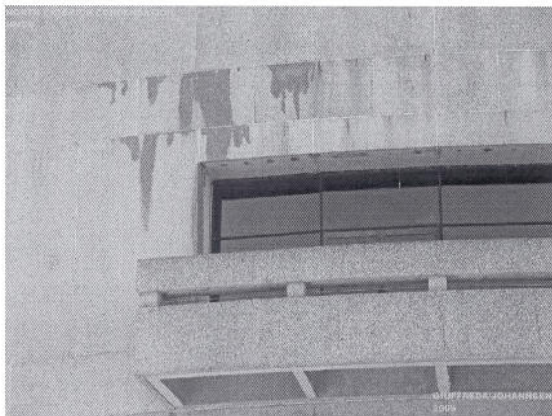
Figure 1. Condensed water leaking from the joints in the wall of the Smithsonian Institution's Hirshhorn Museum and Sculpture Garden in the wintertime. (Photo by Gary Johannsen and Kevin Guifreda)

Figure 1 shows condensing water leaking from the exterior walls of the Smithsonian Institution's

Hirshhorn Museum and Sculpture Garden. This water is a result of condensing humidified air within the walls on cold winter days. The Hirshhorn Museum and Sculpture Garden opened to the public on Oct. 4, 1974, so it is a relatively new building. Because of the architectural design of the building, the structural walls are massive. None the less, the walls get cold and the condensation occurs.

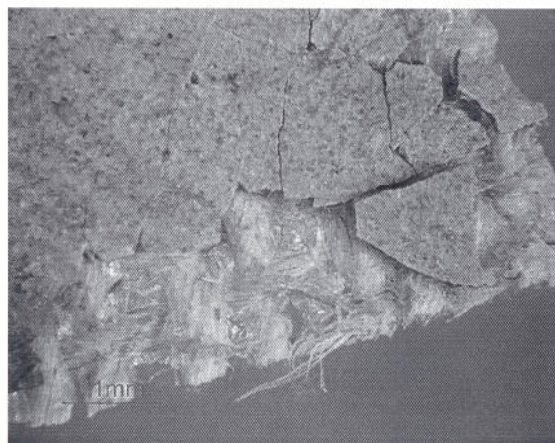
Figure 5. A detail of the same 19th century Italian painting shown in Fig. 4 but looking from the front. (Photograph courtesy of Melvin J. Wachowiak)

Figure 5 shows a detail of the same 19th century Italian painting but looking from the front. The glue size layer is an extremely thin film bridging the gaps in the weave of the canvas. Even though very thin, this layer is still very responsive to changes in RH.

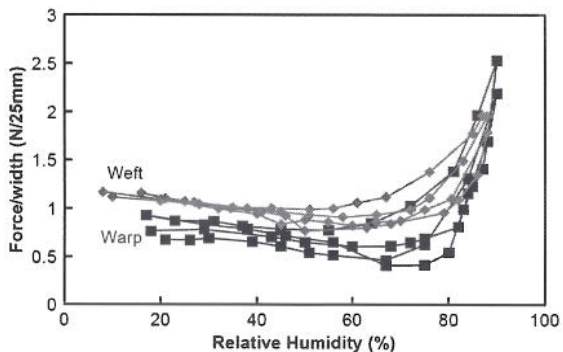
Figure 6. The tensile forces per width, measured in individual restrained samples of the #8800 linen in the warp and fill directions with changing relative humidity. The greatest forces develop when the relative humidity is above 75%.

Figure 6 shows that between 10% RH and 60% RH there is relatively little change in the force on either the warp or fill directions of the textile. From 70% RH on there is a gradual increase in stress and above 80% RH the force increases dramatically. When damp or wet, loose textiles shrink dramatically and when restrained the shrinkage shows up as significant forces in the textile. This is the first indication that dramatic events take place in canvas paintings when the humidity gets very high. This behaviour was replicated using a wide variety of different textiles by Gerry Hedley at the Canadian Conservation Institute. [3]

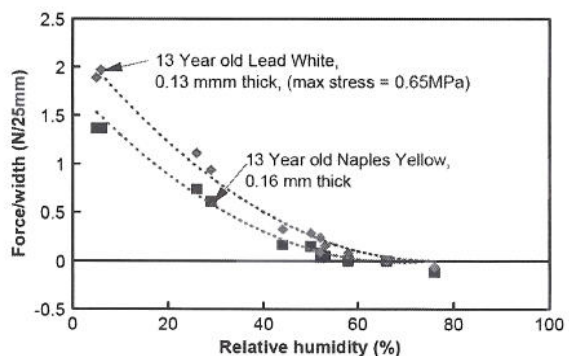
Figure 8. The force per width of restrained samples of lead white and Naples yellow oil paints. The stress of the white lead paint at the maximum force per width of this sample was only 0.65 MPa. The force per width of the paints is considerably lower than the hide glue and a bit higher than the #8800 linen shown in figure 6. The thicknesses indicated for the paint samples is typical of those found in paintings.

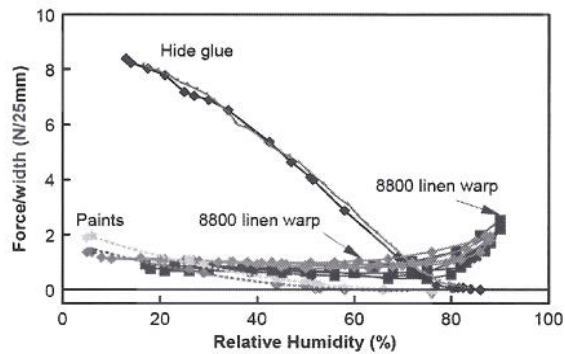
Figure 9. The force per width of restrained samples of linen, hide glue, and lead white and Naples yellow oil paints. The thickness of these films are as shown in their individual figures and would be typical of an oil painting painting. Using this figure it is possible to compare the responses of the individual layers to that of an actual canvas painting and to determine the different forces occurring at different levels of RH.

The information from Figs. 6, 7, and 8 is plotted on the same graph in Fig. 9. This makes it possible to compare the responses of the individual layers of a canvas painting to RH and to identify the RH levels that hold the most potential for damage. For example the fabric is developing high forces only at high RH levels and staying relatively constant at humidity levels below 80%. The hide glue is developing high forces at very low RH levels but loses all strength at levels above 80%RH. The paint films are developing relatively low forces and that is only at very low levels of RH.

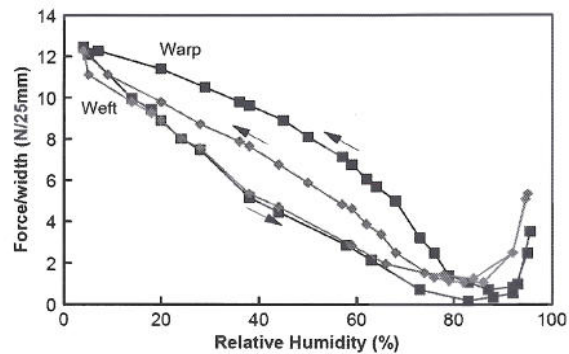
Figure 10. The forces per width of restrained samples of an unknown American portrait painted by Duncan Smith (1906), in both warp and weft directions. These painting samples were constructed with a medium weight machine woven fabric, a hide glue size, a lead white ground and a design layer of raw and burnt umber.

Figure 10 shows the force per width developed in restrained samples of a 1906 painting by Duncan Smith. This painting was constructed with a medium weight, machine woven linen fabric, a hide glue size, a lead white ground and a design layer of raw and burnt umber. It is important to note that there are two areas of high force development, one at the very low levels of RH and the other at the very high levels of RH. This is consistent with the force development of hide glue and canvas as

shown in Fig. 9. In the actual painting the fabric is developing high forces at high RH and the glue size is developing high forces at low RH.

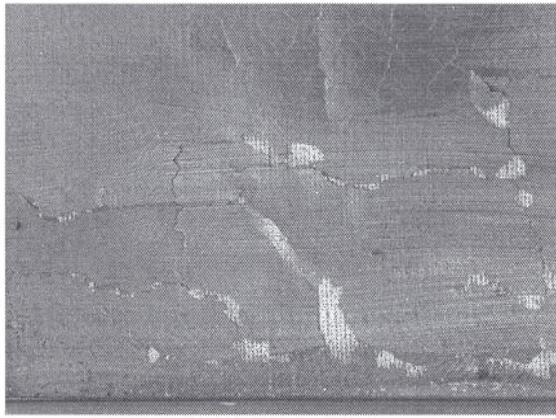
Figure 13. A detail of a 19th century Italian painting. It is clear that total separation of the paint and ground layers from the canvas has occurred. The amount of moisture was sufficient to cause cracking of the design layers and failure of the bond at the glue layer. The canvas shrank, and the paint cleaved from the canvas. (Photo by Matteo Rossi Doria)

Water condensing on paintings often tends to run to the bottom of the painting and typically causes damage as shown in Fig. 13. In this case there

was sufficient water on the canvas that it totally disrupted the adhesive bond of the animal glue size layer. Hence the canvas shrank, glue size lost all of its adhesive strength and the paint and ground layers completely detached from the canvas. Now there is insufficient room to fit the broken pieces of the paint back into proper alignment.

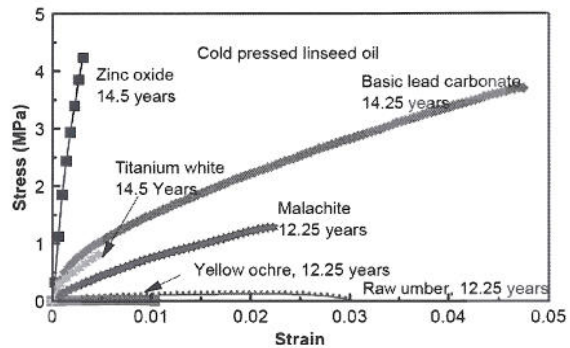
Figure 14. The results of stress-strain tests conducted on paints made with different pigments. The various pigments have a dramatic effect on the mechanical properties of oil paints.

The chemistry of oil paint is very complex and, understandably, properties of dry films vary with the pigment. For example, paints made with basic lead carbonate dry to tough durable films while those made with the earth colors form weak films. [6 7] The mechanical properties of several different paints are illustrated in Fig 14. One would expect that the white lead paint, because of its strength and low dimensional response to moisture would survive large swings in relative humidity. On the other hand one might suspect that weak and dimensionally responsive paints like umber, ochre, and Sienna would most likely suffer considerable damage in the same harsh environment. [8]

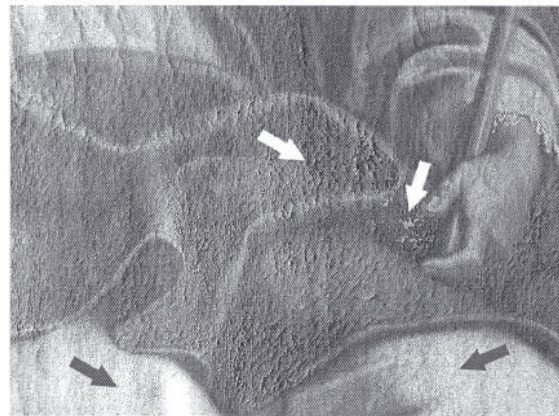
Figure 15. A detail of a painting containing both white lead paints (blue arrows) and paints made with the earth colours, ochre and sienna (red arrows). This painting was damaged by wet walls. (Photo by Matteo Rossi Doria).

At high moisture levels the earth colours have very little strength and the hide glue size has none. Therefore neither has the ability to resist damage. Failure is going to be preferentially in the earth colours. Figure 15 illustrates selective damage to a 19th century Italian painting. Here the white lead paints are relatively intact while the earth colours are seriously damaged. Clearly avoiding high humidity levels is of primary importance. Moisture induced damage to paintings is selective in that the weaker paints will fail and the durable ones will maintain some stability.
