Disfiguring Biocolonization Patterns after the Application of Water Repellents

A.E. Charola¹, J. Delgado Rodrigues² and M. Vale Anjos²

As a result of a multi-year conservation/restoration program for the gardens of the National Palace of Queluz in Portugal, the opportunity to evaluate the long-term performance of conservation interventions on the marble statues that decorate these Baroque gardens was presented.

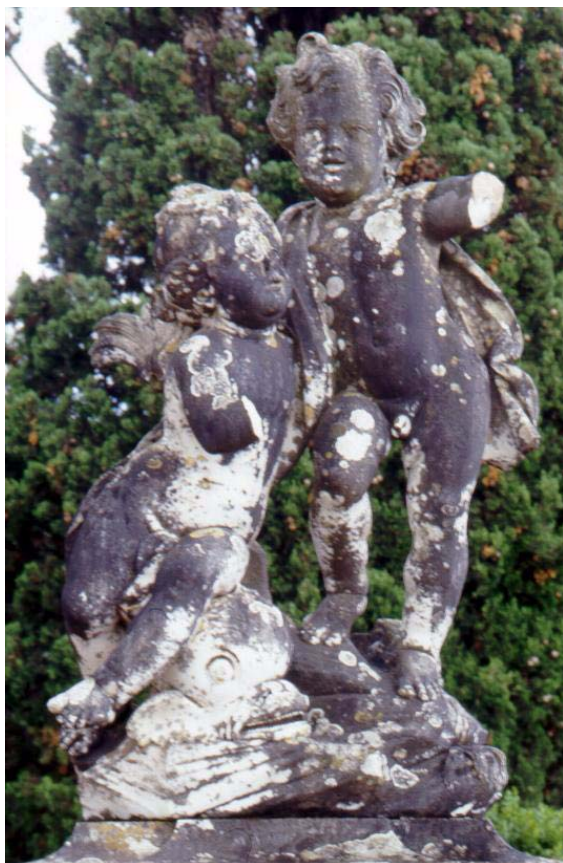
Figure 1: Appearance of a *putti* group before the intervention in 1996/7. Note the dark soiling resulting from biocolonization. This same group is shown in Figure 3 some years after cleaning.

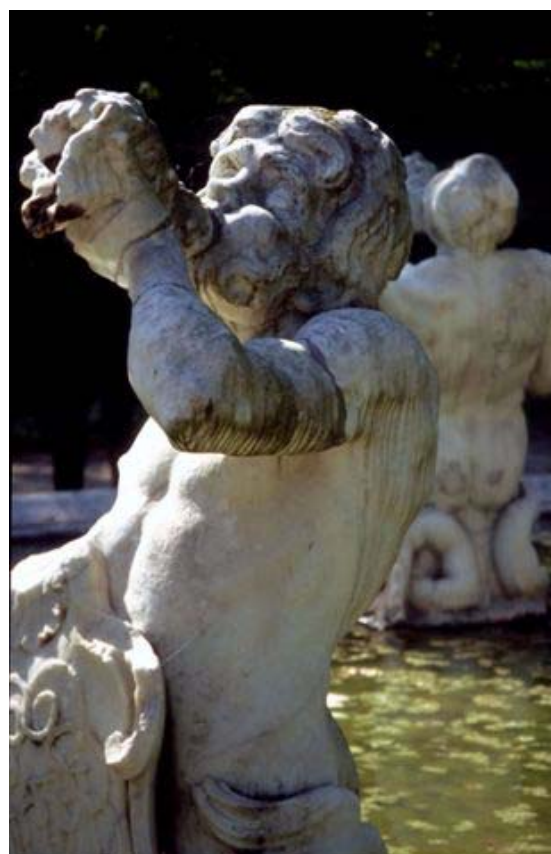
streaking resulting from the biocolonization pattern developed. This is shown in Figure 2, taken some four years after the application of the water repellent. The appearance of this unsightly streaking was attributed to the water repellents used since statues that had not been treated with a water repellent showed a more uniform biocolonization.

Figure 2: The streaking pattern is particularly noticeable under the arm of the Triton. The pattern results from uneven biocolonization. The marble statues are in a fountain that had been cleaned and treated with a water repellent four years before the photograph was taken (Photo 2003).

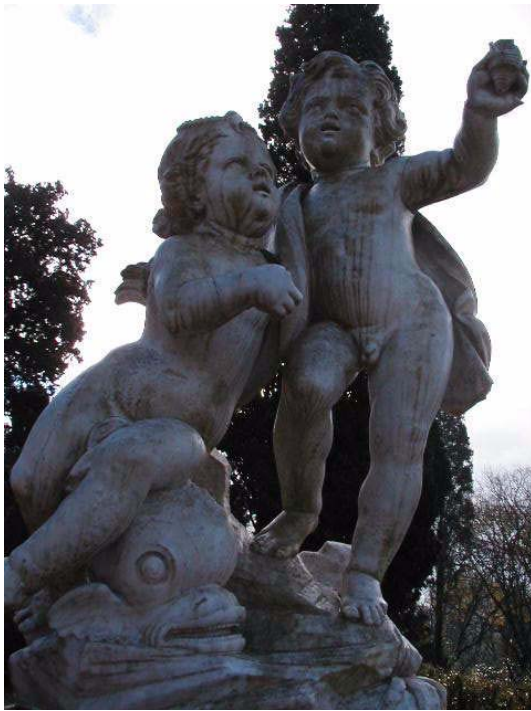
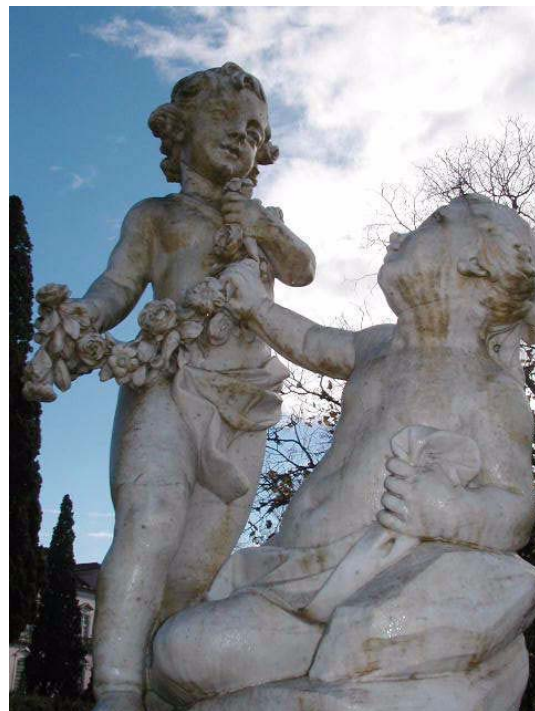
these two pairs showed the streaking effect to a far lower degree, as shown in Figure 3. However, the more exposed areas, such as the top of the heads, were far darker from heavier biocolonization.

Figure 3: Note the difference in streaking from the *putti* pair on the left treated in 1996/7 and that on the right, treated by a different conservation firm in 1997. Photographs taken in January 2003. The group on the left shows more distinct streaking than that on the right, although this one has more generalized colonization on the more exposed areas.

The two *putti* groups (Figure 3) are located close to each other and with similar environmental exposure. They were cleaned at practically the same time and the same water repellent was applied by brushing. Nevertheless, a different re-colonization pattern developed, suggesting, by the fact that the second group had heavier colonization on the most exposed areas as occurs normally on untreated objects, that these had received a lower amount of water repellent. This would suggest that the streaking pattern is enhanced when more water repellent is applied.

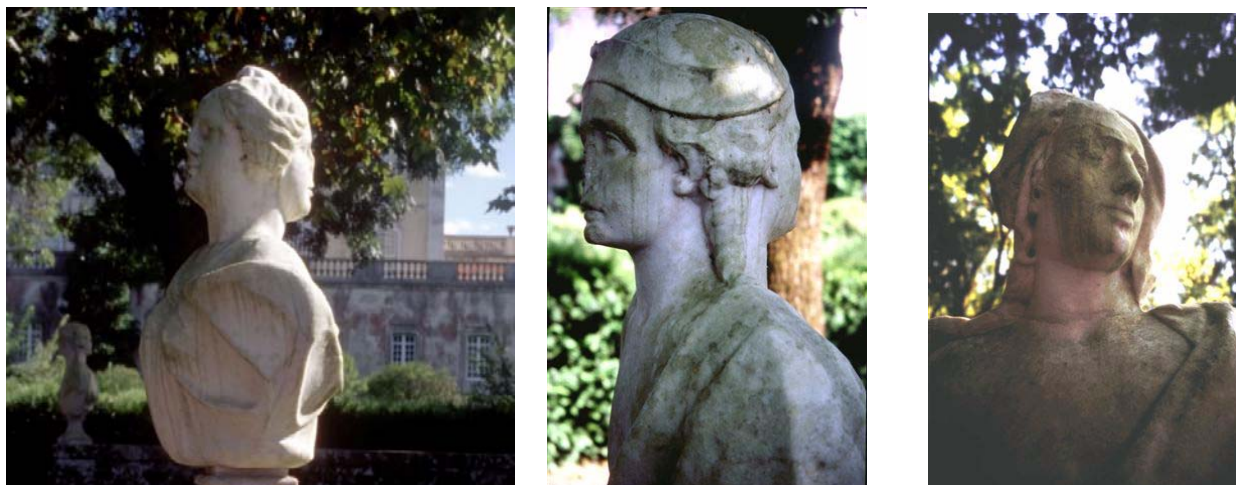
Figure 4: Three bi-face busts to which an aqueous emulsion of an oligomeric siloxane was applied after cleaning in 1999, four years before the photograph was taken (Photos 2003). Note the difference in biocolonization depending on the location of the busts. From left to right, increasing shade.

Comparison of the above mentioned statues with others treated with an aqueous emulsion showed that streaking was not as marked for the latter, although because of their location in a shady area, re-colonization was far more advanced, as shown in Figure 4. The three busts shown belong to a set of four that adorn a balustrade around a fountain located under trees, which shade them to a greater or lesser degree most of the year. The fainter streaking obtained with the water emulsions appears to reflect their slightly lower performance compared to solvent based products [12-13].

In 1995, the bi-faced busts shown in Figure 4 had suffered a previous cleaning but no water repellent had been applied. Since objects in shadier areas are colonized far more rapidly than those in full sunlight, the resulting soiling from biocolonization was heavy enough to warrant, four years later, in 1999, another cleaning when the aqueous water repellent emulsion (of the same oligomeric siloxane at 8 % concentration) was applied. Their appearance after another four years, in 2003, show that only one of them could be considered as requiring another intervention, confirming the effectiveness of water

It is to be noted that the busts shown in Figure 4 and the vase of Figure 5 b were treated by a third firm, using the same aqueous emulsion of the water repellent applied by brushing. The difference in the degree of biocolonization between these objects emphasizes the importance of shade in the rate at which the object will be colonized.

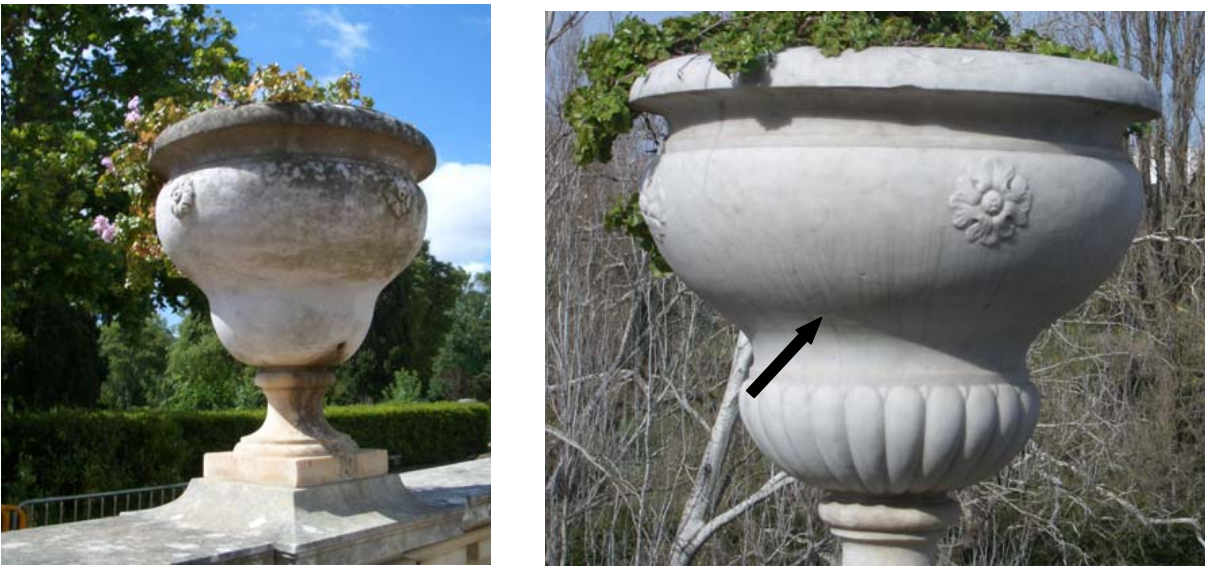
A further example to illustrate the fact that the application of water repellents promotes streaking can be found in the marble vases that decorate the garden. These objects, being of regular shape, do not develop preferential water paths, although biocolonization may favour one side over another depending on their orientation (see Fig. 5 a). However, after cleaning and application of the aqueous emulsion of the water repellent, faint streaking was observed to develop on them as well, as shown in Figure 5 b. This streaking is particularly noticeable when moisture condensation occurs, early in the mornings, confirming that water repellents tend to favour the development of preferential water paths.

Figure 5: (a): A marble vase on the same balustrade of the *putti* from Fig.3 that did not receive a water repellent treatment. Note the even biological colonization that is mainly favoured by the orientation of the object. (b): A marble vase located on the balustrade of a sunny terrace, cleaned and treated with the aqueous water repellent emulsion in 1999, shows the resulting tell-tale streaking nine years later (Photo 2008).
