MICROBIOLOGICALLY INDUCED DETERIORATION OF DOLOMITIC AND CALCITIC STONE AS VIEWED BY SCANNING ELECTRON MICROSCOPY

R.J. KOESTLER, A. E. CHAROLA, M. WYPYSKI
The Metropolitan Museum of Art, New York, U.S.A.

**Vth INTERNATIONAL
CONGRESS ON
DETERIORATION AND
CONSERVATION
OF STONE**

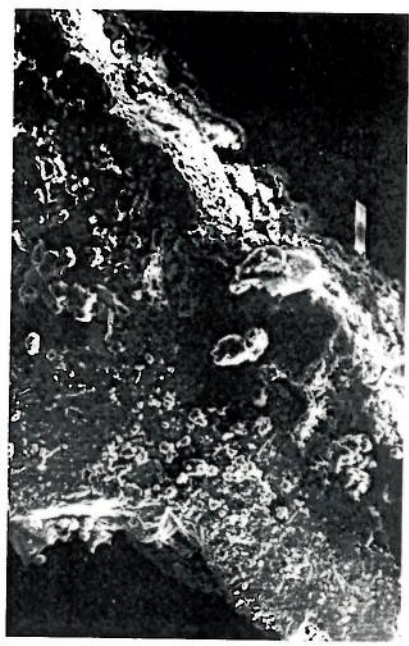
Figure 6 : Xanthoria Parietina on marble (S.E.M. 50X)

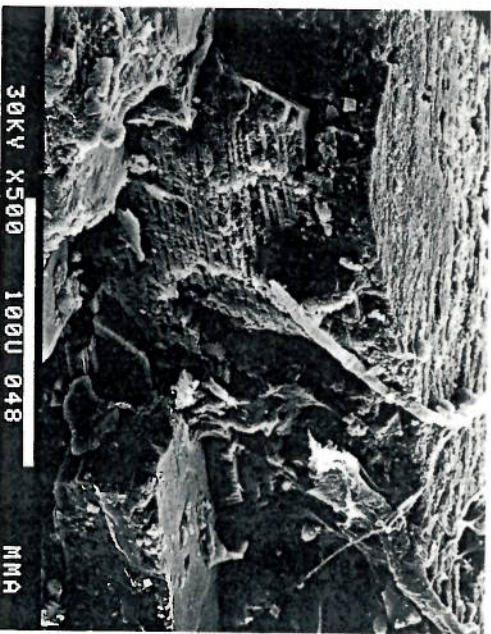
Figure 5 is a detail at higher magnification of a freshly cleaved surface. In this micrograph, the top surface was the exposed one. Fungal hyphae have found their way into the crystal.

Figure 5 : SEM photomicrograph showing detail of a freshly cleaved dolomite surface. The top surface was the exposed one. Fungal hyphae have found their way into the crystal. Note the difference between the etched (left) and the unetched (right) surfaces.

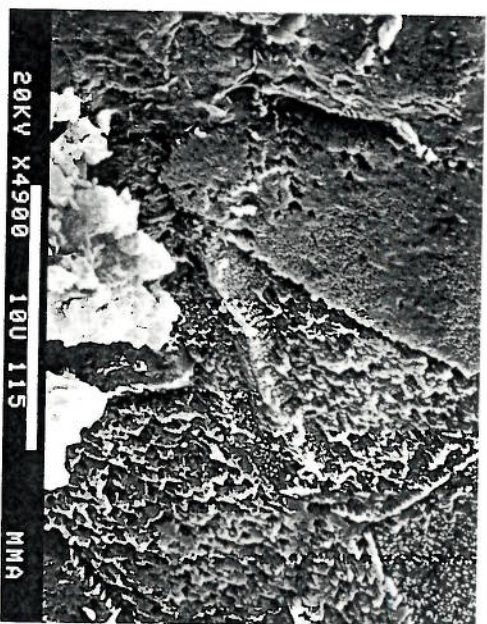
Figure 6 is a photomicrograph of a fractured surface of the limestone used in the construction of the Rudolf Hospital in Vienna, in 1884. This specimen was taken from a fairly undeteriorated area 1-2 cm towards the interior of the stone. Note the presence of fungal hyphae in the lower left corner and the similarity of etching in this micrograph as compared to the previous ones.

Figure 6 : SEM photomicrograph of limestone from Rudolf Hospital, Vienna. This relatively unweathered area is 1-2 cm inside the stone. Note the presence of fungal hyphae in the lower left corner and the etched appearance of the stone.
