In the Palace of the Fallen King: The Royal Residential Complex at Aguateca, Guatemala

The Aguateca Archaeological Project extensively excavated two structures (M7-22 and M7-32) in the Palace Group of the Late Classic Maya (A.C. 600–830) center of Aguateca, Guatemala. Multiple lines of evidence, including site layout, architectural features, soil chemistry, objects stored in a sealed room, and abandonment processes, suggest that these were the buildings where the ruler and his family lived and worked. The use of space in these structures shows some similarities to those of the rapidly abandoned elite residences at Aguateca and of palace-type buildings at other Maya centers. The occupants of this royal complex retained a certain level of visibility, indicating the importance of the ruler's body as the focus of theatrical display. After the royal family evacuated the center, an invading enemy ritually destroyed these buildings, attesting the symbolic importance of the royal residences. The center was almost completely abandoned after this incursion.

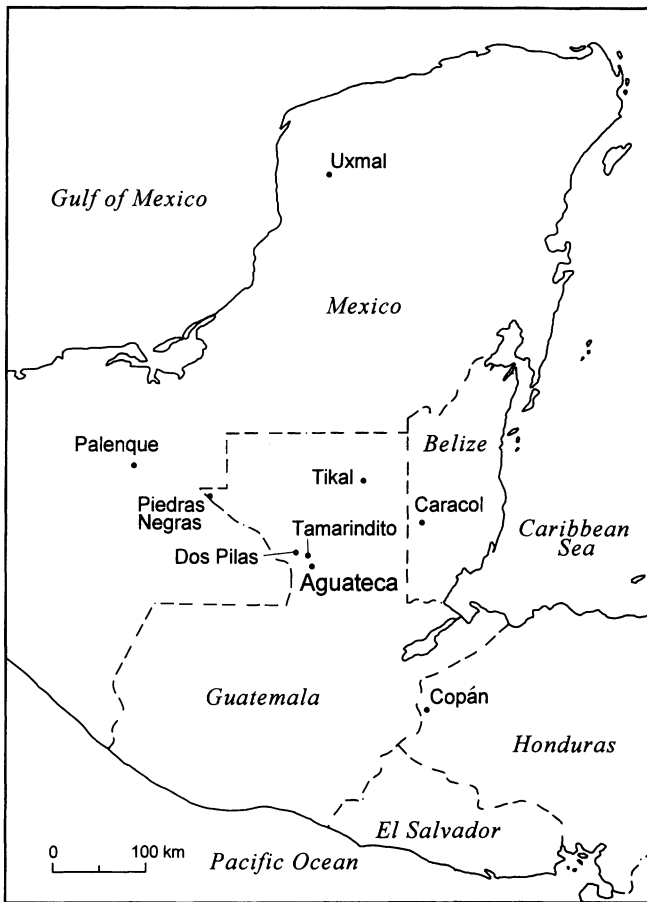
Figure 1. Map of the Maya area with the locations of Aguateca and other sites discussed in the text.

Aguateca is located in the lowland rainforest in the sw part of the Department of El Petén, Guatemala (FIG. 1). It was a medium-sized center built in a naturally defensible location on top of a steep escarpment. Work by Graham (1967) has shown that calendrical dates inscribed on stone monuments found in the Main Plaza span a relatively short period of time, from 9.15.0.0.0 (A.C. 731) to 9.18.0.0.0

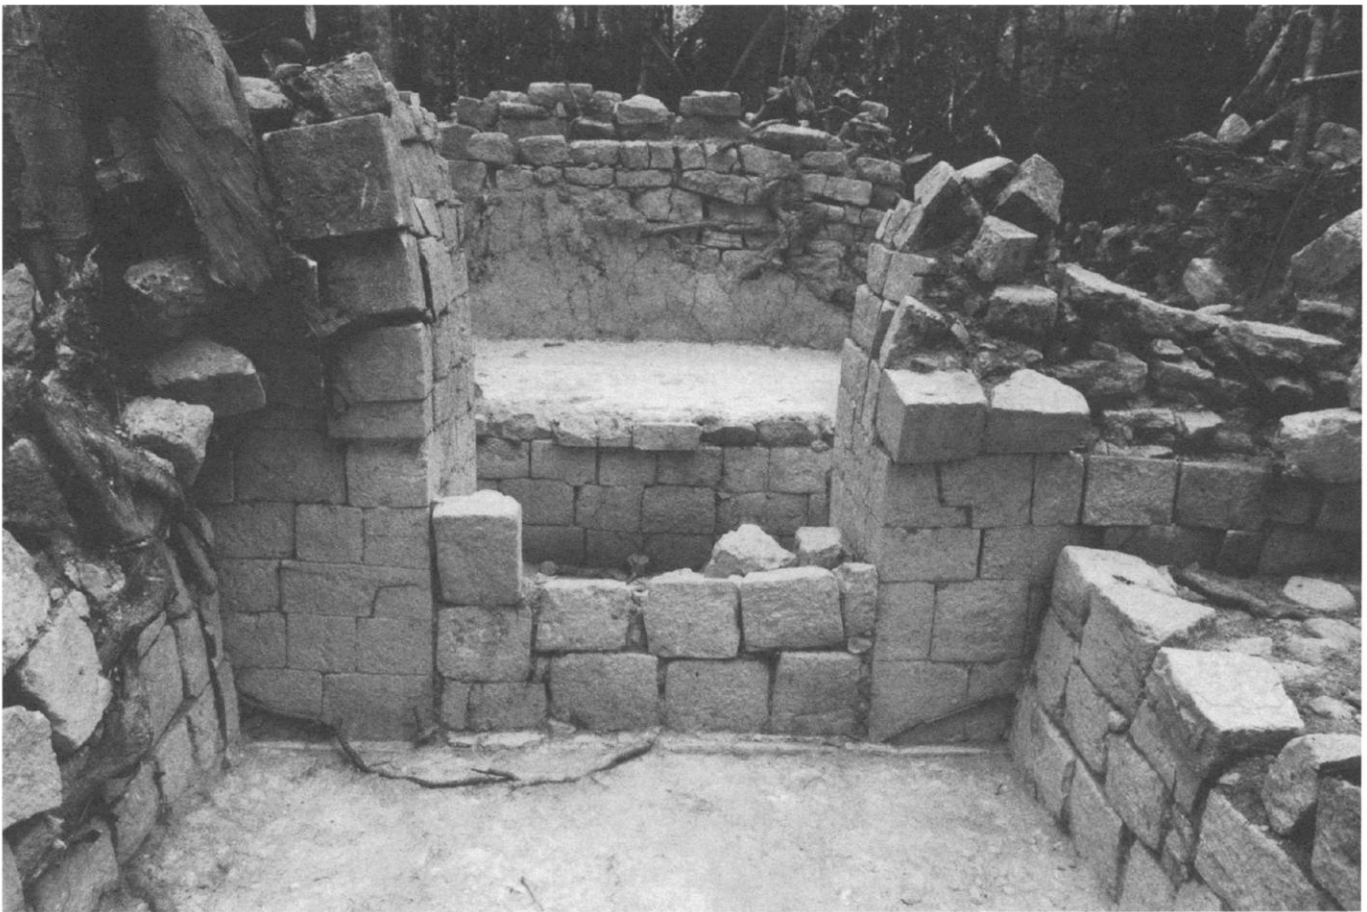
Figure 5. The doorway of the easternmost room of Structure M7-22 after excavation viewed from the east. Note that two courses of stones sealing its entrance are still in situ.

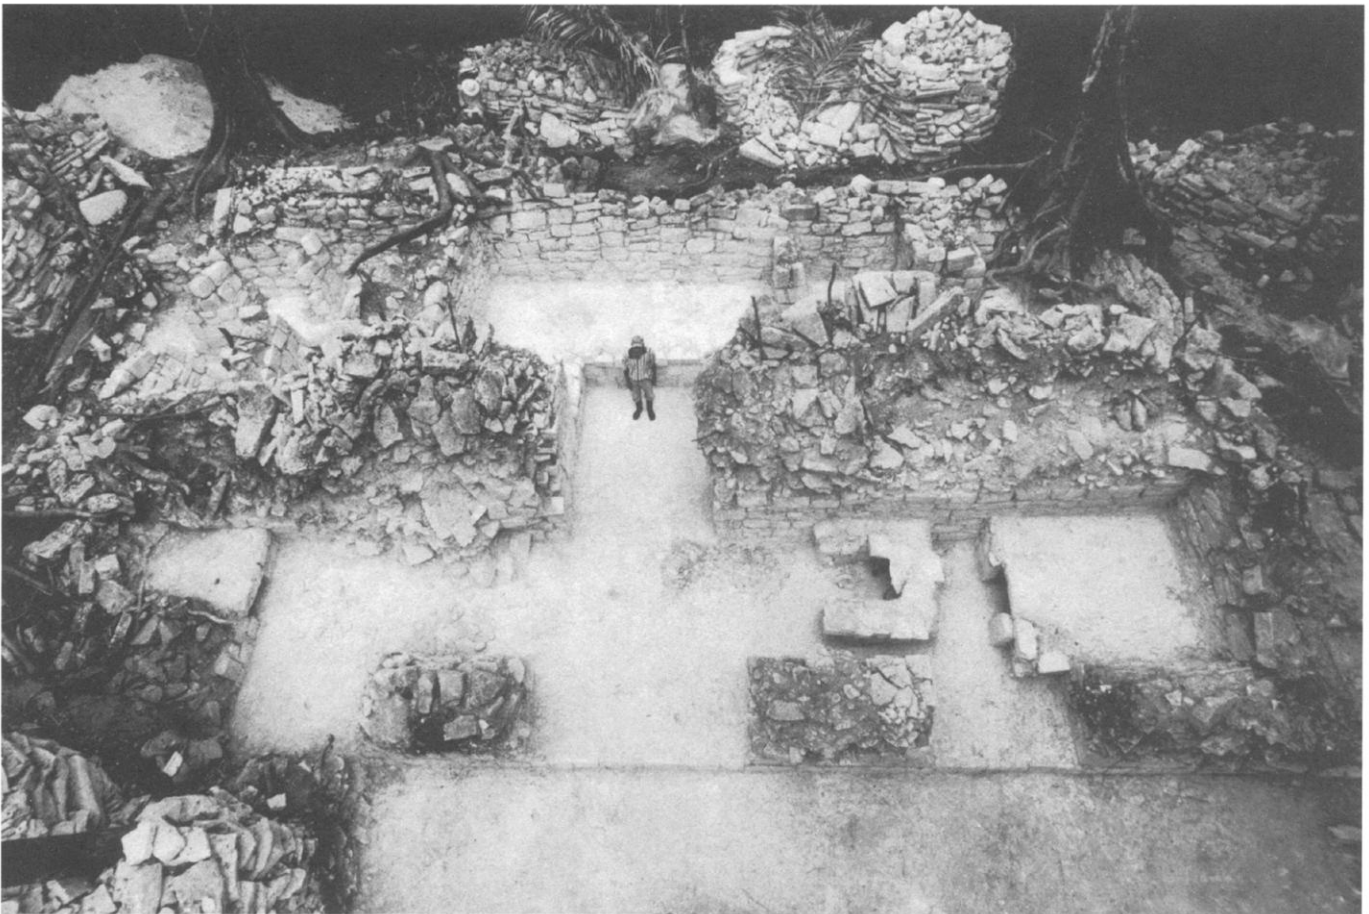
Figure 6. Structure M7-32 after excavation viewed from the east.

Structure M7-32, or the House of Bones, was more elaborately built than Structure M7-22 (FIG. 6). The structure consisted of the north, central, south, and front rooms (FIGS. 7, 8). Dense deposits of broken objects similar to those associated with Structure M7-22 were found in front of the C-shaped bench of the central room, in the front room, and along the northern exterior walls. The bench of the central room had a niche under each wing, but the capstone of the northern niche was deliberately removed and the bench surface next to it was destroyed (FIGS. 9, 10). Dense deposits of fragmentary objects also filled these damaged areas. Of particular interest are broken human bones of at least two individuals mixed in these deposits. According to Lori Wright, they include fragments of crania, mandibles, a scapula, a humerus, an ulna, a radius, fibulae, tibiae, and metatarsi. They were scattered on the floor in front of the central bench, in the broken floor of the bench, in the front room, and on the exterior floors north and south of the building, and some were burned.

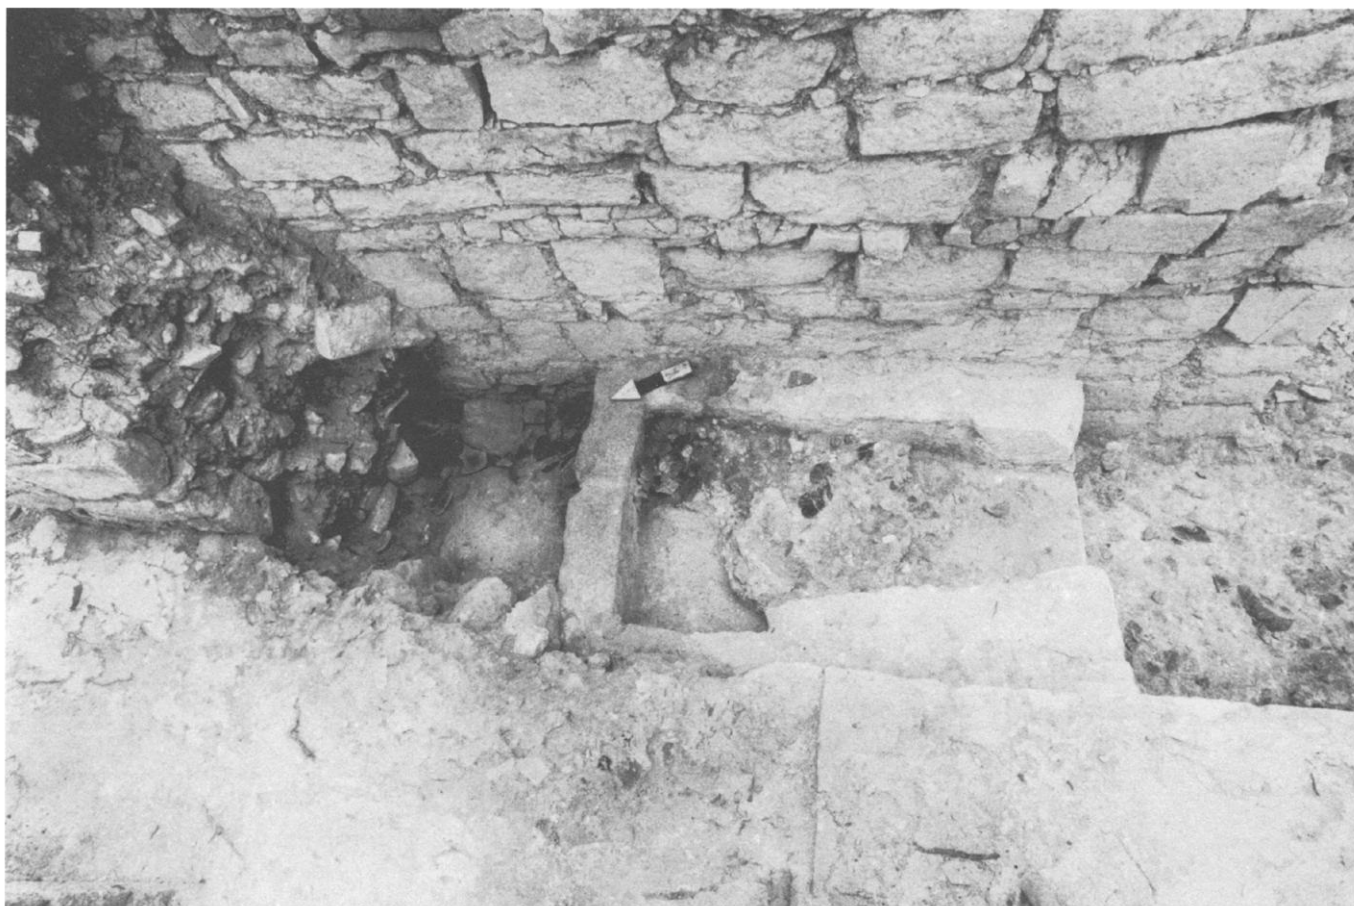
Figure 10. The destroyed niche and the bench surface of the central room of Structure M7-32 viewed from the west. Note that they are filled with broken materials.

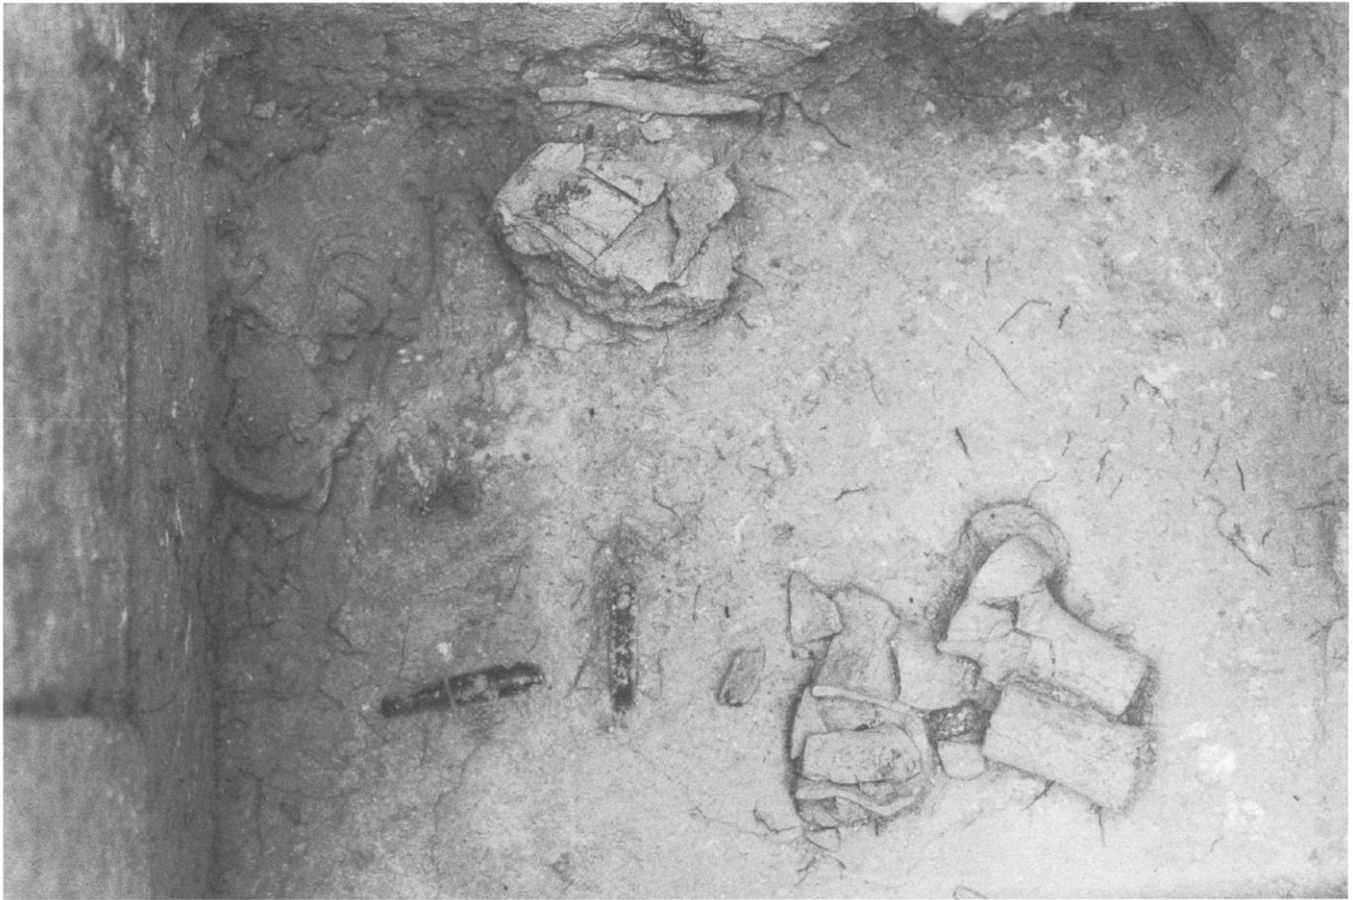
Figure 11. The northern part of the area in front of the bench in the easternmost room of Structure M7-22 during excavation, viewed from the south. The old-man mask is seen in the upper left corner, to the right of which is fragments of the incised conch. Near the lower right corner is a ceramic drum.
