To paint or not to paint: a difficult decision

ABSTRACT: Controversy over proposed repainting of a portion of the former US Patent Office Building in Washington, DC, stimulated technical and ethical questions about painting stone. The oldest part of the building was constructed with tan-colored Aquia Creek sandstone facing, and its surface was painted white only when the next section of the building was faced with marble. The paint had deteriorated over the years, and its last remnants were removed in 1968 when the building was renovated to become the dual seat of the Smithsonian Institution's National Collection of Fine Arts and National Portrait Gallery. As part of further rehabilitation in 2000, the consulting architects proposed painting the sandstone again, but after considerable discussion it has been decided not to repaint for the moment. Issues to be considered in making such an important decision are discussed.

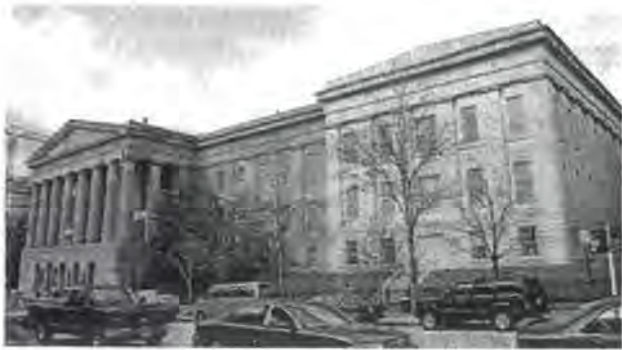
Figure 1. The former US Patent Office Building, Washington, DC, from the southeast (March 2000). The original Aquia Creek sandstone wing is on the left, and a later Texas marble wing, on the right.

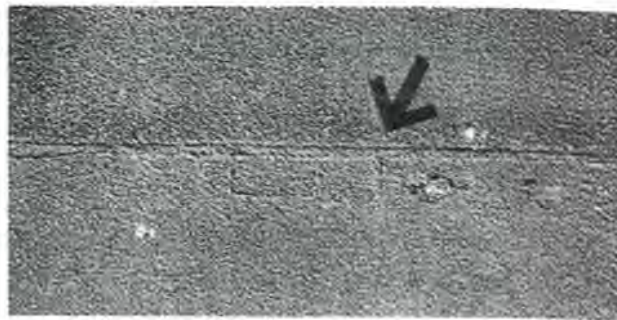
Figure 3. Original Aquia Creek sandstone repair (dutchman) at the center of the photograph, indicated by an arrow.

Aquia Creek sandstone was used for these buildings because it was the least expensive stone available. Government Island, located where Aquia Creek enters the Potomac River about 40 miles downstream from the capital, was purchased in 1792, and quarries on the island enabled the eponymous sandstone to be inexpensively transported by river before construction of railroads. It is a lower Cretaceous rock composed of quartz sand, pebbles, and pockets of clay, cemented by silica (USGS 1975, 9). Considerable variation – ranging from very poor to top quality – and unpredictability contributed to its rejection for later construction. Aquia Creek columns, removed from the east portico of the US Capitol in 1958 when the building was enlarged and re-erected at the National Arboretum in 1988 in the form of a Greek temple, show typical problems of poor-quality stone. Surfaces are disfigured by iron staining, pebble inclusions, scaling, and holes where pockets of clay have washed out. The Patent Office Building variety, however, was apparently top quality: fine-grained, even in color, and apparently repaired with well-crafted "dutchmen" (pieced-in portions of stones) where defects were found during construction (Fig. 3).

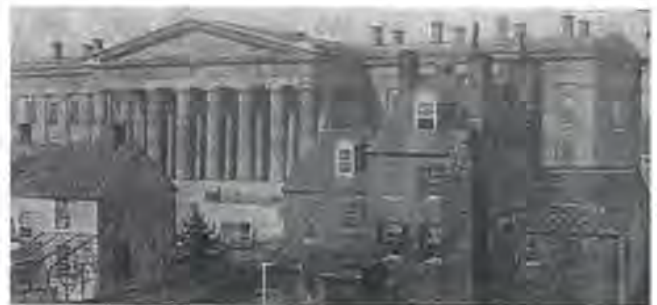
Figure 4. South Aquia Creek sandstone wing of the Patent Office Building by John Plumbe, around 1846 (courtesy, Library of Congress).

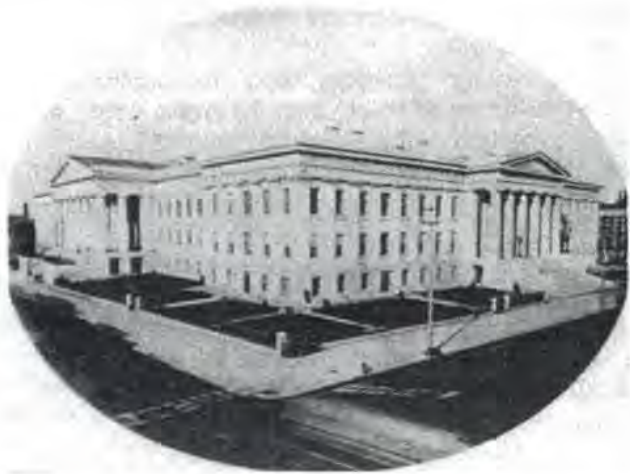
Figure 5. Patent Office Building from the southeast, around 1865. Painted Aquia Creek sandstone wing is at the left.

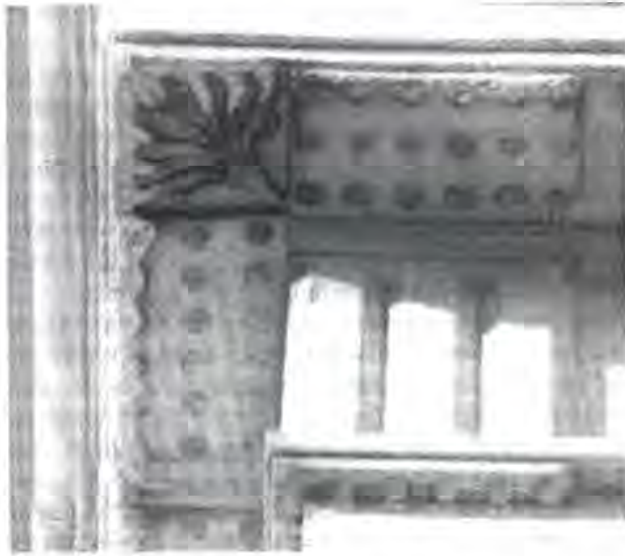
Figure 7. Detail of Texas (Maryland) marble cornice on the later west wing.

There is consensus on all sides that the sandstone on the Patent Office Building is generally in excellent condition. This is attested by sharp arises that contrast markedly with those of marble portions of the building. Sandstone guttae, for example, appear hardly different from the day they were carved (Fig. 6), while marble guttae are often deteriorated to the point of being entirely lost (Fig. 7). Significant sandstone deterioration is found only just below the roof, especially adjacent to joints, and on the lowest sandstone course above a granite sill on the courtyard elevation, where delaminating stone has been repaired many times.
