Basilica of the National Shrine of the Assumption of the Blessed Virgin Mary

Red “Staining” on Marble: Biological or Inorganic Origin?

Brightly colored “stains” on white marble at the Memorial Amphitheater at Arlington National Cemetery prompted a scientific investigation to determine their origin.

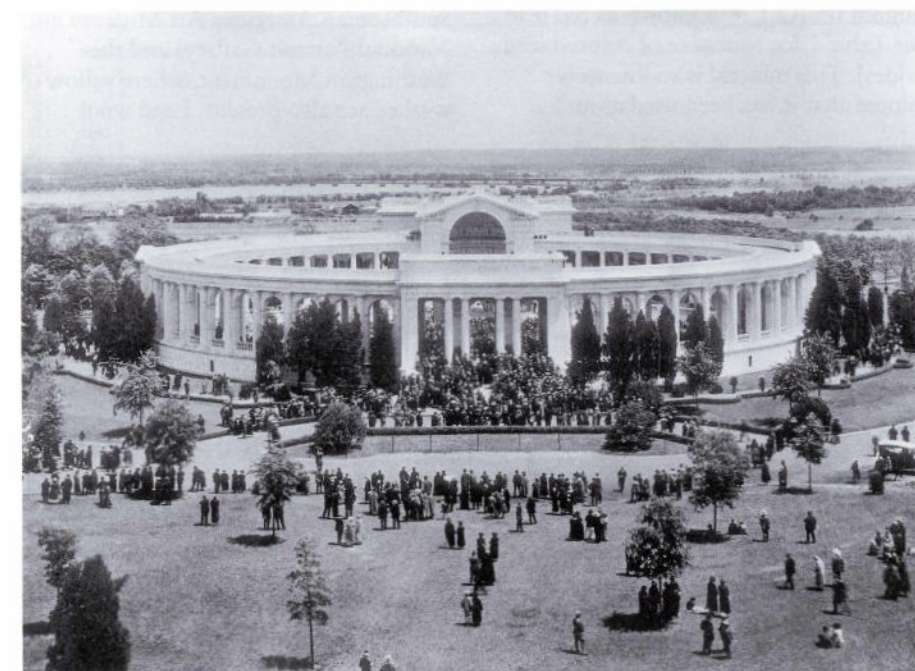
Fig. 1. Memorial Amphitheater, Arlington National Cemetery, view from the mast of the USS Maine Mast Memorial, probably at the dedication of the memorial in 1920. Library of Congress, Prints & Photographs Division, Theodor Horydczak Collection.

Type 1 stains: on marble pavers between external columns of the building's portico. In contrast, staining is absent on adjacent blocks below the columns (Figs. 2 and 3). These pavers are by far the most common location for colored stains on the building. Close scrutiny of the photograph taken around 1920 indicates that the stains were already present then, suggesting that they had formed almost immediately (Fig. 1).

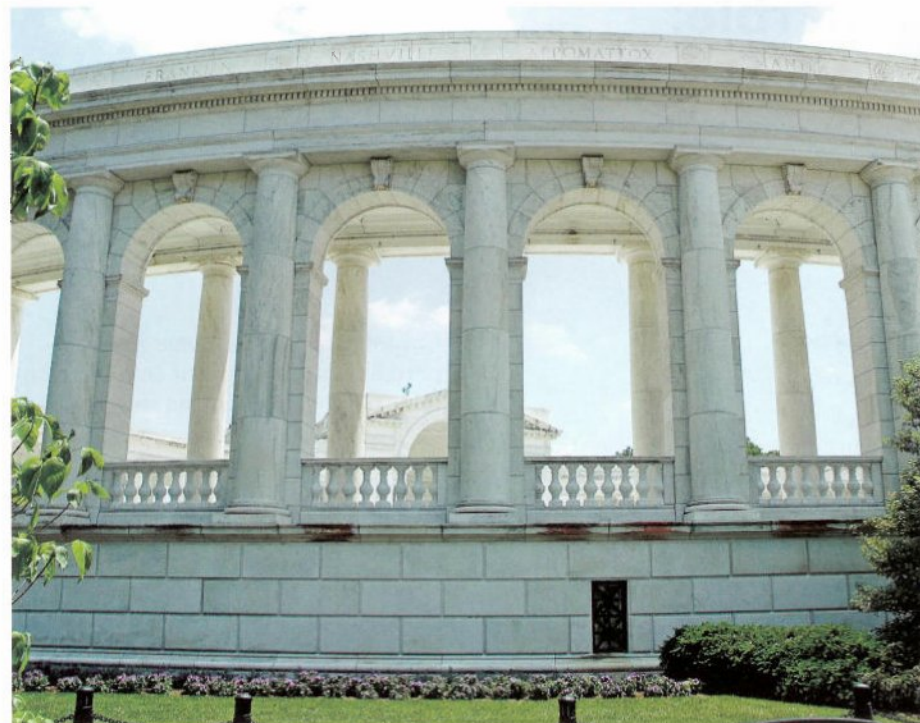
Fig. 2. Memorial Amphitheater, exterior portico. The largest areas of colored stains are on paving blocks between columns outside the balustrade on the exterior portico (type 1 stains). Photographs taken by the authors in 2008, unless indicated otherwise.

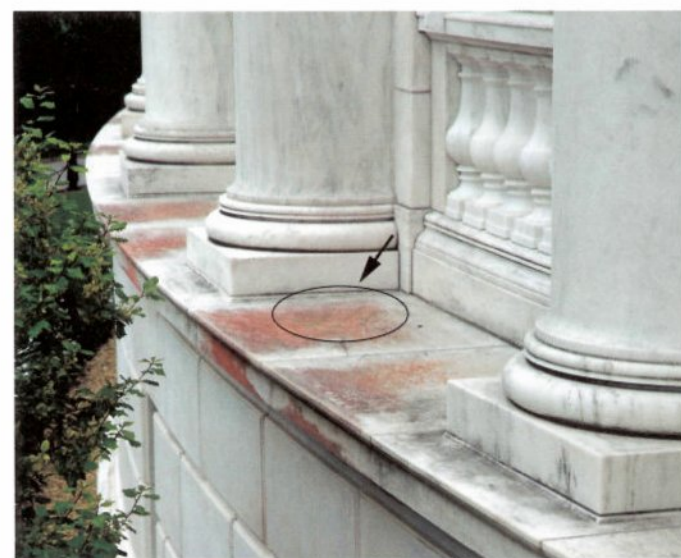
Fig. 3. Base of the two right arches, 2009. Sweeps of a water-washing wand can be seen in the encircled area, with the arrow indicating their direction.

Today the stains are characterized by red spots and yellow washes on horizontal surfaces of the pavers, which slope away from the marble balustrade of the portico. Evidence of water washing is visible as light streaks noted in Figure 3, apparently from the strokes of power-washing equipment; although some soiling on top of the colored stains was removed by the washing, the stains themselves appear to have been unaffected. More densely colored red and brownish purple areas are predominant

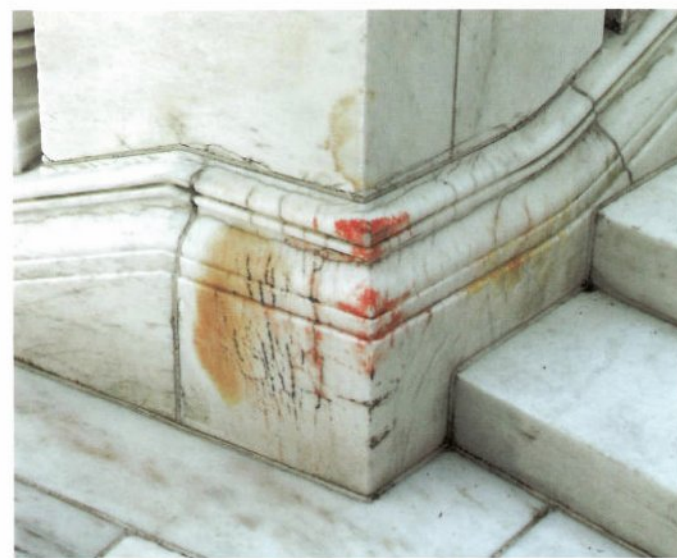
Fig. 4. Corner post of an exterior stairway (type 2 stains). Staining appears unchanged since photographs were published by Einhorn Yaffee Prescott in 1998.

Type 2 stains: on a single base block of a stairway corner post outside the portico leading to the Memorial Display Room north of the theater's stage. This spot is arguably one of the most disfigured areas on the monument, in part because its intensely colored stains are found on an otherwise pristine staircase (Fig. 4). Bright orange-red areas are concentrated next to spalled-off corners and along crevices. Minium has been identified in samples by X-ray diffraction analysis (XRD) and Raman spectroscopy (see the XRD and Raman sections below for details of the techniques). Black *Veruccaria* lichens, visually identified by Smithsonian lichenologist Paula DePriest, are also associated with the crevices but appear to be unconnected with staining, apart from the fact that both depend on moisture. Orange and yellow washes appear

further from the corner. The source of lead is apparently sheet lead in the joint above the block: a positive test for lead at a pointing loss was produced using Plumbtesmo test strips (see the microchemical-testing section below for details). EYP photographs reveal that Clorox was tested to decolorize stains on this block, apparently without any effect, since they appear the same today.²⁰ Another EYP photograph shows corner-post blocks that exhibit similar but more severe staining on the same stairway; they have since been replaced with new blocks.

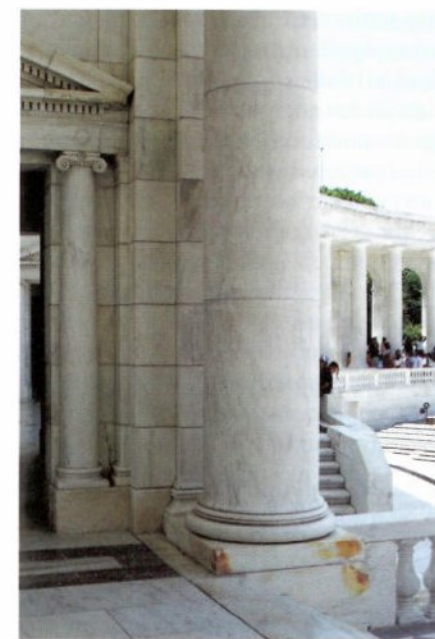
Fig. 5. Stained corners on column-base blocks near the stage of the amphitheater (type 3 stains).

Type 3 stains: on column and pilaster bases at an entrance to the portico just north of the stage. Corners and high-relief areas are generally brownish purple, with other colored stains (red, orange, and yellow) at their perimeters (Fig. 5). No sources of lead could be seen, but sheet lead is likely present in joints above stained areas, where it was used for cushioning or shimming the columns or pilasters.

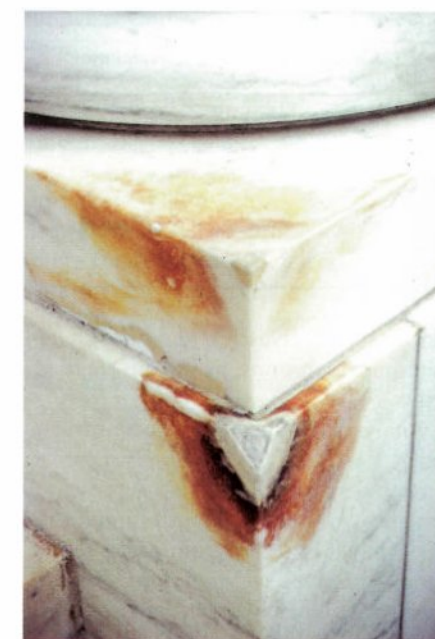
Fig. 6. Detail of corner block shown in Figure 4, photographed in 2004.

One fascinating block in this area features a unique example of change over the past five years (Figs. 6 and 7). Comparison of photographs taken in 2004 and 2009 show that brownish purple, orange red, orange, and yellow stains have migrated downward and outward over this period, with marked expansion of the area of yellow wash. These changes in staining may have been accelerated by a large number of wet-dry cycles from exposure to sun, wind, and rain. Higher evaporation rates are well known to occur on corners of stone blocks, and the location of this particular block at an entrance to the portico increases its exposure to wind. One side of the block also faces west, the prevailing direction from which rain arrives in the Washington area. Finally, this area is a primary entry point to the amphitheater from the much-visited Tomb of the Unknowns, and, as a result of its prominent location, stains have no doubt been subjected to attempted cleaning. Circular marks left by a grinder or sander on the surface of the block attest to heavy-handed attempts at stain removal. Cleaning solutions may also have increased the formation, dissolution, and redistribution of lead compounds, al-

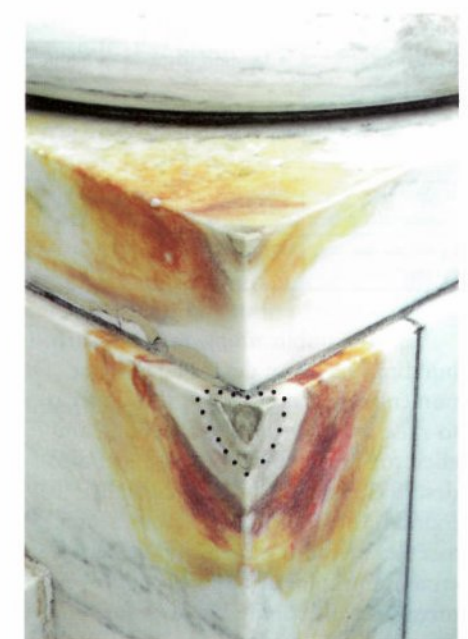
Fig. 7. Detail of same area shown in Figure 6, photographed in 2009, showing the outward migration of stains. The ring of dots indicates the previous inner perimeter of staining on the lower block.

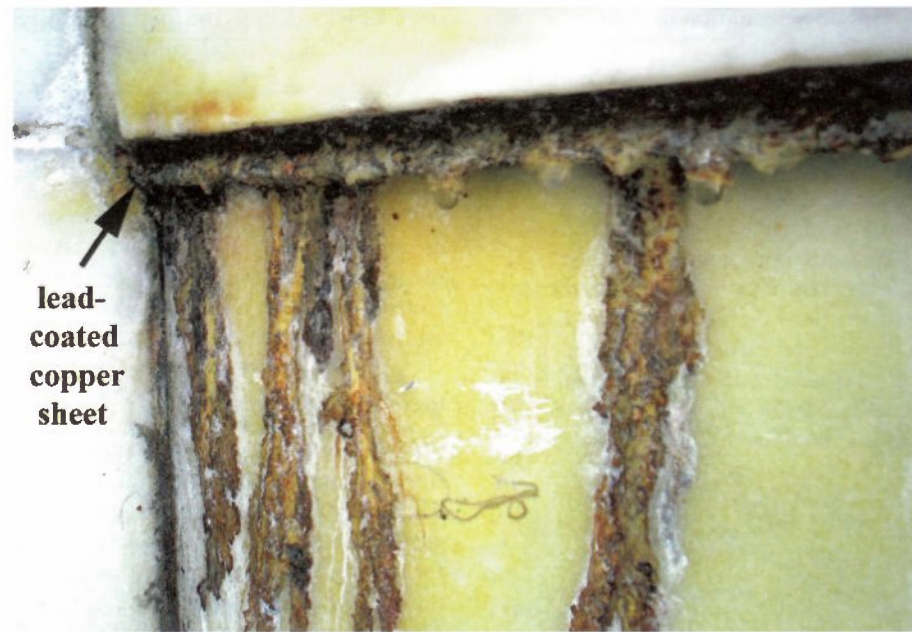
Fig. 10. Yellow and red staining related to lead-coated copper sheet in a joint (type 4 stains). The water droplets visible in the photograph reflect the large amount of water shed by this membrane, resulting in thick calcium incrustations from dissolved marble coating the sheet and running down the marble face.

Type 4 stains: adjacent to a lead-containing moisture barrier placed underneath the viewing-box pavers. The exposed lead-coated copper drip edge of the moisture barrier has deposits of bright orange-red and yellow material on and near it (Fig. 10). XRD confirmed the presence of minium in a sample taken from the metal sheet and of litharge in a sample from an adjacent yellow wash. The lead-coated copper sheets were almost certainly installed to prevent water penetration into basement rooms under the viewing boxes. Stalactites and water droplets on the drip edge, as well as rivulets of calcium deposits on the wall below, attest to copious amounts of water running off the barrier. Yellow and orange staining above the copper sheets reflects capillary rise of the lead oxides.

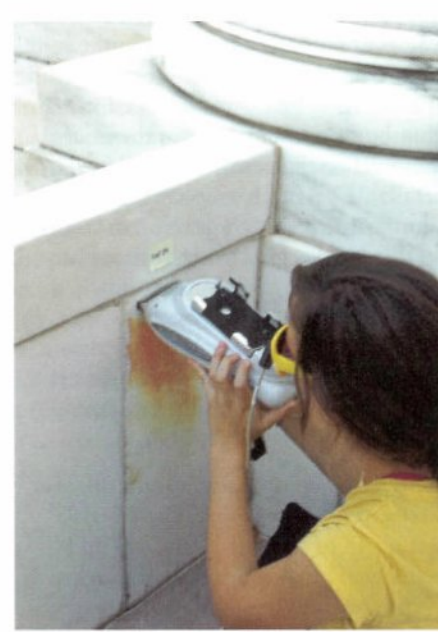
Fig. 11. Stone from the viewing-box enclosure with identical stains on opposite faces (type 5 stains). Vertical cracking of the stone next to the joint probably contributed to staining by its retention of moisture. X-ray fluorescence analysis performed on stone above the stain showed no lead, while the stain itself did.

Type 5 stains: on opposite sides of a viewing box enclosure stone. Matching orange patches on opposite faces of one block are unique at the amphitheater (Fig. 11). XRF analysis showed that lead is present in stained areas but absent from adjacent white areas like the one being tested in the photograph. No lead is visible at the joint. However, the location of the stains near it suggests that the source of lead is likely related to the attachment of the block to the adjacent stone, possibly by an iron clamp that was set with hot lead or lead wool to inhibit corrosion of the

iron. Cracks next to the joint retain moisture that probably contributes to staining.

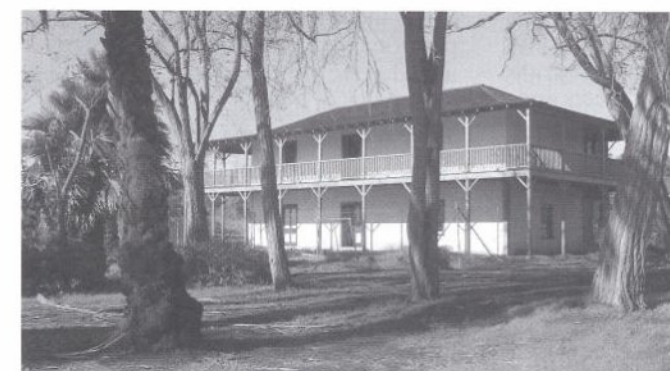
Fig. 1. The Las Flores Adobe, a nineteenth-century adobe rancho on U.S. Marine Corps Base Camp Pendleton in north San Diego County, 2006. The building is associated with the historic *Rancho Santa Margarita y Las Flores* and is a National Historic Landmark. All images courtesy of the authors, unless otherwise noted.

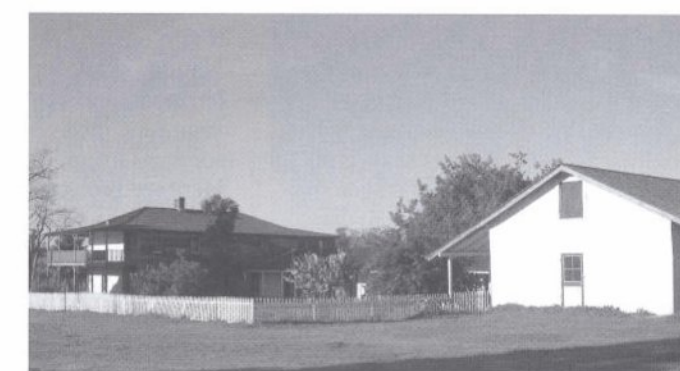
Fig. 2. Courtyard enclosed by the Monterey block (left) and the gable-roofed carriage barn (right).
