SMITHSONIAN INSTITUTION
BUREAU OF AMERICAN ETHNOLOGY
BULLETIN 121

ARCHEOLOGICAL REMAINS IN THE
WHITEWATER DISTRICT
EASTERN ARIZONA

PART I. HOUSE TYPES

By FRANK H. H. ROBERTS, JR.

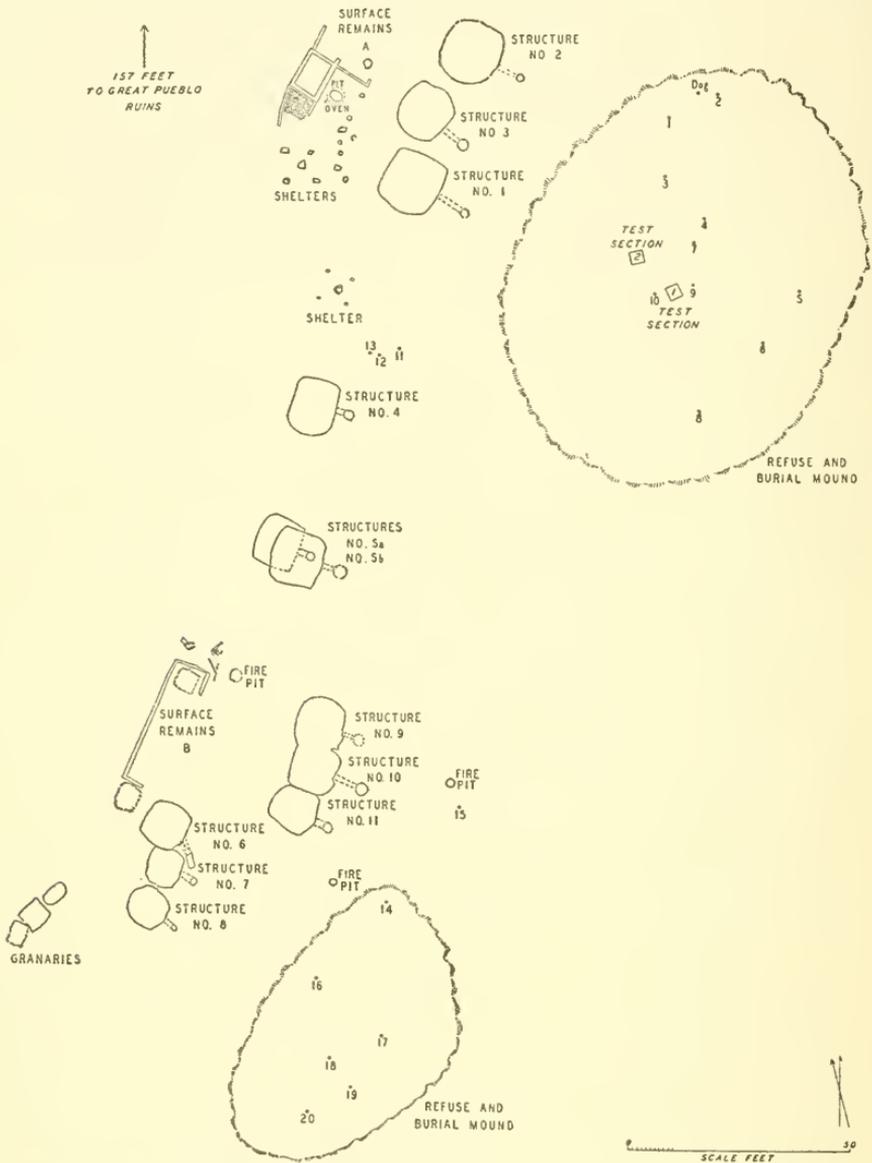
FIGURE 1.—Group 1 pit and surface remains. Numbered dots indicate location of burials.

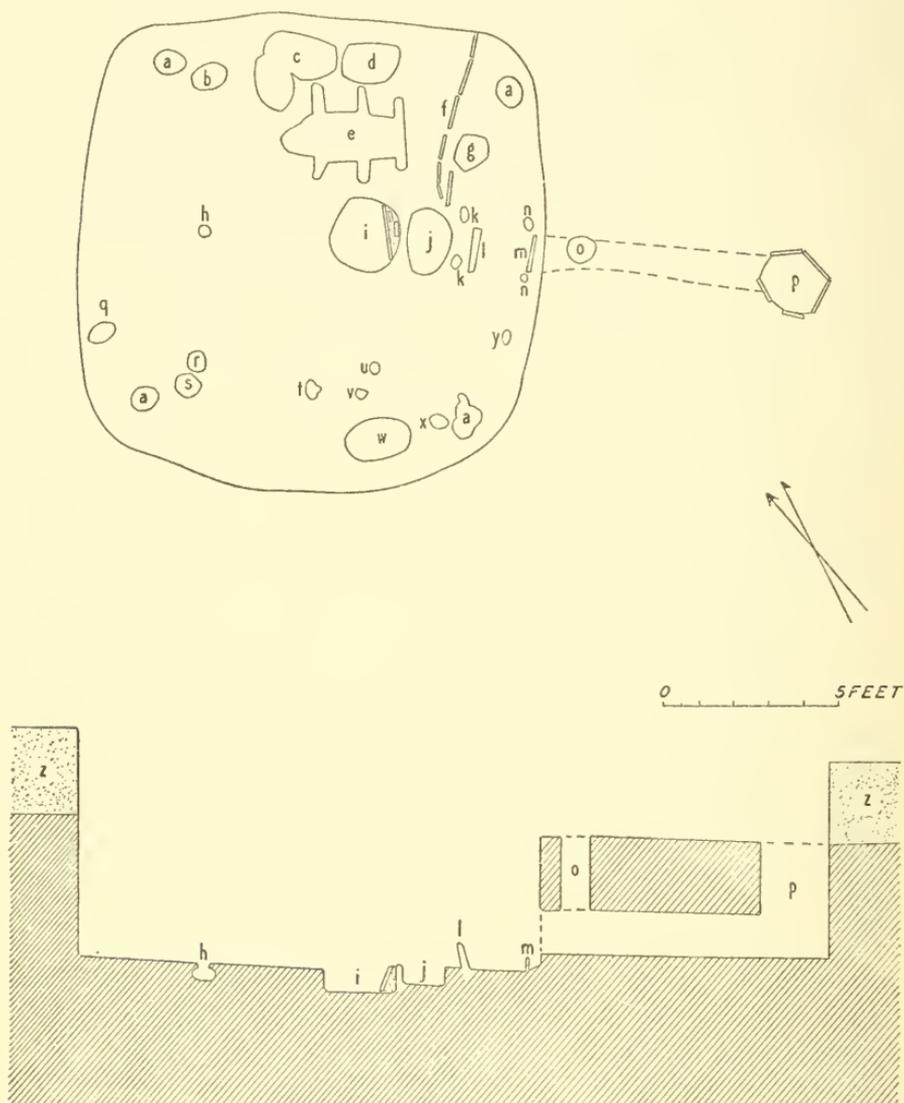
FIGURE 2.—Structure 1. *a*, holes for support posts; *b*, *c*, and *d*, storage basins; *e*, basin in floor; *f*, wall forming compartment; *g*, basin in floor; *h*, sipapu; *i*, fire pit; *j*, ash pit; *k*, ends of ladder poles; *l*, deflector; *m*, stone to protect ventilator opening; *n*, pole placement; *o*, small shaft in ventilator; *p*, main ventilator shaft; *q*, pot rest or storage hole; *r*, *s*, *t*, *u*, *v*, *w*, *x*, and *y*, storage holes and basin; *z*, sand accumulation above old ground level.

The larger basin-like depressions (fig. 2, *c*, *d*, *w*) possibly served as places in which baskets or jars were set, although there was no indication that such had been the case. What function the curiously shaped depression *e* may have been intended to fulfill is a question for which no answer has been found. At the time when the remains were excavated a small pitcher of the culinary variety of pottery was sitting in the end toward the ventilator side of the room. Several who saw the house suggested that loom sticks may have been placed across the depression in the arm-like projections at each side of the central portion. In view of weaving practices in general, as they are known throughout the Southwest, this does not seem to be a good explanation. There was nothing about the depression itself to furnish a clue.

The hole marked *h*, figure 2, corresponds in its general size and position to similar ones found in most pit houses and in many present-day kivas. In the kivas or ceremonial chambers the feature is called the sipapu, because the modern Pueblos use that name or a close variation of it to designate the hole. According to them it symbolizes the mythical place of emergence through which their ancestors are supposed to have passed in their journey from the inner portions of the earth, where they were created, to the surface of the world upon which they now live. Whether a similar interpretation was made in the past or not is a matter of conjecture. The belief is so firmly implanted in Pueblo mythology, however, that it may with considerable justification be assumed that the prehistoric people regarded the feature in the same light. A further support for this theory is derived from

seven stones forming a bin-like enclosure at the southeast corner of the room (fig. 2, *f*; pl. 3, *a*). One of the typical interior elements in Modified Basket Maker houses consists of a low wall of stone slabs separating the ventilator or, as was the case in many of the dwellings of that period, the entrance side of the chamber from the rest of the room. Sometimes the partition wall extended entirely across from support post to support post. Then again it was broken by a doorway in front of the passage opening into the wall. Occasionally a house is found that only has corner bins at that side of the room.²⁰ The enclosure in one corner of No. 1 is very suggestive of the more complete examples found in the Chaco Canyon houses and possibly represents a survival in the houses of a later day of a characteristic common during a previous stage in house development. The purpose of such compartments is not known. Two metates or grinding stones were found in the present example. This would suggest that the enclosure may have served as a mealing bin for the house. On the other hand it is quite possible that the stones were placed there during intervals when they were not in use, since one was leaning against the partition and the other against the wall. The bin may have served solely in the capacity of a storage place. Firewood, jars containing surplus food and other items connected with the daily life of the people could have been placed there where they would not interfere with the general trend of affairs in the main part of the structure. Somewhat comparable enclosures in the earth lodges of some of the Plains Indians, dwellings which in many ways bear a strong resemblance to the pit houses of the Southwest, despite the fact that they were largely surface structures, were employed for storing the supply of firewood in winter.²¹

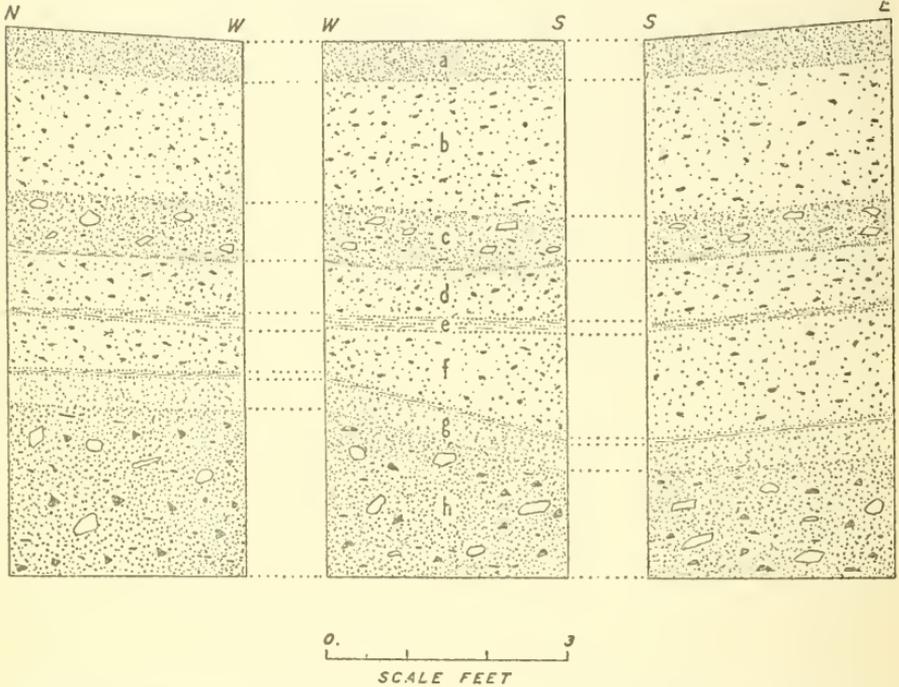
FIGURE 3.—Pillar left from fill in structure 1. N, W, S, and E, indicate north, west, south, and east corners. *a* to *h*, Strata in fill.

The second stratum (fig. 3, *b*) was considerably thicker than the first. It was 1 foot 6 inches (45.72 cm) from top to bottom. The main content was blow sand and ashes with some charcoal. Toward the lower half there was a marked increase in the number of potsherds present. In fact there was only one other layer in the entire pillar which contained more. This would suggest that there was considerable activity around the site at that time and the remains of many broken vessels found their way into the abandoned pit. The stratum did not give distinct evidence at this point of having typical refuse material in it and it does not seem that it can be attributed to house sweepings and other waste matter being dumped there. Rather would the character of the fill at this point suggest a more or less natural gravitation of objects into a depression.

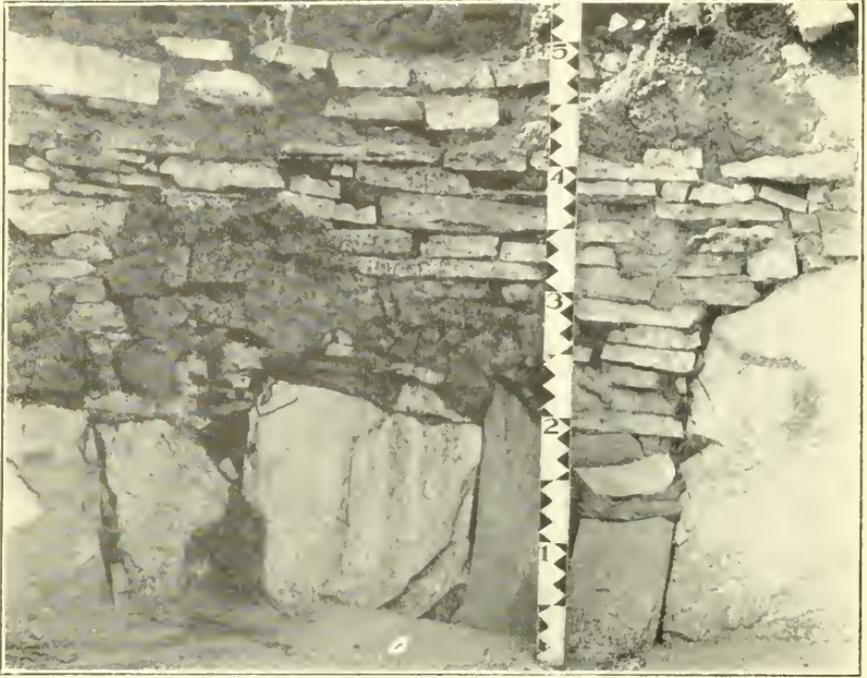
a. Masonry wall resting on slab foundation.

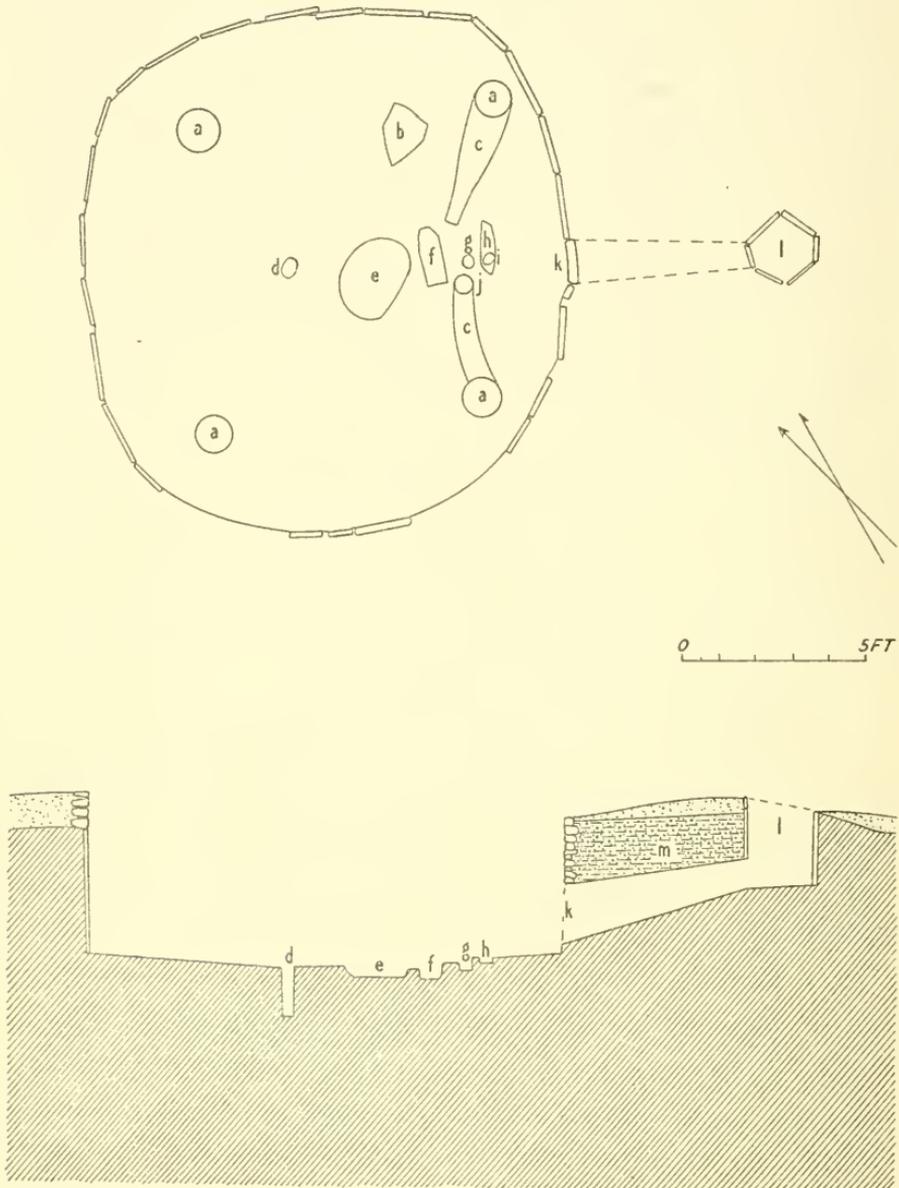
FIGURE 5.—Structure 2a. *a*, holes for main support posts; *b*, stone embedded in floor; *c*, adobe ridges forming compartment; *d*, sipapu; *e*, fire pit; *f*, ladder box; *g*, storage hole; *h*, groove in floor; *i*, pole mold; *j*, storage pit; *k*, ventilator opening; *l*, ventilator shaft; *m*, fill above ventilator passage.

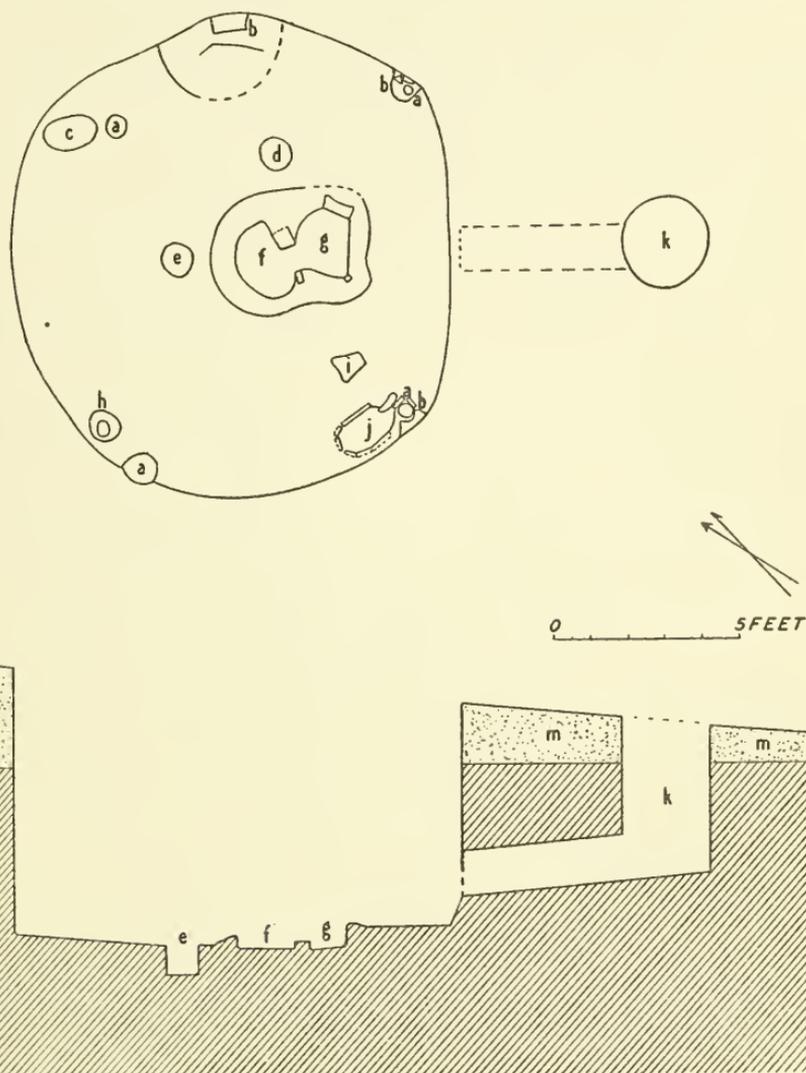
FIGURE 6.—Structure 3. *a*, support posts for superstructure; *b*, pilasters; *c*, storage basin; *d*, storage hole; *e*, sipapu; *f*, fire pit; *g*, ladder box; *h*, storage hole; *i*, stone embedded in floor; *j*, secondary fire pit; *k*, ventilator shaft; *m*, sand accumulation above old surface.

The superstructure was supported by four posts set in the floor and one pilaster or masonry pillar. Two of the support posts had been braced with mud plaster placed between them and the wall in the same fashion that the post in No. 2 had been buttressed (pl. 7, *b*). One curious factor in this connection is that in both Nos. 2

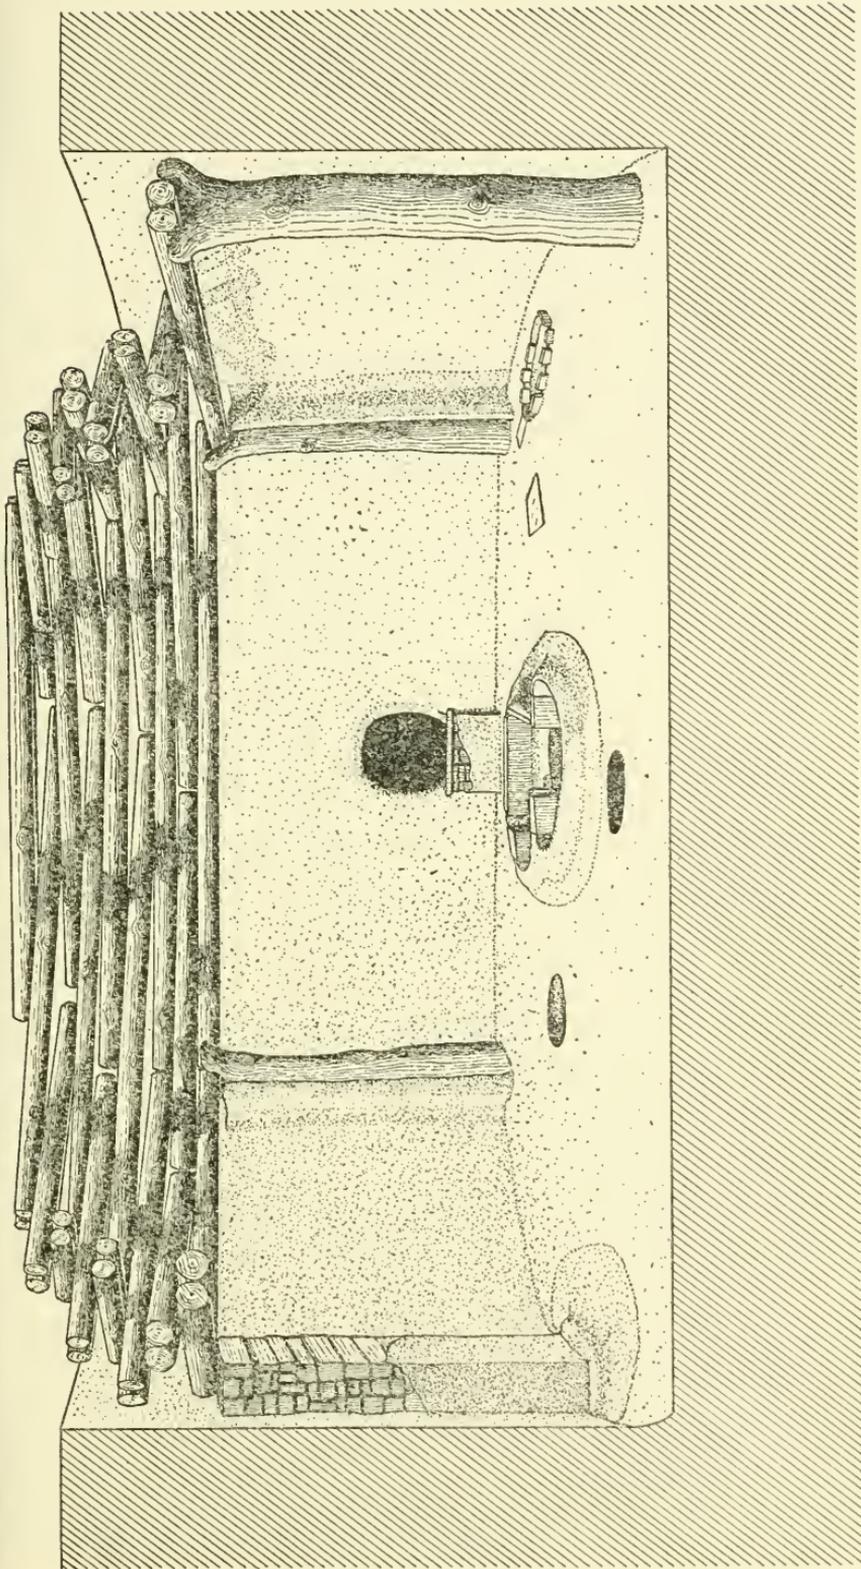
FIGURE 7.—Postulated reconstruction of cribbed roofing erected over pit of structure 3. One side removed to show method of laying timbers.

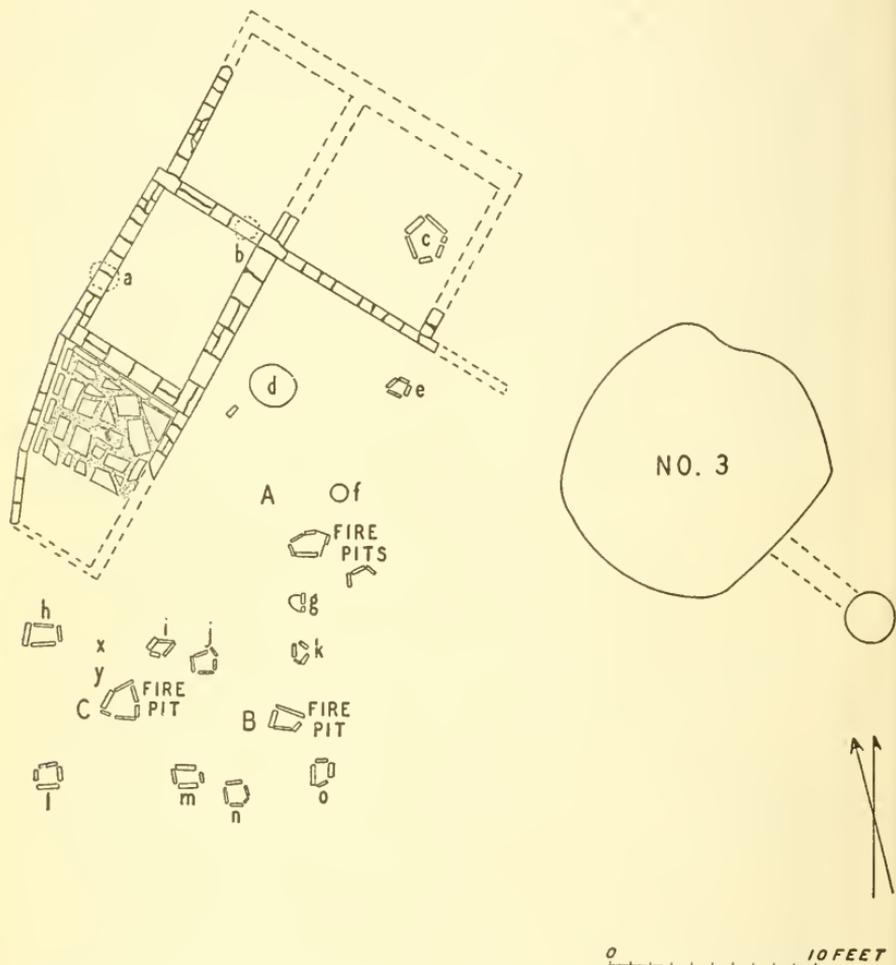
FIGURE 8.—Remains of surface building A. *a* and *b*, fire pits beneath foundations; *c*, fire pit in floor of room; *d*, opening into pit oven; *e*, *f*, and *g*, placements for portico posts; *h*, *i*, *j*, *k*, *l*, *m*, *n*, and *o*, placements for shelter posts; *x*, location of fragment of child's skull; *y*, location of black-on-white bowl.

extended across former fire pits (fig. 8, *a*, *b*). At the time the structure was built these pits were apparently on or just below the existing level of occupation. They were filled with stones and mud before the wall was carried across them (pl. 8, *a*). Another feature, that of a porch or portico, was indicated by the row of post molds or holes along the front of the structure. A similar feature was found near house 15 and inasmuch as the latter exhibited better the

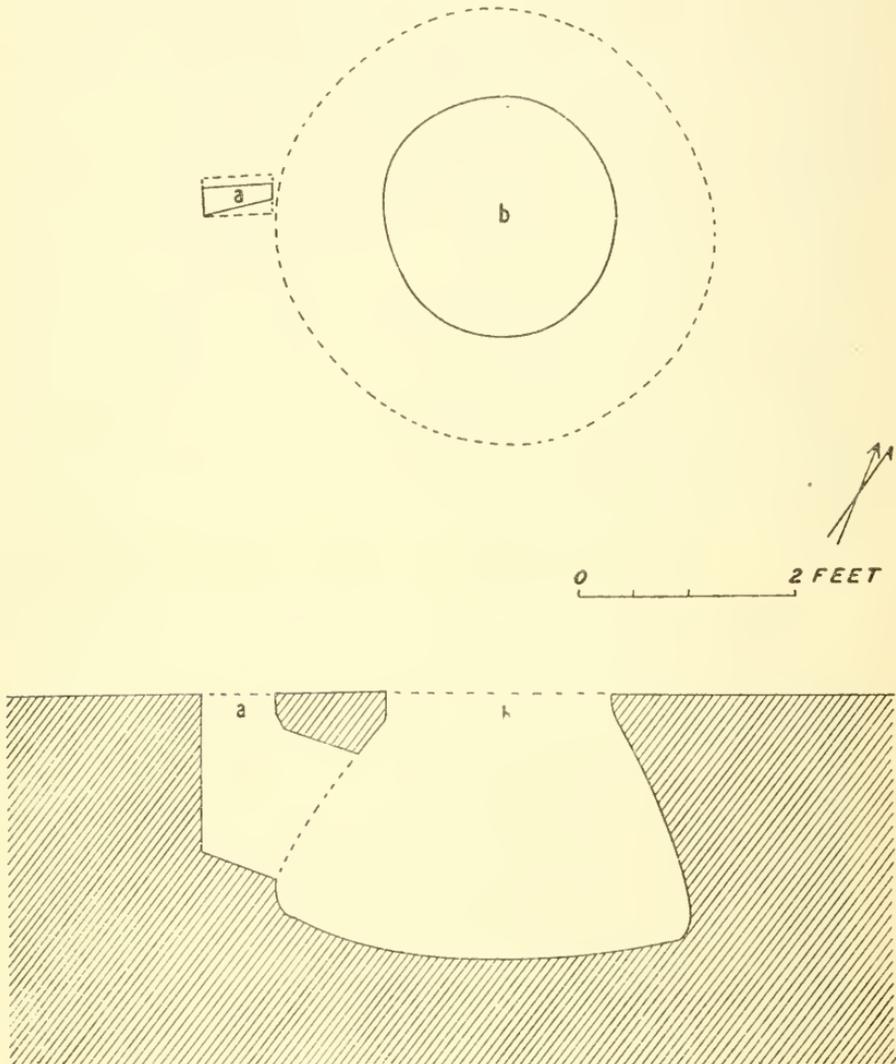
FIGURE 9.—Pit oven. *a*, flue; *b*, opening on ground level.

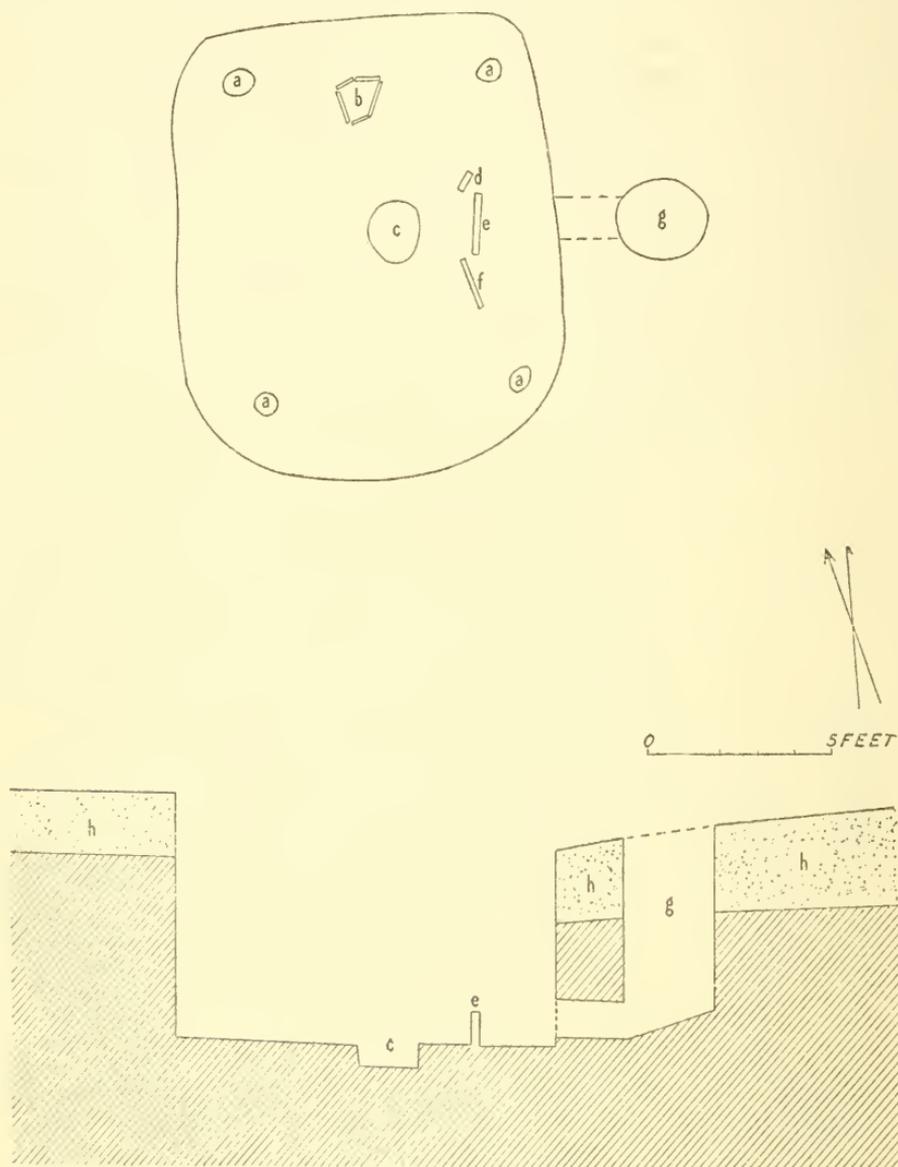
FIGURE 11.—Structure 4. *a*, holes for main support posts; *b*, storage box in floor; *c*, fire pit; *d*, standing stone; *e*, deflector; *f*, standing stone; *g*, ventilator shaft; *h*, sand accumulation above original surface.

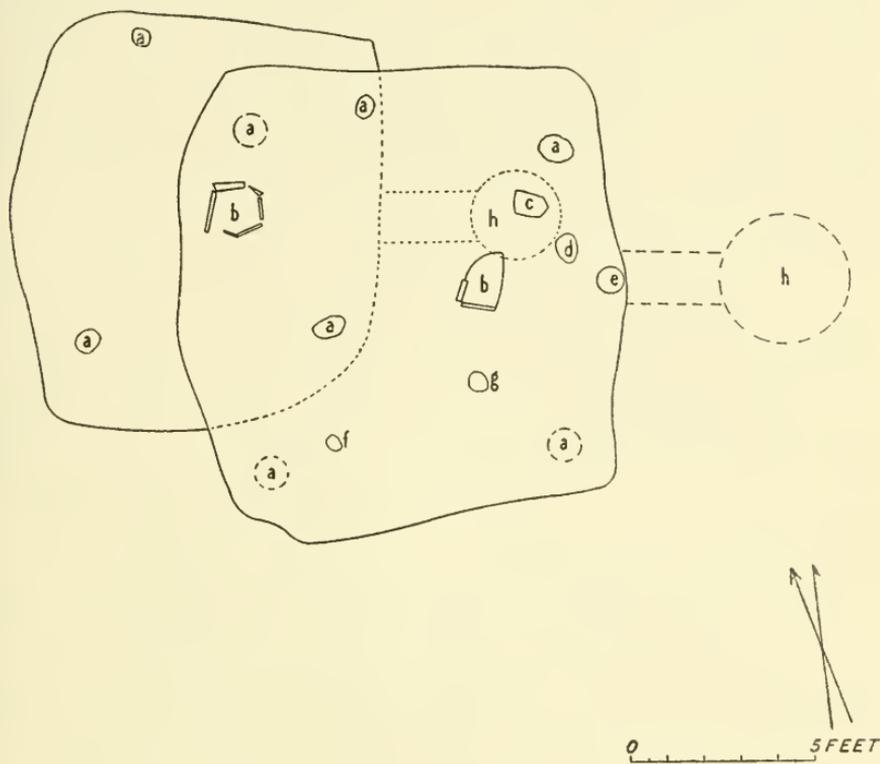
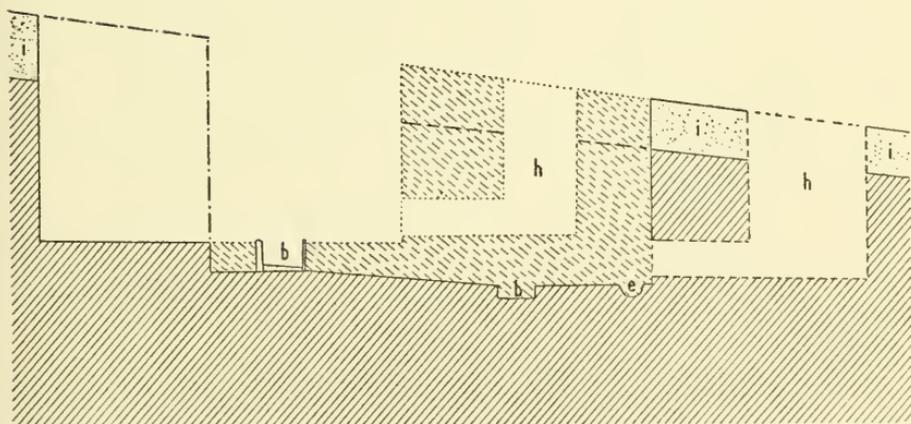
FIGURE 12.—Structures 5a and 5b. *a*, holes for main superstructure supports; *b*, fire pits; *c*, stone embedded in floor; *d*, basin in floor; *e*, hole in floor; *f* and *g*, storage holes; *h*, ventilator shaft; *i*, sand accumulation above old surface.

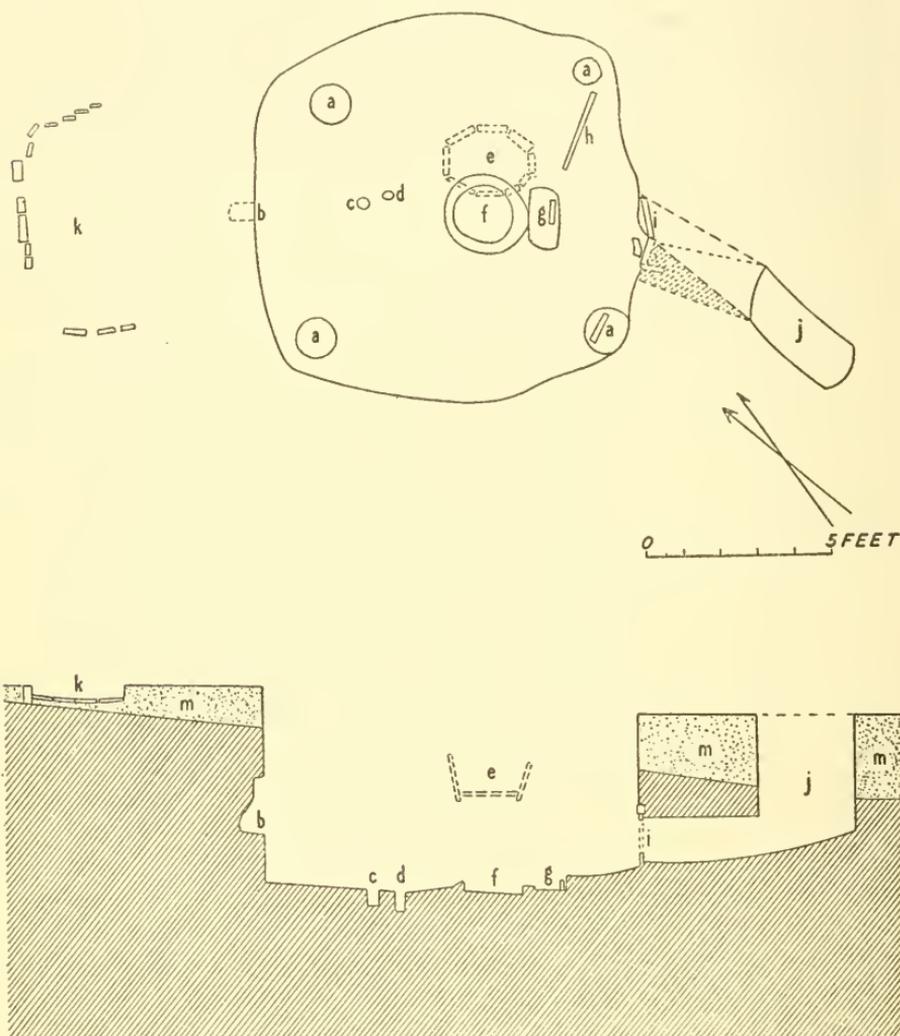
FIGURE 14.—Structure 6. *a*, holes for main roof supports; *b*, placement for roof brace; *c*, storage hole; *d*, sipapu; *e*, fire pit in fill; *f*, fire pit for fire; *g*, ladder pit; *h*, stone forming bin; *i*, ventilator stone; *j*, ventilator shaft; *k*, remains of granary; *m*, sand accumulation above old surface.

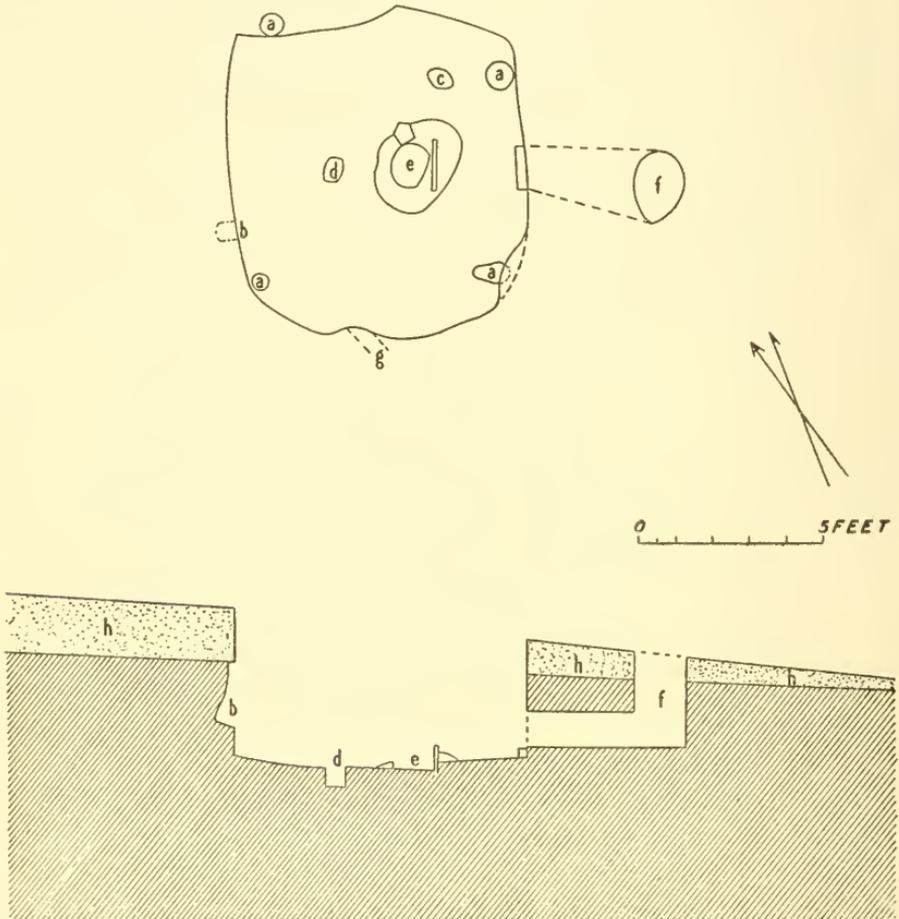
FIGURE 15.—Structure 7. *a*, holes for main support posts; *b*, placement for brace; *c*, storage hole; *d*, sipapu; *e*, fire pit; *f*, ventilator shaft; *g*, opening into 8; *h*, accumulation above original surface.

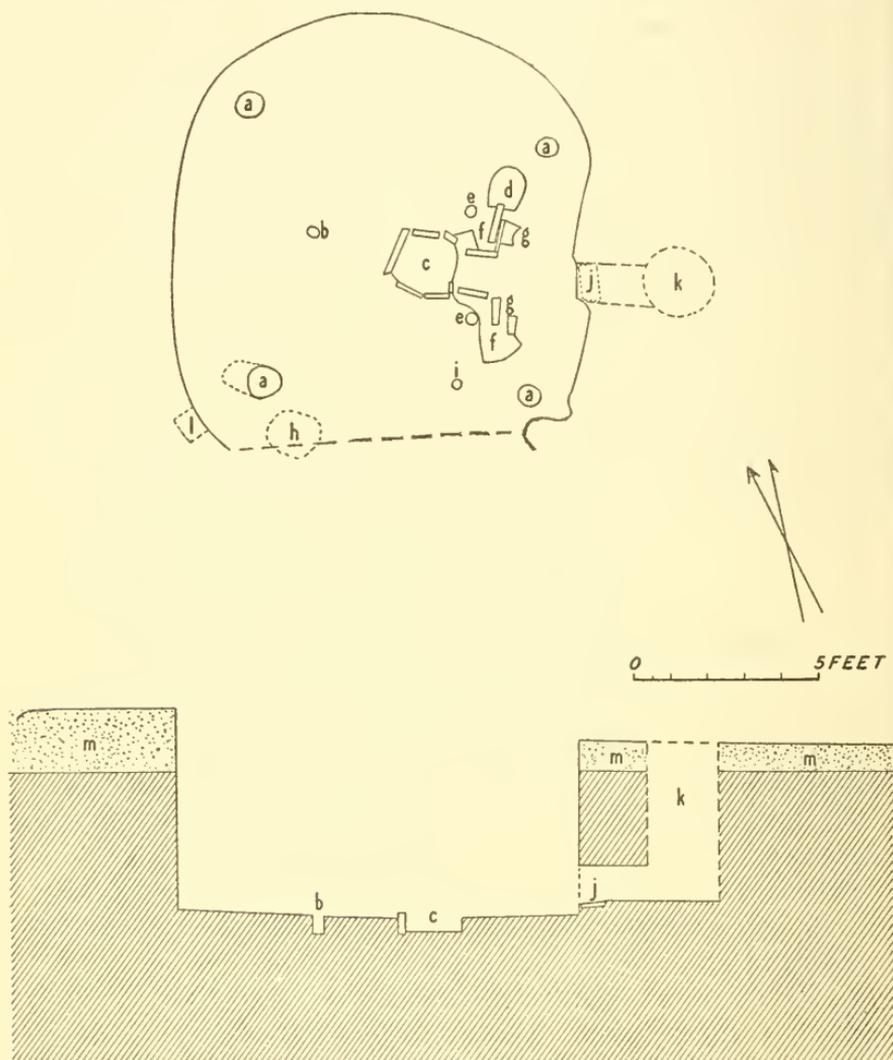
FIGURE 18.—Structure 9. *a*, holes for main support posts; *b*, sipapu; *c*, fire pit; *d*, fallen stone from compartment wall; *e*, holes for small poles; *f*, adobe plaster placement for compartment wall slabs; *g*, stones in compartment wall; *h*, location of support post for superstructure over 10; *i*, storage hole; *j*, ventilator opening and sill; *k*, ventilator shaft; *l*, placement for roof brace; *m*, sand accumulation above old surface.

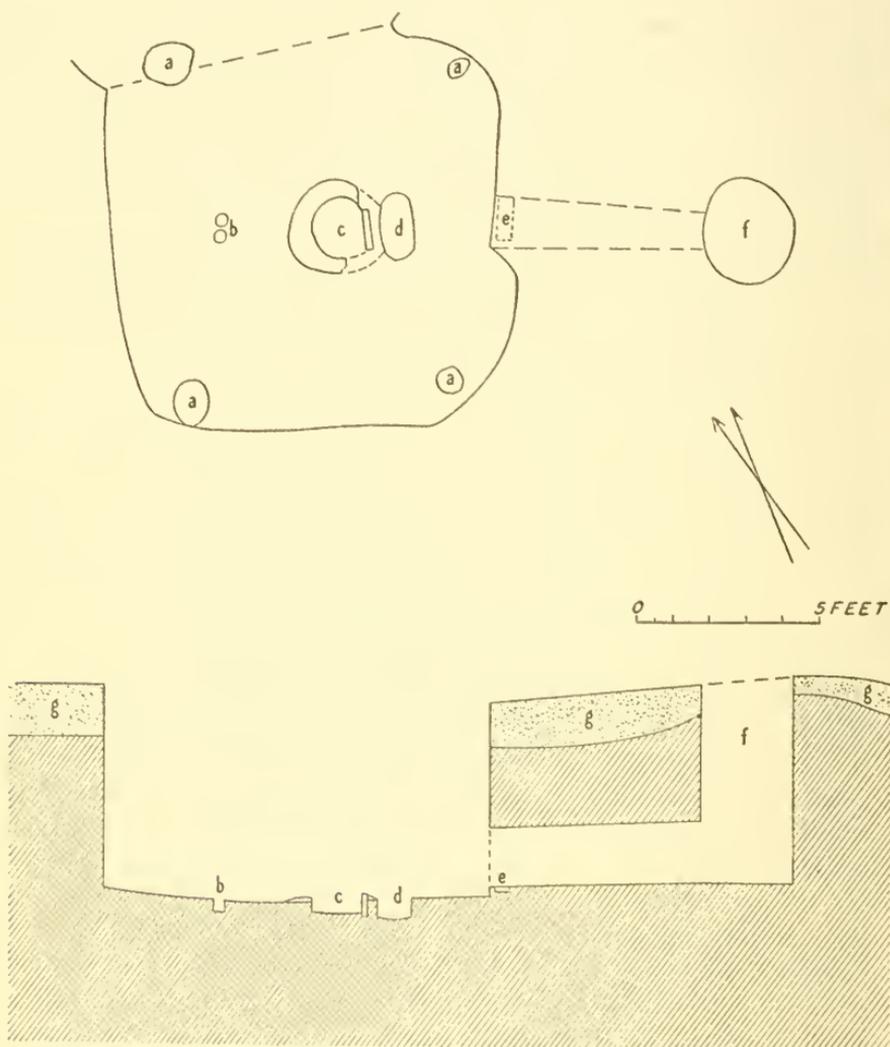
FIGURE 19.—Structure 10. *a*, holes for support posts; *b*, sipapu; *c*, fire pit; *d*, ladder box; *e*, ventilator opening; *f*, ventilator shaft; *g*, accumulation of sand above original surface.

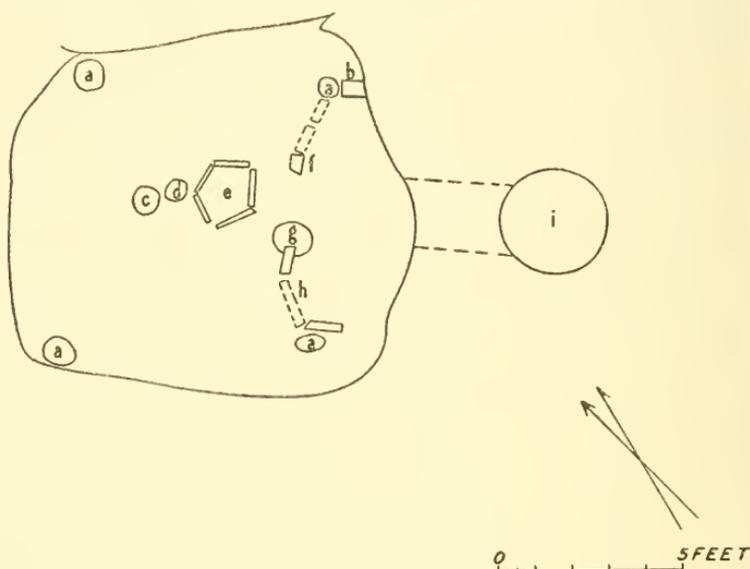
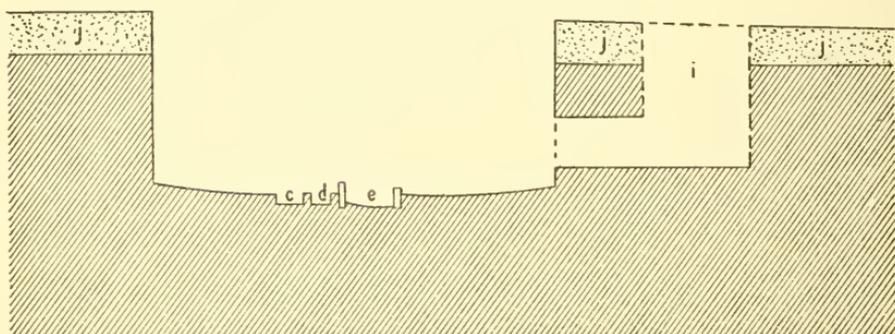
FIGURE 20.—Structure 11. *a*, holes for main support posts; *b*, stone in compartment wall; *c* and *d*, holes in floor in position of sipapu; *e*, fire pit; *f*, stone in compartment wall; *g*, storage basin; *h*, stone mold; *i*, ventilator shaft; *j*, accumulation of sand above original surface.

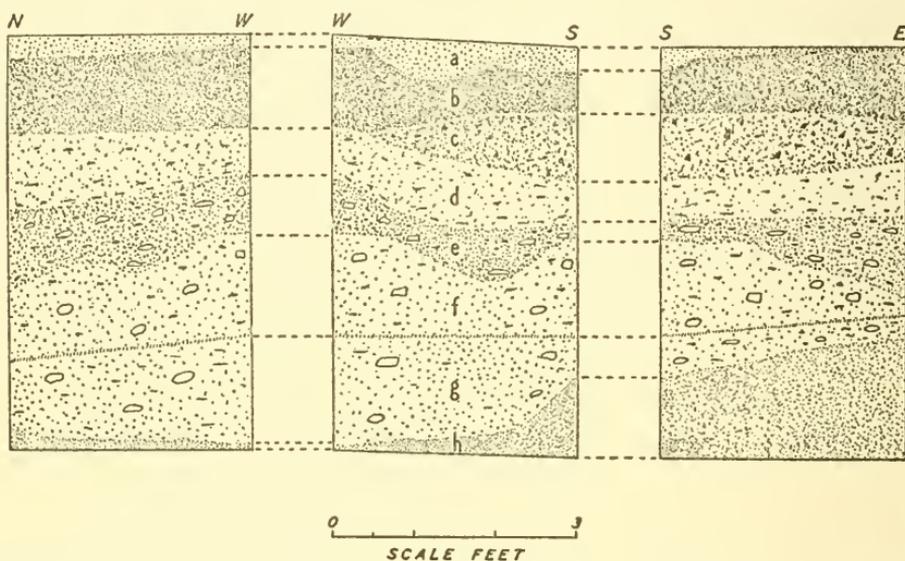
FIGURE 22.—Test pillar from fill in structure 10. N, W, S, and E, indicate north, west, south, and east corners.

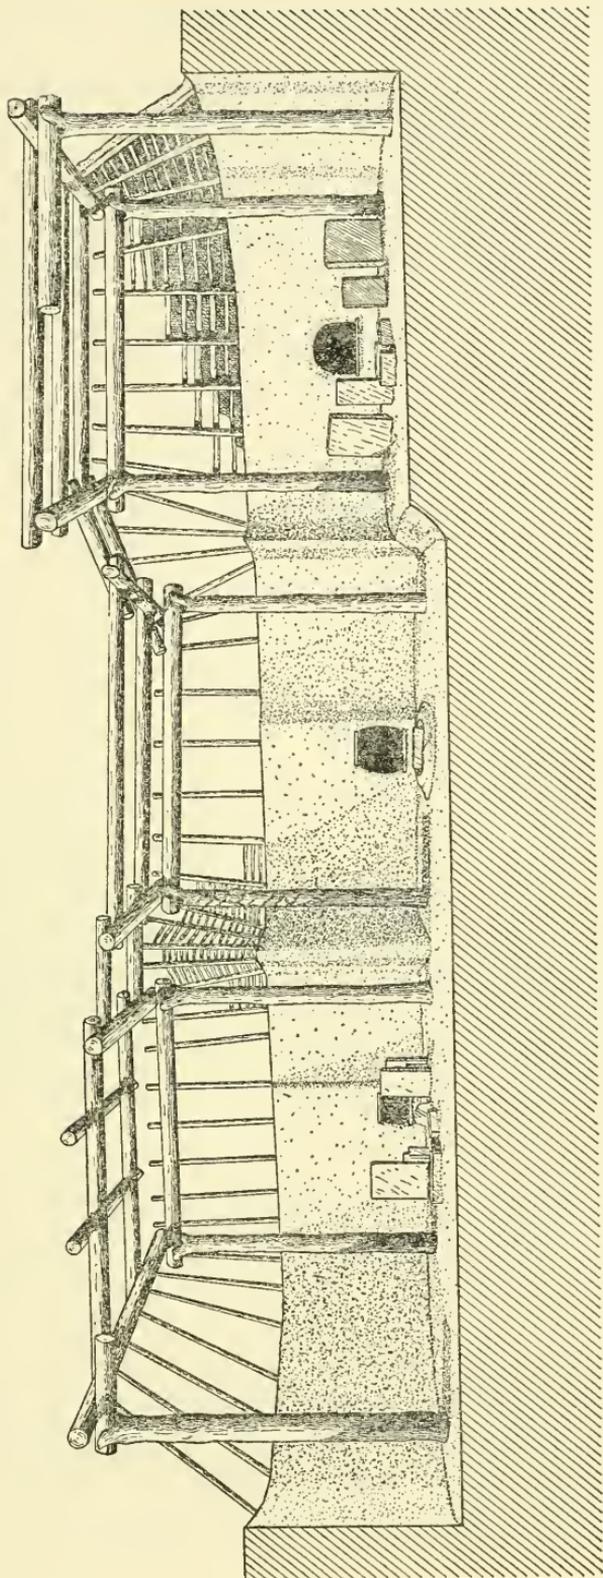
FIGURE 23.—Postulated reconstruction of timber arrangement in superstructure erected over pits 9, 10, and 11. Some of main support posts omitted at front of drawing to show construction more clearly.

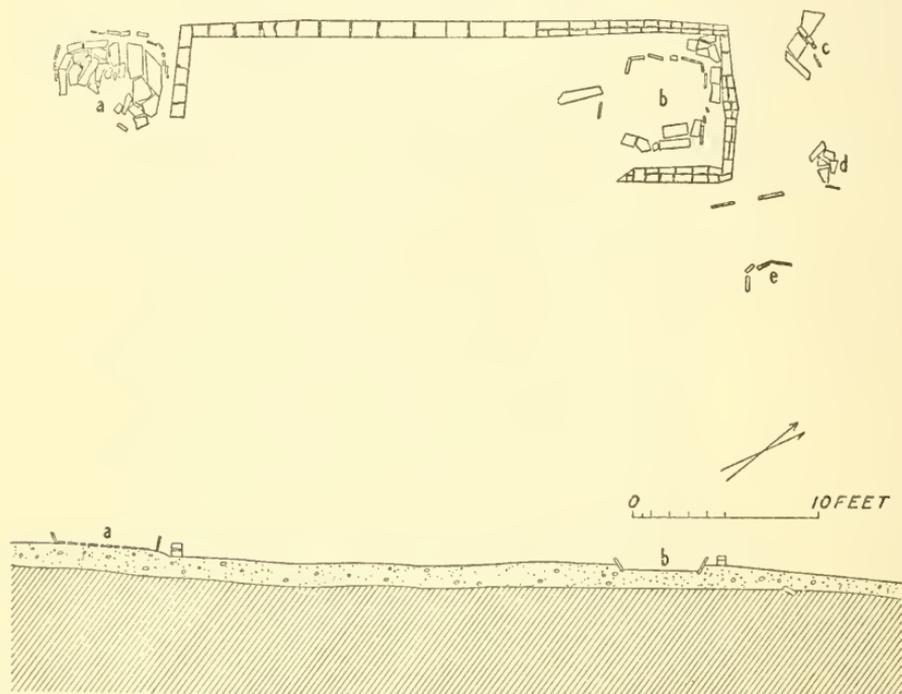
FIGURE 24.—Surface remains B in first group. Granary pits at *a*, *b*, *c*, and *d*; exterior fire pit at *e*.

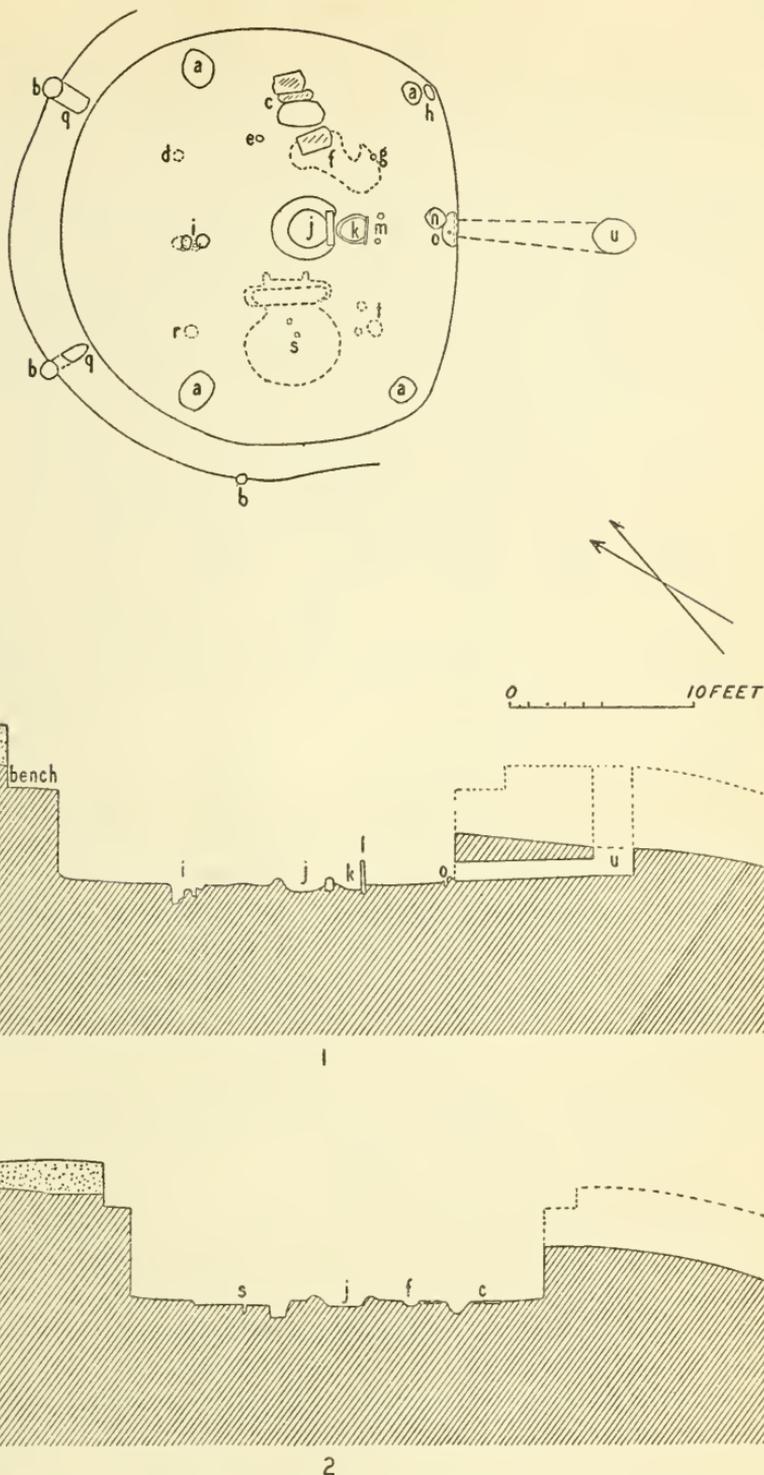
FIGURE 26.—Structure 12. *a*, holes for main support posts; *b*, secondary supports at back of bench; *c*, paving on floor; *d*, plastered-over hole in floor; *e*, storage hole; *f*, plastered-over basin; *g*, storage hole in floor; *h*, storage basin; *i*, sipapu holes; *j*, fire pit; *k*, ash pit; *l*, deflector; *m*, ends of ladder poles; *n*, cover stone for ventilator; *o*, shelf for cover stone and hole for small post to hold stone; *q*, plaster ridges on bench; *r*, plastered over hole; *s*, plastered over basin suggestive of subfloor kiva vault; *t*, plastered-over holes; *u*, ventilator shaft; *v*, sand accumulation.

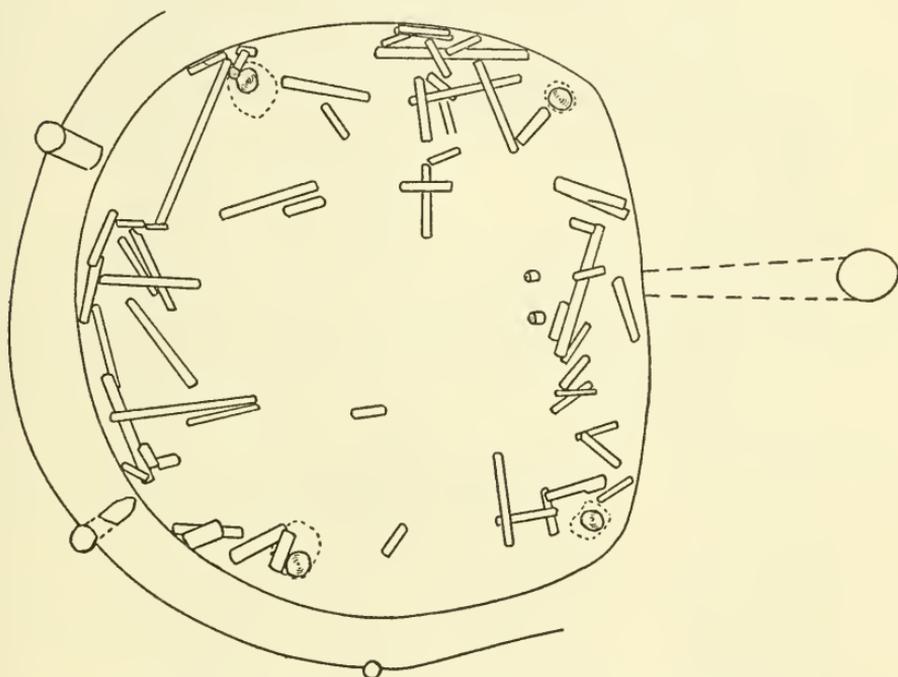
FIGURE 27.—Positions of burned timbers on floor of structure 12.

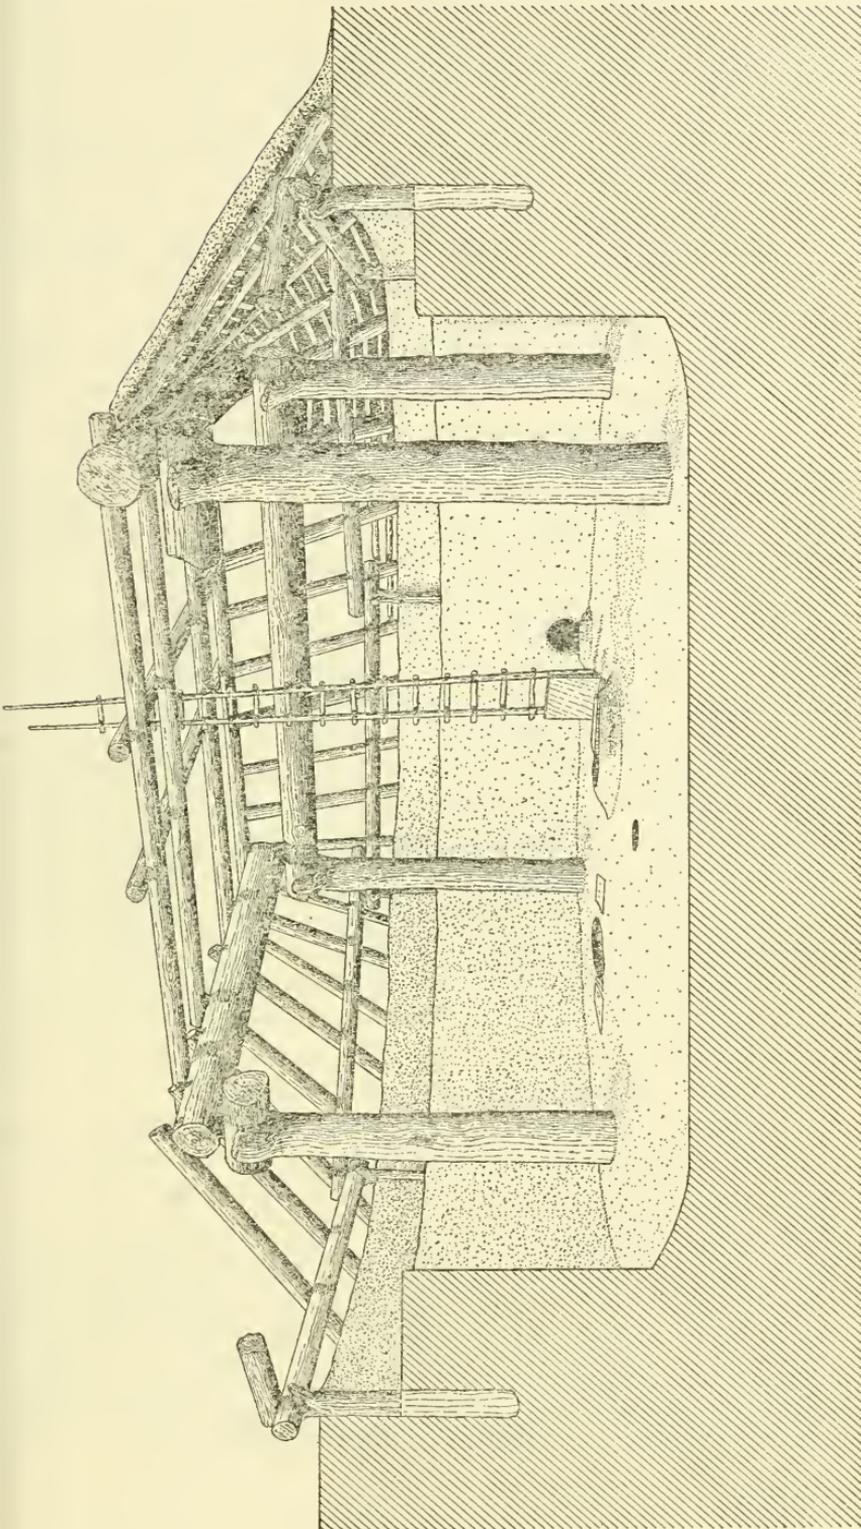
FIGURE 28.—Postulated reconstruction of superstructure erected over structure 12. Some of front timbers omitted from drawing so as not to complicate the diagram.
