SMITHSONIAN INSTITUTION
BUREAU OF AMERICAN ETHNOLOGY
BULLETIN 121

ARCHEOLOGICAL REMAINS IN THE
WHITEWATER DISTRICT
EASTERN ARIZONA

PART I. HOUSE TYPES

By FRANK H. H. ROBERTS, JR.

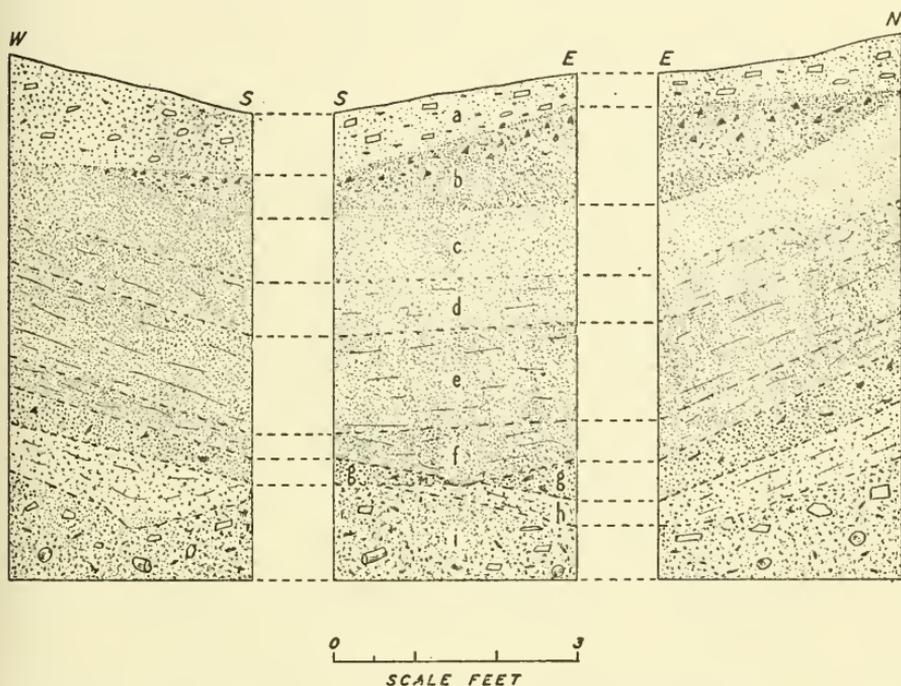
FIGURE 29.—Pillar left from fill in structure 12. E, W, N, and S. indicate east, west, north, and south corners.

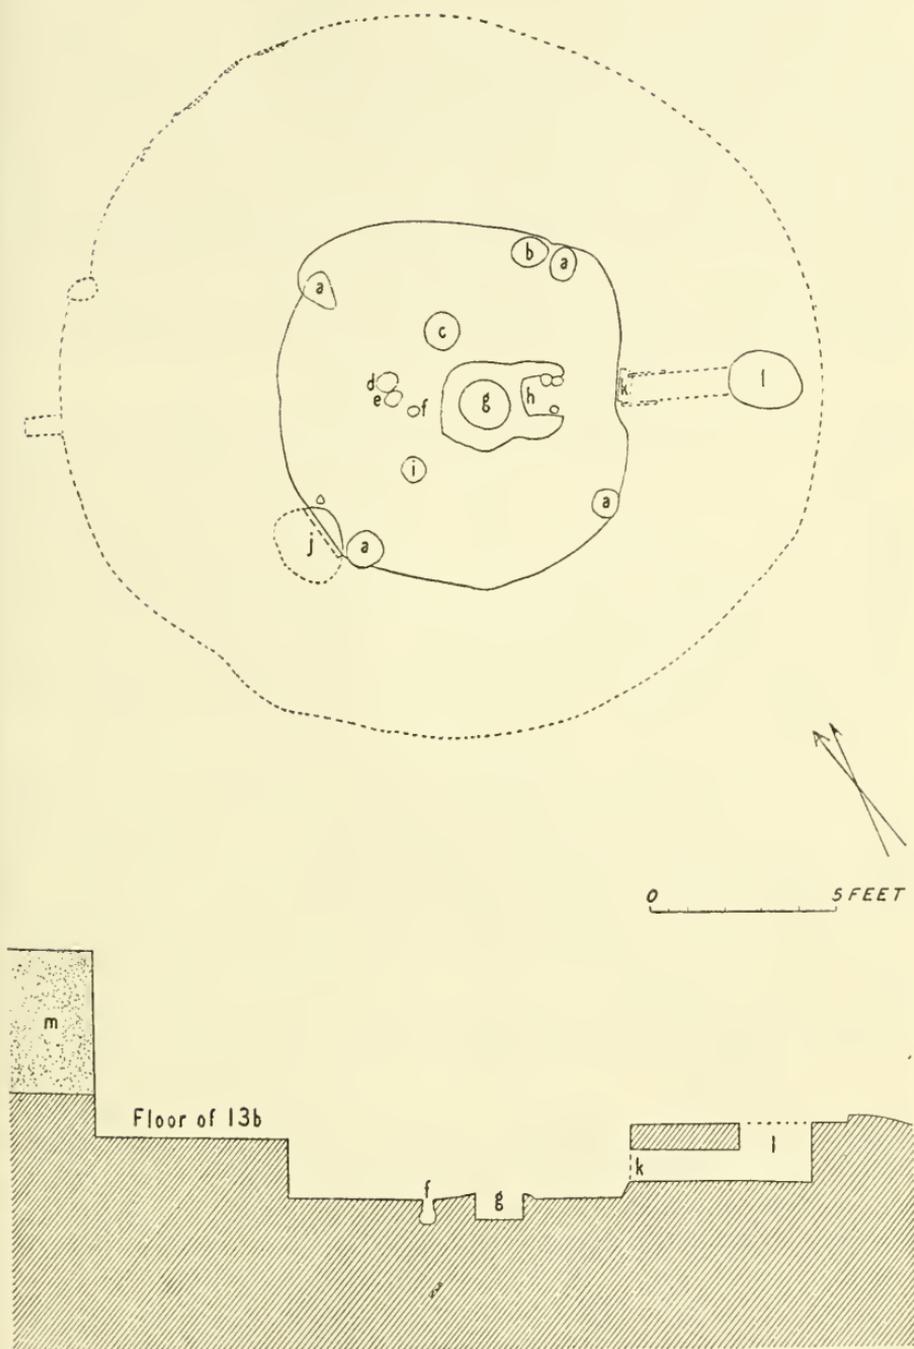
FIGURE 30.—Structure 13a. *a*, holes for superstructure support posts; *b*, *c*, *d*, and *e*, storage holes; *f*, slipapu; *g*, fire pit; *h*, ladder box; *i*, storage basin; *j*, storage pocket in wall; *k*, ventilator opening in chamber; *l*, ventilator shaft; *m*, accumulated sand. Dotted lines indicate position of 13b.

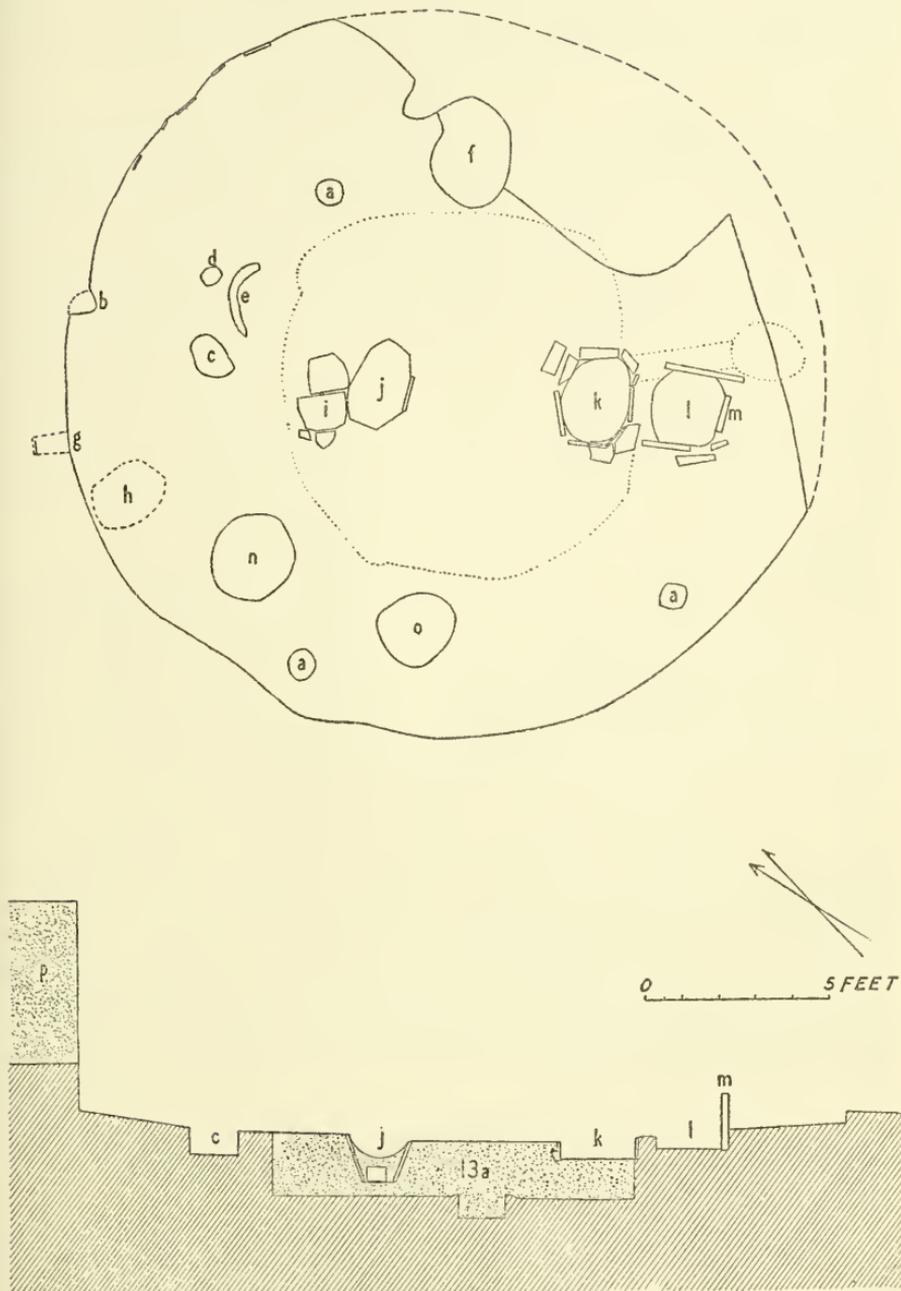
FIGURE 31.—Structure 13b. *a*, holes for main support posts; *b*, beam placement; *c* and *d*, storage holes; *e*, groove in floor; *f*, storage basin; *g*, wall pocket or Katsina niche; *h*, basin covered by floor plaster; *i*, stones embedded in floor; *j*, basin in floor; *k*, fire pit; *l*, ladder box; *m*, deflector stone; *n* and *o*, storage basins; *p*, drift sand. Dotted lines show position of 13a.

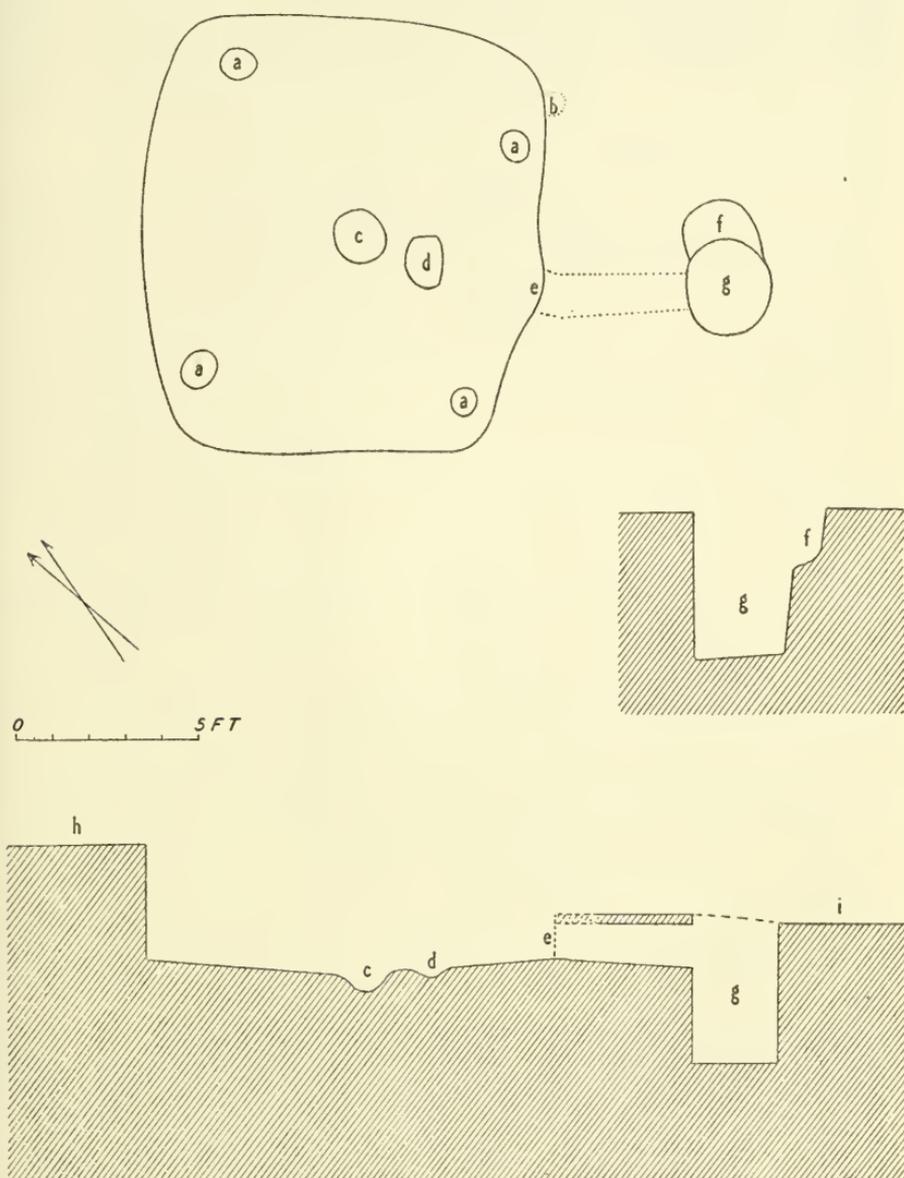
FIGURE 32.—Structure 14. *a*, holes for main support posts; *b*, wall pocket; *c*, fire pit; *d*, ladder box; *e*, ventilator opening; *f* and *g*, exterior opening to ventilator shaft; *h*, platform of dance court dais; *i*, floor of dance court.

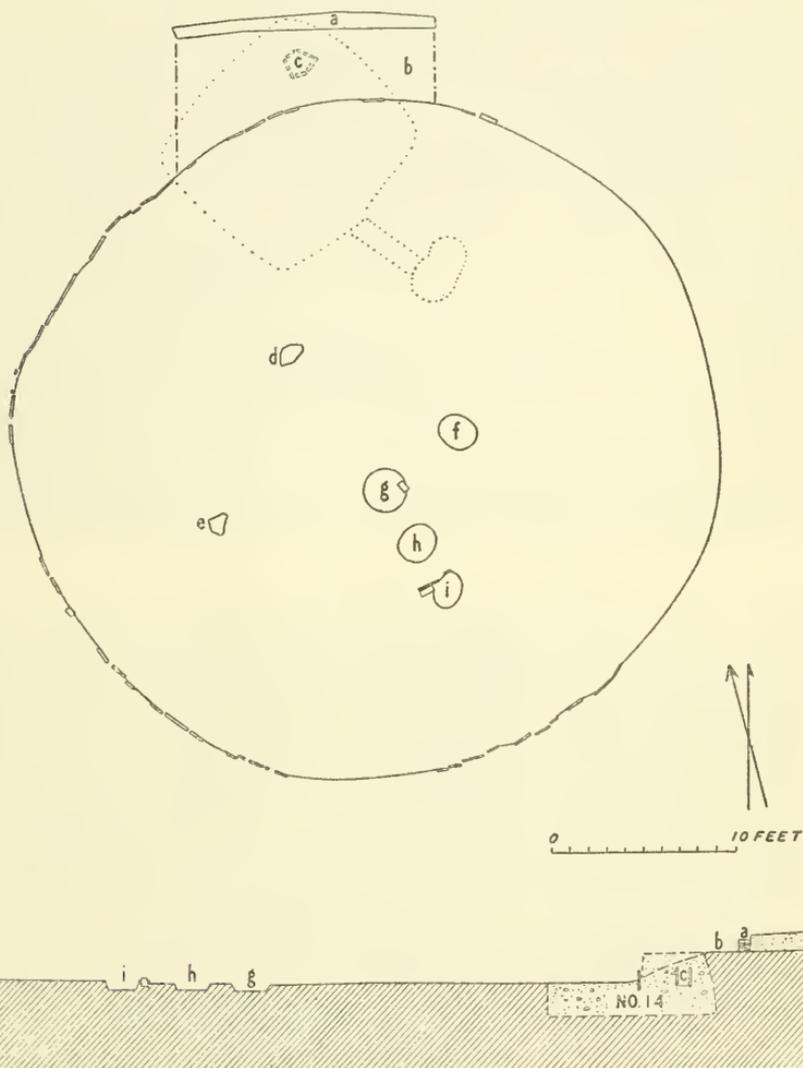
FIGURE 33.—Dance court. *a*, masonry wall; *b*, dais; *c*, fire pit; *d* and *e*, stones embedded in floor; *f*, basin in floor; *g*, fire pit; *h*, ash pit; *i*, basin in floor. Dotted lines show location of structure 14.

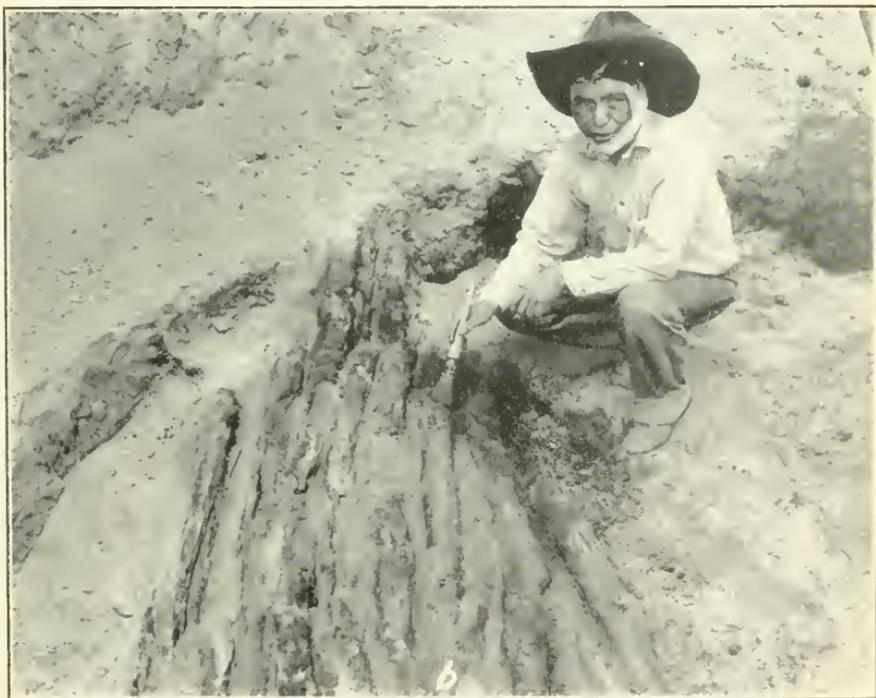
b. Series of slanting side poles for roof of structure 15.

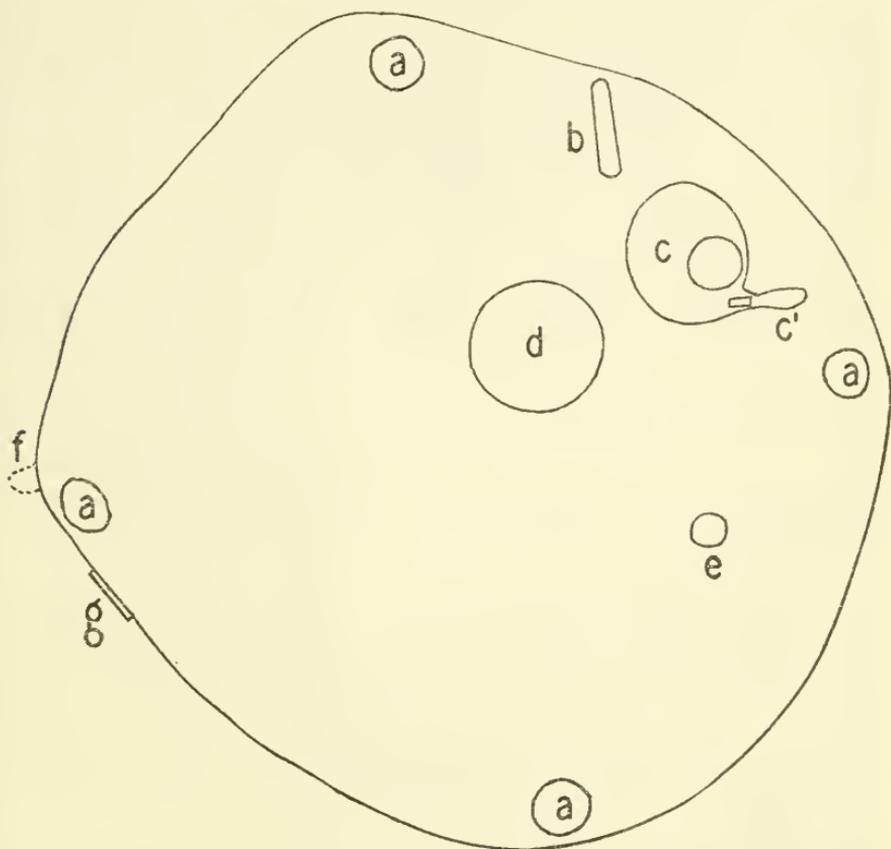
FIGURE 34.—Brush shelter. *a*, holes for support posts; *b*, stone in floor; *c*, storage pit in floor; *d*, fire pit; *e*, storage hole in floor; *f*, placement for roof brace; *g*, slab in wall.

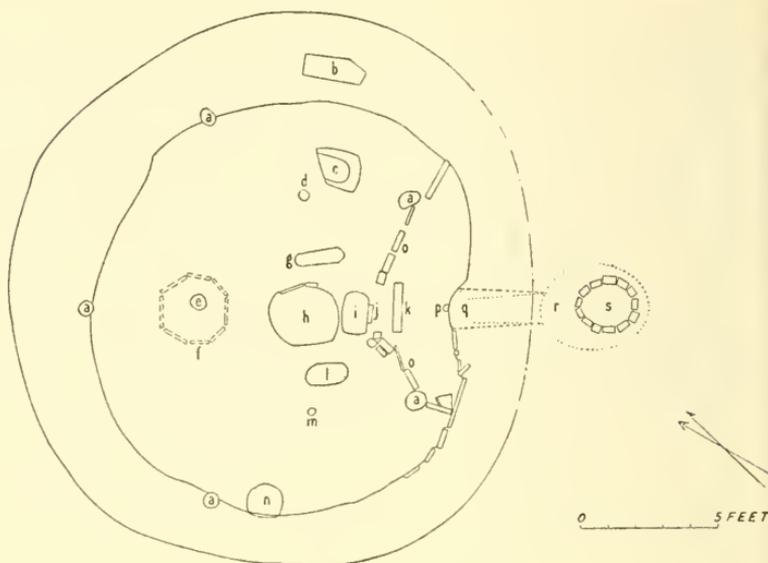
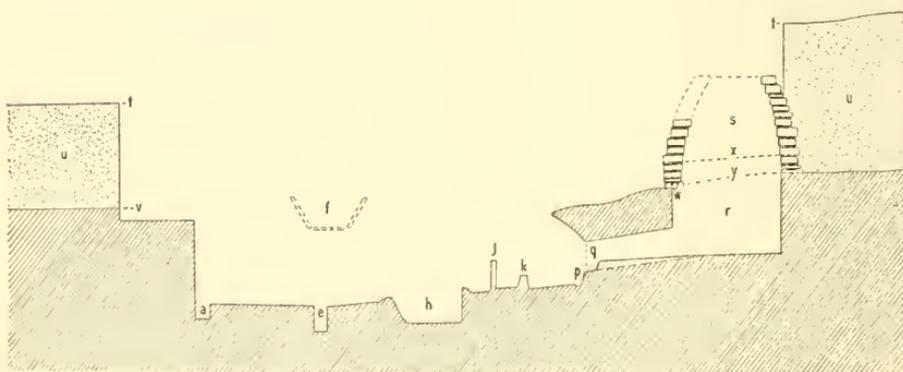
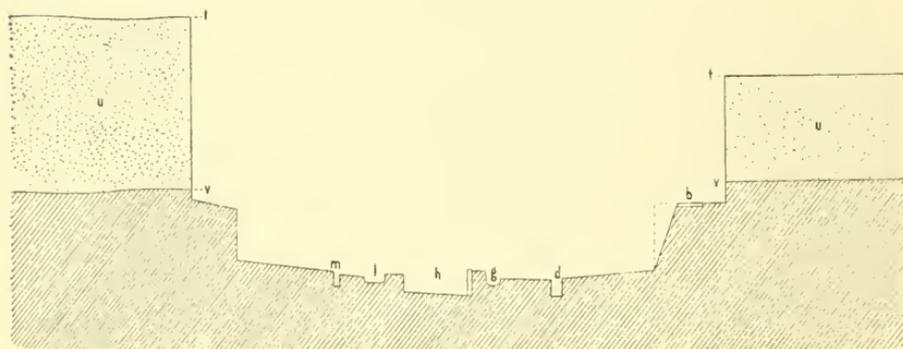
FIGURE 36.—Structure 15. *a*, holes for support posts; *b*, stone embedded in bench top; *c*, metate on floor; *d*, small storage hole; *e*, sipapu; *f*, fire pit; *g*, basin in floor; *h*, fire pit; *i*, ash pit; *j*, deflector; *k*, step and ladder brace; *l*, basin in floor; *m*, storage hole in floor; *n*, storage basin; *o*, compartment wall; *p*, hole for post to brace cover stone; *q*, ventilator opening; *r*, base of ventilator shaft; *s*, ventilator opening on ground; *t*, present surface; *u*, sand accumulation; *v*, original surface; *w*, wooden support for masonry; *x*, floor in granary; *y*, surface of accumulated material in shaft.

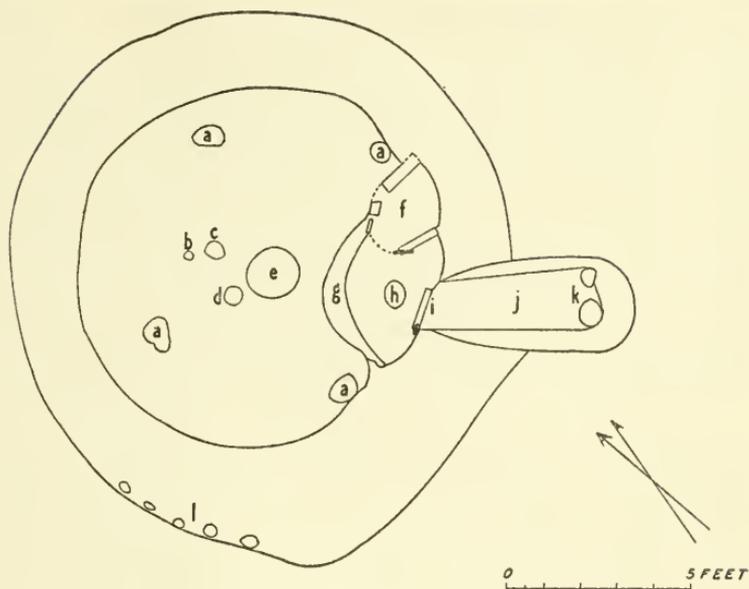
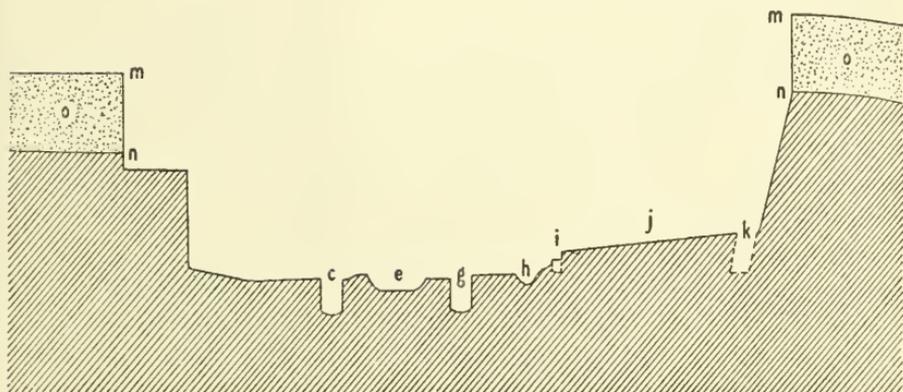
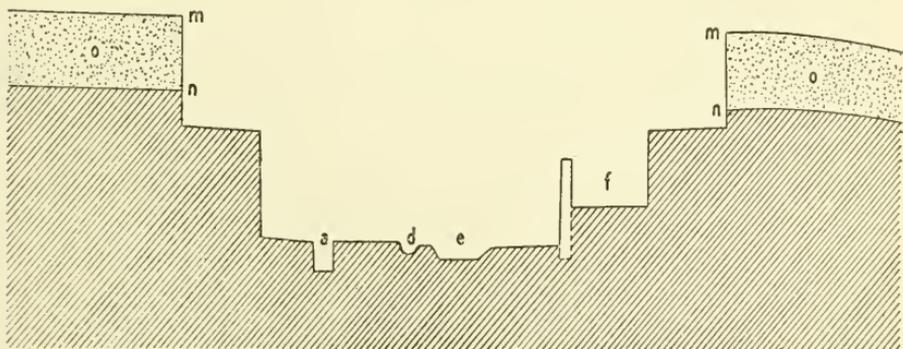
FIGURE 40.—Structure 10. *a*, holes for main roof supports; *b*, small storage hole; *c*, sipapu; *d*, pot rest; *e*, fire pit; *f*, storage bin; *g*, groove for compartment wall; *h*, basin in floor; *i*, sill in passage opening; *j*, passage; *k*, holes for ladder poles; *l*, placements for side poles; *m*, present surface; *n*, old surface; *o*, sand fill.

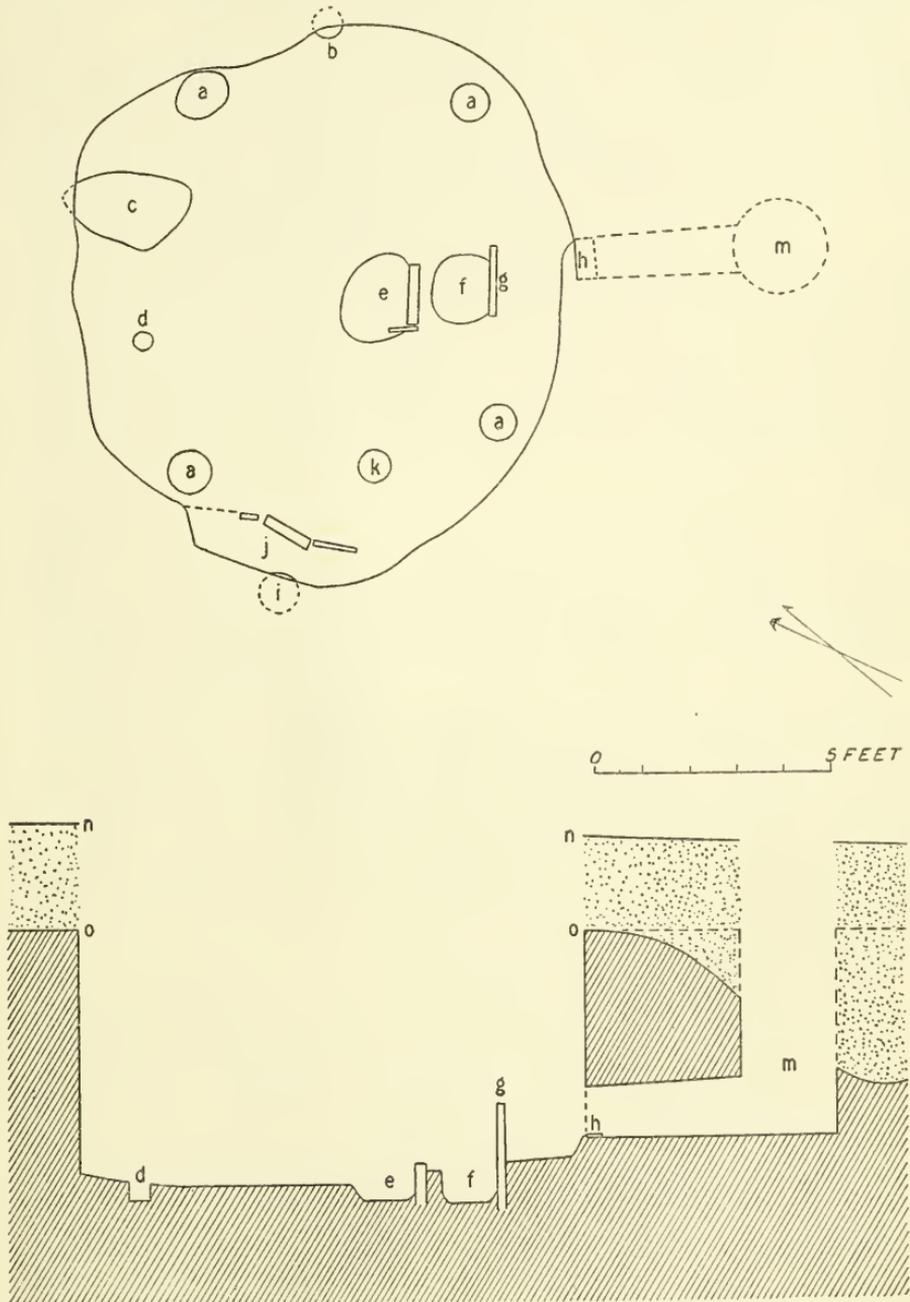
FIGURE 42.—Structure 17. *a*, holes for support posts; *b*, subwall pocket; *c*, storage pit; *d*, sipapu; *e*, fire pit; *f*, basin for ashes and ladder; *g*, deflector; *h*, sill in ventilator opening; *i*, subwall pocket; *j*, storage bin; *k*, pot rest; *m*, ventilator shaft; *n*, present ground level; *o*, original surface.

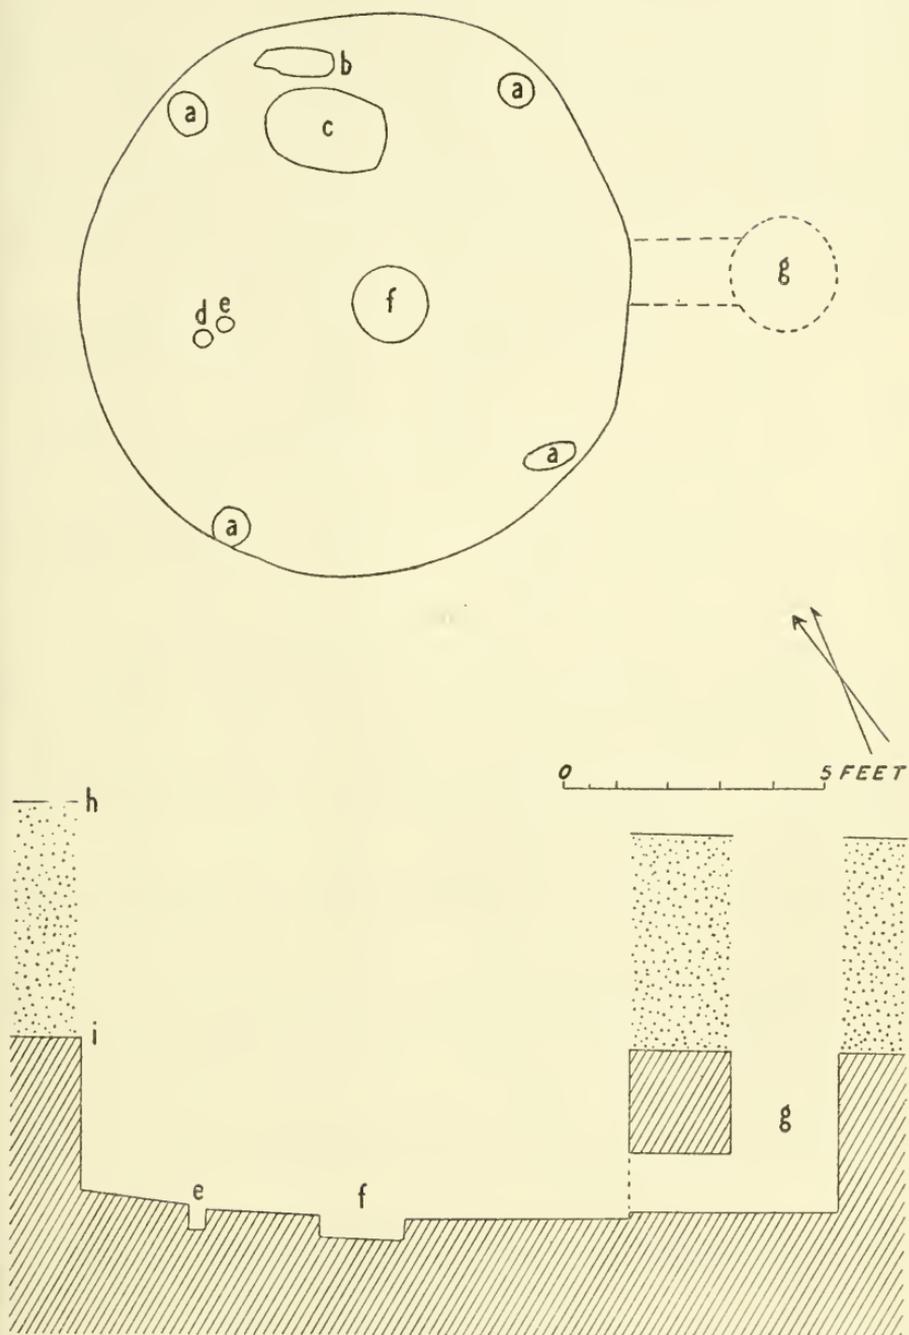
FIGURE 43.—Structure 18. *a*, holes for roof supports; *b*, storage pit in floor; *c*, storage basin; *d* and *e*, sipapus; *f*, fire pit; *g*, ventilator shaft; *h*, present surface; *i*, old ground level.

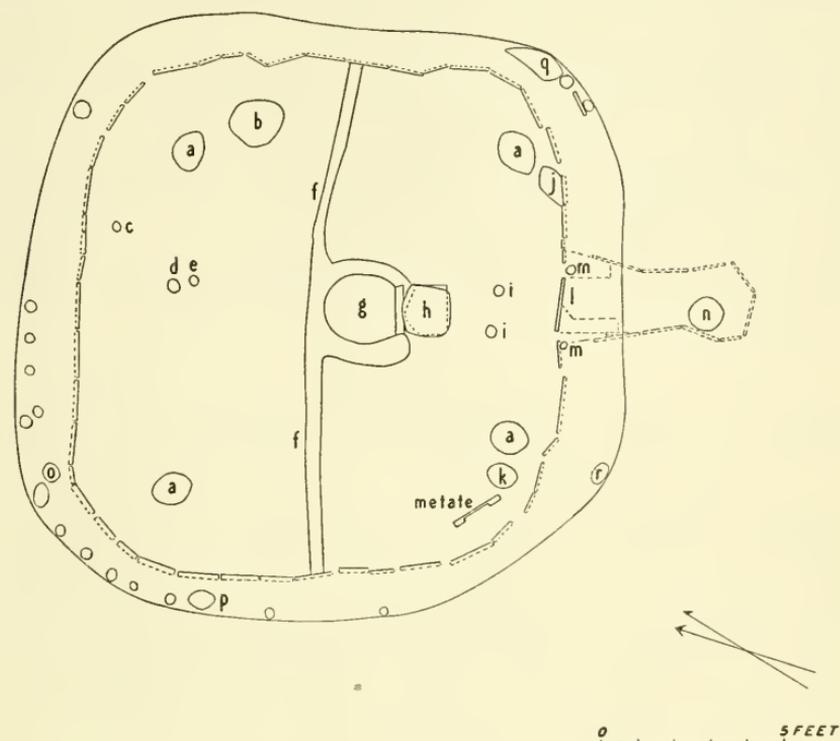
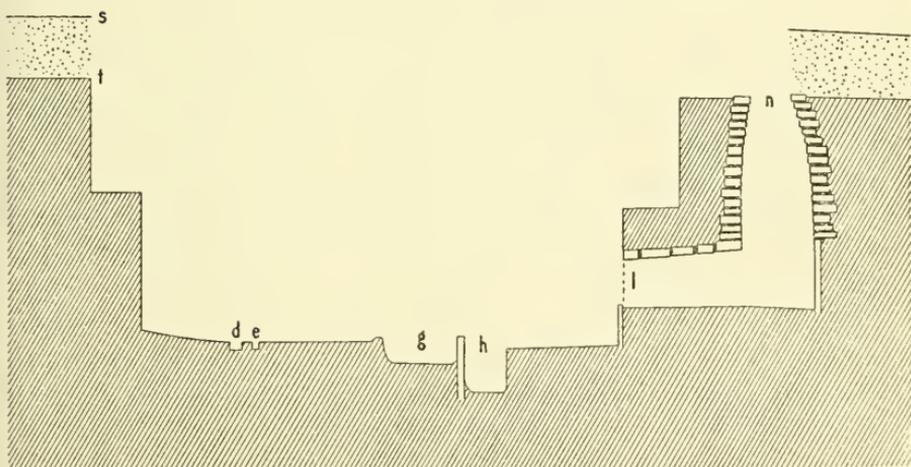
FIGURE 45.—Kiva A. *a*, holes for roof supports; *b*, storage pit; *c*, storage hole; *d* and *e*, sipapus; *f*, plaster ridge on floor; *g*, fire pit, *h*, old ladder pit; *i*, ladder pole depressions; *j*, storage pocket; *k*, pot rest or storage pocket; *l*, ventilator aperture; *m*, poles reinforcing ventilator opening; *n*, ventilator shaft; *o*, slanting timber placements; *p*, *q*, *r*, storage pockets on bench top; *s*, present surface; *t*, old ground level.

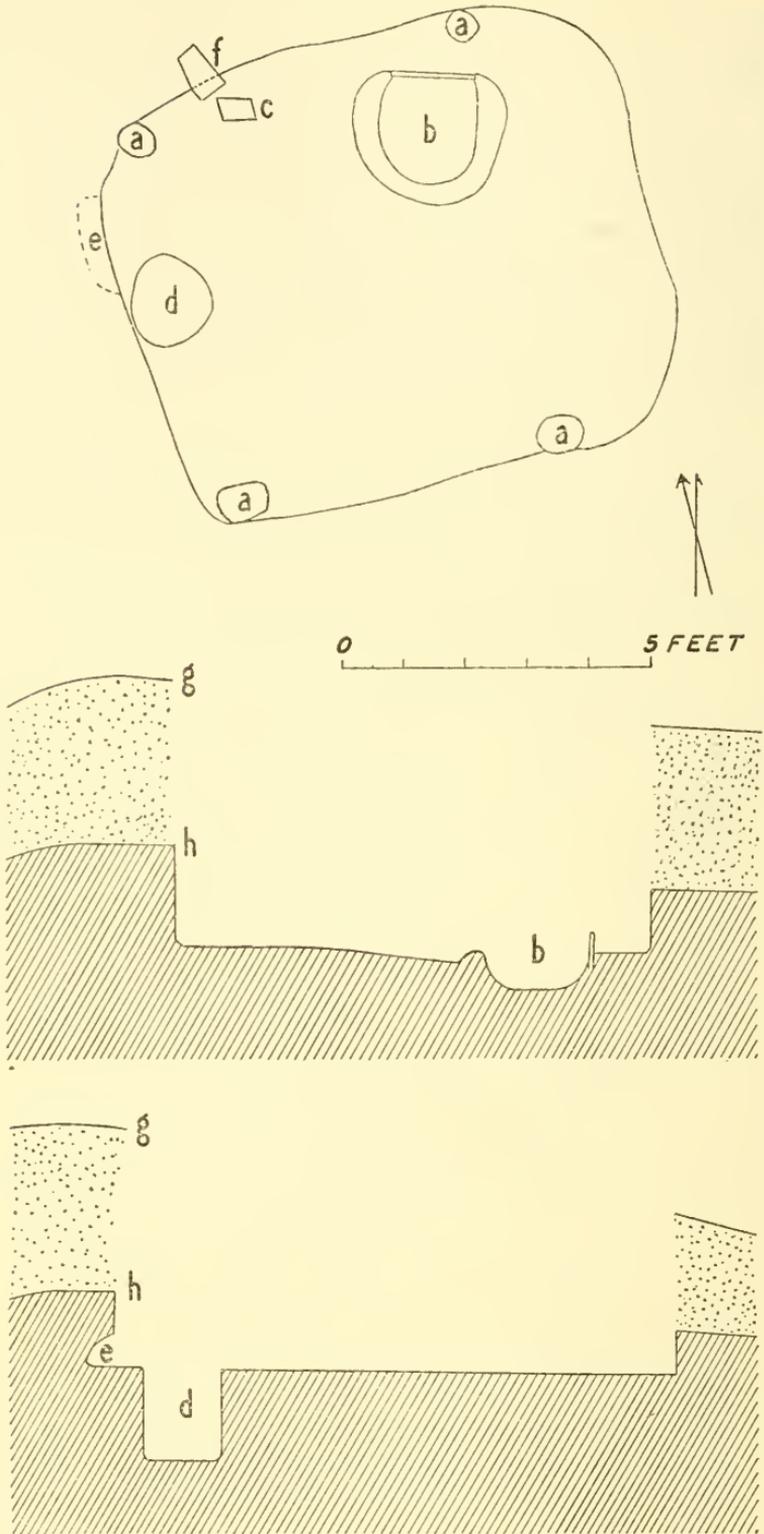
FIGURE 46.—Brush shelter. *a*, holes for roof supports; *b*, fire pit; *c*, stone step; *d*, storage pit in floor; *e*, subwall pocket; *f*, stone tread; *g*, present surface; *h*, old ground level.

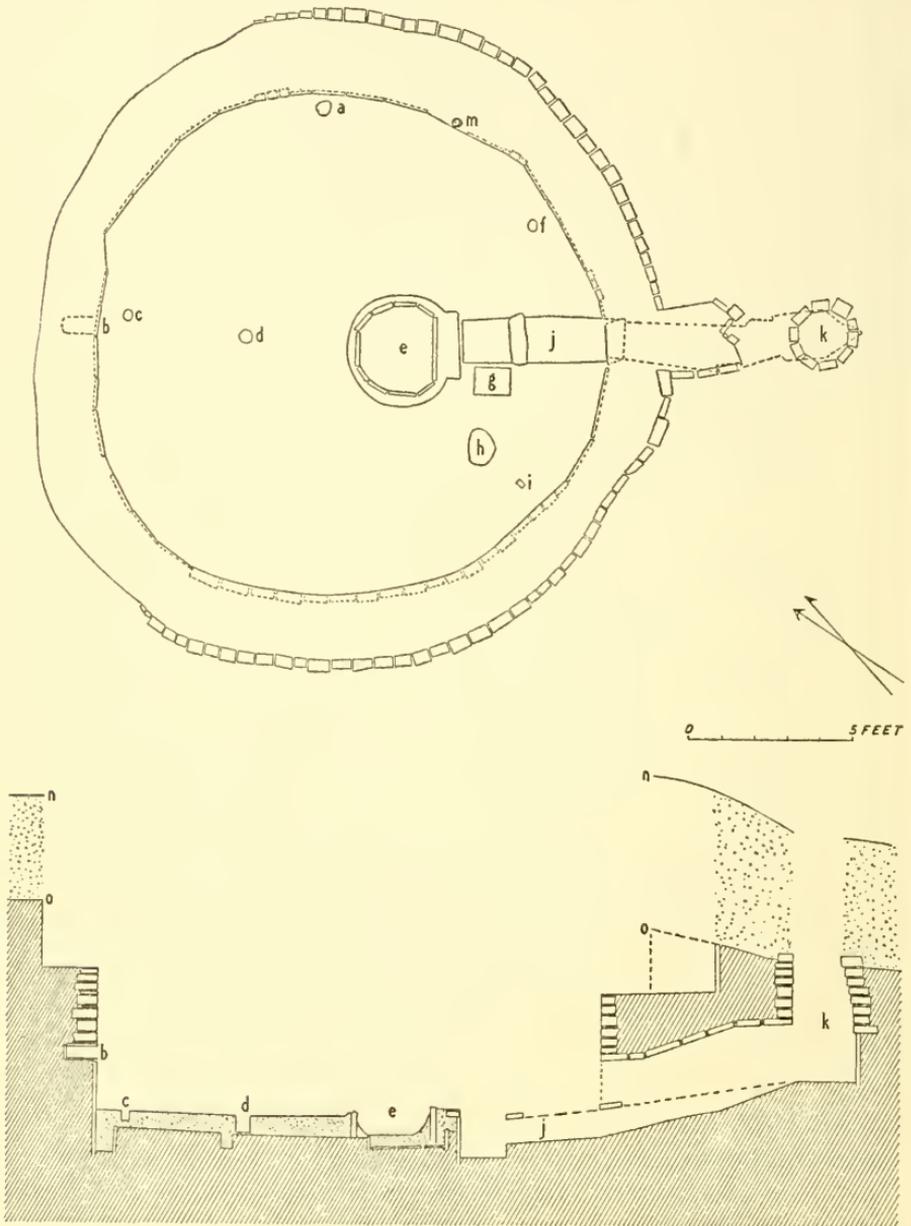
FIGURE 47.—Kiva B, upper floor level. *a*, storage hole in floor; *b*, Katsina niche; *c*, storage hole in floor; *d*, sipapu; *e*, fire pit; *f*, storage hole; *g*, ash pit; *h*, stone in floor; *i*, stone in floor; *j*, subfloor ventilator trench; *k*, ventilator shaft; *m*, post incorporated in bench; *n*, present ground level; *o*, original surface.

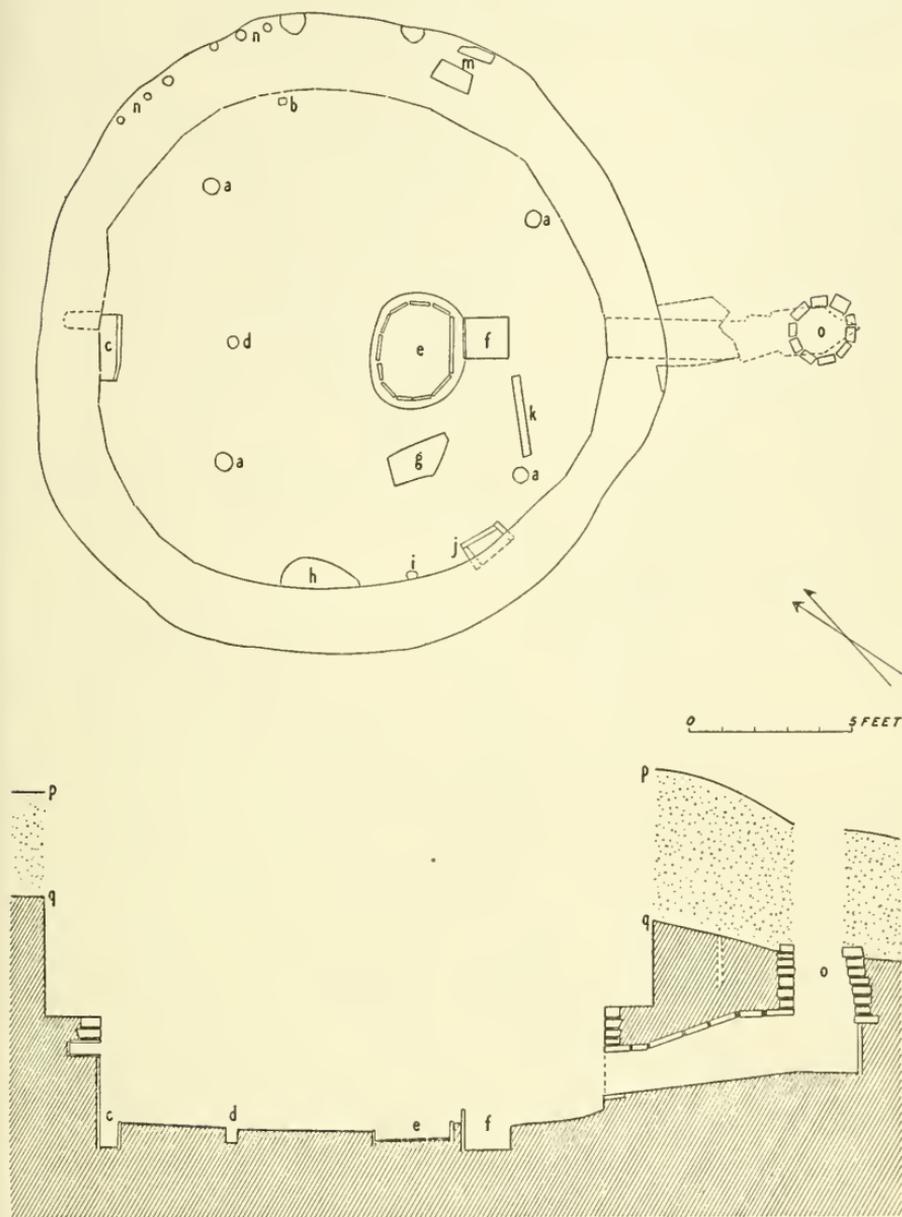
FIGURE 48.—Kiva B, original floor level. *a*, holes for main roof posts; *b*, stone in floor; *c*, storage box; *d*, sipapu; *e*, fire pit; *f*, ladder box; *g*, stone embedded in floor; *h*, storage pit; *i*, storage hole; *j*, subwall storage box; *k*, stone in floor; *m*, stones embedded on bench top; *n*, holes for slanting side poles; *o*, ventilator shaft; *p*, present ground level; *q*, original surface.

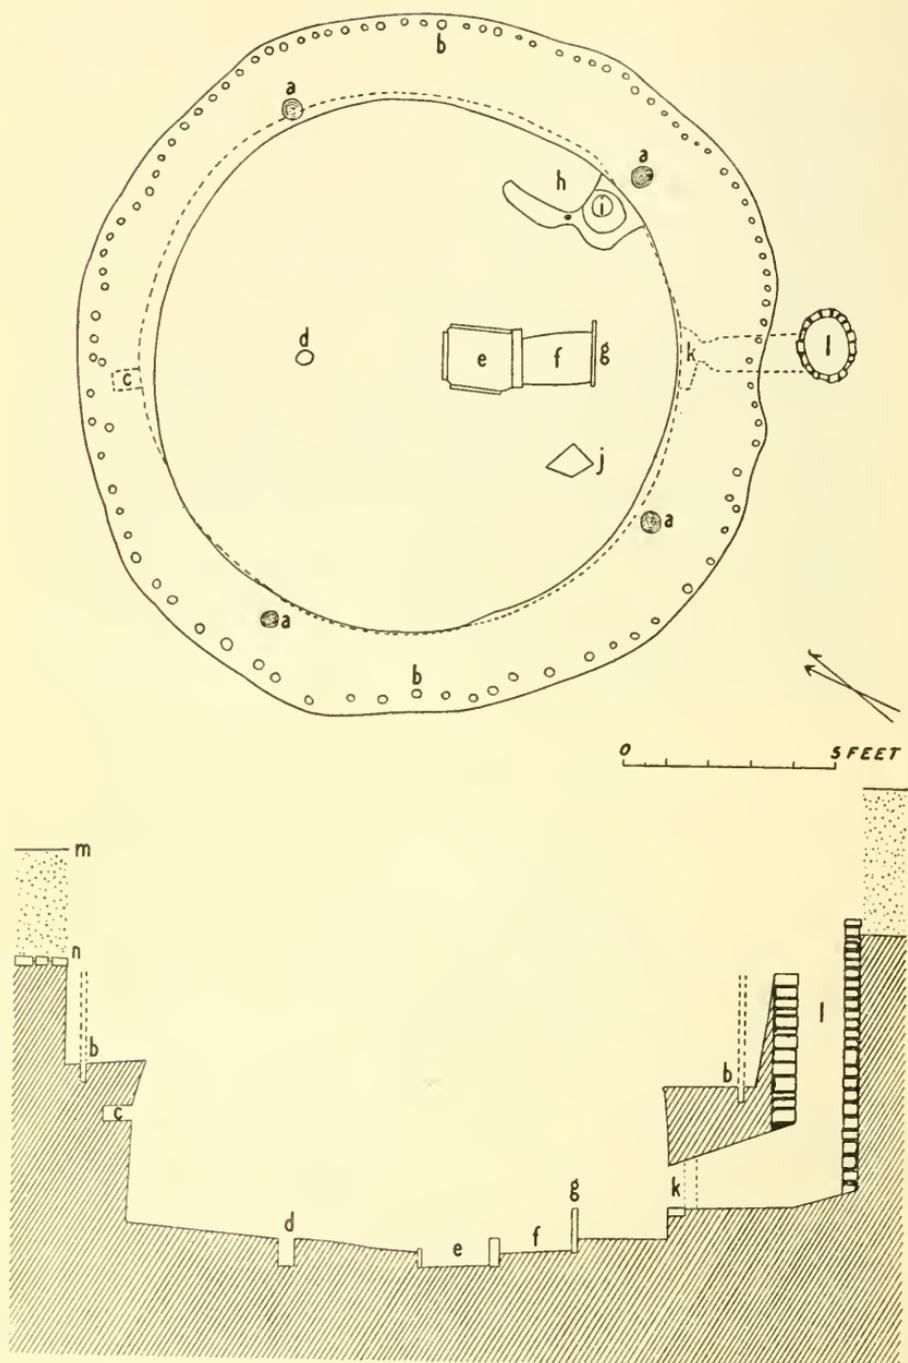
FIGURE 51.—Kiva for unit No. 3. *a*, posts incorporated in bench to reinforce wall; *b*, holes for poles forming wainscoting; *c*, Katsina niche; *d*, sipapu; *e*, fire pit; *f*, ash pit and ladder box; *g*, deflector; *h*, shallow basin in floor; *i*, small circular basin with stone bottom; *j*, stone embedded in floor; *k*, ventilator opening; *l*, ventilator shaft; *m*, present surface; *n*, old ground level.

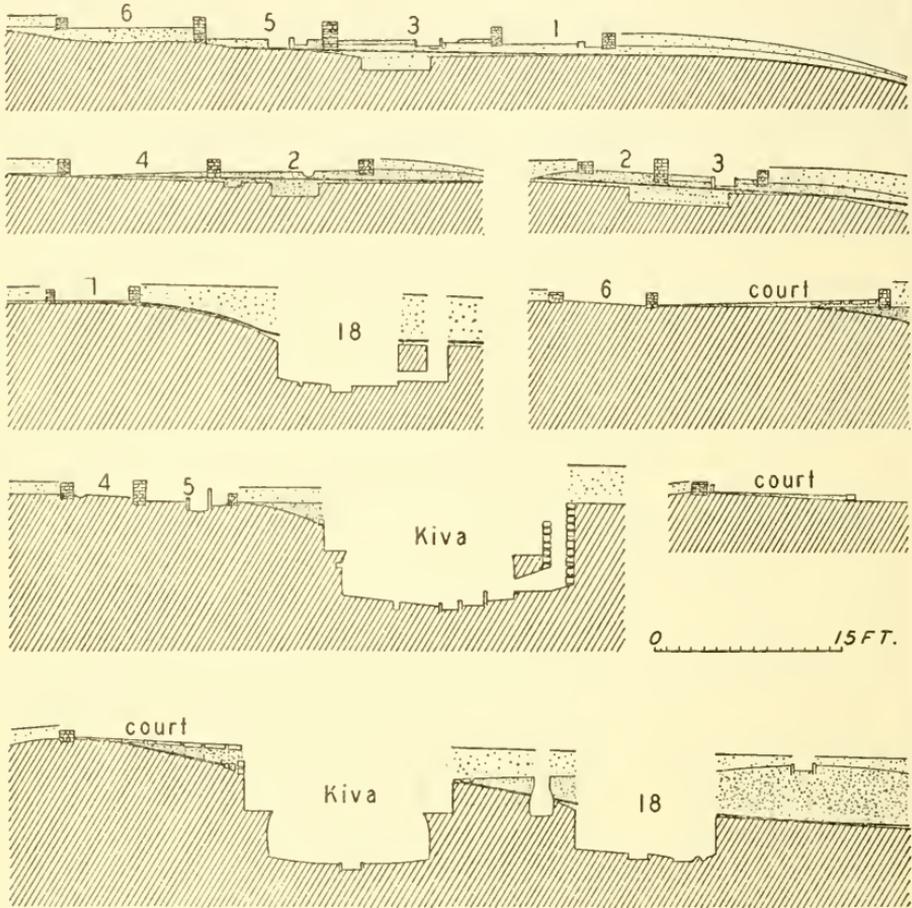
FIGURE 52.—Sections in third unit. Heavy line passing through fill indicates layer of red earth separating occupation level of pit structure and that of subsequent unit.
