Biocolonization of Stone: Control and Preventive Methods

Proceedings from the MCI Workshop Series

Edited by
A. Elena Charola,
Christopher McNamara,
and Robert J. Koestler

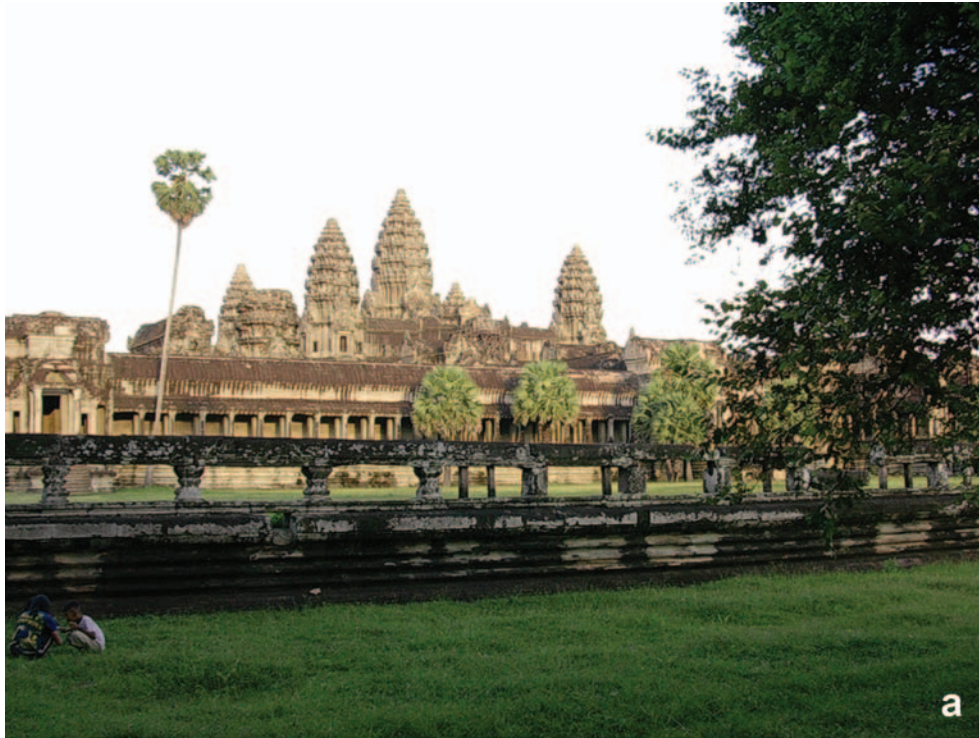
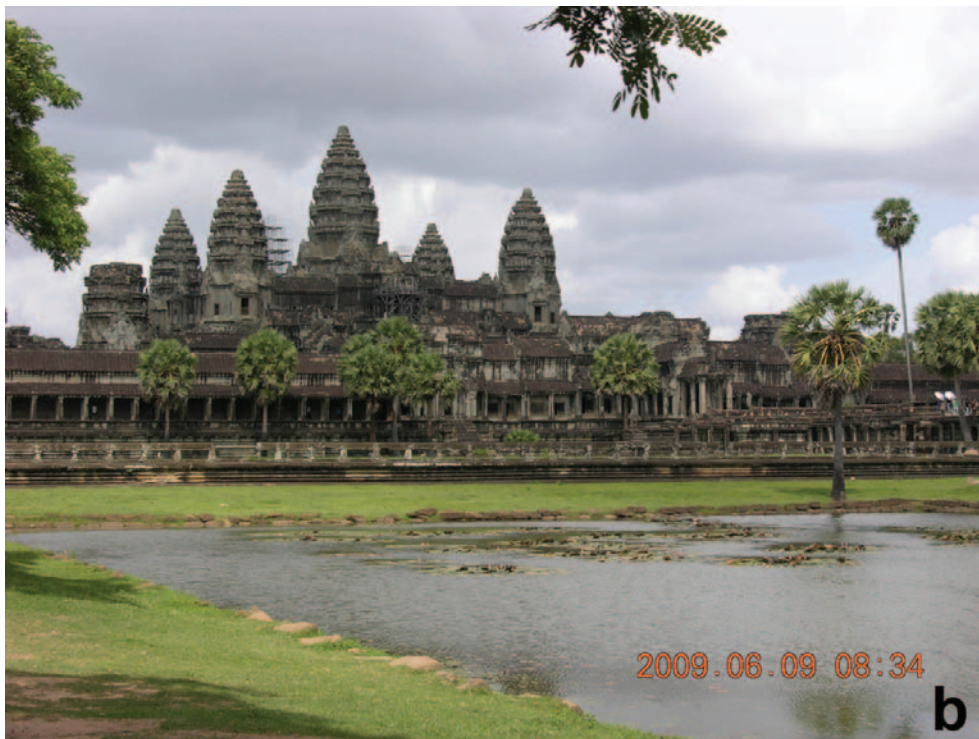
FIGURE 1. View of the Angkor Wat temple (a) around 2004 and (b) in 2009. The color variation is mostly the result of different lighting and of the damp stone in the later photograph. Note that incipient biological recolonization is becoming evident.

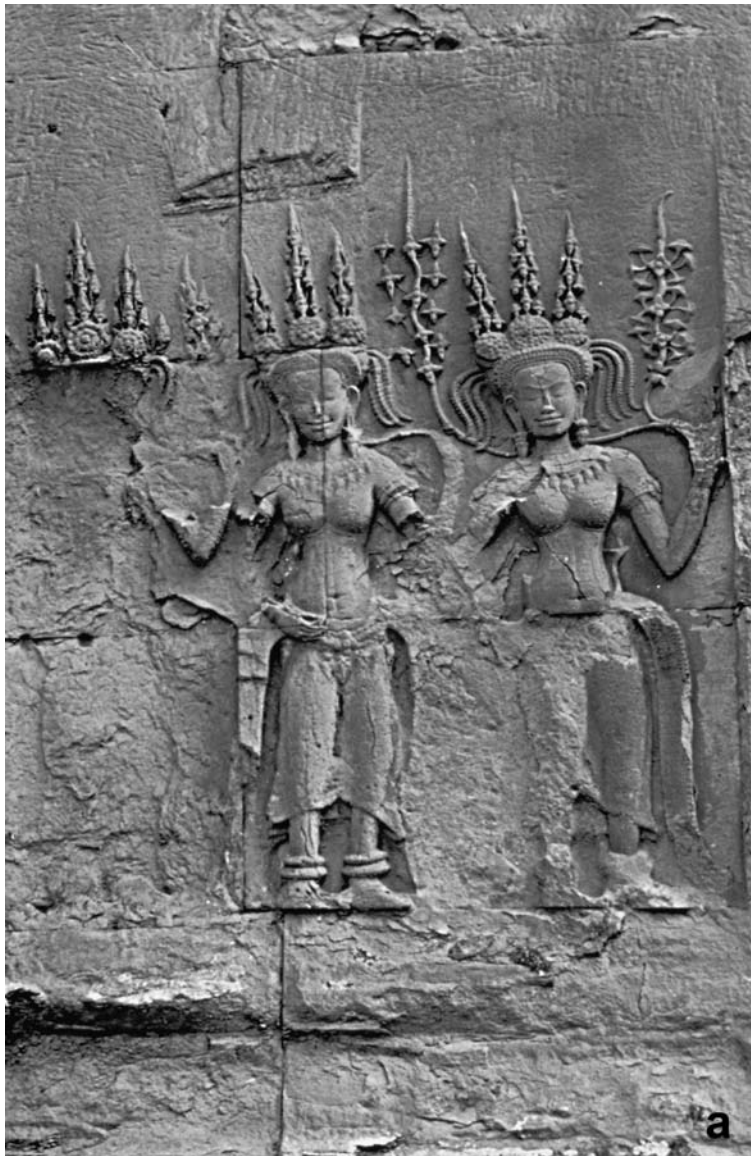
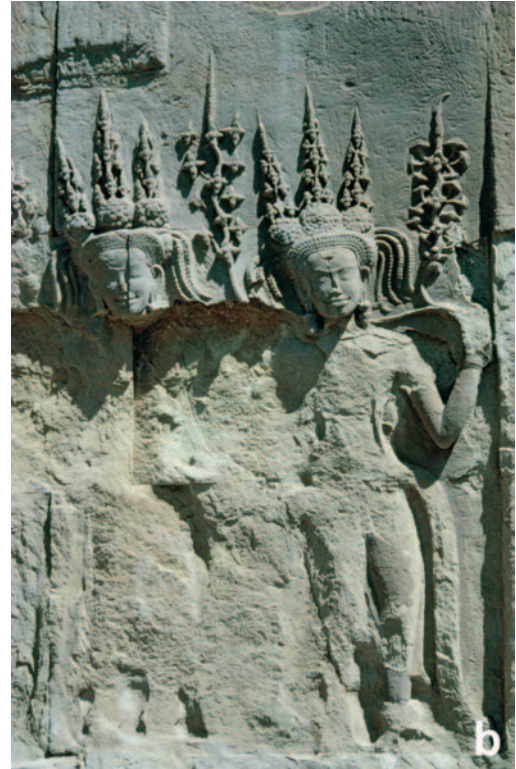
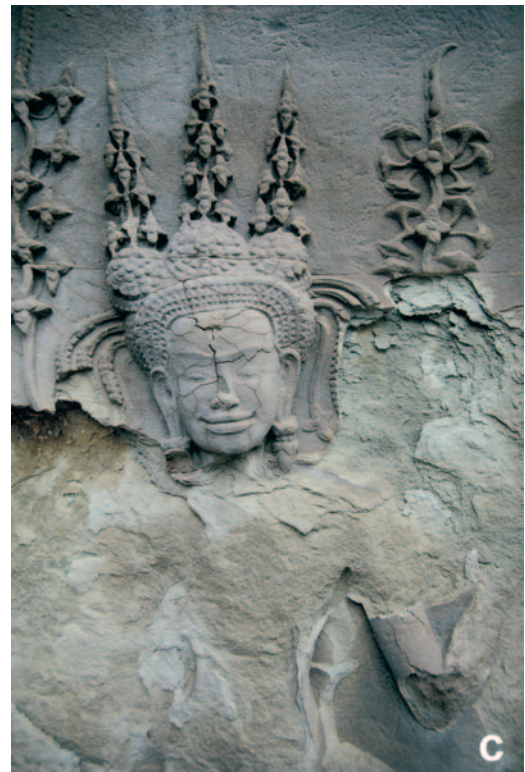
FIGURE 2. Detail of one of the Apsara reliefs showing increased loss over time, induced by scaling and flaking of the sandstone: (a) 1959, (b) 1995, and (c) 1996.

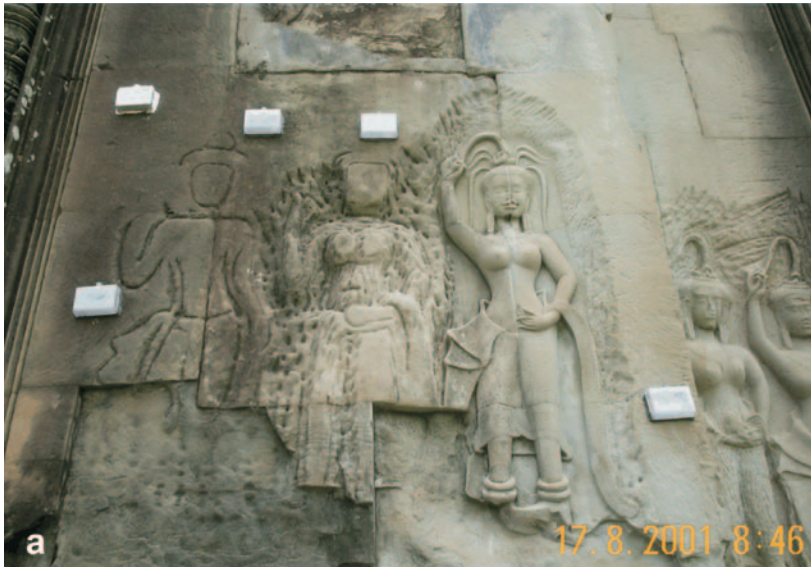
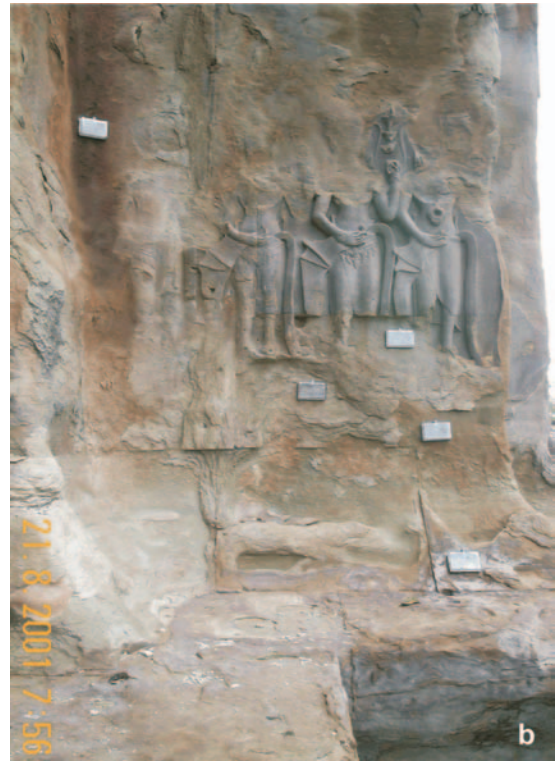
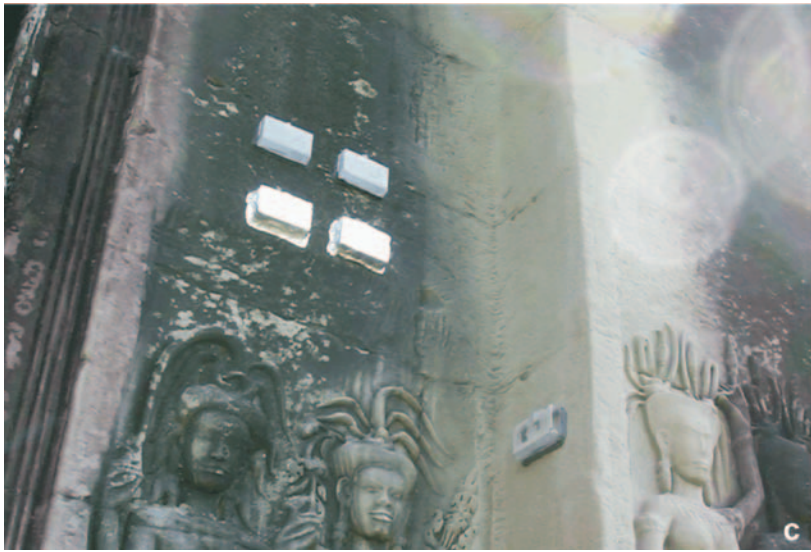
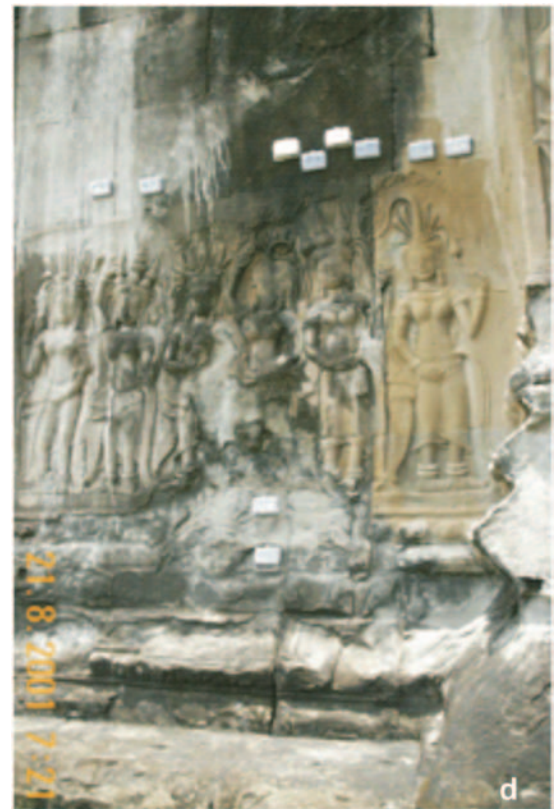
FIGURE 3. Four of the seven test sites used to monitor the metabolic activity of the biocolonization. (a) Apsara relief with slight black patina. (b) Apsara with iron oxide patina and flaking. (c) Apsara with black iron oxide patina and scaling. (d) Apsara treated in the past with Paraloid B-72 and with different colored patinas. Note that the white or pale blue squares are the devices installed for measuring the microflora metabolic activity.

Nondestructive methods, such as adenosine triphosphate (ATP) measurements, respiration measurements, and contact agar plates, were used to assess the microbial infestation at the mentioned test sites as well as on other areas in the Angkor temple complex that had been treated previously with various biocidal formulations. For example, ammonium formaldehyde (also called formamide or formamine) was applied by French scientists in the late 1960s at Bayon; ammonium zinc fluosilicate, tributyltin oxide (TBTO), and pentachlorophenol (PCP) were used by Indian restorers at Angkor Wat around 1990; copper sulfate solutions and sodium hypochlorite applications were made by Frank Preusser (Getty Conservation Institute) for the World Monuments Fund Project around 1995 at the "Preusser Hall" in Preah Khan; and Metatin

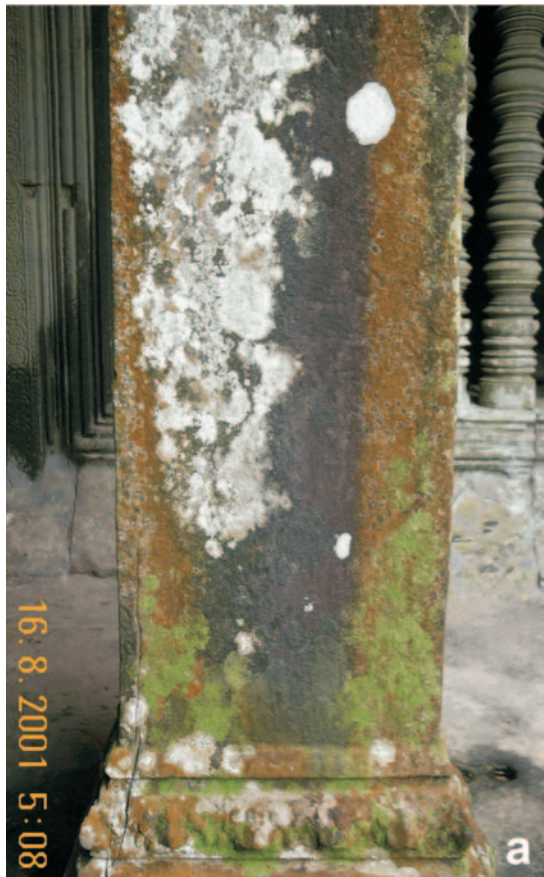
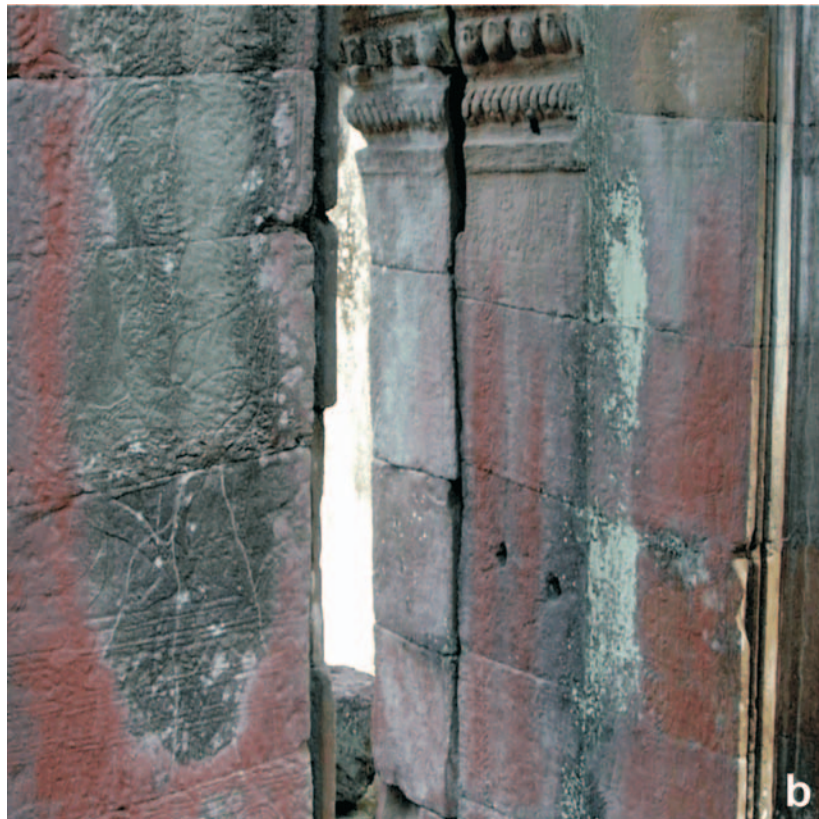
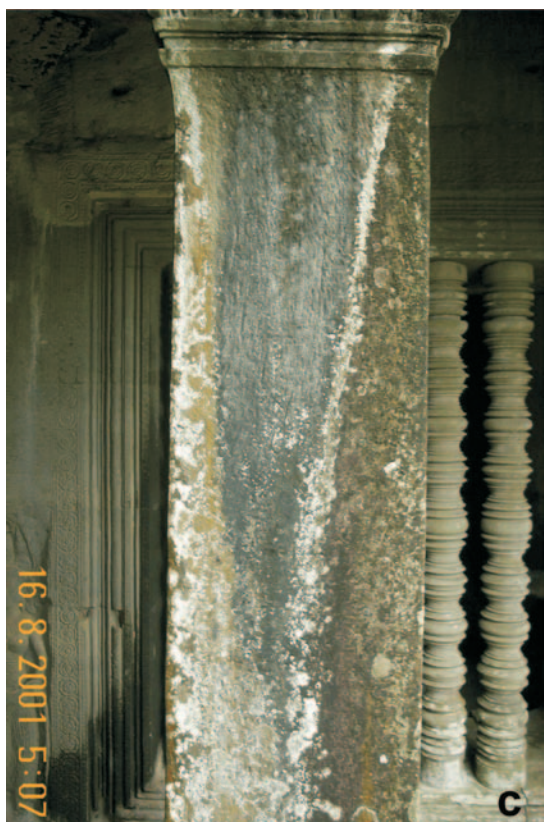
FIGURE 4. Colored biofilms of different photosynthetic organisms, e.g., lichens, algae, and cyanobacteria, found on the stones at the Angkor monuments, depending on exposure and microclimate.

The evaluation of the macroflora showed that the stones have a significant cover of lichens, such as the *Parmelia*, *Caloplaca*, *Pyxine*, *Dirinaria*, and *Lepraria* species. Only in very humid areas can green algae, such as *Pleurococcus* sp., be found. There are also some distinct red and black areas that could be related to green algae, such as the *Trentepohlia* sp., which appear red-brown under normal conditions, and cyanobacteria, such as *Gloeocapsa* and *Scytonema* sp., which can appear black (Figure 4).

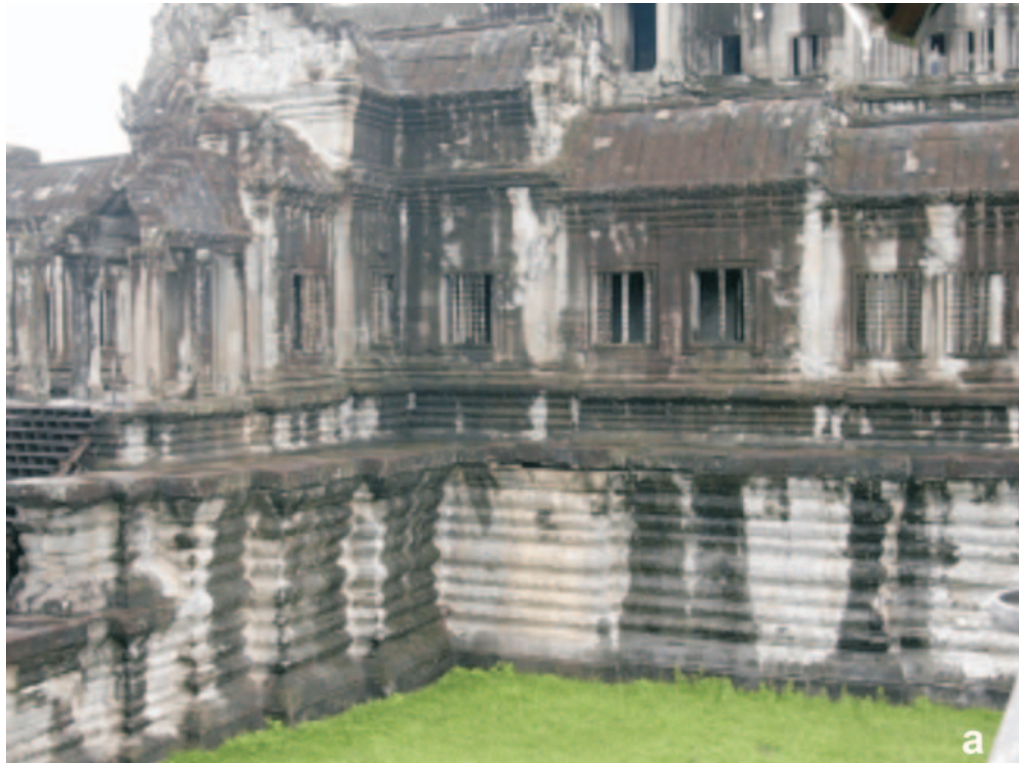
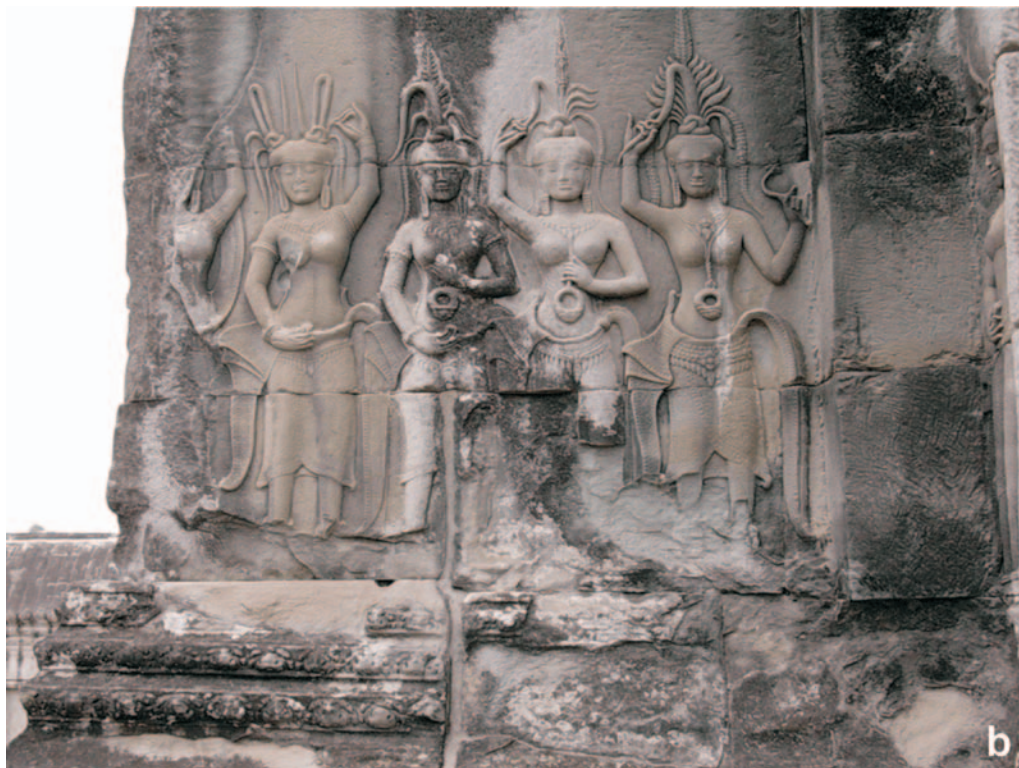
FIGURE 5. (a) The removal of the natural lichen biopatina at Angkor Wat resulted in an intense colonization by blackening microorganisms. (b) The increased thermohygic stresses to the clay-bearing sandstone resulted in severe flaking and delamination on the exposed carved surfaces.

In the early 1990s, a biocide-based cleaning was carried out under an Indian conservation project that removed the surface biocolonization. Subsequent years showed an intensive blackening of the treated stone surfaces due to uncontrolled overgrowth of black-colored cyanobacteria. The resulting thermal effect of the blackened surfaces, especially under tropical conditions, added to the normal thermohygric stress suffered by an already weakened and sensitive clay-bearing stone, leading to increased delamination, scaling, and flaking of the surface. Thus, the removal of the biopatina of lichens can be considered a major threat to the endangered stone material (Figure 5).

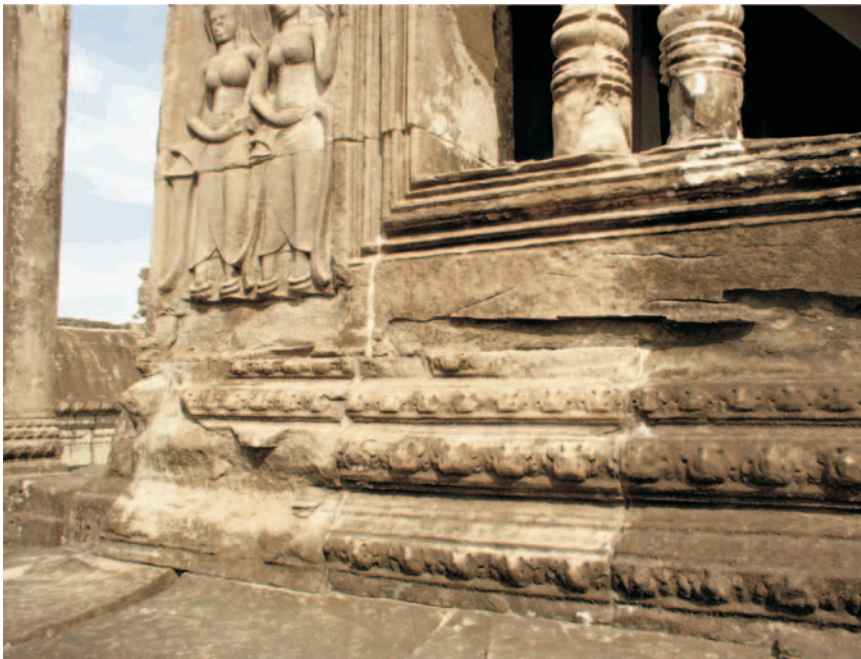
FIGURE 12. Successful application of algal wash at the southern library, southern exposure, four years after treatment.

The long-term growth-controlling effect of the algal wash, the copper complex formulation, could be observed even after seven years of exposure at the first biocide test field (BT I) treated in 1997. Figures 11 and 12 show two of the sections of the second test site (BT II) after four years of the application of algal wash in 2001. It should be noted that no mechanical cleaning had been performed at or after the application of the biocide.

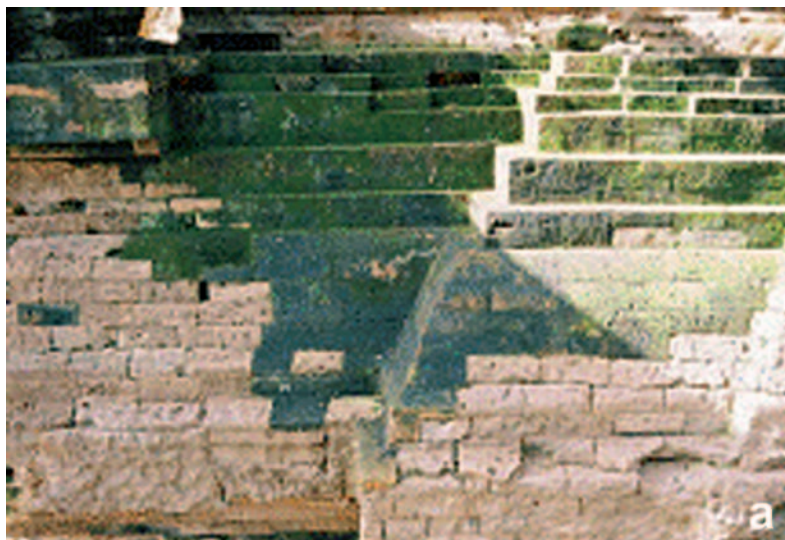
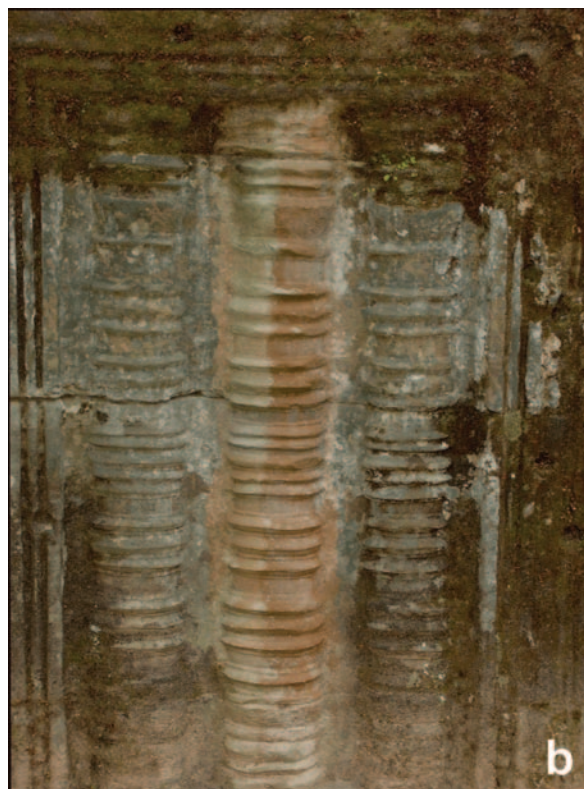
FIGURE 13. (a) Algal infestation of a brick wall because well water was used to soak the brick prior to its use. (b) Selective infestation by red-colored green algae at the temple of Ta Nei after treatment with a water repellent.

Finally, it has to be considered that conservation treatments, such as cleaning, consolidation, or hydrophobization, need to be evaluated with regard to their possible contribution toward the recurrence of microbial colonization. For example, the use of local well water for soaking bricks prior to their use resulted in an algal infestation of the finished wall constructed with them (Figure 13a), whereas the application of a water repellent at the temple of Ta Nei resulted in the selective reinfestation by *Trentepohlia* sp., the red-colored green algae (Figure 13b).

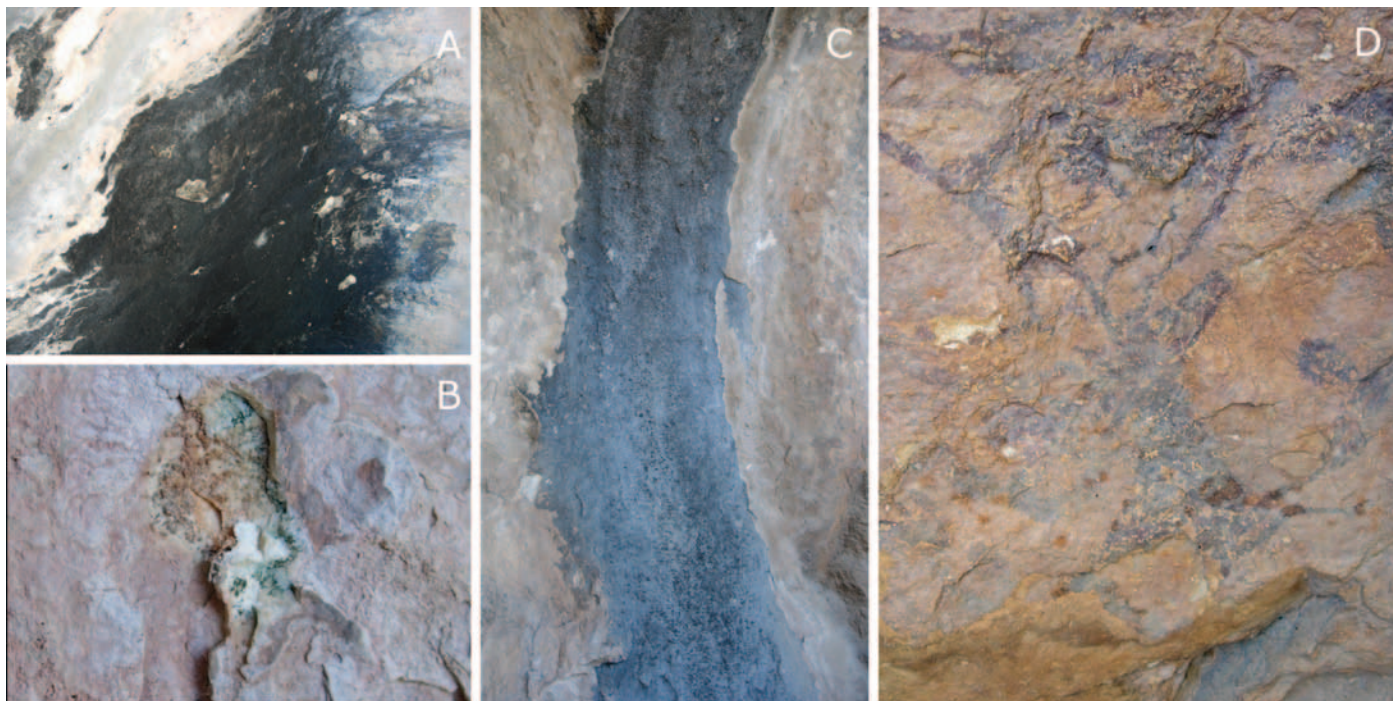
FIGURE 4. Three characteristic types of microbial colonies observed in the natural Muriecho L shelter. (A) A black crust, (B) the development of a cryptoendolithic community, and (C) a zone affected by runoff water are shown. (D) Some of the paintings representing human and animal figures in this shelter are also presented.

The zone influenced by surface water paths showed the dominance of the cyanobacteria *Anabaena*, *Nostoc*, and *Microcoleus*. Bacteria associated with these phototrophs were mainly represented by Actinobacteria (e.g., *Pseudonocardia*). Chloroflexi represented a major group in DNA-based analyses, suggesting that this group might be dominant at some seasonal periods, depending on the environmental conditions. In addition, these chloroflexi were highly related to phototrophic bacteria, specifically to the genera *Cloroflexus* and *Roseiflexus*. These two genera are generally thermophilic photoheterotrophic bacteria, suggesting that they probably become active and develop mainly during the summer period when annual temperatures are highest (frequently over 40°C).

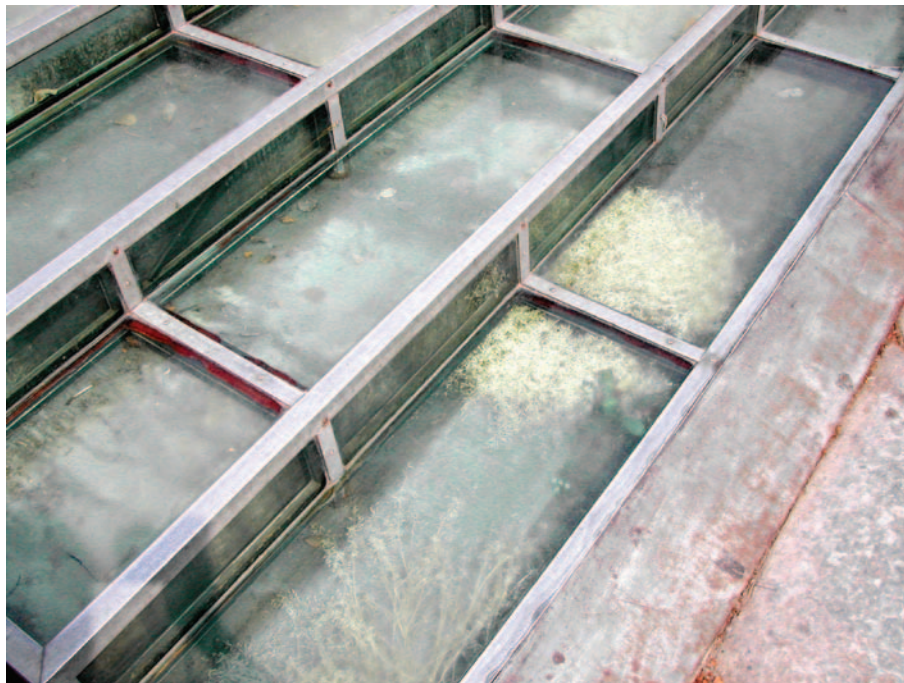
FIGURE 1. A glass cover over a marble stairway on the archaeological site of Ding Ling, China. Note the moisture condensation and the thick growth of plants underneath the glass, completely obscuring the sculpted marbles.

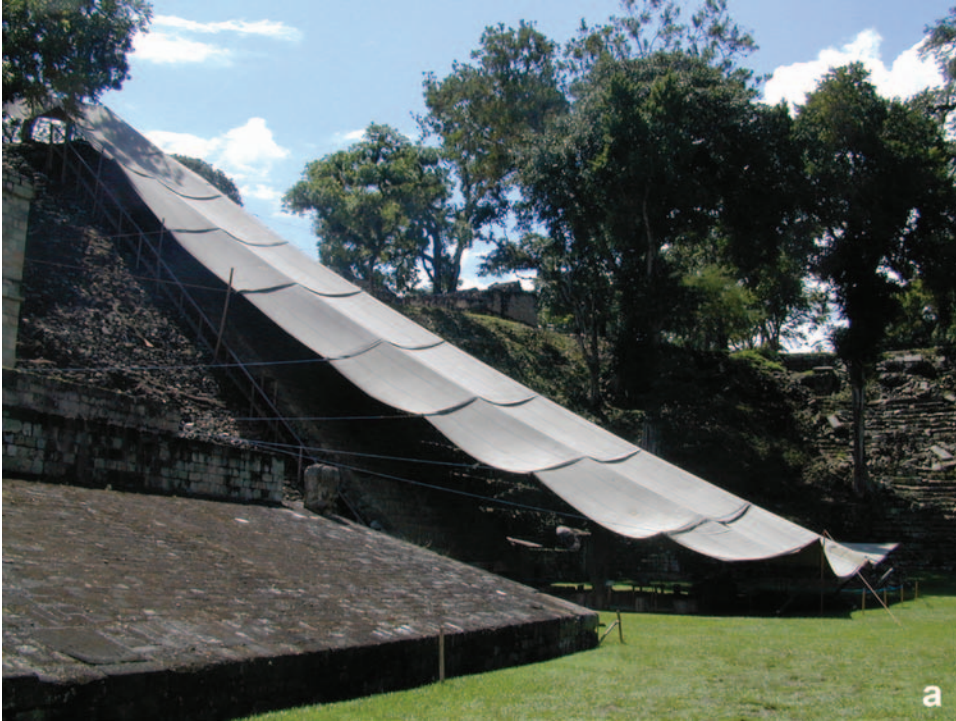
FIGURE 2. (a) Protective shelter installed over the Hieroglyphic Stairway in Copán (Honduras). Nonprotected stones to the left of the stairway show a thick blackish biocolonization. (b) View of the stairway under the tarpaulin. Only a slight covering of cyanobacteria and algae remain, and all lichens have disappeared. Note that the stone has a natural greenish hue.

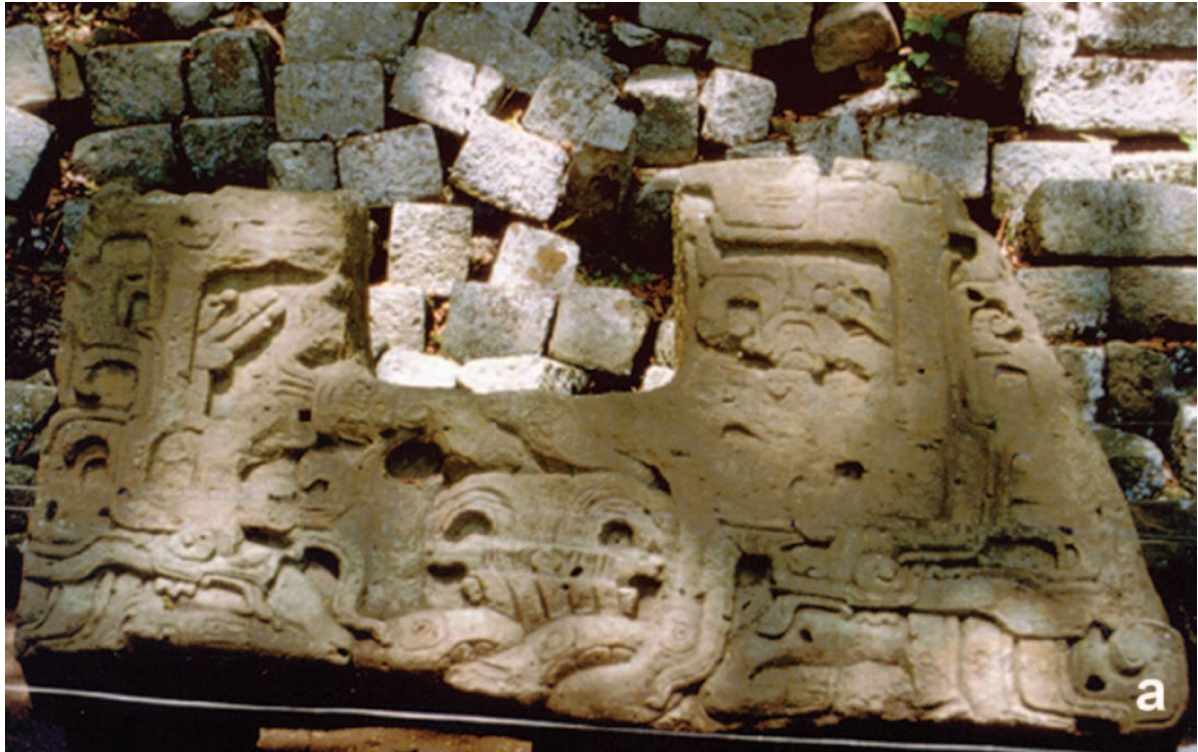
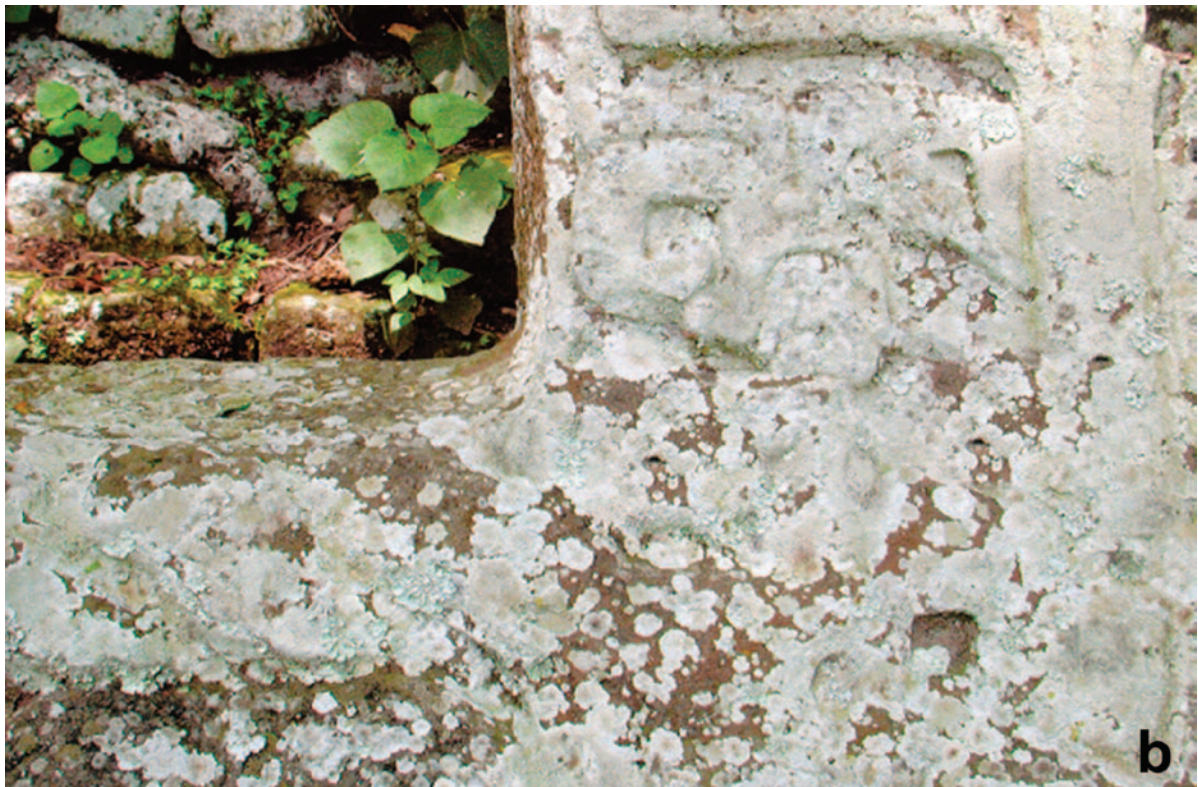
FIGURE 3. (a) Altar 41, Copán (Honduras). Appearance of a nonprotected carved stone immediately after cleaning and the application of a biocide. (b) Detail of the same area, 15 years later, showing intense recolonization by lichens.

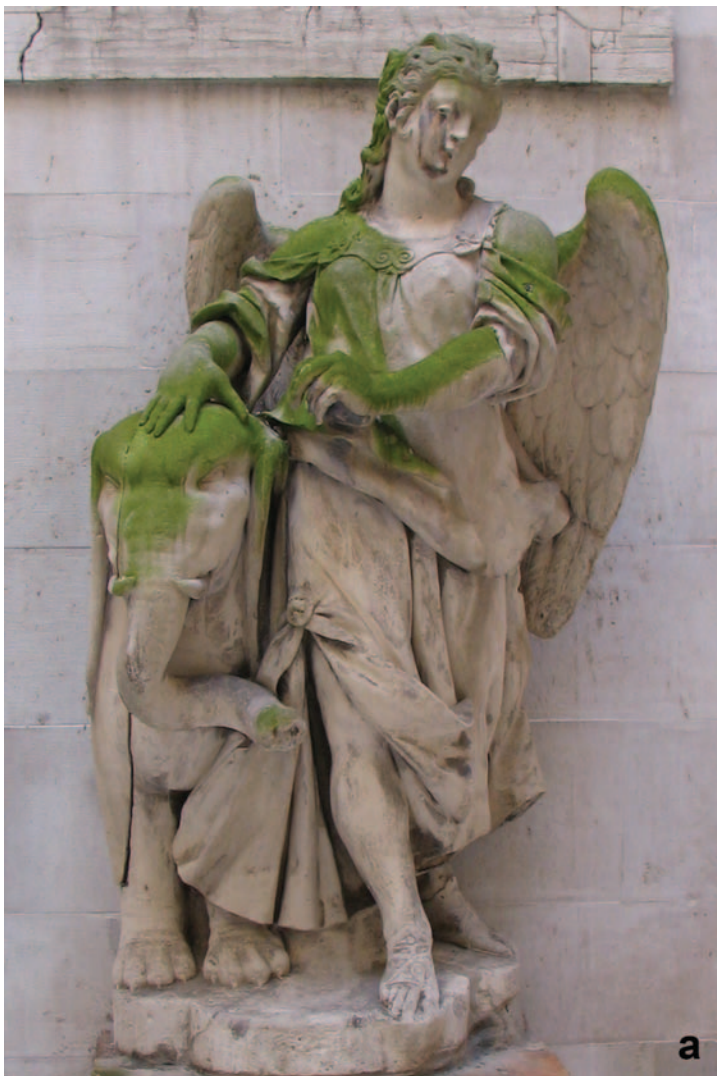
FIGURE 4. Two limestone statues in different environments: (a) urban environment (Venice, Italy) and (b) rural environment in a park in Passariano, Italy, showing that the geometrical configuration of the statues favors wetting of some areas where biocolonization will develop preferentially and that the biocolonization developed is dependent on the environment.

The hydrophobization effect has a variable duration, in most cases years, although in other cases it may be limited to months or even only weeks. The duration depends on the type of product, concentration, and amount applied for a given type of stone. On surfaces that have lost their water repellency or have not been treated with a water repellent, biological recolonization begins on those areas that are directly wetted by the rain, and these are correlated to the geometry of the object (Nascimbene et al., 2009), as shown in Figure 4. On surfaces that retain

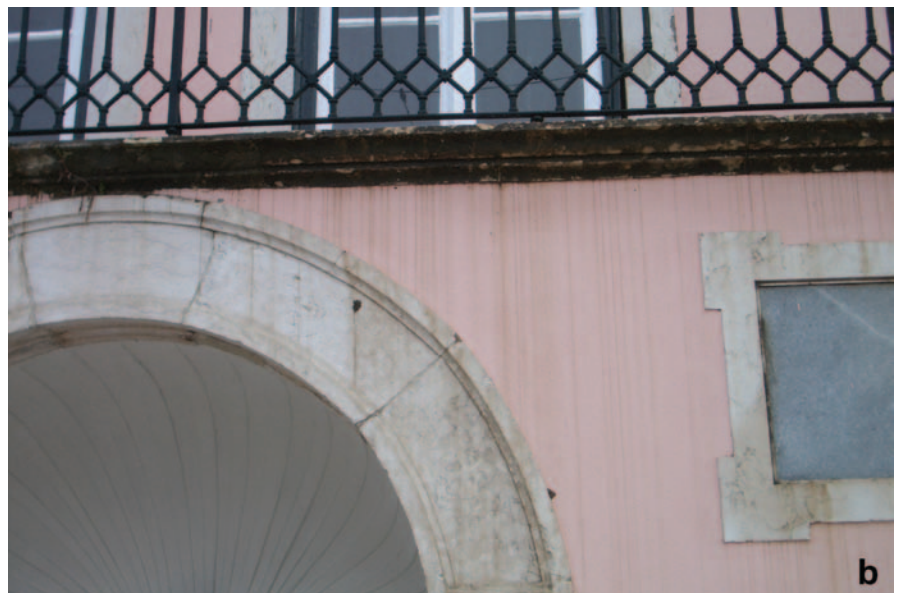
FIGURE 5. (a) Detail of a limestone sculpture treated with a water repellent, showing the resulting streaked pattern where biocolonization develops (Villa Pisani, Stra, Italy). (b) Detail of the garden wall of the Palace of Belem (the residence of the president of Portugal) in Lisbon. Note that only the render is water repellent, showing the streaking effect. On nonhydrophobized surfaces, such as the stone in the arch and around the plaque, colonization is more diffuse.

water repellency, a striped pattern develops where dust accumulates and biocolonization develops first (Charola et al., 2008). As expected, these stripes develop on the areas that receive direct rain or water flow, as shown in Figure 5.

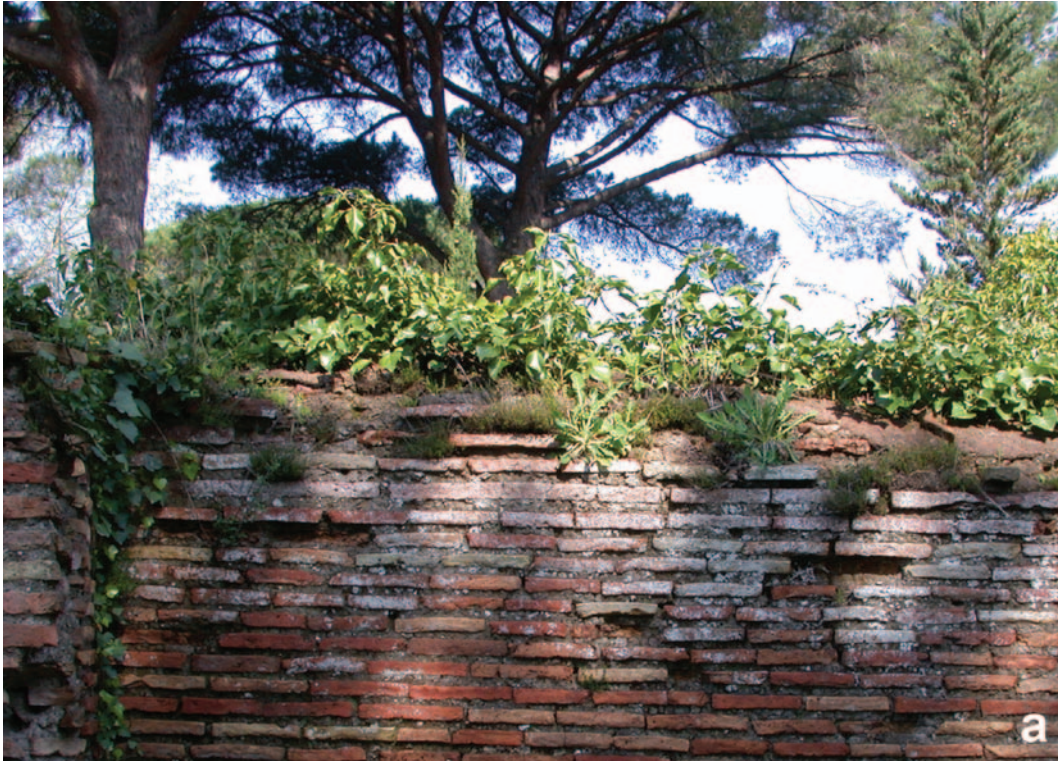
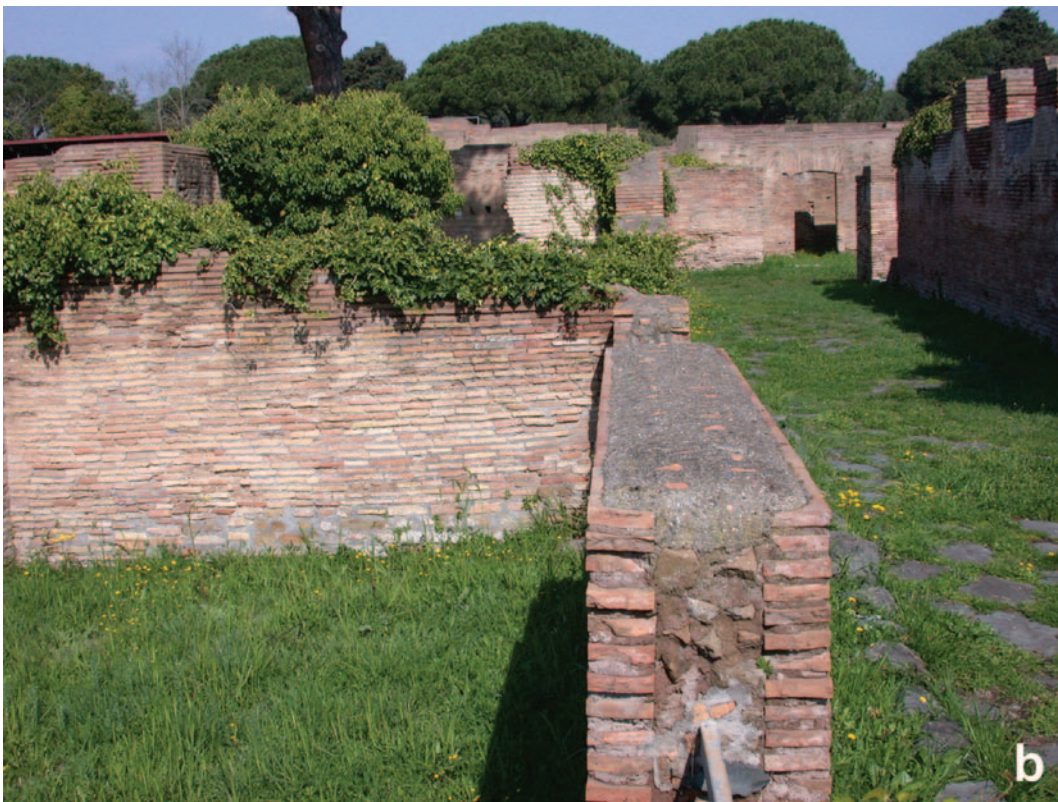
FIGURE 6. (a) A brick wall near the archaeological area of Ostia Antica (Italy) where no capping was installed. The horizontal surfaces capture the water that is retained in the wall, favoring the development of the whole range of colonizing species. (b) The same site some years after the installation of the capping.

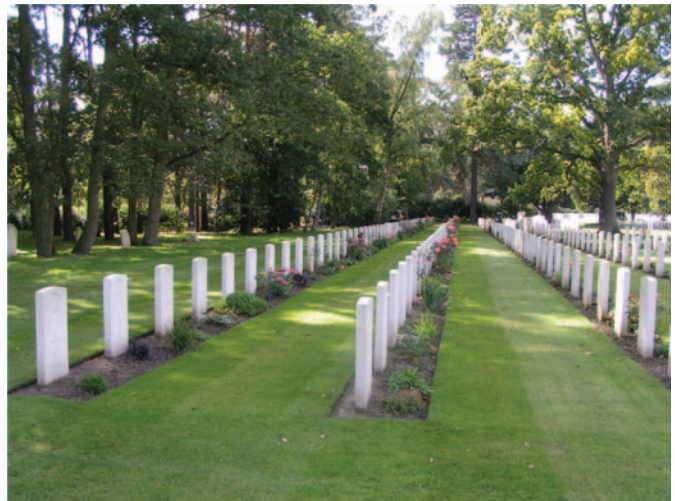
FIGURE 1. Study headstones at Brookwood Military Cemetery. All headstones are of similar aspect and known age, but environmental conditions vary. The oak tree to the right and stand of trees to the left were considered very likely to have an effect on algal growth.

The study site was Brookwood Military Cemetery in Surrey, United Kingdom, which is administered and in the care of the Commonwealth War Graves Commission. Headstones were chosen from sections 11 and 12 (British and Australian) of the cemetery (Figure 1), where algal contamination was known to be a serious problem during the winter months. All headstones were of Portland limestone and had a similar aspect (facing northwest) but were influenced to varying degrees by overhanging or shading vegetation. Most headstones had splash plants in front of them, but these varied in size, shape, and form. All headstones

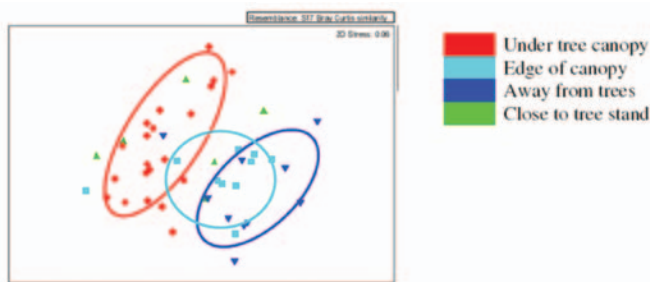
FIGURE 5. MDS ordination showing similarity in percentage cover of algal contamination in October 2006 between groups of headstones influenced to varying degrees by tree cover.

A second survey confirmed that broad-scale patterns of algal contamination were evident in October 2006 (Figure 5) and that the effect of tree cover was still the most influential factor. Unlike in the initial survey, an additional group of headstones were investigated that were situated close to a stand of trees but not directly beneath the canopy. These headstones were shaded for parts of the day and were in full sunlight for parts of the day. Figure 5 clearly shows a gradient in patterns of algal cover that directly corresponds with a gradient in tree cover. Algal cover on headstones under a tree canopy (red group) is different from that on headstones not affected by tree cover (dark

blue). Headstones situated at the edge of the canopy (light blue group) are somewhat intermediate in algal cover. The group of headstones situated close to a stand of trees has variable patterns of algal cover, and these are similar to a range of other headstones placed throughout the study area. Given that these headstones would be influenced to varying degrees by tree cover, this result is to be expected.

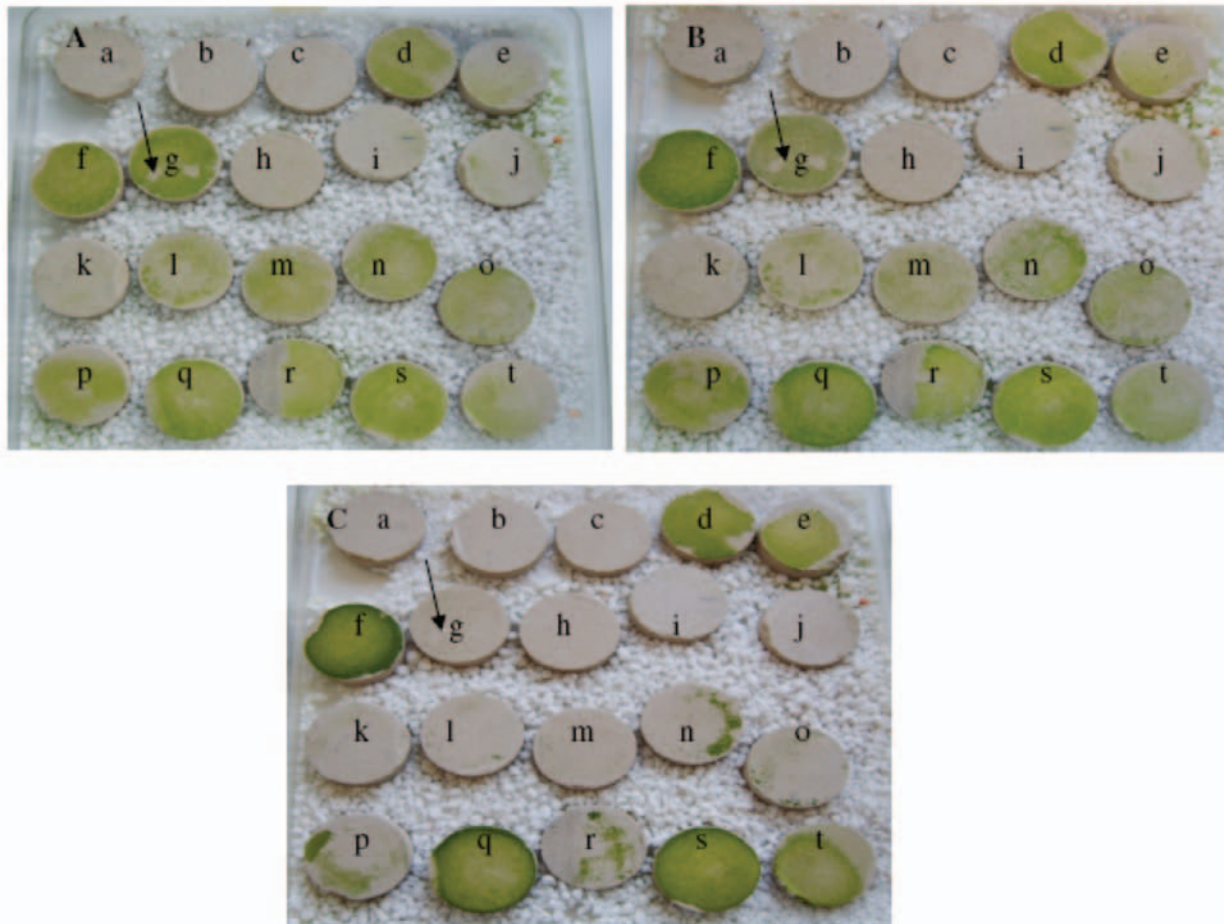
FIGURE 11. NC64A growing on stone discs at room temperature (25°C) under natural light for (A) 2, (B) 3, and (C) 6.5 weeks after initial treatment. Discs a–c are the negative controls where no algal growth occurred, and discs d–f are positive controls. Discs h–k were treated with high virus concentration, discs l–o with intermediate virus concentration, and discs p–t with low virus concentration. The arrow corresponds to the limestone disc that was treated with a high virus concentration after algal growth was established.

A second series of experiments was done where large-diameter (4 cm) limestone discs were simultaneously inoculated with a growing culture of *Chlorella* NC64A and a series of dilutions of the appropriate virus and incubated on a bed of moist vermiculite without extra nutrients. It was observed that on those limestone discs that were treated with the highest concentration (dilutions 1–4) of viruses, algal growth was not established. However, when higher dilutions were applied, algal growth was established. Algal growth was not established on those discs treated with high virus concentration, even three weeks after treatment (Figure 11). On the first, second, and third week after the experiment started, the limestone discs were retreated with the corresponding virus dilutions. At this time, one of the positive control discs (showing untreated algal growth, disc g) was treated with virus (Figure 11). By comparing Figure 11a and 11b, it can be seen that (1) no algal growth occurred on discs h–k, (2) algal growth decreased in discs l–o, and (3) no effect was seen on discs

p-t. Three and a half weeks after the last treatment, it was evident that algal growth had been completely inhibited and *Chlorella* NC64A had disappeared. Algal growth had also disappeared on discs k-m (high levels of virus) and was reduced in discs n-p and r (intermediate levels of virus). No effect was seen on discs q, s, and t, which had received low levels of virus.

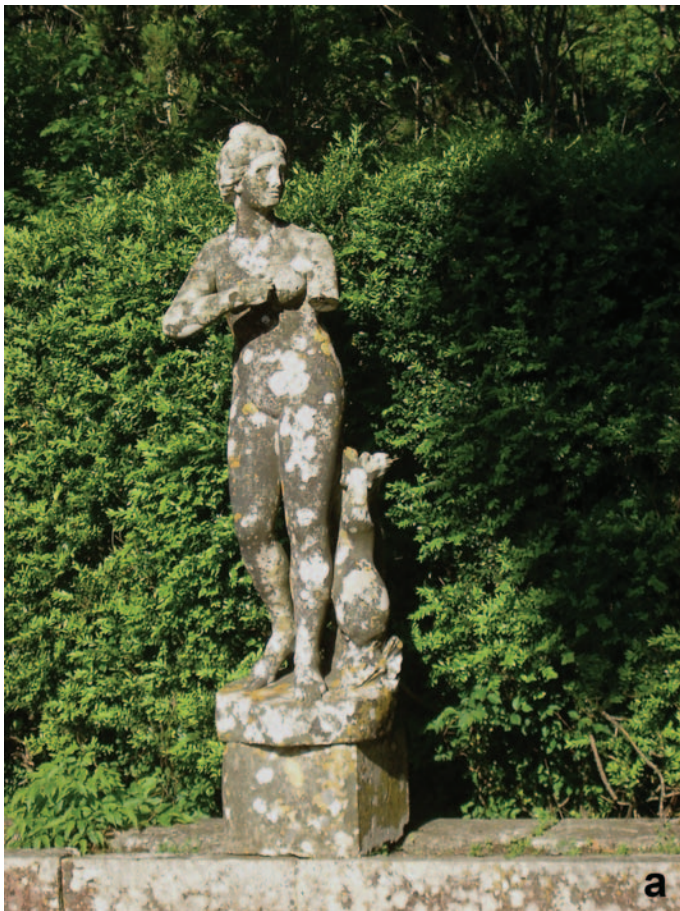
FIGURE 1. Two marble sculptures in the Queluz gardens, both of which are heavily colonized by lichens. Note the different types of lichen colonization on the sculptures as a function of their local environments.
