Biocolonization of Stone: Control and Preventive Methods

Proceedings from the MCI Workshop Series

Edited by
A. Elena Charola,
Christopher McNamara,
and Robert J. Koestler

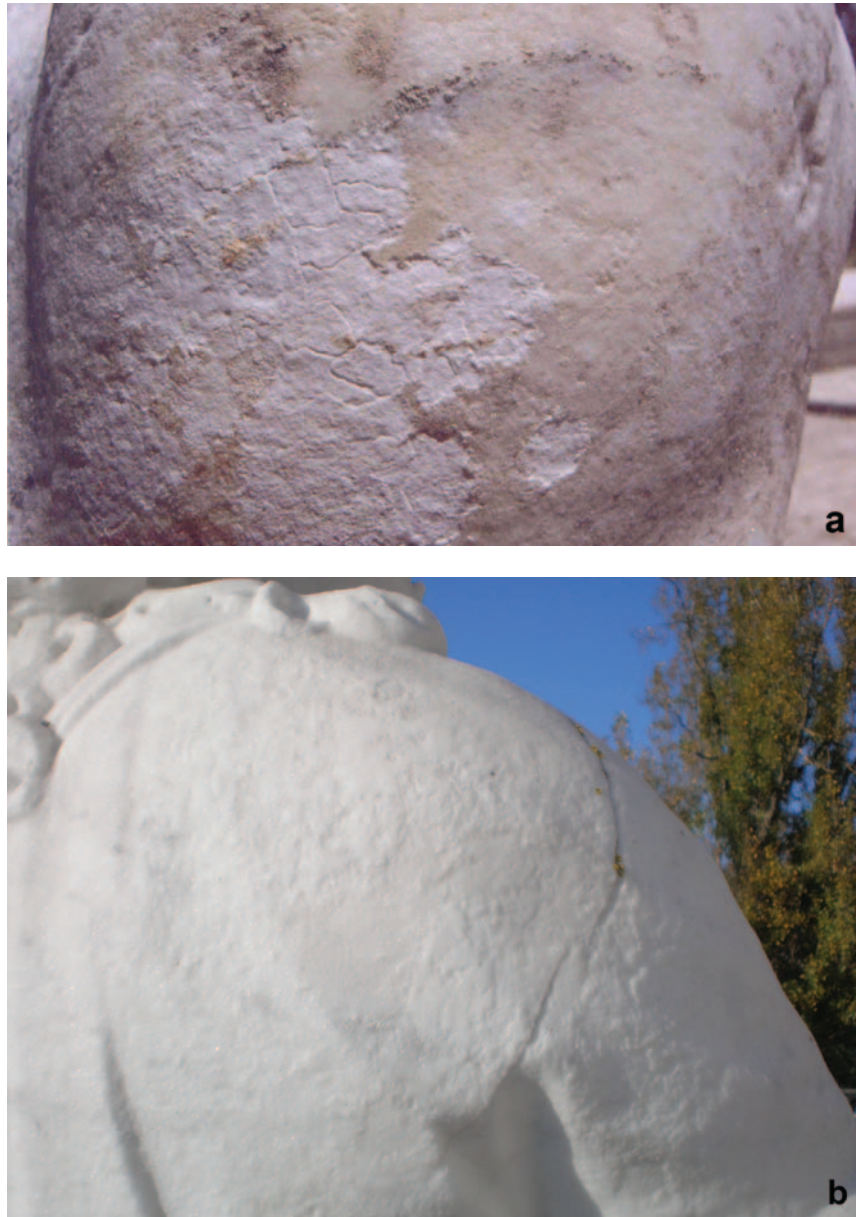
FIGURE 4. Surface conditions left by two different cleaning methods: (a) application of a biocide and gentle brushing (roughly 30×40 cm area) and (b) aggressive grit blasting (area about 40×50 cm).

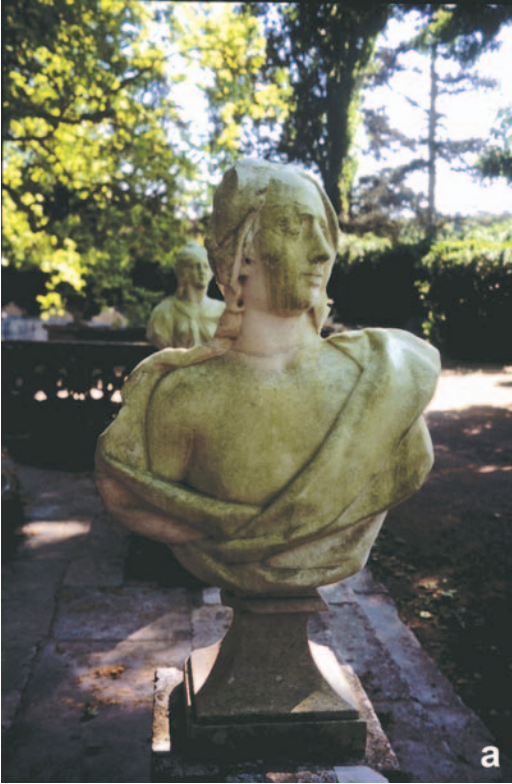
FIGURE 5. Aspect of two of the more-shaded busts four years after the last cleaning. The difference in visible biocolonization between seasons is clearly seen between (a) the spring, after a wet winter, and (b) the fall, after a dry summer, in 2003.

that are under or very close to large trees. This is illustrated by four busts that decorate a balustrade surrounding a lead sculpture group and a fountain. Two of them in particular are directly under a large sycamore tree that provides a very favorable environment for biocolonization. The busts were cleaned in 1993 by grit blasting. Two years later, they underwent low-pressure water washing, and a biocide was applied. Four years later, in 1999, they needed to be cleaned again, this time with sodium hypochlorite poultices and the application of both a biocide and an aqueous dispersion of a water repellent. The repeated cleaning required clearly shows how fast recolonization can take place in this sheltered area. Figure 5 shows the appearance of these busts four years after cleaning.

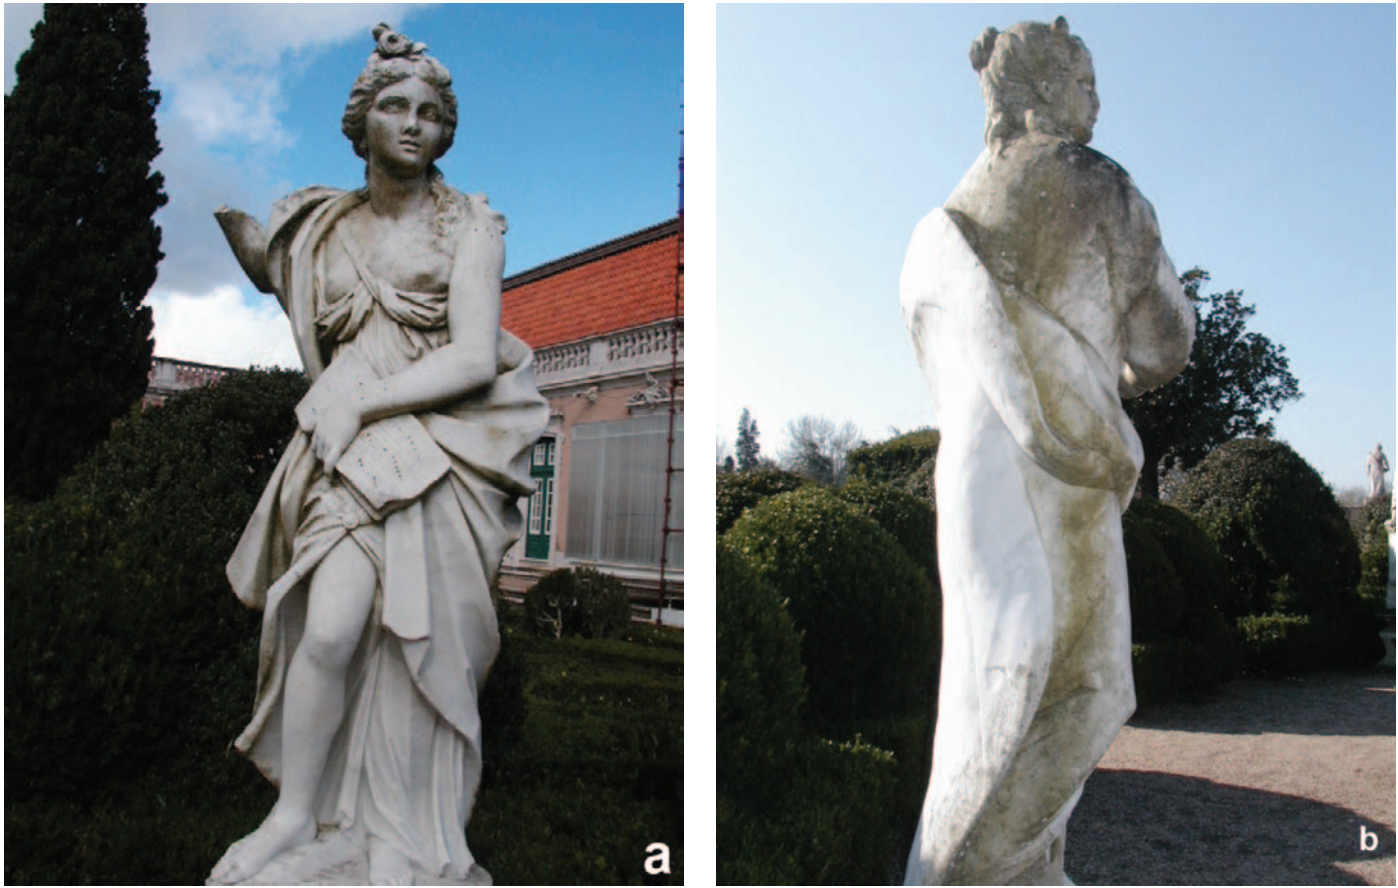
FIGURE 7. Recolonization condition of the arts statues in 2003, seven years after the 1996 cleaning: (a) *Music* and (b) *Painting*. Cleaning had been carried out with biocides and low-pressure washing, followed by the application of a water repellent.

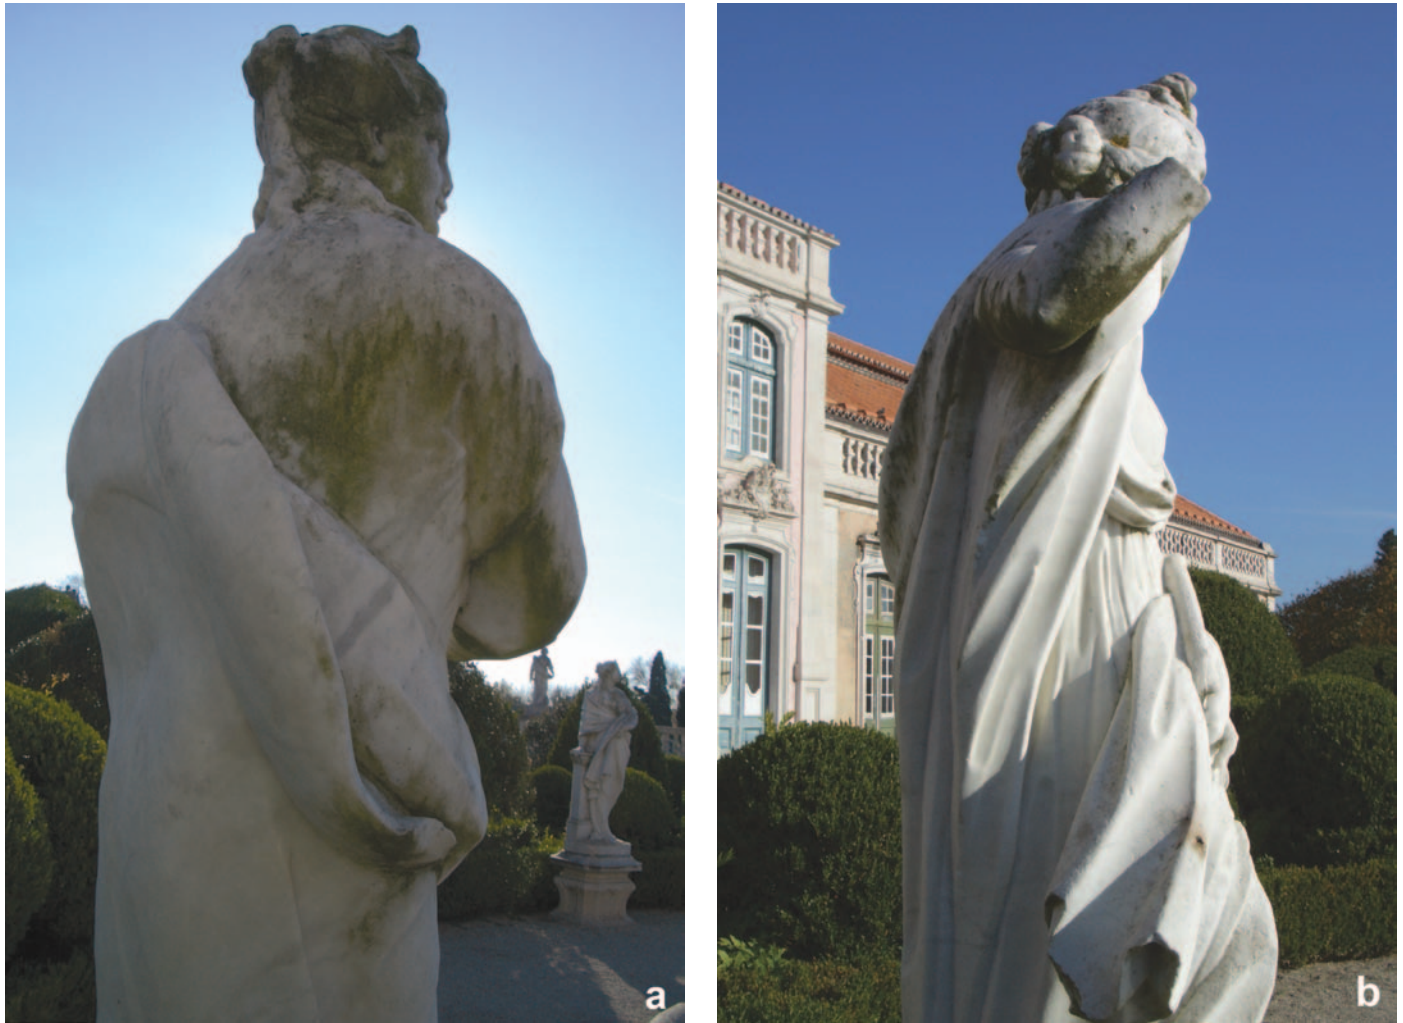
FIGURE 8. The arts statues in 2008, five years after cleaning with abrasive methods, showing recolonization of green algae in the northward-facing areas: (a) *Painting* and (b) *Music*.

were widespread on the north- and northeast-facing areas, and lichens were already present on the south-facing areas (Figures 8 and 9).

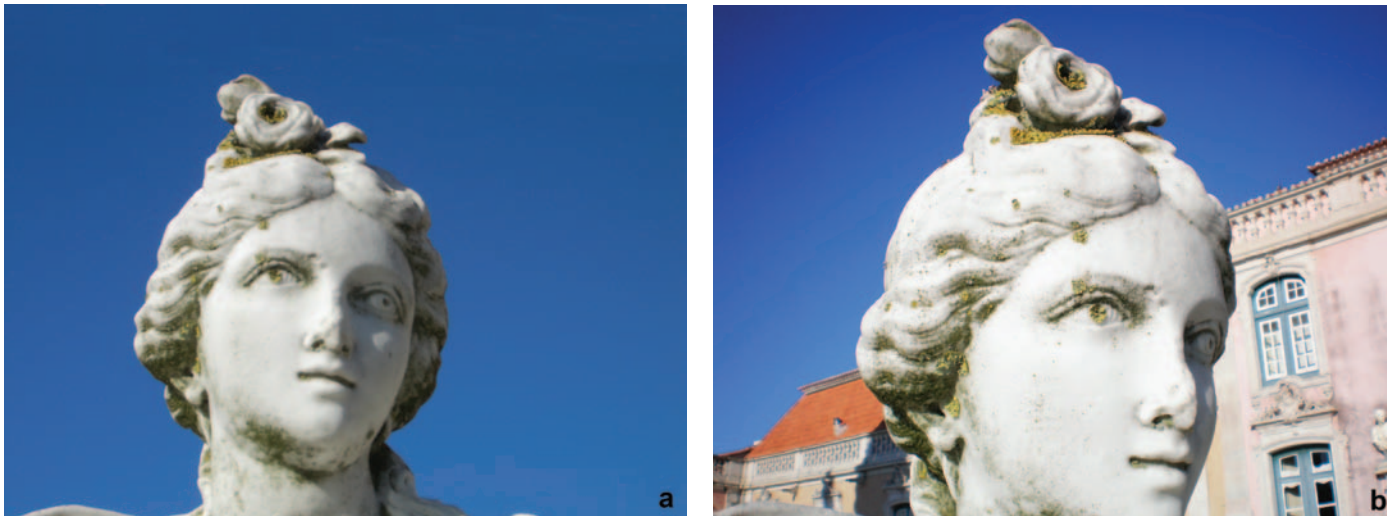
FIGURE 9. The face of *Music*, showing the first occurrences of lichens on the sunny south-facing areas. (a) Lichens and growth of algae on the relatively protected underside of the chin. (b) A detail of the lichen growth.

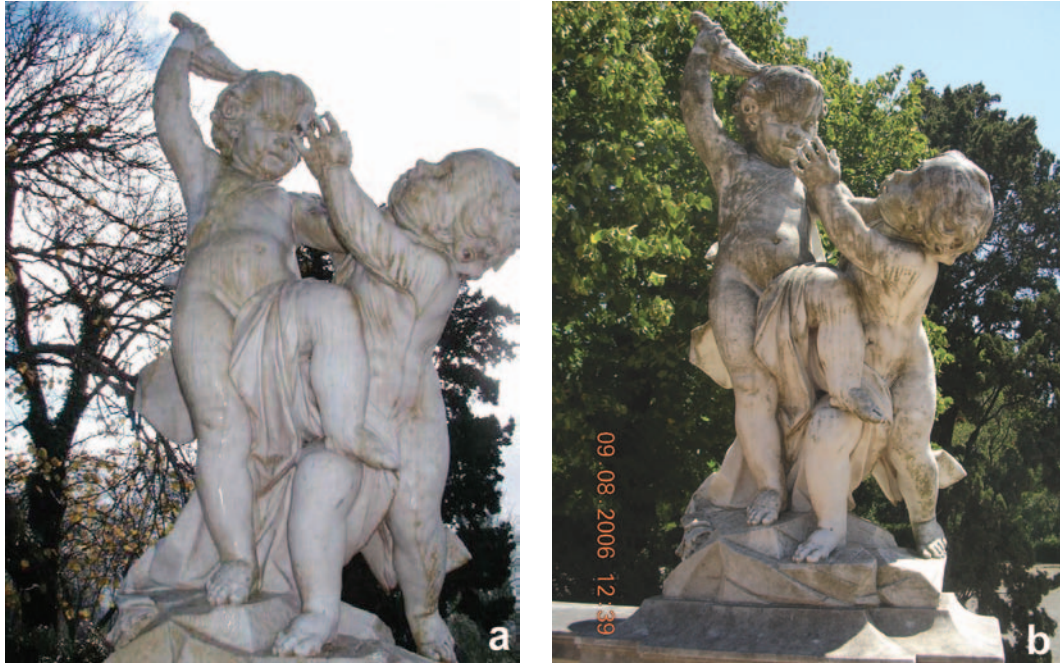
FIGURE 11. Recolonization of one of the putti groups cleaned in 1996. Appearance is shown (a) in 2003 and (b) in 2006. Note the well-defined dark green stripes in (a) as a result of the water-repellent treatment and their subsequent evolution to heavier features over time.

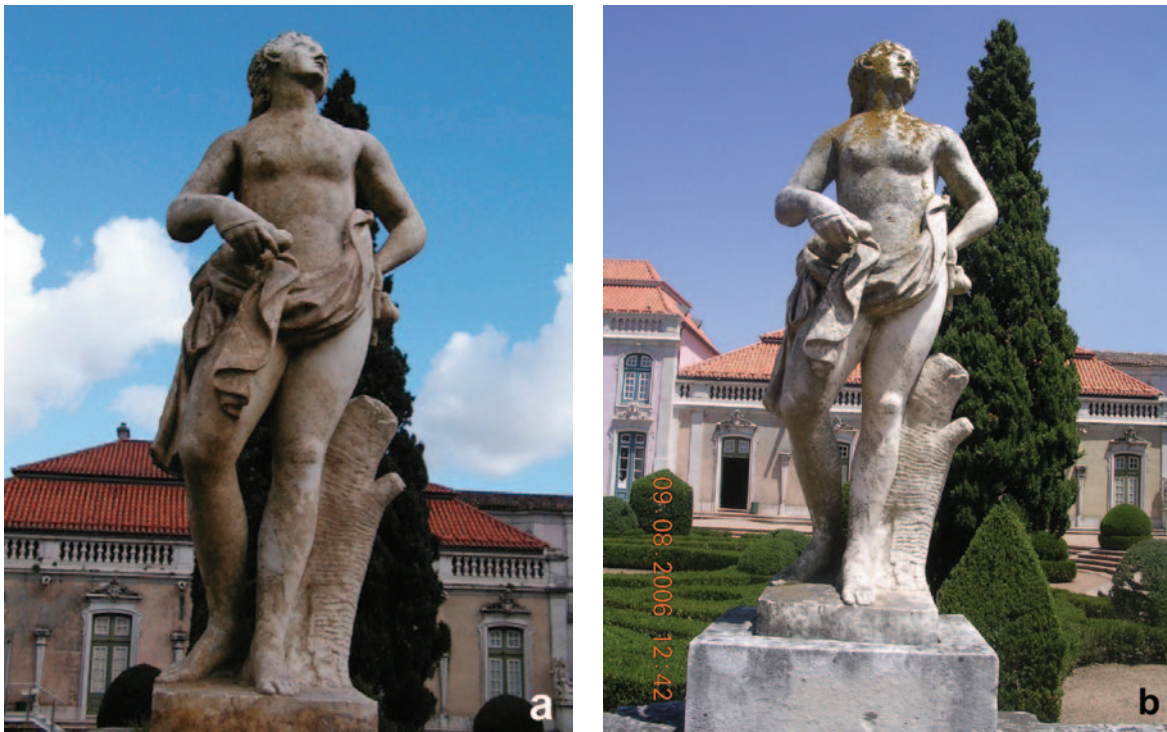
FIGURE 12. Sculptures located in open, unsheltered spaces. Recolonization is shown (a) four years after cleaning and (b) seven years after cleaning. Note the initial relatively slow increase in biocolonization, with the subsequent appearance of lichen colonization.

On the other hand, the sculptures shown in Figure 12 are located on the balustrade between the Malta and the Hanging gardens. This is a totally unsheltered space where they are exposed to direct sunlight for most of the day.

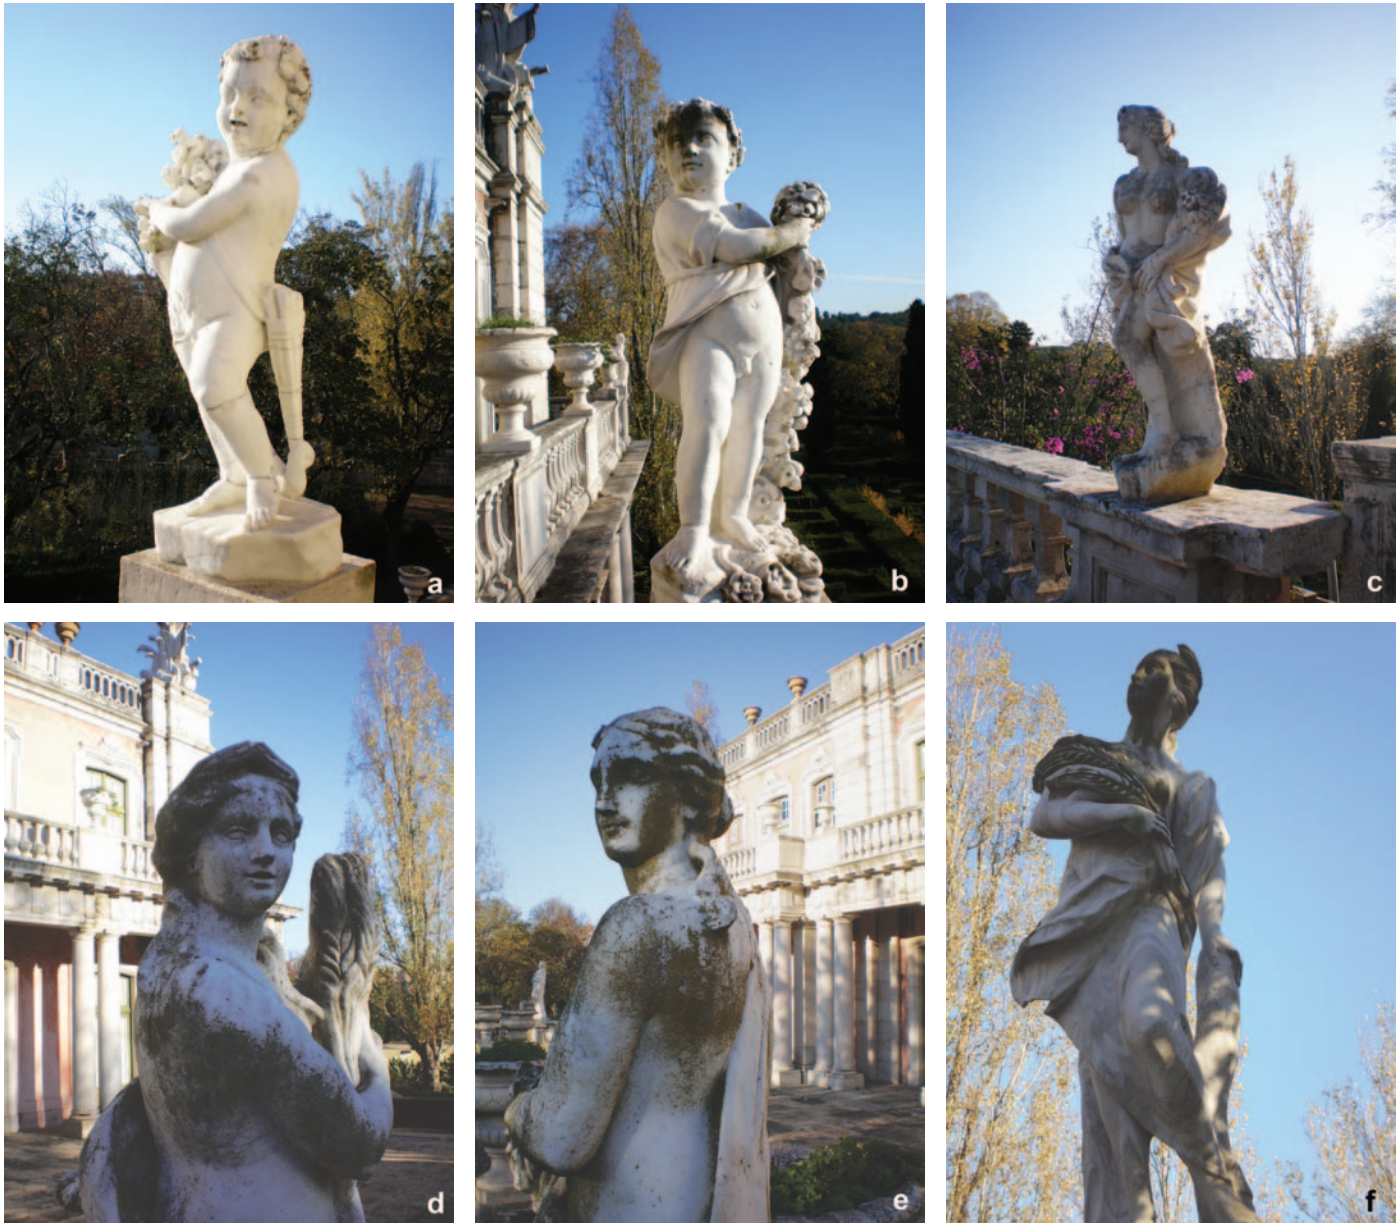
FIGURE 13. Appearance of the sculptures from the (a–c) upper and (d–f) lower balustrades eight years after application of a biocide. Note the significant increase in average colonization of the lower balustrade, where the statues are shaded on the east by the palace building and on the west by tall trees.

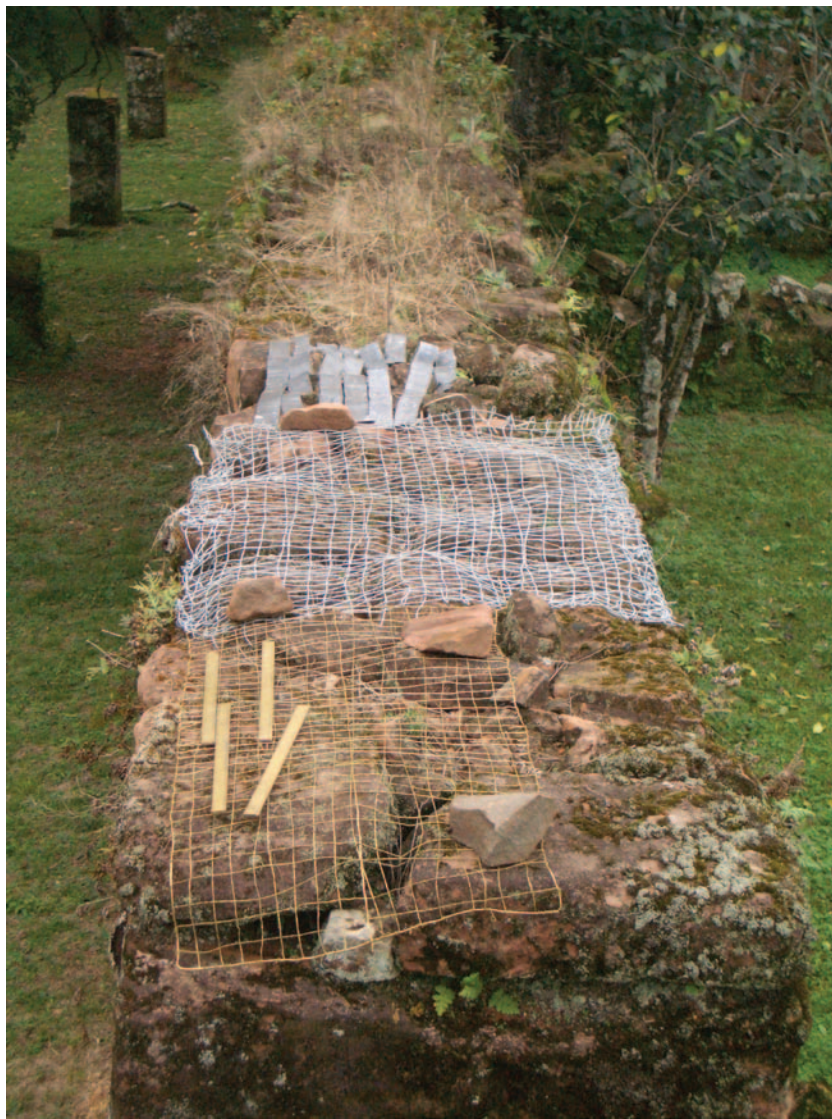
FIGURE 2. View of the top of the wall with the passive system in place. From the front to the back are brass mesh and strips, zinc mesh, and lead strips.

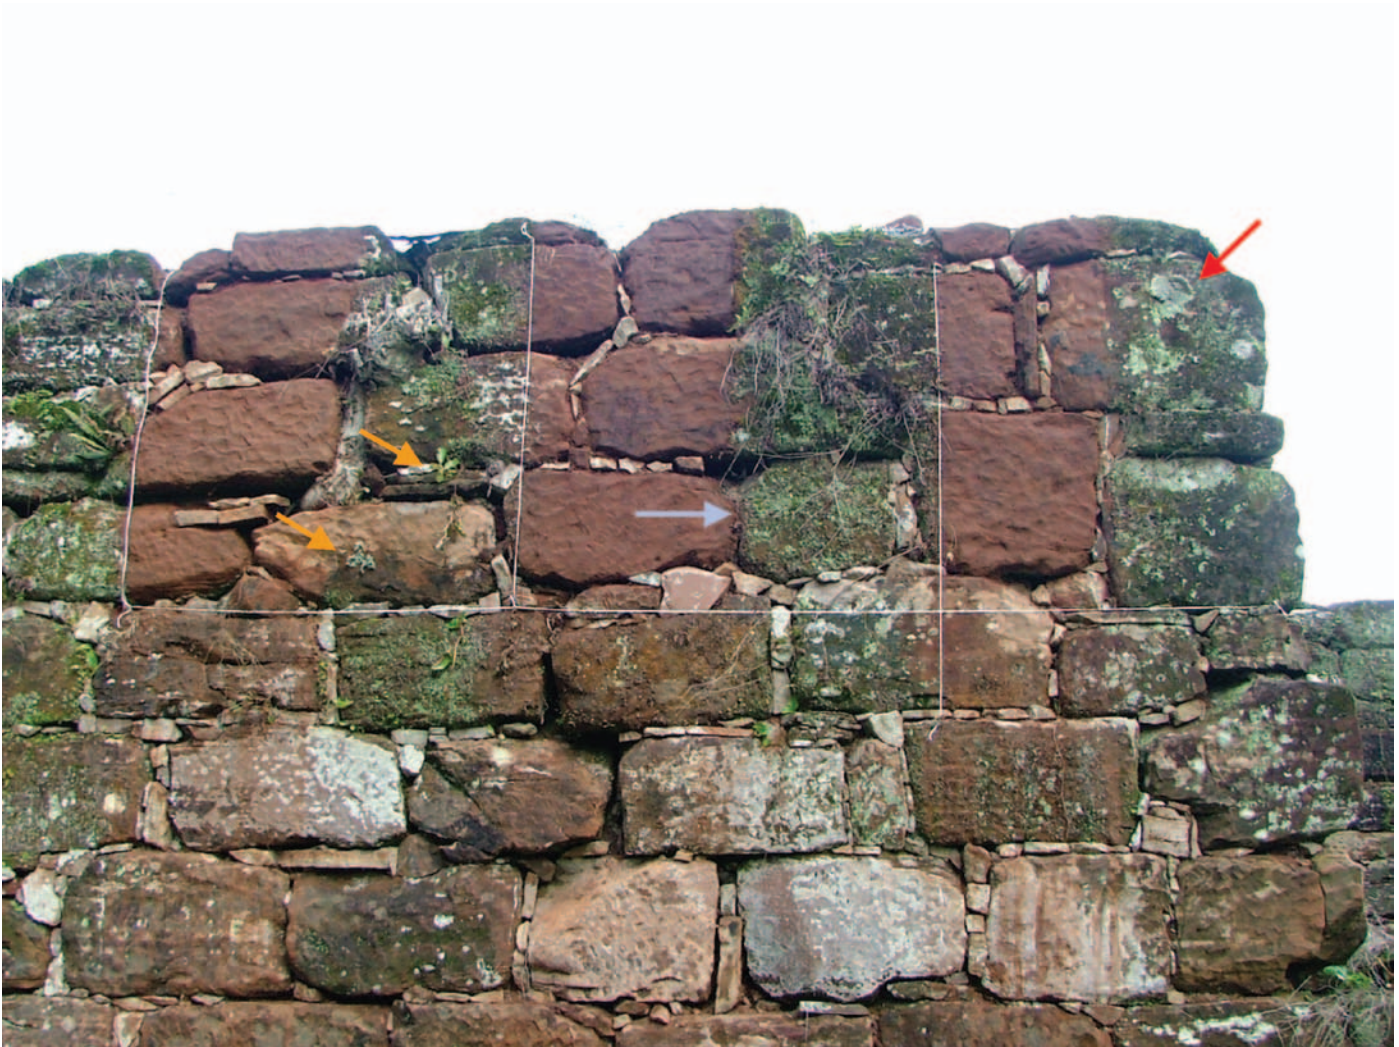
FIGURE 3. View of the north side of the wall where the passive control systems were installed on the top. The left area is below lead strips, the middle area is below zinc mesh, and the right area is below brass mesh (photo taken in May 2007). The left half of each area had been cleaned at the beginning of the experiment; the right half was left uncleaned and served as a control. The upper orange arrow points to a small plant, and the lower one points to a hepatica. The blue arrow points to a moss- and hepatica-covered block. The red arrow points to a detaching lichen.

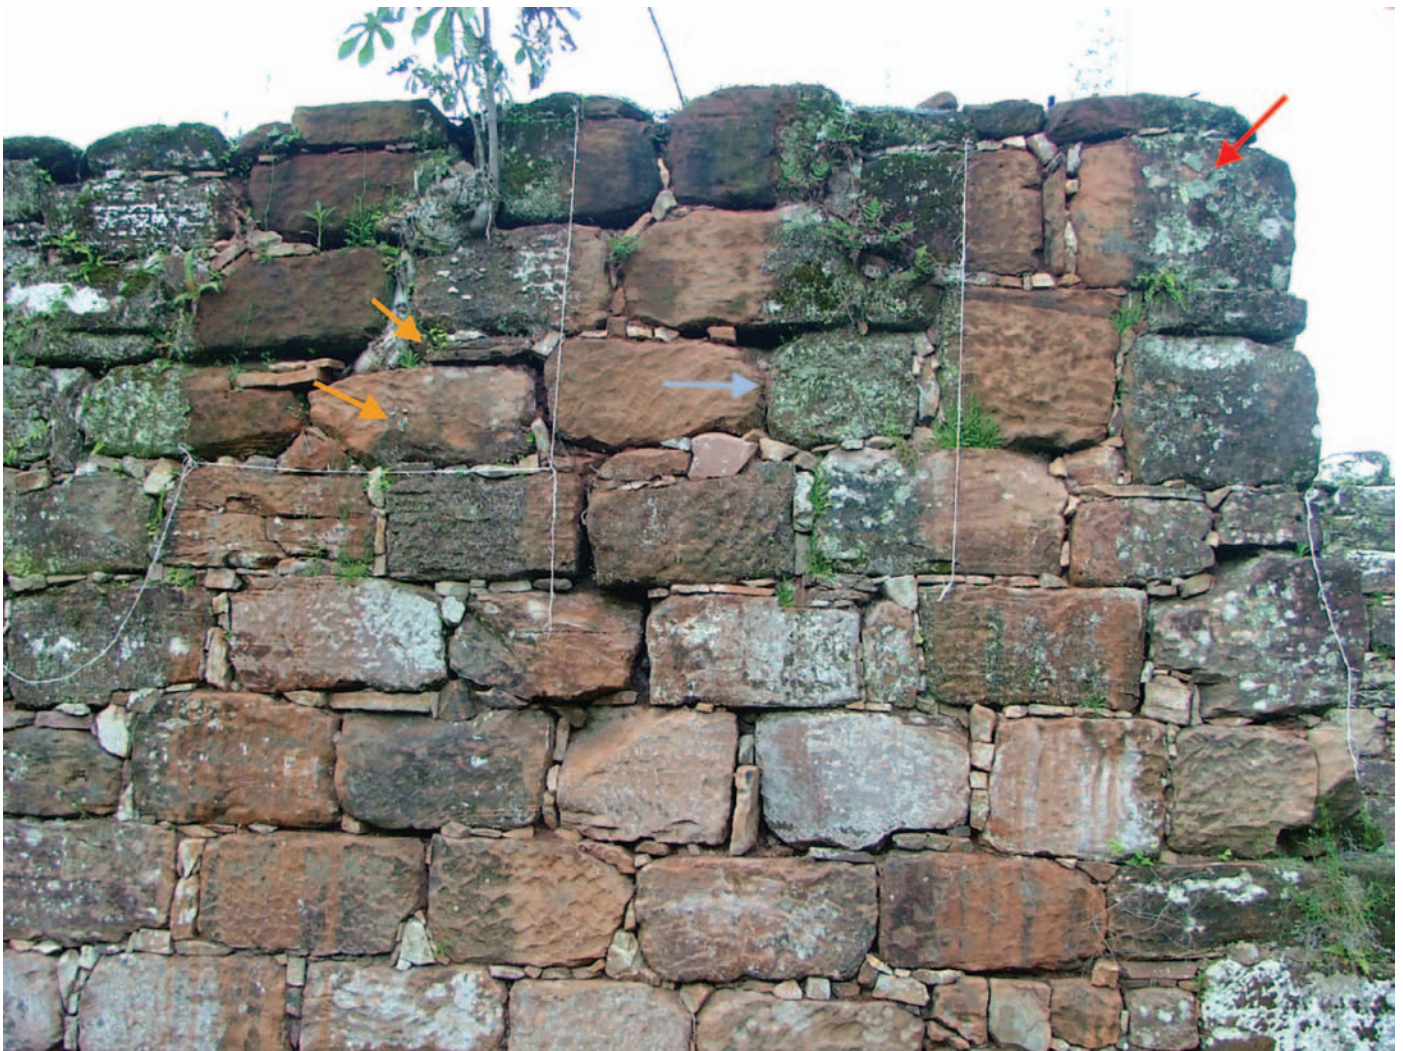
FIGURE 4. Same view as the one in Figure 3 16 months after the installation of the passive control system (photo taken in August 2008). The upper orange arrows point to the area where the small plant noted in Figure 3 has disappeared, and the lower orange arrow points to a decrease in hepatica cover. The blue arrow points to a diminished moss and hepatica cover. The red arrow points to the area where the detaching lichen was lost.

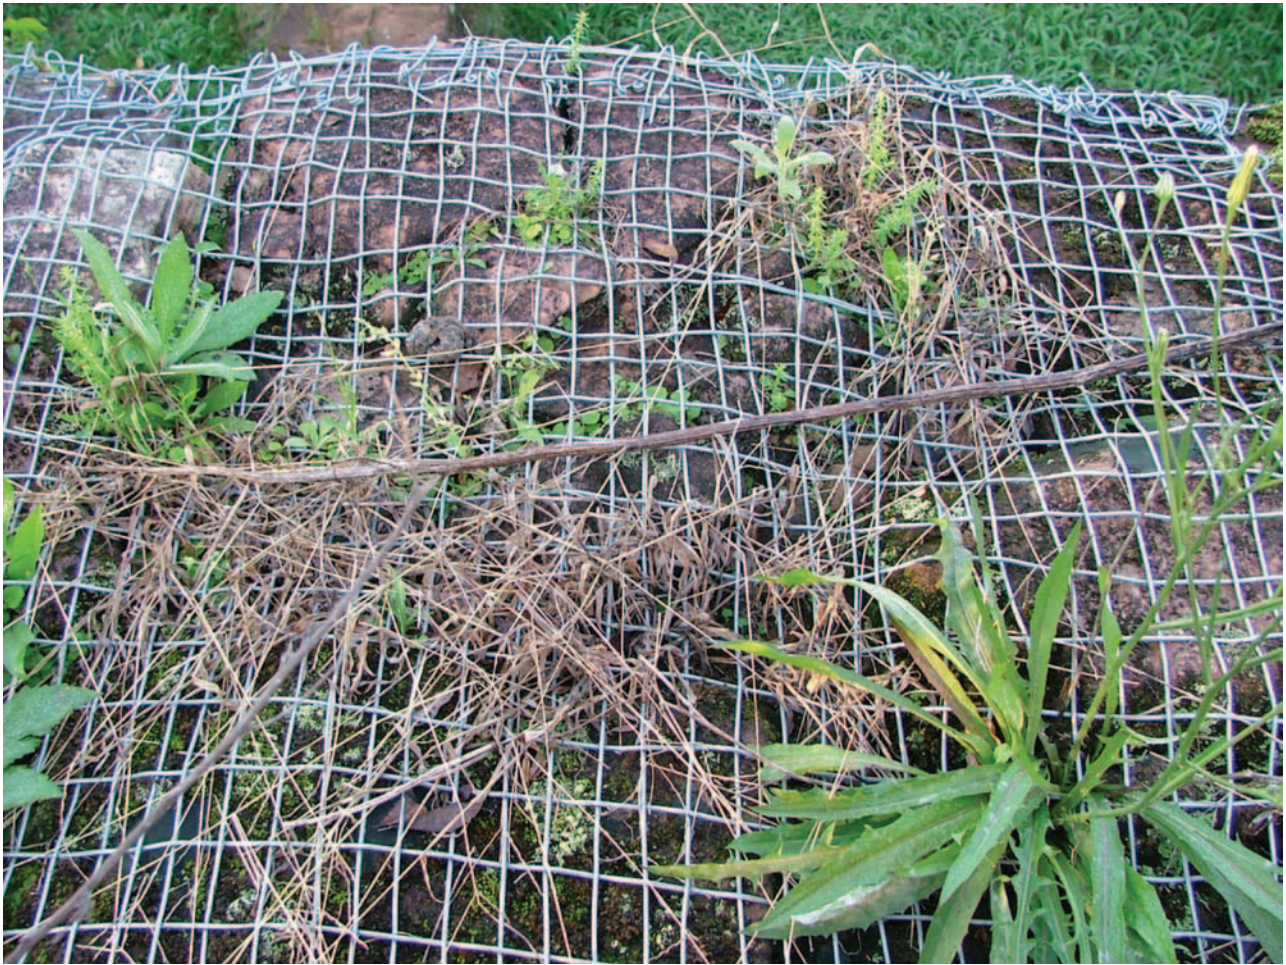
FIGURE 5. View of the center section of the top of the wall, covered with the zinc mesh. Note the abundant growth of higher plants. Similar growth was found in open joints of other sections as well (photo taken in August 2008).

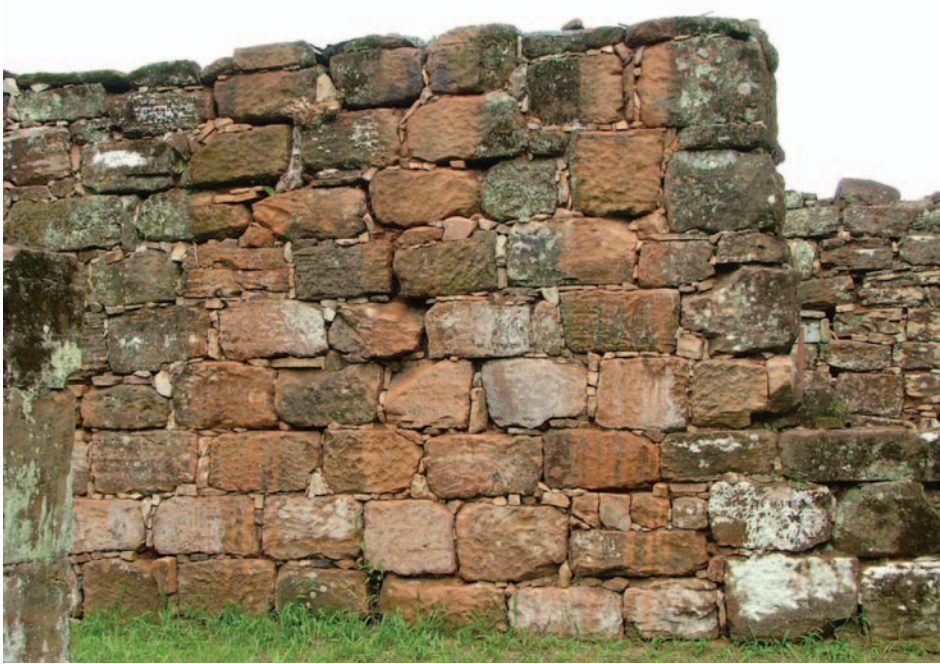
FIGURE 6. View of the side of the wall three months after hand removal of higher plants and brushing on all test areas (photo taken December 2008).

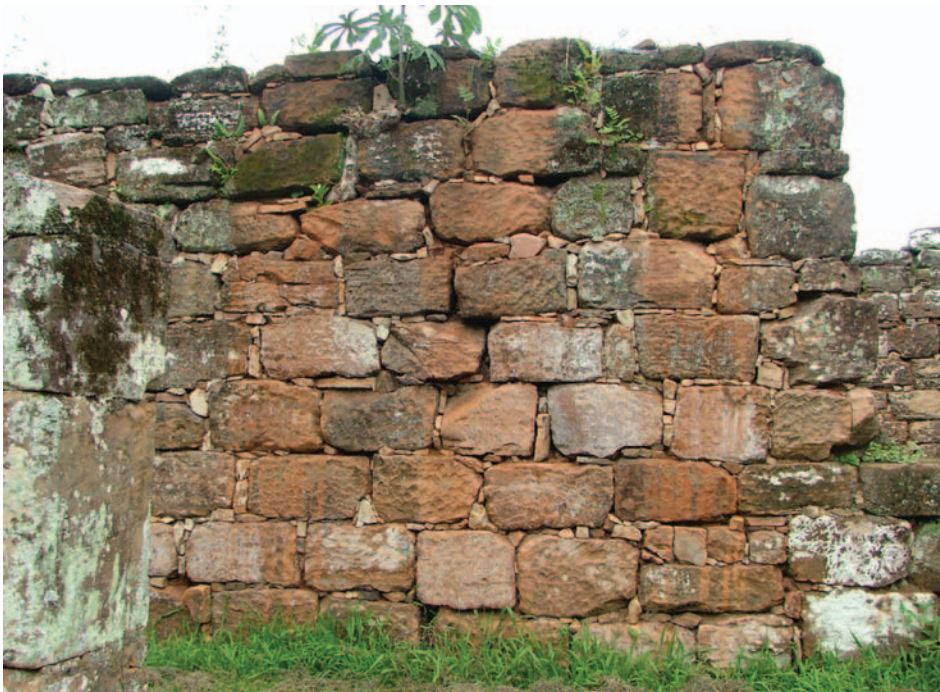
FIGURE 7. Same view as in Figure 6, five months after the September 2008 cleaning (photo taken in February 2009). Ferns, smaller plants, and the *Manihot tveediana* bush have regrown on the originally uncleaned control areas. No obvious recolonization has occurred on the originally cleaned areas.

Figure 7 shows the appearance of the wall in late summer (February 2009, five months after the second cleaning). The *Manihot tweediana* bush, ferns, and other smaller plants have reappeared. No obvious recolonization has occurred on the originally cleaned areas.

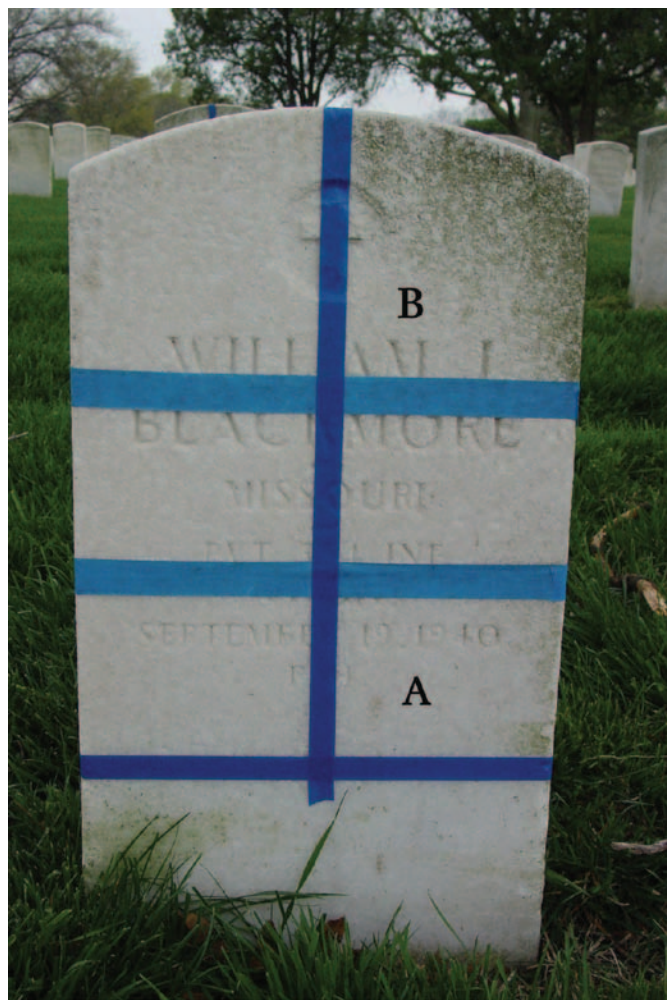
FIGURE 2. Biological growth observed on the test stone at Jefferson Barracks after six months: area A is treated with Kodak Photo-Flo, and area B is treated with $\text{H}_2\text{Orange}_2$ Grout Safe cleaner.

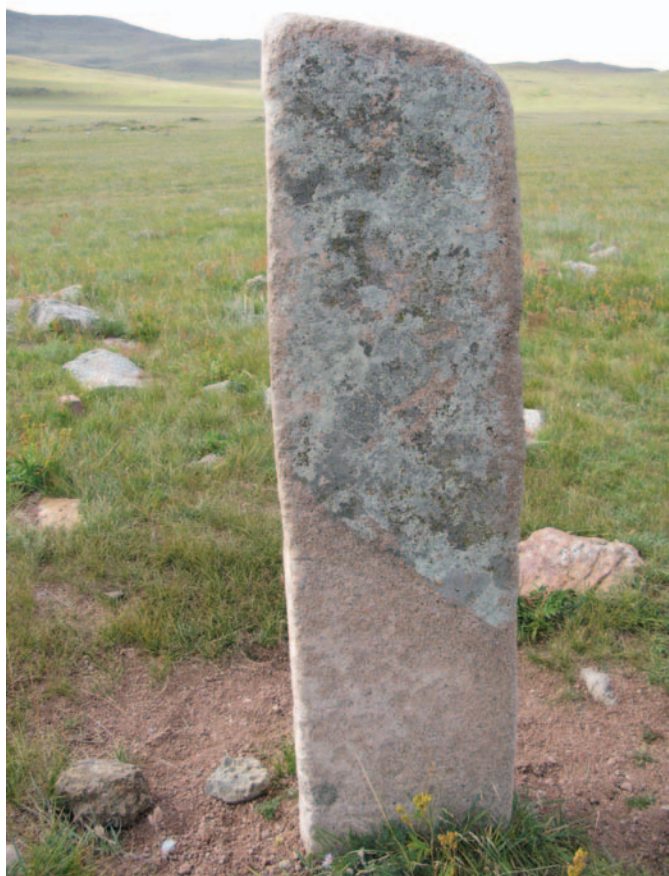
FIGURE 5. Another deer stone at the Ulaan Tolgoi site showing mixed lichen colonization. Note the slanted lower edge of the biocolonization, which reflects that this stone most likely was partly buried to this line.

note that the mineral green lichen cover originally ended rather abruptly with a slightly angled line across the stone (see Figure 6), as did the mixed lichen cover on another stone in the site (see Figure 5). The position of the lichens suggests that for many years the treated stone was lying practically flat on the ground with its upward side (now the north side) half covered with the soil up to this line. In this case, moisture in the soil's boundary layer and the sunlight's angle of insolation would have combined to support a continuous cover of the lichen species, a situation also seen in outcropped rocks in the area. Consequently, the stone may have been colonized by a single lichen rather than by the mixed lichen colonization found on most of the other standing deer stones (as in Figure 5). With a change in the stone's position to standing, the moisture content in this upper area would have dropped, and the lichen cover would have begun a steady decline over the five years it was photographed.

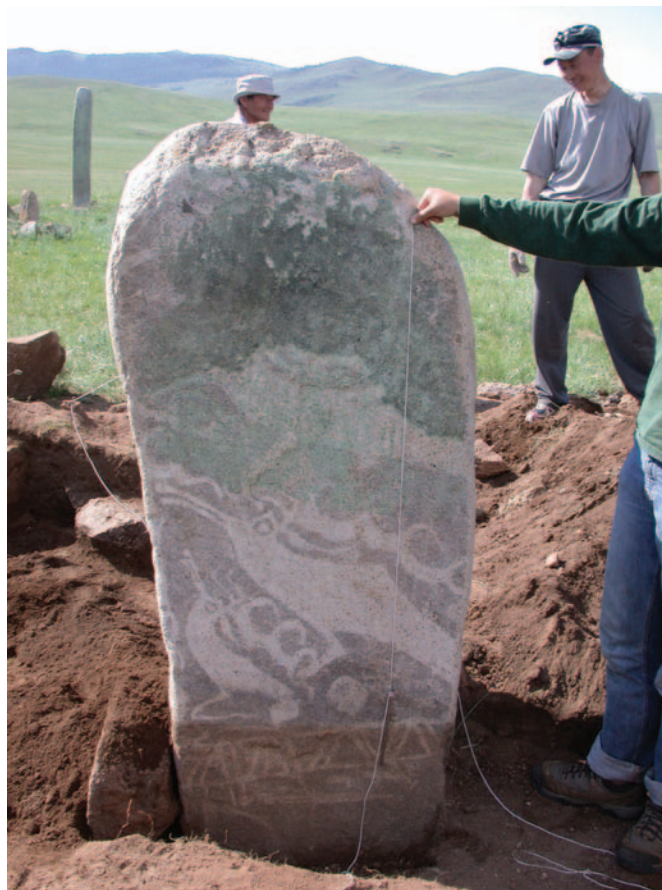
FIGURE 6. North side of the deer stone (DS4) at the Ulaan Tolgoi site with uniform lichen colonization photographed in 2004 before treatment. The string shown serves to mark the boundary of the area that was treated with ethanol.

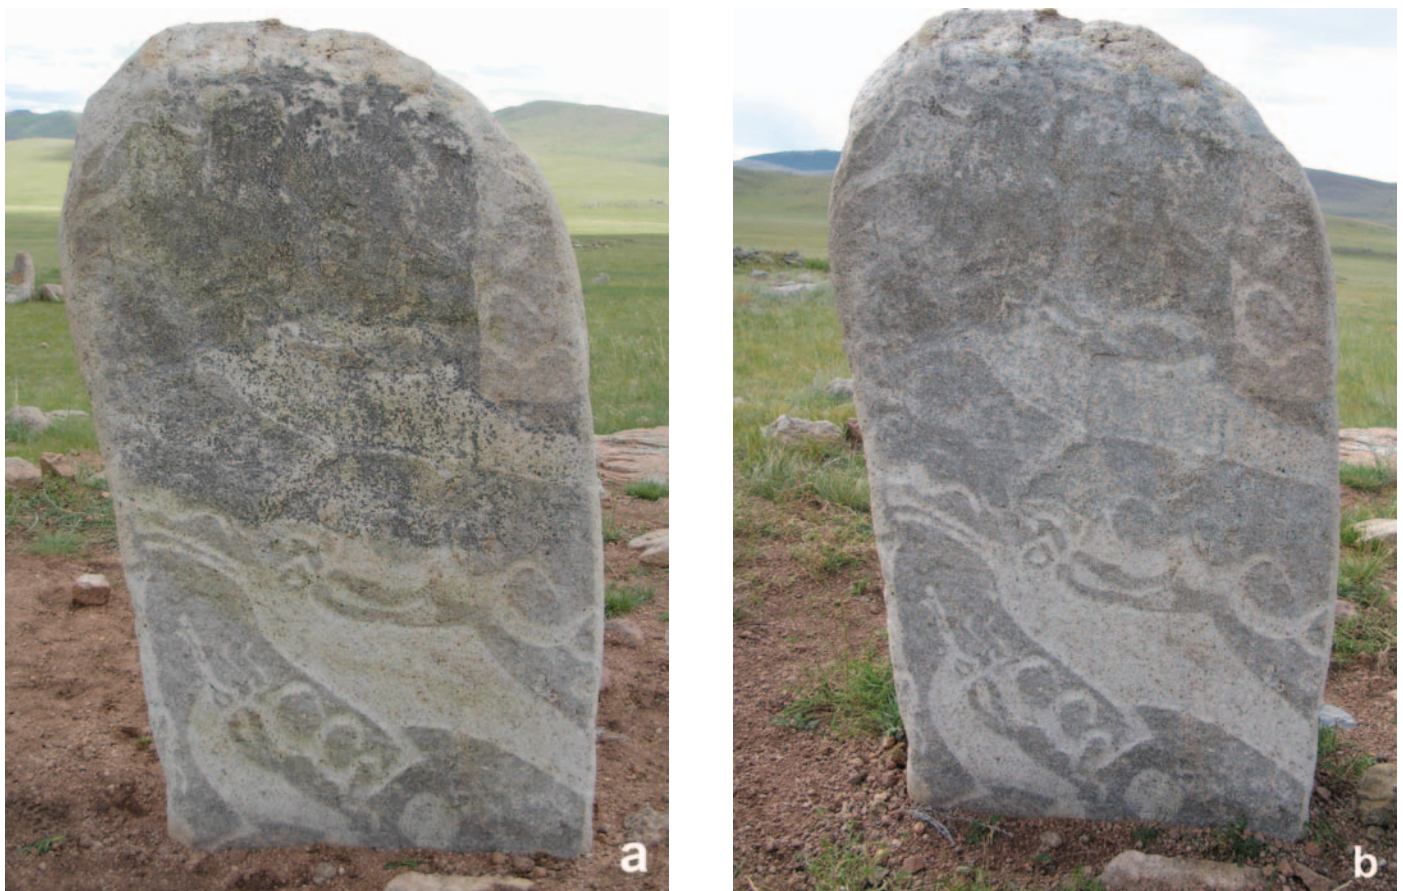
FIGURE 7. North side of the deer stone (DS4) from Figure 4 (a) in 2007, three years after the application of ethanol, and (b) in 2009, five years after the treatment. Note the diminishing difference between the treated area and the rest of the stone.

After the treatment in 2004, the deer stone was examined and photographed annually, except in 2006. The first year after the ethanol application, 2005, the lichens in the treated strip turned brown, indicating that the one-time treatment had killed their algal partners. By the third year, 2007, the plantlike thalli in the treated area had dropped off the stone. Notably, during the same period the sweep of the lichen on the entire north side of this deer stone also began to turn brown and thin out, demonstrating that the colony is dynamic. By 2009, all the lichen was entirely brown and flaking, and the untreated area was almost as bare as the treated area (Figure 7). Figure 8 shows a detail of the edge of the treated area, four years after the

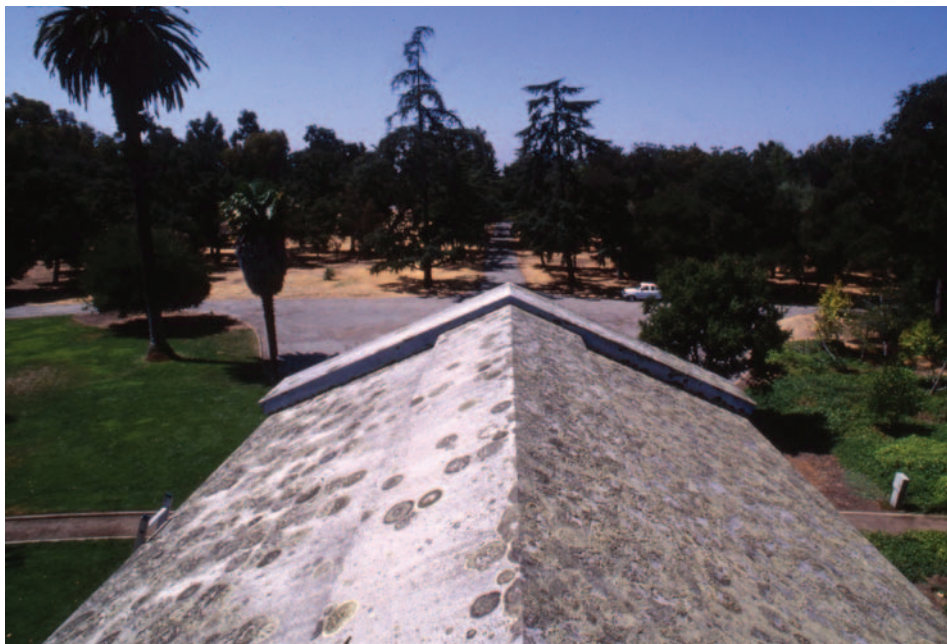
FIGURE 2. The roof of the Stanford Mausoleum in 1995, showing the heavy lichen colonization that had developed over 106 years.

The Stanford Mausoleum is a small neoclassical building of rectangular plan measuring approximately 8 × 12 m. In 1889 the entire building (including the roof) was constructed of gray-colored granite from Barre, Vermont (Figure 1). In 1995, Stanford University commissioned a condition survey of the building because of severe water penetration problems that had developed over the previous 106 years. Apart from those problems, the roof had developed significant lichen colonization, including foliose and crustose lichens. The former were identified as belonging to the Parmeliaceae family and probably to the *Xanthoparmelia* genus since the latter is a common lichen found in the San Francisco Bay area (Figure 2).

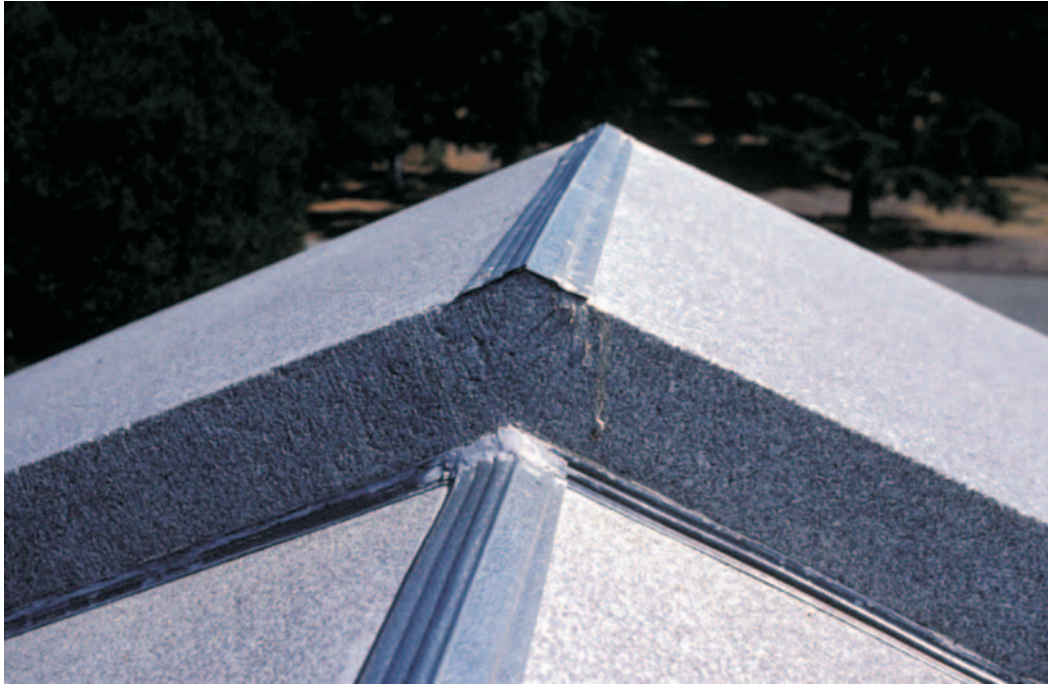
FIGURE 3. The roof of the Stanford Mausoleum after cleaning in 1997, showing the zinc strips installed on the roof's ridges.

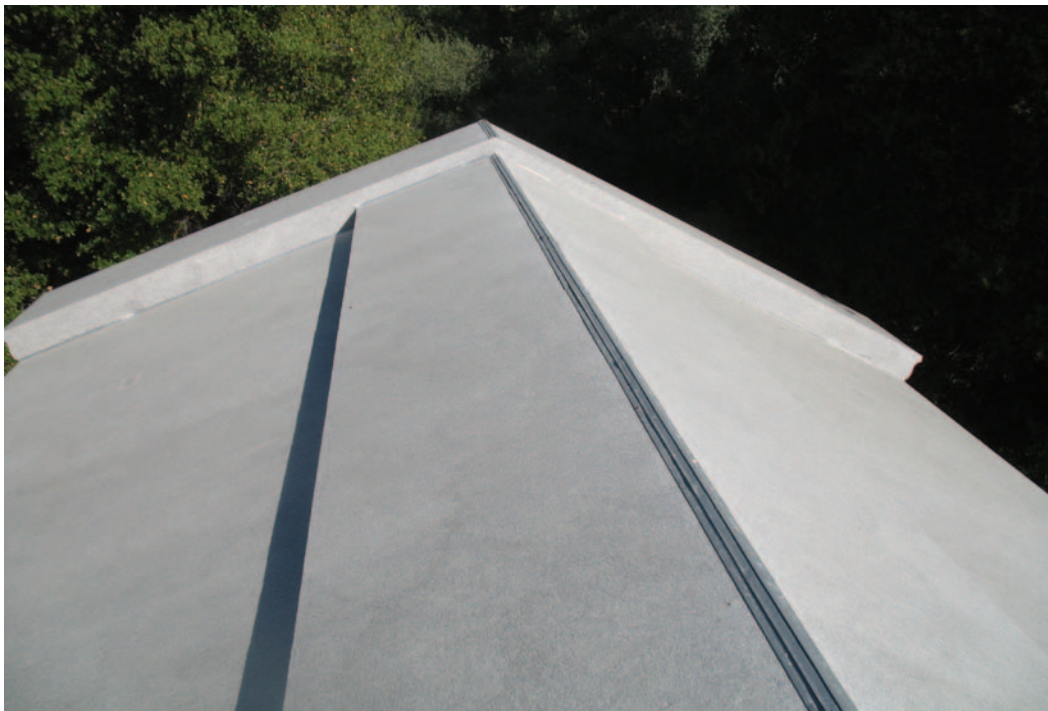
FIGURE 4. The roof of the Stanford Mausoleum in 2009, 12 years after the cleaning and the installation of the zinc strips.

Twelve years later, the roof was inspected to evaluate the effectiveness of the zinc strips. No biological colonization was evident, and only minor soiling, which could be attributed to a passing seagull, was found (Figures 4 and 5). Nevertheless, lichen colonization is slow to develop, and judging from lichen colonization of other materials, it certainly would require more than five years to develop (Henriques et al., 2007; Delgado Rodrigues et al., this volume). Only a small amount of soiling, under the roof cornice, had reappeared (Figure 6).

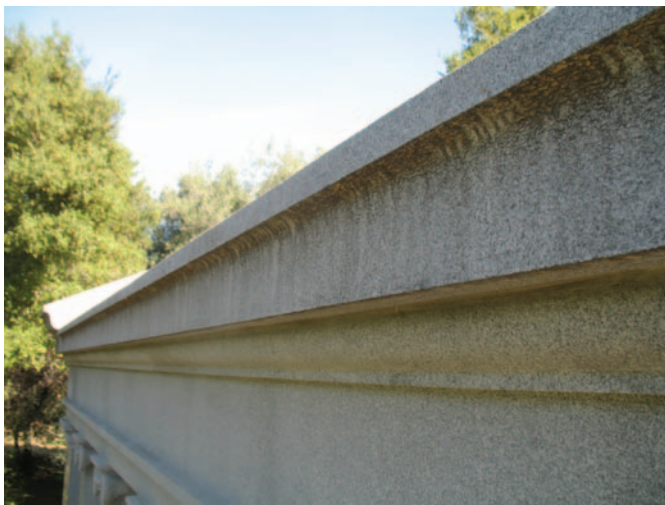
FIGURE 6. Detail of the cornice in 2009, showing new soiling.
