A. Elena Charola* and Christine Bläuer

Salts in Masonry: An Overview of the Problem

DOI 10.1515/rbm-2015-1005

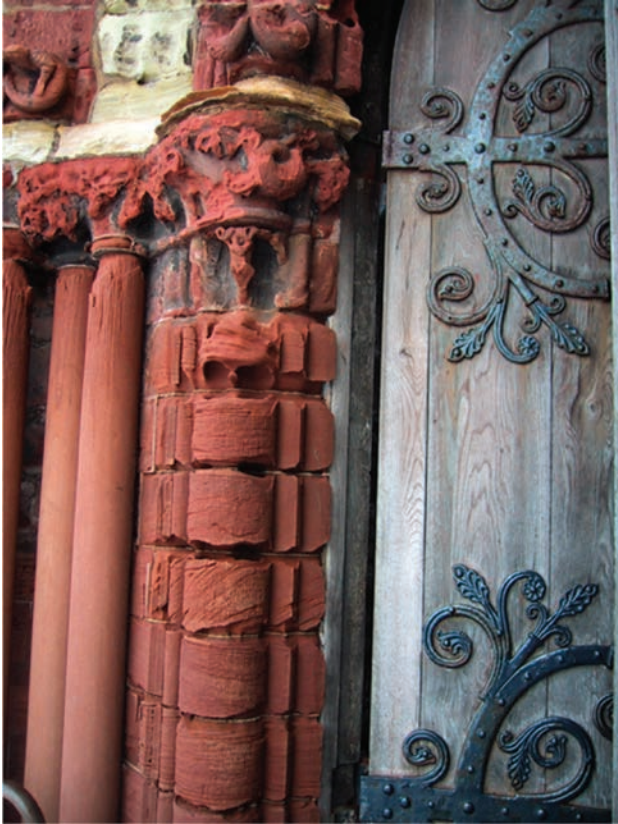
Figure 1: Typical weathering patterns caused by salts (granular disintegration and alveolization) on sandstone at the portal of St. Magnus Cathedral, Kirkwall, Orkneys.

A condition survey is required prior to any major conservation intervention and it is usually during this process that the presence of salts is suspected either because salt efflorescence can be seen right away or deterioration patterns often associated with salts are observed (Figure 1).

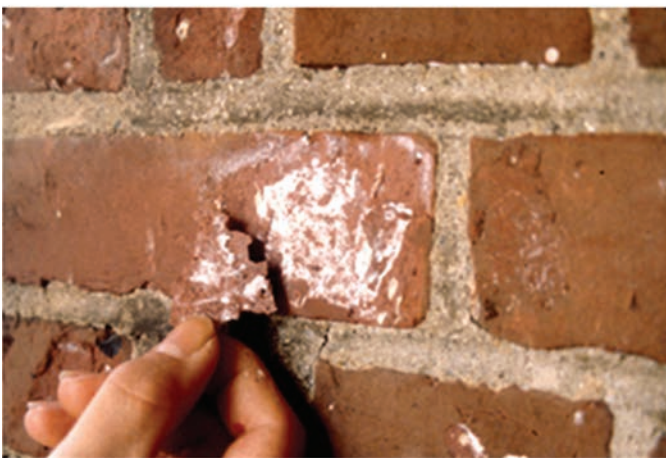
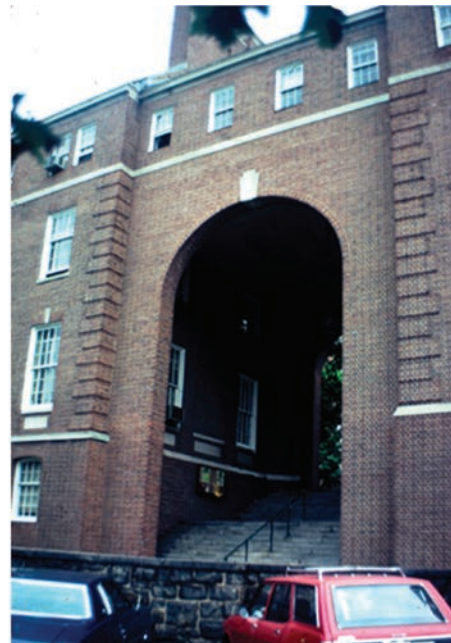
Figure 2: Left: Sodium sulfate crystallizing at the subsurface in brick masonry causing the detachment of the flake that is being held showing the salt present also on its underside. Right: Portal at the Manhattan College in New York City, where this occurred. Figure 3 provides further information about this damage.

However salt damage will not only present different morphologies on the various materials but these are also dependent on the environmental conditions (Figure 2).

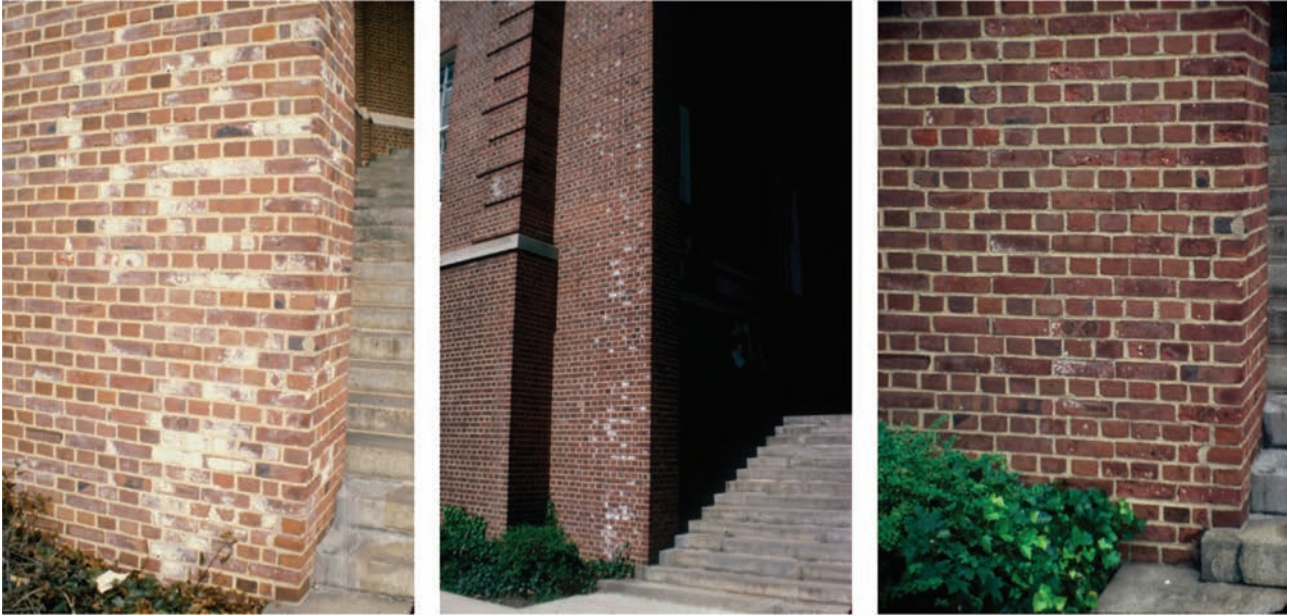
Figure 3: Detail of the brick masonry at the portal (Figure 2 right) on the left side as it appears in winter (which are dry, $T < 3^{\circ}\text{C}$, RH $\sim 50\%$; left) when efflorescence is most visible; in spring (where humidity increases, $T \sim 10^{\circ}\text{C}$, RH between 60 and 85%; center), and during summer (which are damp, $T \sim 30^{\circ}\text{C}$, RH between 70 and 90%; right) where practically no efflorescence is visible because of the hygroscopicity of the sodium sulfate. The salt is inherent to the brick and mainly crystallizes out near the edge of the arch where more evaporation takes place.

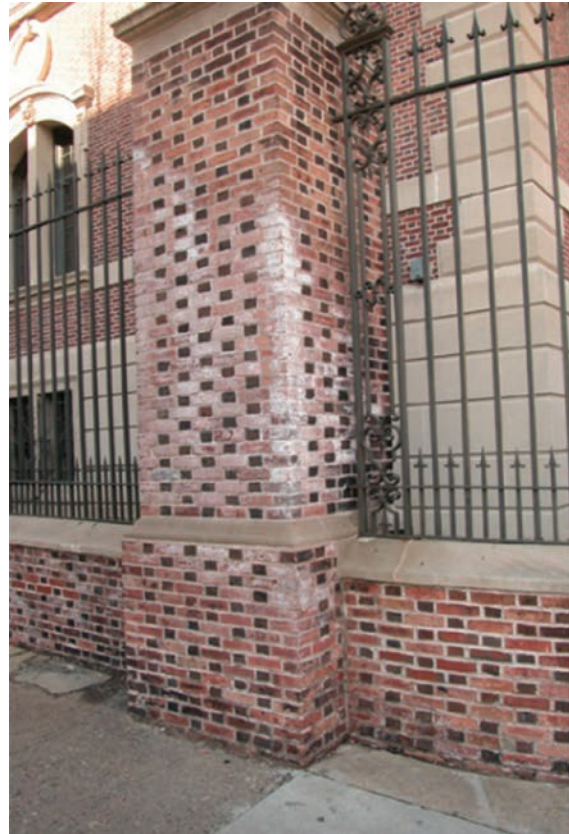
Figure 4: On the fence surrounding the Silverman Hall Law Building of the University of Pennsylvania, efflorescence began to appear one year after its cleaning (1999) and continued to increase with each passing year. While the cleaning products were properly washed off from the building itself where no salt deterioration occurred, this careful procedure was not applied for the fence (Photo January 2005). Efflorescences are visible during the dry winters, while in the humid summers, these areas appear damp.

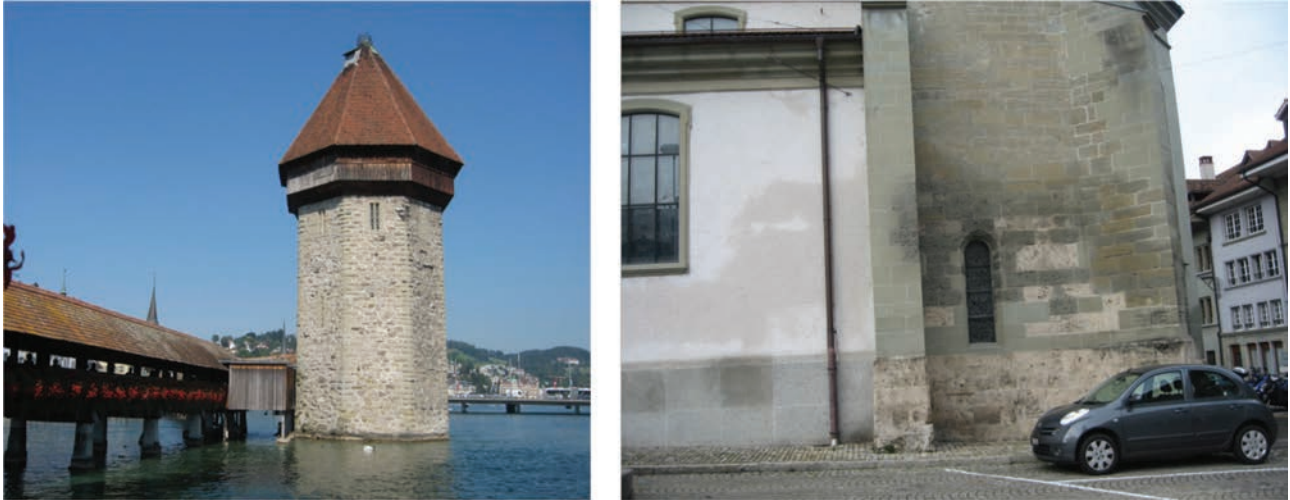
Figure 5: Left: Tower at the Kapellbrücke on the Reuss river, built with Molasse sandstone some 700 years ago. Even though the tower has its foundations sunk into the bed of the river, no rising damp is observed. Right: Detail of the Basilique Notre Dame, Fribourg, where damp areas are found up to about 4–5 m high. The Basilica was built by the former infilled moat of the Castle; nearby there had been a cemetery, and later, on market days, animals would be standing there contributing to enrich the soil with salts while deicing salts are used in winter.

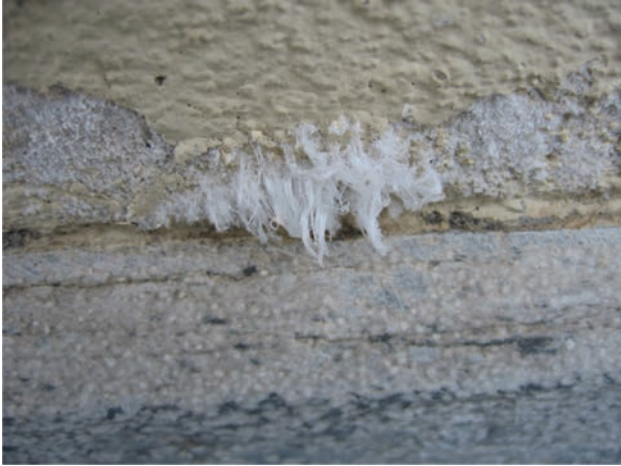
Figure 6: The paint of a façade is detached by the growth of long salt whiskers (over 1-cm long) that mechanically push away the paint from the surface.

will push it away and the paint will tend to powder or flake off, depending on the nature of the paint (Figure 6).

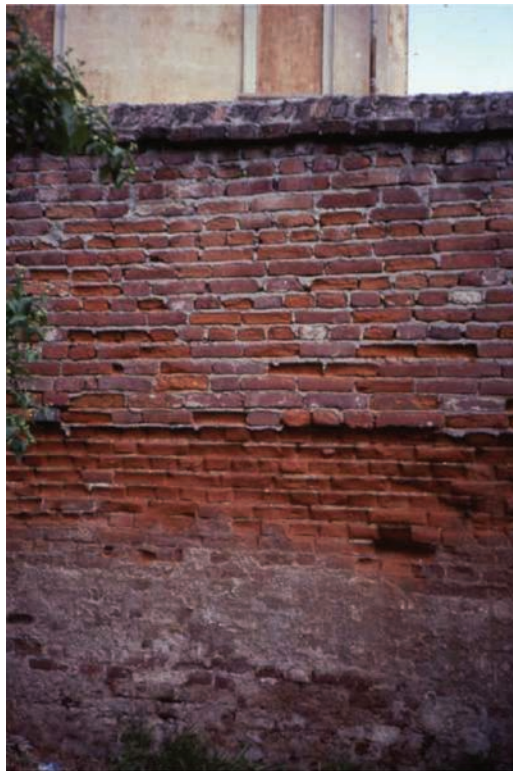
Figure 9: Old brick masonry wall in a garden that was repointed with a cement mortar. Note that major damage occurs in the center area where salts crystallize out as subflorescence (between half a meter to 1 m height) and that the bricks are damaged first being more porous than the cement mortar. The lower area, where the wall is mostly damp, concretions tend to form with salt efflorescence right above it, but less damage is evident.

The shape and environment of the building will play an important role. For example, corners will evaporate faster than a flat surface because of a higher specific surface and because air circulation will be enhanced by protruding features. That is why fluted columns generally show deterioration at the flute edges. Considering equal thermohygric conditions, evaporation will occur preferentially in materials with higher porosity and well connected coarse pores [76, 77]. This also explains why lime mortars in historic structures weather away first, as they have a higher porosity and lower mechanical strength than the brick or stone they bind so that salts will concentrate there. When these buildings were repointed using a more resistant and less porous material, such as Portland cement mortar, then the brick or the stone would deteriorate (Figure 9) leading to a damage that cannot be repaired as easily.

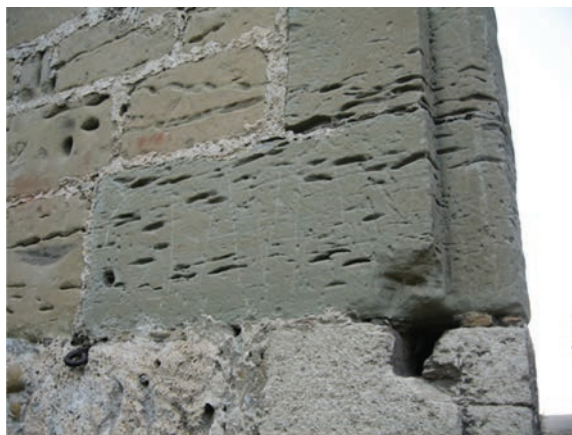
Figure 10: Molasse sandstone in the Fribourg city wall. The Burdigalien formation often contains inclusions of very fine-grained marl (a calcareous mudstone) with fine pores that tend to weather out first.

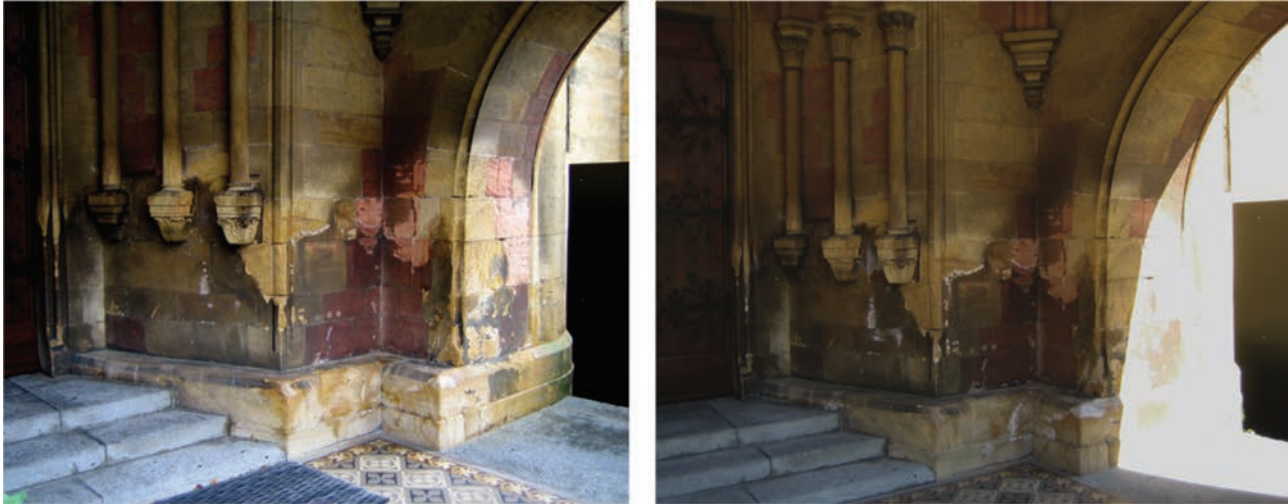
Figure 11: Western porch of the Collegiale of Neuchâtel (Switzerland). Left shows a detail of the wall on a relative humid day in October 2009; Right, the same detail on a relative dry day in April 2010. Salt efflorescence from a mixture of sodium sulfate, gypsum and sodium chloride is clearly visible on both figures. The wall on the left, at higher RH, shows damp halos around the efflorescence from the deliquescence of all salts; on the right, at lower RH, the sodium chloride deliquesces by taking up the water from the sodium sulfate decahydrate thus showing slightly less efflorescence. (Images and information by Bénédicte Rousset).

In the case of salt mixtures, the solution does not have a single DRH but rather a range of relative humidity above which it will be deliquescent. For example, at 25°C a saturated sodium sulfate solution has a 91.4% DRH, while that of a saturated sodium chloride solution is 75.3% [95:109]. However, if these salts are together in solution, the system will deliquesce between 74.5% and 80.5%, because the composition of the system will vary during this process. As has been summarily expressed by Steiger and Dannecker [96], at 74.5% RH the NaCl will deliquesce at the expense of the hydration water of mirabilite, the stable solid phase at that temperature (Figure 11).

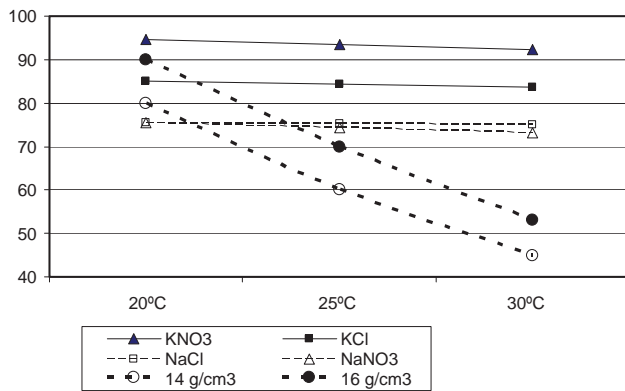
Figure 13: The graph shows the changes of equilibrium RH for NaCl, KCl, NaNO₃, KNO₃ as a function of the temperature (data from [95:154]). The changes of RH for two different absolute humidity values are also plotted showing that at least two salts will turn hygroscopic when the temperature falls to 20°C or below (data from [112]).

To clarify the mechanism, Figure 13 shows the DRH changes for the four mentioned salts, chloride and nitrate of sodium and potassium, as a function of temperature. Included in the graph are the corresponding changes of RH with temperature for two absolute humidity levels, 14 and 16 g/cm³. It can be seen that a 5°C temperature

change, from 25°C to 20°C, will make the two sodium salts (at 14g/cm³) and a third one, KCl (at 16 g/cm³) deliquesce and subsequently creep upon crystallization.
