Smithsonian
Museum Conservation Institute

MCI #6304

MICROSCOPIC CHARACTERIZATION OF THE BIOCOLONIZATION ON THE
NATIONAL MUSEUM OF THE AMERICAN INDIAN BUILDING

November 2010

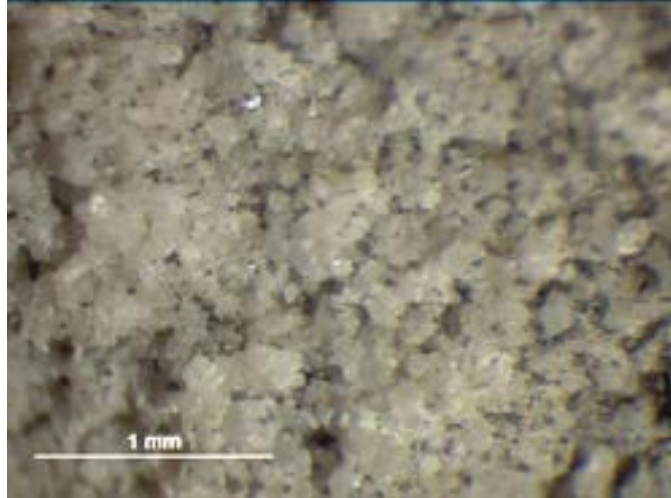
Sample #2 shows an irregular colonization of the surface, visually appearing as dark brown spots, following the boundary crystals as shown in Figure 1. The polished cross-sections show an appreciable development of photosynthetic microorganisms also within the stone, to a depth of *ca.* 1 mm (Figures 2 and 3).

**Figure 1. Photograph of sample #2 under a stereomicroscope, showing the spot-like irregular colonization. (*Subsequently published in Capitelli et al. 2012).*

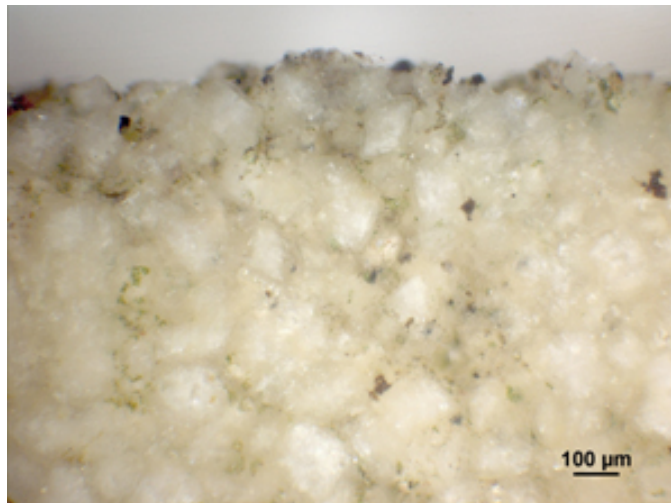
**Figure. 2. Polished cross-section of sample #2 showing the penetration of photosynthetic microorganisms into the stone. (*Subsequently published in Capitelli et al. 2012).*

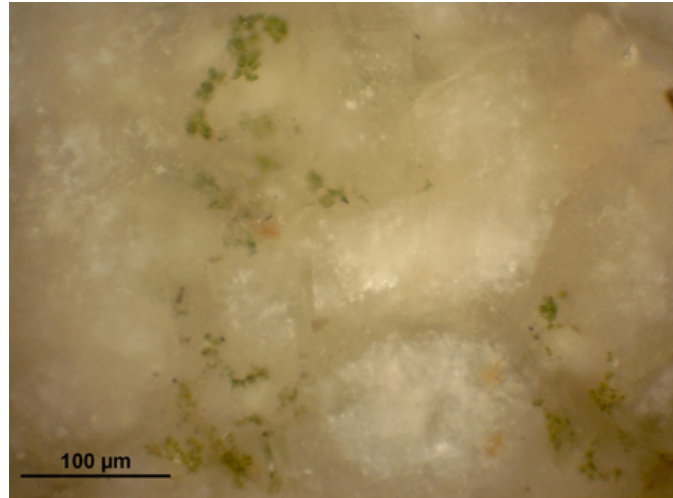
Figure 3. Higher magnification view of the inner part of the polished cross-section of sample #2 showing the green cyanobacteria colonies growing along grain boundaries.

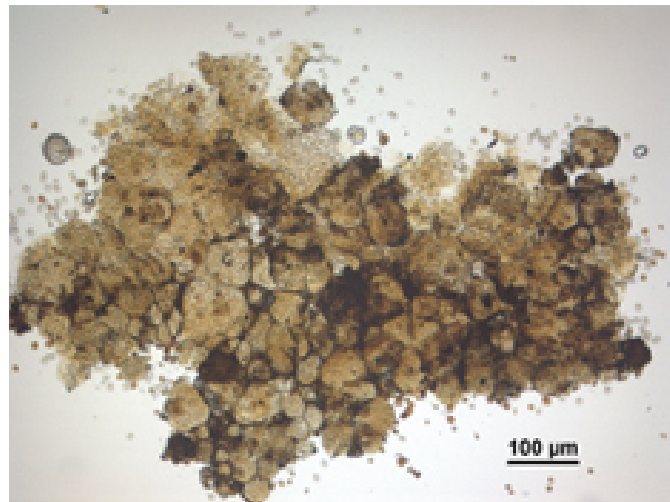
The examination of dark material scraped off the surface and suspended in water on a slide showed colonies of cyanobacteria closely joined side by side that are very difficult to separate as shown in Figure 4. The predominant colonies are *Gloeocapsa* sp. with coloured sheaths (Figure 5); few other cyanobacteria species were recognized: *Aphanocapsa* sp. and *Chroococcus lithophilous*.

Figure 4. Fresh slide of the black material growing on the surface of sample #2.

and predominance of *Gloeocapsa* sp. colonies (Figures 4 and 9). In sample #7 a filamentous cyanobacterium, *Lyngbya* sp., is dominant (Figure 19). No fungi have been detected. The different predominant species in the samples could be ascribed to different microclimatic parameters, such as water availability—that is higher for sample #7 than for sample #5—time of wetness, substrate orientation, exposure to sunlight, in the sampled areas.

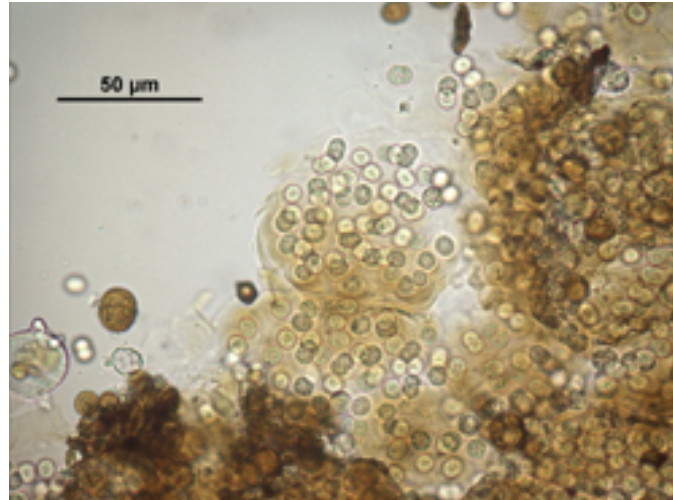
*Figure 5. Higher magnification of the previous sample, showing *Gloeocapsa sp.* colonies on the surface of sample #2. (*Subsequently published in Capitelli et al. 2012).

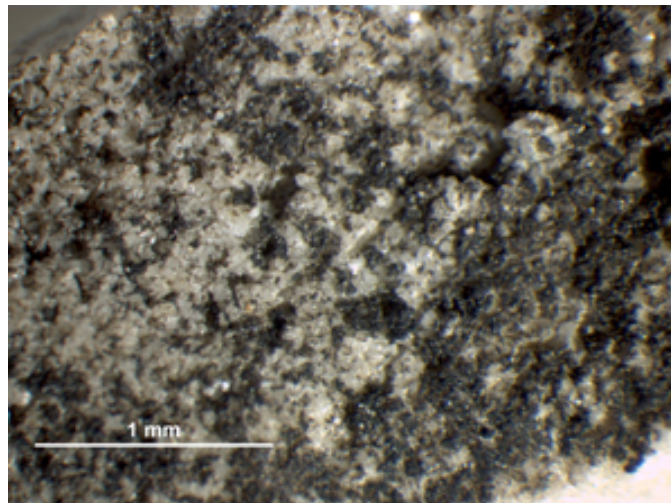
Sample #5 has a more abundant biocolonization coating than sample #2 with clusters of microorganisms closely joining together as shown in Figure 6.

*Figure 6. View of the surface of sample #5 under a stereomicroscope, showing clusters of microorganisms that start to join each other. (*Subsequently published in Capitelli et al. 2012).

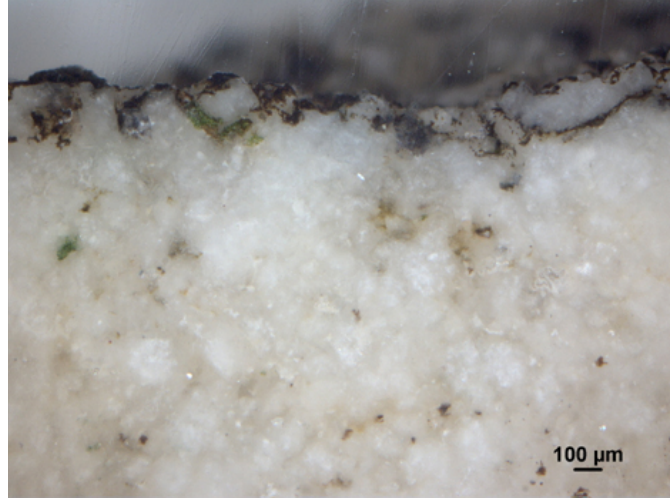
The polished cross-sections show an irregularly distributed penetration of microorganisms into the stone to a maximum depth of *ca.* 1 mm (Figure 7). The presence of endolithic growth is higher in correspondence with the more colonized areas on the stone surface (Figure 8).

*Figure 7. Polished cross-section of sample #5 showing the penetration of biocolonization down to 1mm. (*Subsequently published in Capitelli et al. 2012).

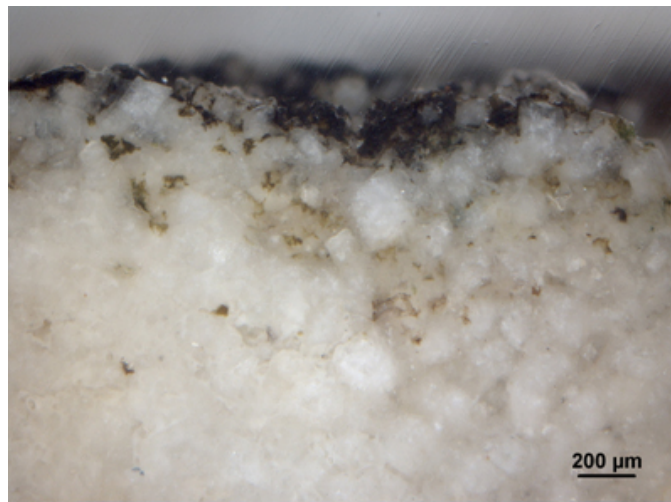
Figure 8. The same sample, at higher magnification, showing colonization developing along grain boundaries.

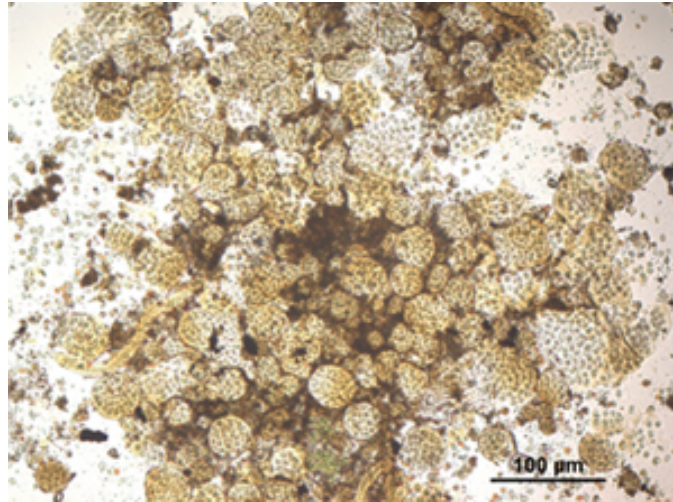
Examination of the dark material on the surface proved to be very similar to that of sample #2 as shown in Figure 9. Again, colonies of *Gloeocapsa* sp., with dark sheath, are closely joined and very difficult to separate. Few other cyanobacteria species were recognized: *Aphanocapsa* sp. and *Chroococcus* sp. (Figure 10).

Figure 9. Fresh slide of the black material scraped from the surface of sample #5.

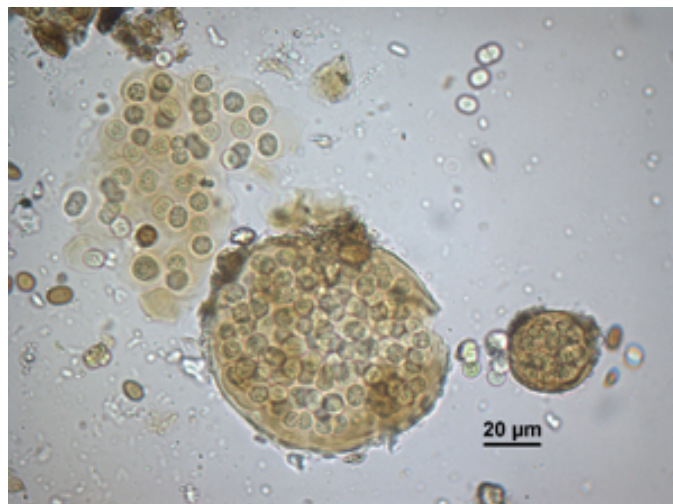
Figure 10. Higher magnification of the previous figure showing *Gloeocapsa* sp. colonies recognizable by their dark sheath.

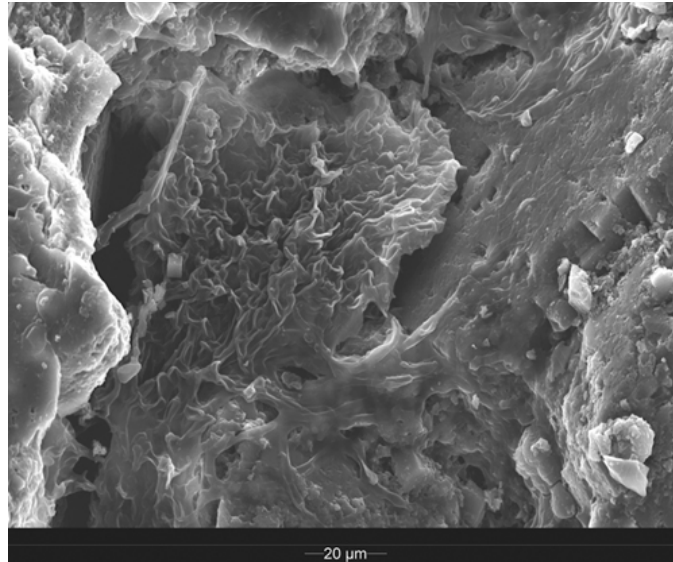
SEM observations of sample #5 showed dehydrated cyanobacteria colonies (Figure 11) and a lot of extracellular polysaccharide substances firmly attached to the stone (Figure 12). In Figure 13 a cluster of cells in a small hole in the stone can be seen.

Figure 11. SEM photomicrograph of sample #5 showing dehydrated cyanobacteria colonies on the surface of a dolomite crystal.

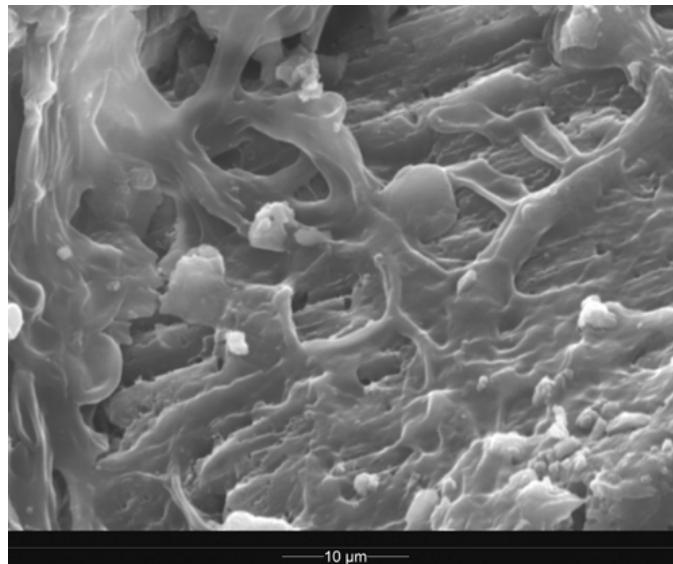
Figure 12. Higher magnification view showing significant amounts of EPS firmly adhering to the stone.

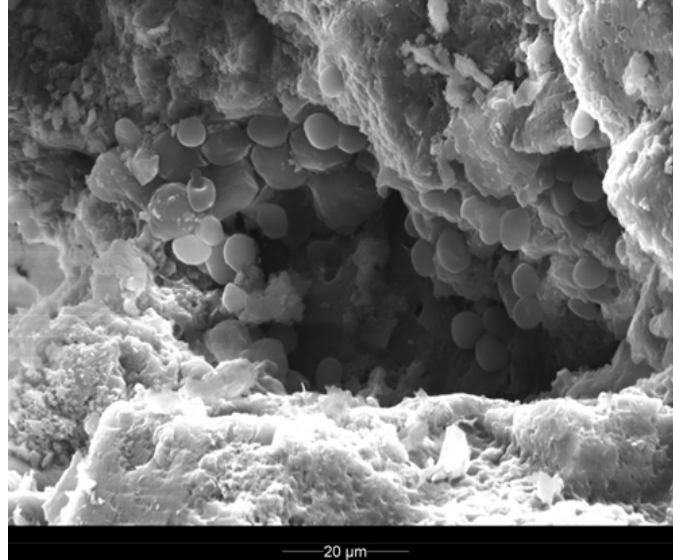
**Figure 13. SEM photomicrograph showing a cluster of cells growing within a small hole in the stone surface. (*Subsequently published in Capitelli et al. 2012).*

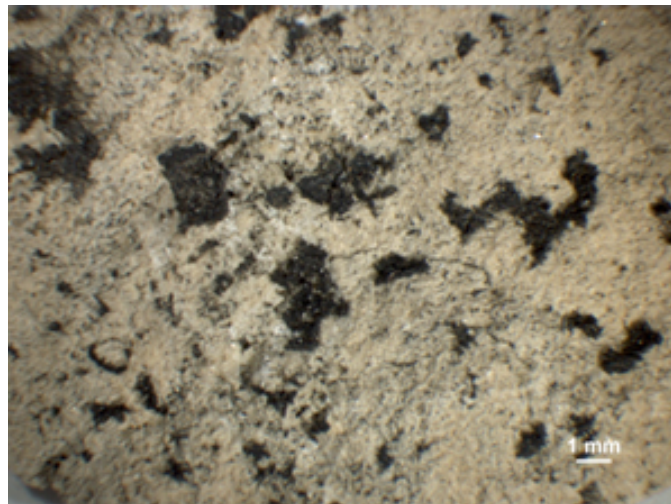
Sample #7 observed under a stereomicroscope shows the presence of black material irregularly distributed on the surface, with localized concentrations as shown in Figure 14. At higher magnification dark filamentous structures are noticeable in the less colonized areas (Figure 15).

Figure 14. Stereomicroscope view of the sample surface (#7) with localized biocolonization.

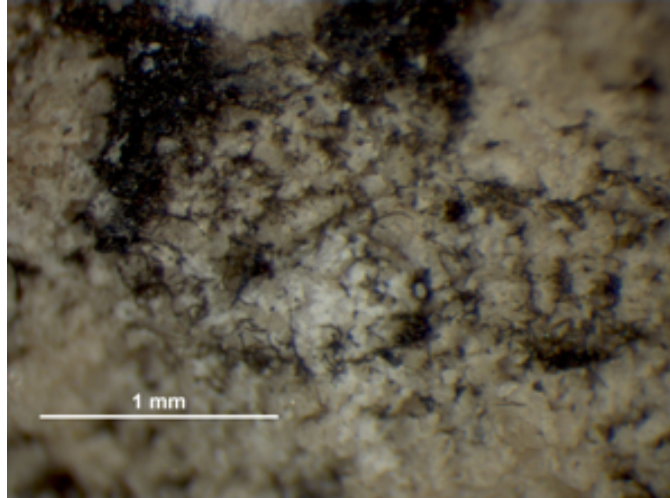
**Figure 15. A detailed view of the localized colonization from Figure 14. (*Subsequently published in Capitelli et al. 2012).*

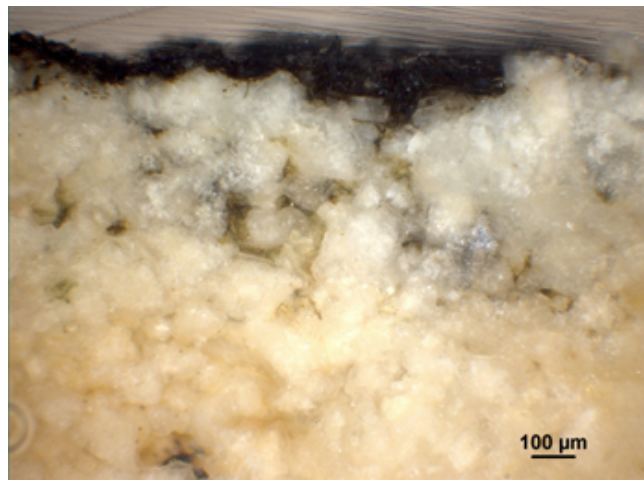
Polished cross-sections show the presence of microorganisms on the surface forming a layer reaching some 0.2 mm thickness in the clusters as shown in Figure 16. In addition they penetrate into the stone to an average depth of *ca.* 0.6 mm, although some cyanobacteria can reach a maximum depth of 1 mm (Figures 17 and 18). Greater penetration into the stone generally corresponds to the thicker surface colonization, a result of the amount and quality of insolation. The penetration seems to follow porosity and pre-existing microcracks of the stone.

Figure 16. Polished cross-section of sample #7 showing the thick layer of biocolonization on the surface. (Reprinted with permission from [4] Capitelli et al. 2012.)

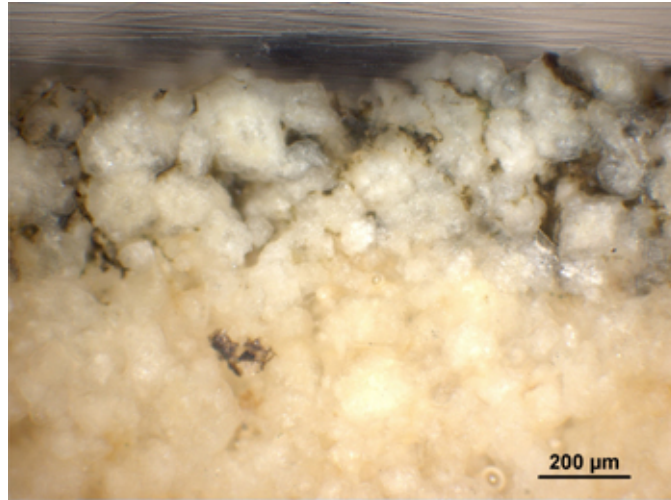
Figure 17. Detail of Figure 16 polished cross-section showing the penetration of the colonization into the stone.

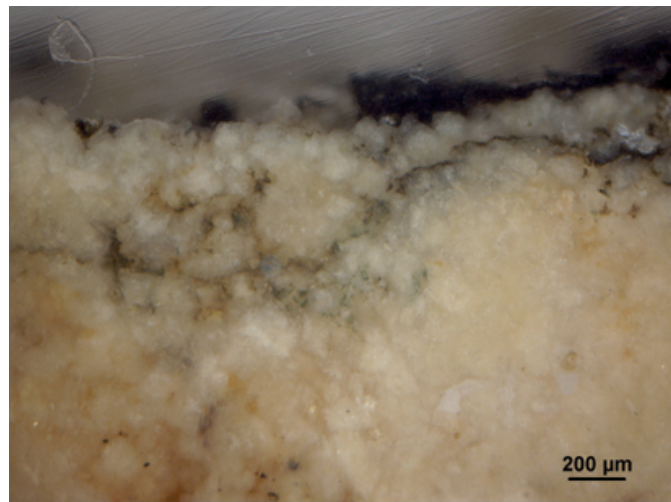
Figure 18. Another area of Figure 16 showing how the colonization grows into fissures of the stone.

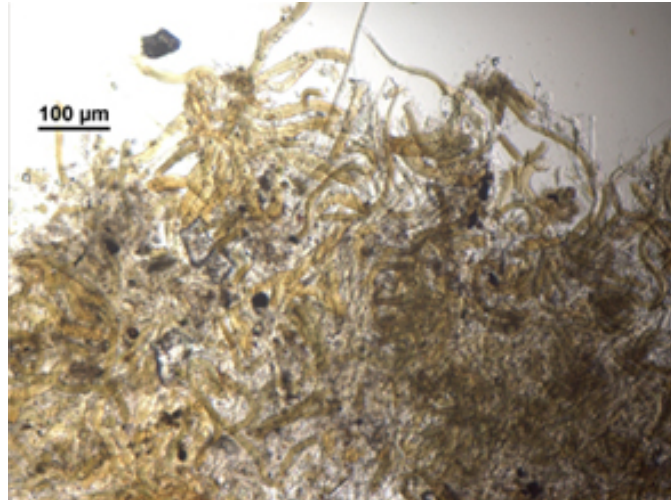
Figure 19. Fresh slide of the black material growing on the surface of sample #7 showing the prevalence of filamentous cyanobacteria.

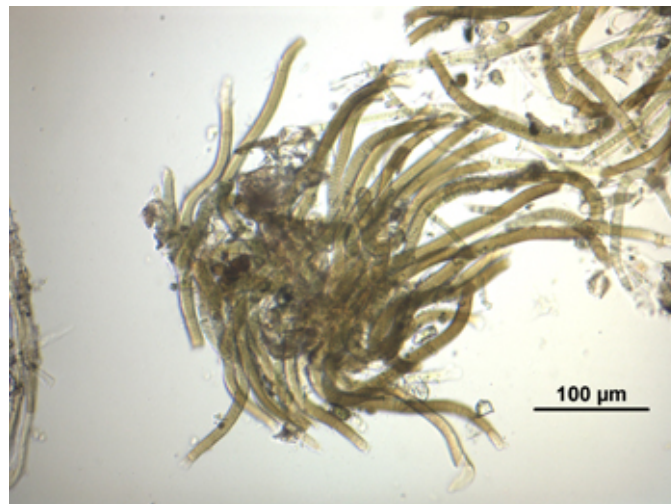
The examination of fresh slides showed a clear prevalence of a filamentous cyanobacterium with dark sheath belonging to the genus *Lyngbya* sp (Figure 20). Other cyanobacteria, such as *Calothrix* sp., *Pseudoanabaena* sp., *Aphanocapsa* sp. were only rarely observed.

**Figure 20. Higher magnification of the previous figure showing a cluster of the filamentous cyanobacteria. (*Subsequently published in Capitelli et al. 2012).*

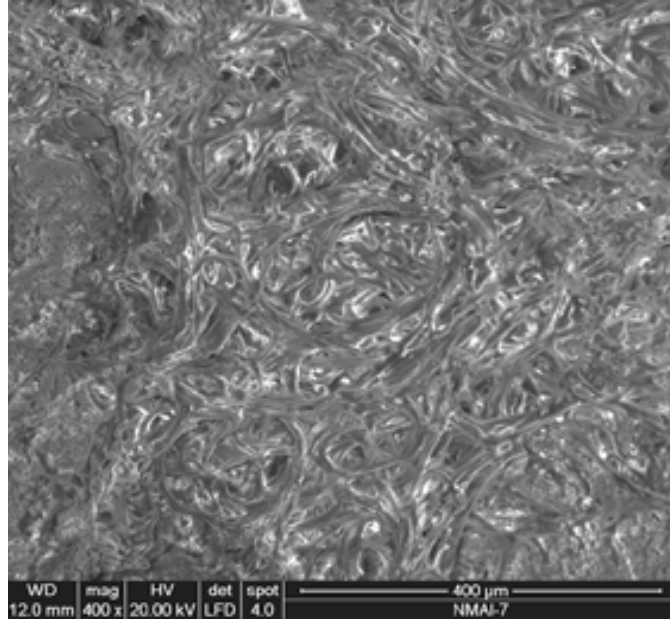
SEM observations show that the network of filaments is firmly attached to the stone (Figure 21). In some areas, particulate matter (Figure 22) and pollen adhere to the sheaths of cyanobacteria.

Figure 21. SEM photograph of sample #7 showing a cluster of filamentous cyanobacteria.

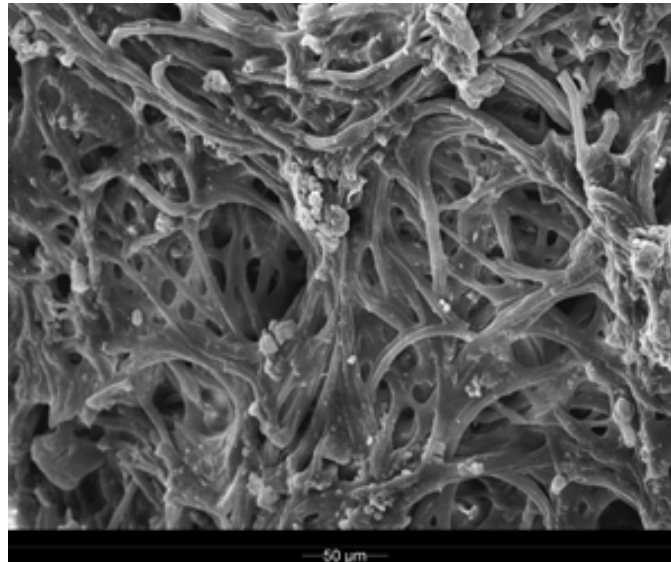
Figure 22. Higher magnification view showing filamentous cyanobacteria and particulate matter adhering on them.

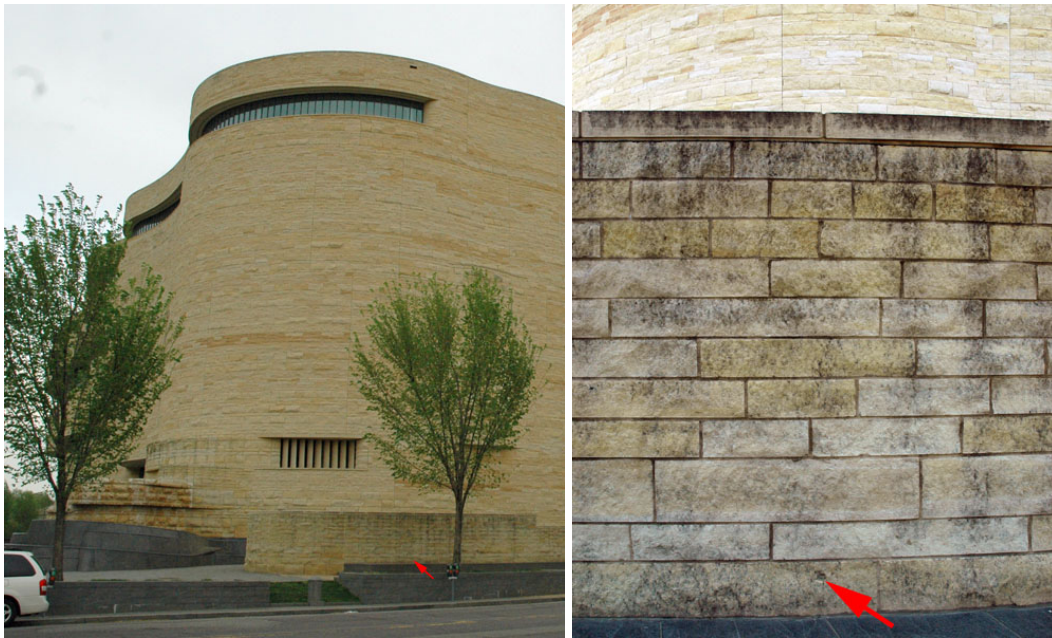
Sample #2, a fairly large spalling flake with overall black surfaces on both front and back, was readily detached from the lowest course of the loading dock wall on the west side of the building. The sample area receives rainwater from sloping capstones without any overhang; some rainwater also splashes up from the black granite ledge below (Figure 1).

Figure 1. Sample #2 location indicated by arrows: left, general view of the exterior loading dock wall; right, detail (April 2010).

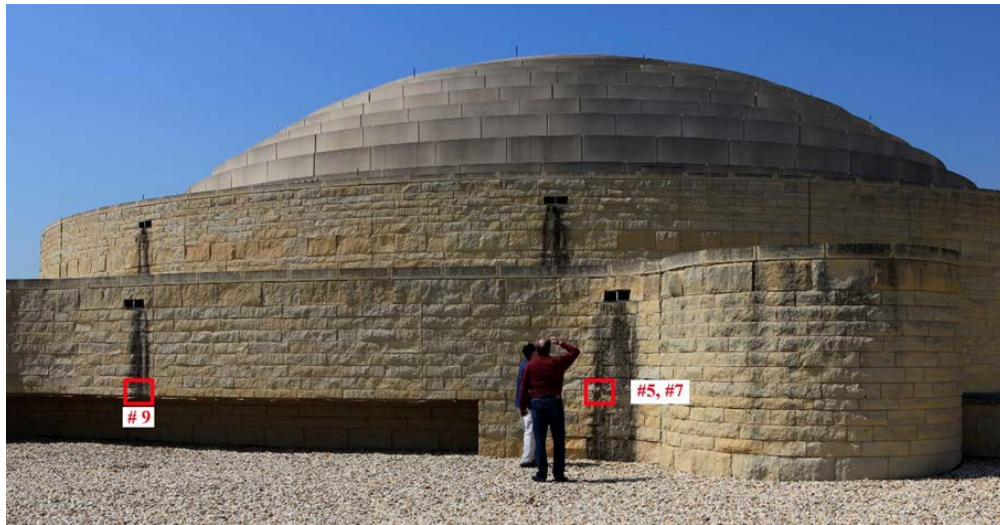
Samples #5, #7, and #9 were taken from areas of heavy biocolonization on the fifth floor terrace east wall below scuppers that drain the roofs above (Figure 2). Samples #5 and #7 were spalling flakes easily detached from below the same scupper: #5 from an area with a uniform black deposit and sample #7 from a slightly recessed area on an adjacent block with spotty surface biocolonization (Figure 3L). Sample #9 was scraped from dense black material on a membrane below a second scupper (Figure 3R).

Figure 2. Left, view of the east face of the 5th floor terrace showing locations of samples #5, #7, and #9 from darkened areas below two scuppers, which drain water from the small terrace above and, in turn, the main roof terrace with the dome (April 2010).

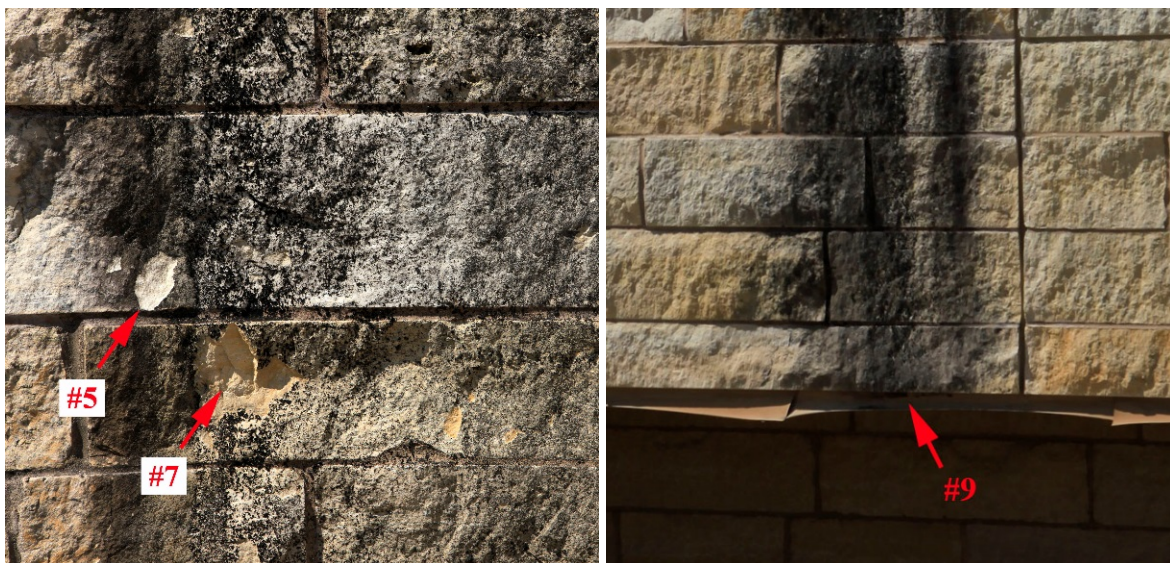
Figure 3. Details of sample locations shown in the previous figure. Left, samples #5 and #7 were flakes detached from areas indicated by the arrows. Note the uniform black colonization where sample #5 was taken, compared to the spotty area to its right where sample #7 was removed; right, sample #9 was scraped from the membrane at the bottom of the wall (April 2010).
