Smithsonian
Museum Conservation Institute

MCI #6304

EVALUATION AND TREATMENT OF MICROBIAL BIOFILMS ON THE NATIONAL
MUSEUM OF THE AMERICAN INDIAN BUILDING

November 2010

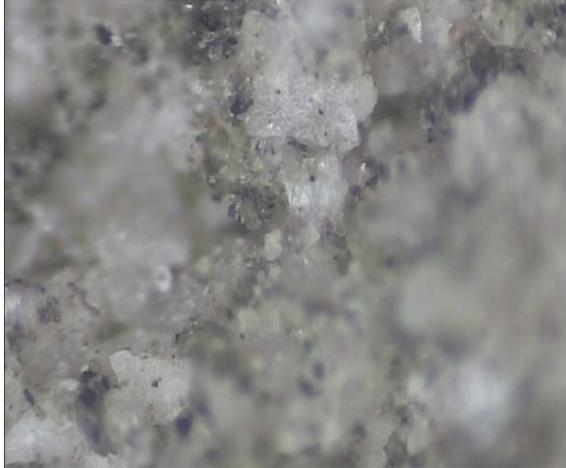
The microscopical examination clearly indicated that the microbial biofilms consist mainly of phototrophic microorganisms, especially cyanobacteria, showing greenish (Figure 1) as well as encrusted structures (Figure 2).

Figure 1. Green photosynthetic microorganisms on the stone surface of sample #2 from the low wall.

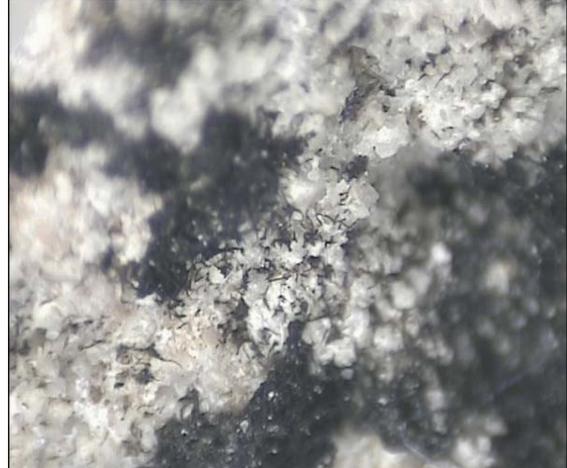
Figure 2. Encrusted cyanobacterial structures on the surface of sample # 7.

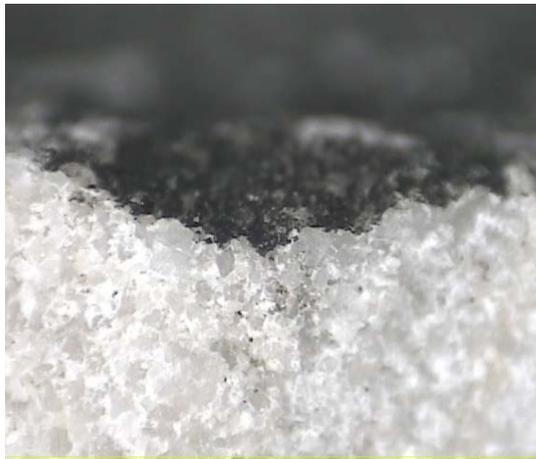
The microbial biofilms were mostly located on the surface of the stones and penetrated less than 1 mm beneath the surface (Figure 3) seldom reaching deeper (Figure 4). While sample #2 yielded a variety of microbial consortia, samples #5 and #7 were dominated by photosynthetic algae and cyanobacteria. Sample #9 consisted mainly of cyanobacteria (*Lyngbya sp.*, *Gleocapsa sp.* and others), as found on the other samples mentioned above.

Figure 3: Superficial microbial biofilm on the stone surface of sample #5.

From the above study and the observations carried out onsite, it can be concluded that the black stains on the stone surfaces of the NMAI building are mainly caused by photosynthetic cyanobacteria (primarily due to the flow of water over the stones). Since the microbial biofilm does not reach deep into the stone, its current biodeteriorating impact can be considered as low.

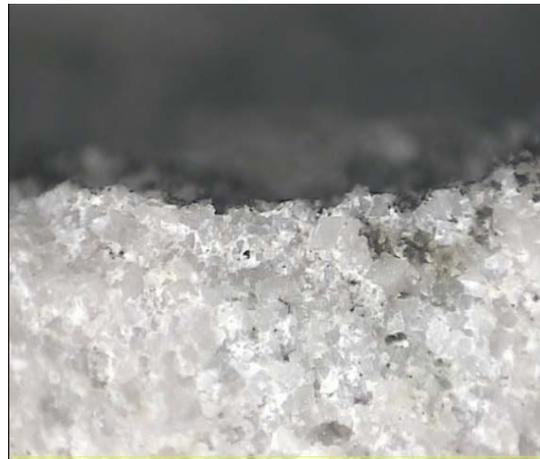
Figure 4. Detail of the previous figure showing that the microbial biofilm rarely reaches deep into the stone profile.

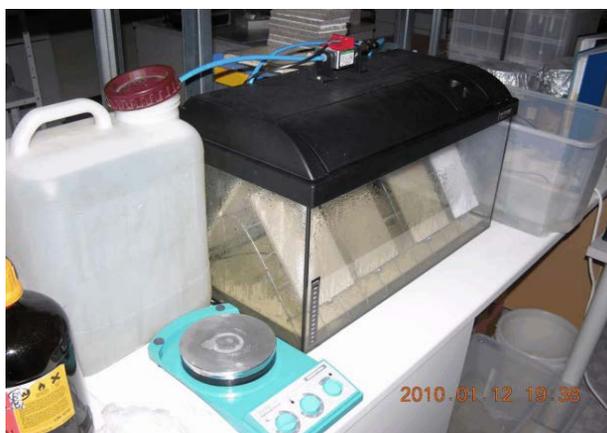
The cut specimens (5 cm x 10 cm) with typical microbial biofilms were pretreated with 70% isopropanol or a 5% stabilized hydrogen peroxide solution. After a slight desiccation the specimens were treated with different biocidal formulations, such as Keim Algicide Plus (based on a mixture of quaternary ammonium salts and isothiazolone), Schülke & Mayr Parmetol DF 12 (based on isothiazolone), and the LBW- Bioconsult's proprietary algicidal formulation called "Mélange d'Angkor" (based on copper compounds and undisclosed ingredients). The treated test panels were incubated in a moist cabinet with a 12/12 h light/dark cycle with periodic spraying and wetting (4 times per day), with different liquid algal solutions (Figure 5).

Figure 5. Principle of the dynamic CSTB-Test: (left) Inoculation solution with algae; (center) Moist incubation chamber with illuminated samples in front; (right) Collector for sprayed algal solution.

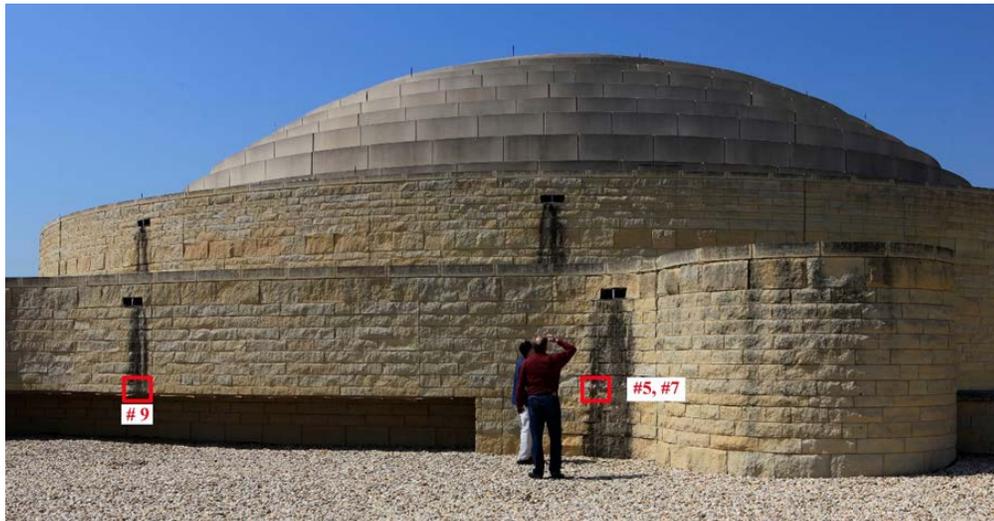
Samples #5, #7, and #9 were taken from areas of heavy biocolonization on the fifth floor terrace east wall below scuppers that drain the roofs above (Figure 2). Samples #5 and #7 were spalling flakes easily detached from below the same scupper: #5 from an area with a uniform black deposit and sample #7 from a slightly recessed area on an adjacent block with spotty surface biocolonization (Figure 3L). Sample #9 was scraped from dense black material on a membrane below a second scupper (Figure 3R).

Figure 2. Left, view of the east face of the 5th floor terrace showing locations of samples #5, #7, and #9 from darkened areas below two scuppers, which drain water from the small terrace above and, in turn, the main roof terrace with the dome (April 2010).

Before any steps are taken towards the removal of this biocolonization it should be considered whether the impact of water could be eliminated as the main reason for biocolonization is the alternation wet-dry cycling to which the stone is subjected.
