Building stones of the National Mall

This guide accompanies a walking tour of sites where masonry was employed on or near the National Mall in Washington, D.C. It begins with an overview of the geological setting of the city and development of the Mall. Each federal monument or building on the tour is briefly described, followed by information about its exterior stonework. The focus is on masonry buildings of the Smithsonian Institution, which date from 1847 with the inception of construction for the Smithsonian Castle and continue up to completion of the National Museum of the American Indian in 2004. The building stones on the tour are representative of the development of the American dimension stone industry with respect to geology, quarrying techniques, and style over more than two centuries. Details are provided for locally quarried stones used for the earliest buildings in the capital, including *Aquia Creek sandstone* (U.S. Capitol and Patent Office Building), *Seneca Red sandstone* (Smithsonian Castle), Cockeyville Marble (Washington Monument), and Piedmont bedrock (lockkeeper's house). Following improvement in the transportation system, buildings and monuments were constr

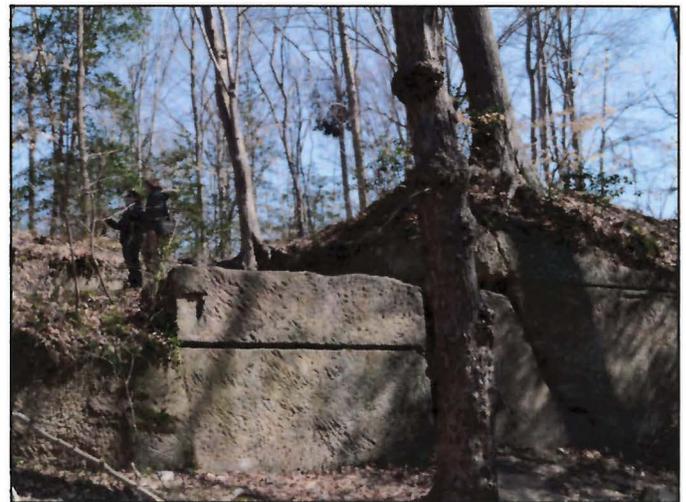
Figure 4. *Aquia Creek sandstone* quarry, Stafford, Virginia. Note channels and pecking to define the vertical surface.

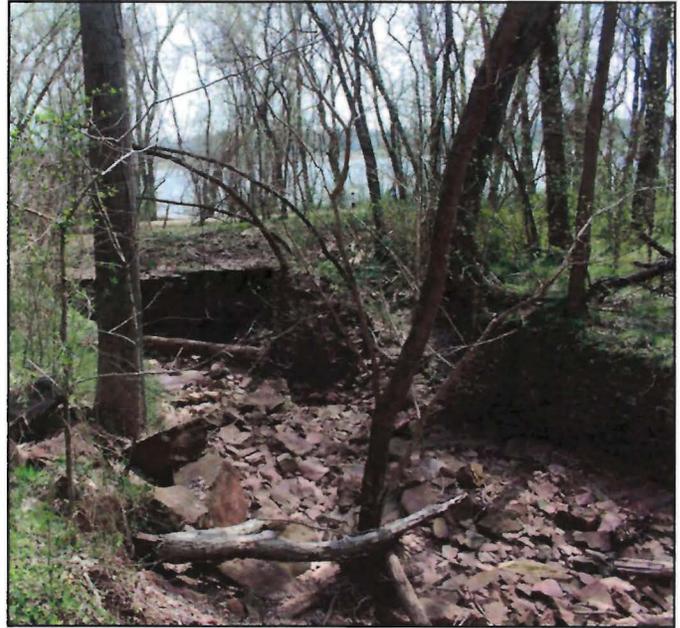
Figure 6. Waste stone fills Bull Run Creek, where *Seneca sandstone* for the Smithsonian Castle was quarried. The C&O Canal runs over the culvert in the background. Courtesy James C. Douglas.

Seneca sandstone is an arkosic, micaceous sandstone found near where Seneca and Bull Run Creeks enter the Potomac River ~40 km northwest of Washington (Fig. 6). It has been quarried since 1774, but the opening of the C&O Canal to Seneca in 1831 made possible the operation of the quarries on a large-scale commercial basis. The stone was also used to line the canal's walls and locks along several reaches in Maryland (Southworth et al., 2008, p. 23–27). The first major use in the district was for the Smithsonian Castle (stop 9). The stone was popular in the Victorian period for churches as well as homes, but fell from fashion with the end of that era. Quarrying had mostly ceased by 1900 as good-quality stone became scarce, and the quarries were completely abandoned after severe flooding in 1924 (Peck, 2013,

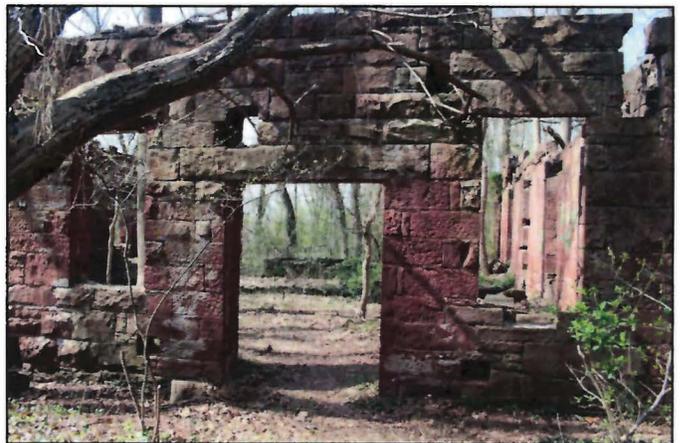
Figure 7. Cutting building, *Seneca sandstone*, Seneca Creek State Park.

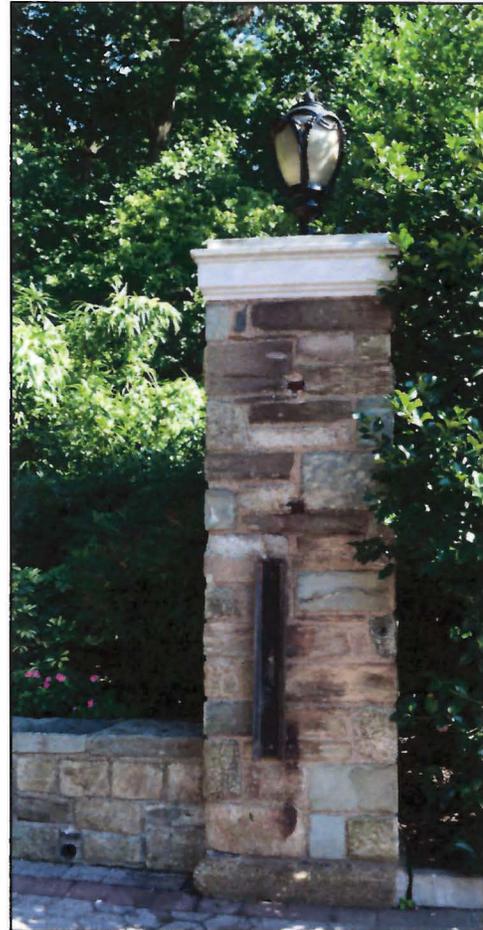
Figure 9. Gatepost (91 cm wide), entrance to the National Zoo, made of local stones.

These stones were used for many homes and private buildings, notably the oldest house in Washington—the Old Stone House (1765) on M Street in Georgetown. For public buildings, they were mainly used for foundations, such as those of the White House, Capitol (stop 14), and Washington Monument (stop 6), or as backing stone, such as in the Washington Monument (stop 6) or Smithsonian Castle (stop 9). In the early twentieth century, they were used for buildings at the National Zoo, which were meant to evoke the American wilderness in keeping with Frederick Law Olmsted’s plan for the landscape (Ewing and Ballard, 2009, p. 48). Their characteristic visual appearances can be seen on a gatepost at the National Zoo in Figures 9 and 10 and on the lockkeeper’s house (stop 6.3).

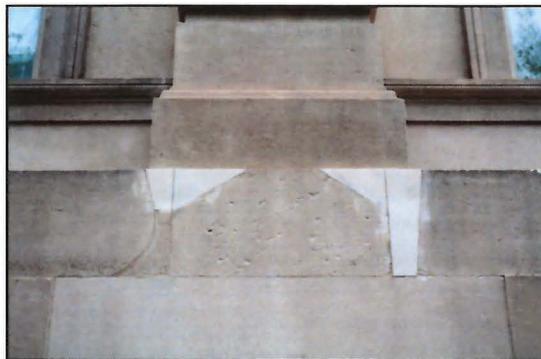
Figure 12. U.S. General Post Office/Hotel Monaco, *Westchester marble*. Corroding iron cramps between blocks below corners of the pilaster resulted in the crack at left and dutchmen (stone infill). Pockmarks in the center block (81 cm wide) are from weathering out of tremolite.

Restoration of the Hotel Monaco included cleaning of the stone and installation of stone infill known as dutchmen, mainly in the *Westchester marble* (Fig. 12). The dutchmen were inserted below pilasters where the stone was damaged by corrosion expansion of iron cramps between blocks (M.K. Oehrlein, Office of the Architect of the Capitol, 16 July 2015, personal commun.).

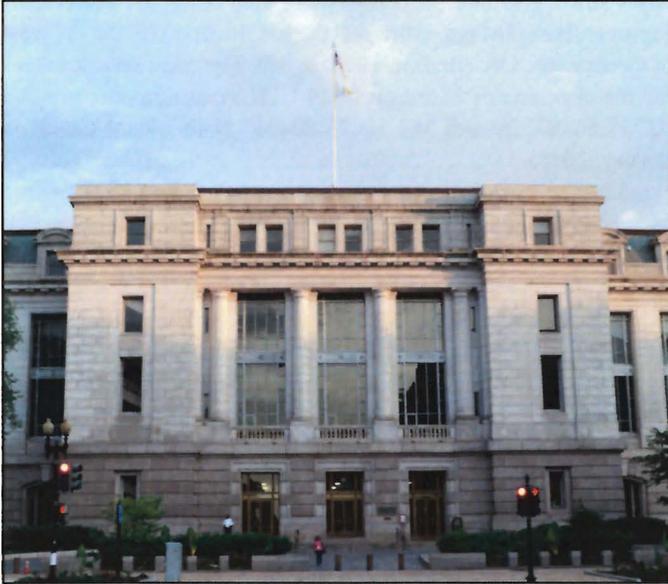
Figure 13. National Museum of Natural History. Ground floor is Milford Granite; next two floors, Bethel Granite; and top floor, Mount Airy Granite.

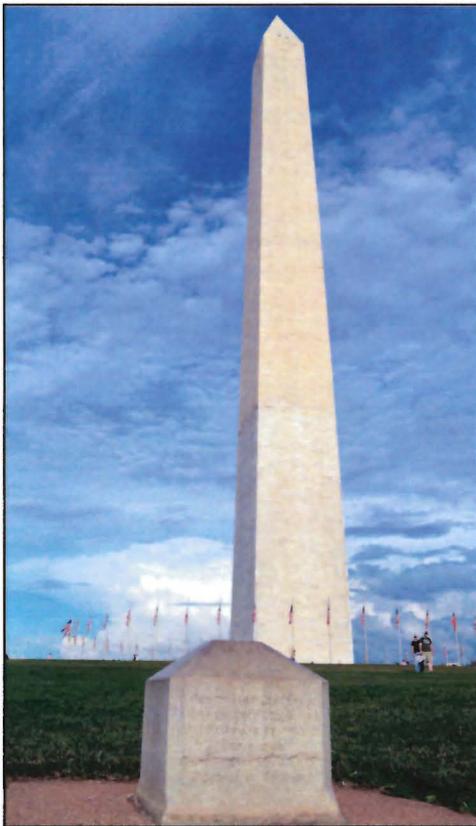
Figure 14. Washington Monument, showing *Texas marble* on the bottom third and *Cockeysville marble* on the upper two thirds. The Jefferson stone is in the foreground. Compare with the 1851 view in Figure 2.

Differential weathering also distinguishes the stone types on the Washington Monument. The *Texas marble* has suffered from disaggregation of its large grains, edges of blocks are no longer sharp, and the monument bears many patches. Yellow, red, and orange stains from lead shims used as spacers can be seen at the base (Grissom et al., 2010; Jacob, 2005, p. 12). The open joints of the dry-laid stones at the top contribute to wetness on the interior from the ingress of rainwater. The entire monument suffered damage throughout during the 2011 earthquake but the upper regions were particularly affected (Shadidi et al., 2014; Wells et al., 2015). It was completely scaffolded for repair of cracks and broken keys that secure stones in the pyramidion. While the scaffolding was still in place, the elevation of the monument was remeasured using state-of-the-art GPS methods. The architectural height was found to be 169.046 m \pm 1.0 mm (National Geodetic Survey, 2015). This is \sim 0.19 m shorter than the 169.24 m based on Casey's original estimate. The difference is mainly due to a revised definition of the datum point.

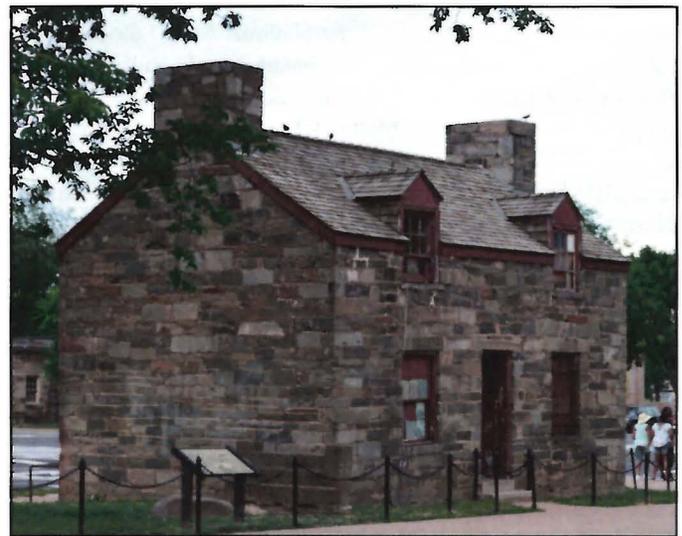
Figure 18. Lockkeeper's house, *Potomac bluestone*.

Located on the southwest corner of 17th Street and Constitution Avenue, the lockkeeper's house was built in 1835 after the eastward extension of the C&O Canal joined the Washington City Canal, where the Tiber Creek had emptied into the Potomac River (Fig. 18). The house is mainly constructed of *Potomac bluestone* (see "Local Stone Industry" section for details about the stone). It is in essentially the same location as it was originally, but it has been moved once; a second move is anticipated in the near future, so that it is further from this major intersection.

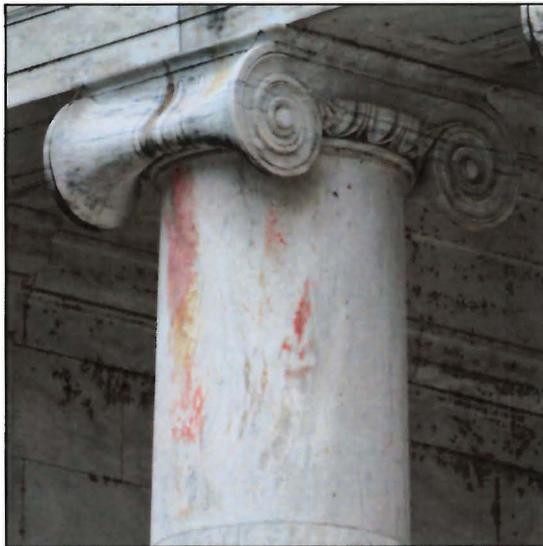
Figure 19. Detail of a Shelburne Marble ionic capital, Jefferson Memorial. Horizontal cracks visible in the volute have resulted in falling stone from some columns. Biological staining can be seen on the wall behind.

The Jefferson Memorial has had chronic problems with biological staining from spiders and midges, which are attracted to lights on the monument at night (Fig. 19). In addition, in May 1990, the lower part of a volute, the scroll-shaped part of an ionic capital, fell to the ground (McGee, 1996). A survey of other capitals found that the combination of volute geometry and bedding planes in the stone produced horizontal cracks that could lead to failure. Consequently, loose fragments were removed from eight capitals; an additional 25 volutes on 13 columns were found to pose a significant risk of failing. These broken and cracked volutes were subsequently repaired. Pink and yellow stains seen on the column in Figure 19 have the appearance of lead oxides, probably caused by lead shims (Grissom et al., 2010).

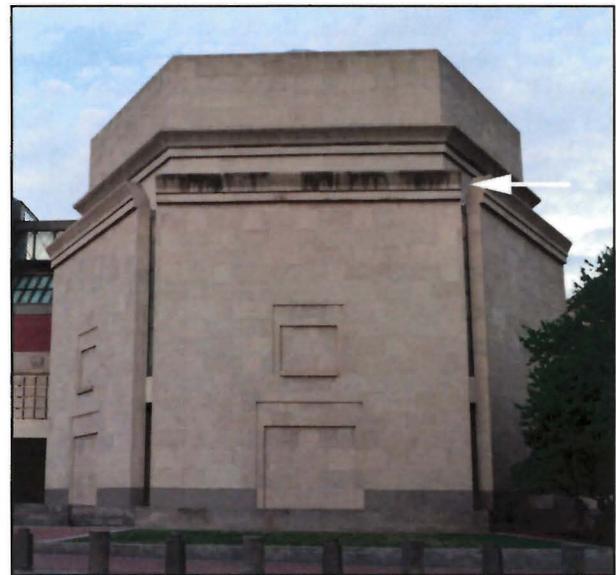
Figure 20. U.S. Holocaust Memorial Museum, Salem Limestone. Zinc strips installed in 2010 have reduced black biocolonization except in the area indicated by the arrow, where they were not installed.

with biocolonization on the limestone led to installation of zinc strips atop the stone in 2010, which inhibit biological growth (Wessel, 2011). This has been largely effective as can be seen by the staining in a few areas where the strips were not installed (Fig. 20).

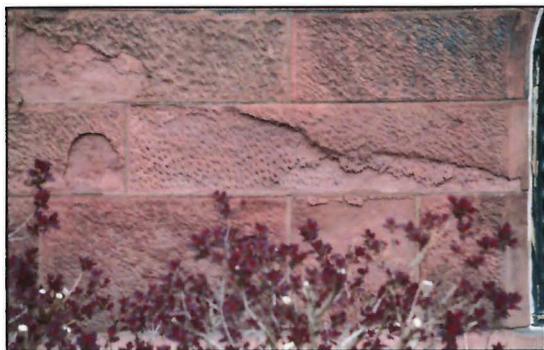
Figure 21. Detail of *Seneca sandstone*, west façade of the Smithsonian Castle. Central block (206 cm wide) shows retooled surfaces after multiple delamination.

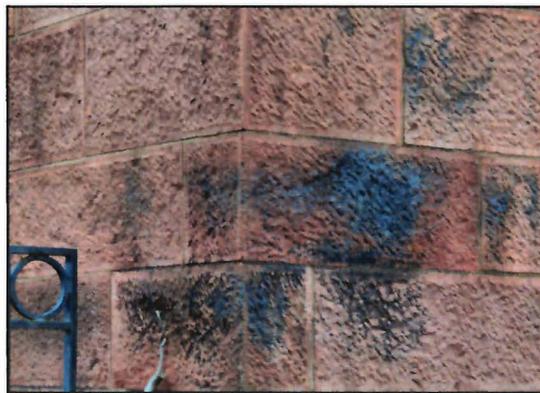
Figure 22. Dark blue–black patches on the *Seneca sandstone*, southwest corner of the Smithsonian Castle, on which X-ray fluorescence spectrometry found elevated manganese. The block with the darkest patch measures 71 cm in width.

Recently, another type of weathering has been identified on the Castle sandstone. This consists of blue-black iridescent patches growing on the stone surface (Fig. 22). Nondestructive testing with portable X-ray fluorescence spectroscopy has shown that these patches are enriched in manganese (Grissom et al., 2014; Livingston et al., 2014). They appear to be similar to desert varnish, which is produced by microbial activity. Further research is under way to develop a better understanding of the basic mechanisms of this process and its rate of growth.

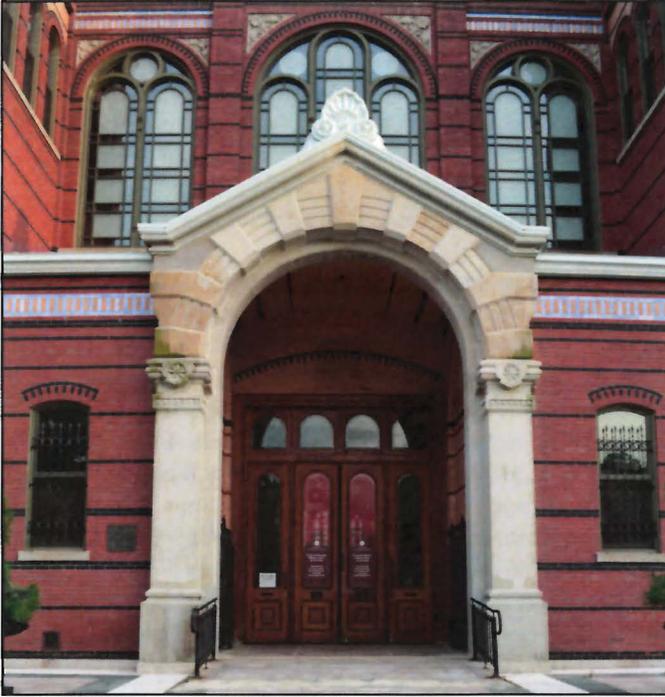
Figure 23. North entrance to the Arts and Industries Building, *Euclid bluestone*. Iron staining on the archway is typical of the stone. Bases for the shafts were replaced with Buena Vista Sandstone around 2009.

Weathering has caused spalling and disaggregation of the *Euclid bluestone*, especially of the lowest stones of the

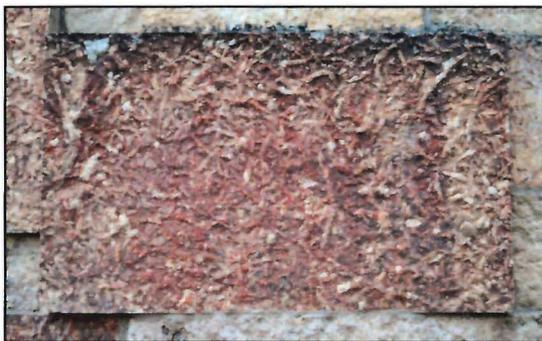
Figure 25. Trace fossils on a “roughback” block of *Kasota stone* (157 cm wide), National Museum of the American Indian.

“Roughback” stones, also known as fleuri or quarry creek, are the highly colored blocks located at ground level on some areas of the building (Fig. 25). These face-bedded blocks were split parallel to the bedding planes to show the bedding surfaces, which are colored by iron and manganese deposits in rusty hues ranging from yellow to red to dark-brown and purple. Many trace fossils are also exposed, as seen in Figure 25. They can be

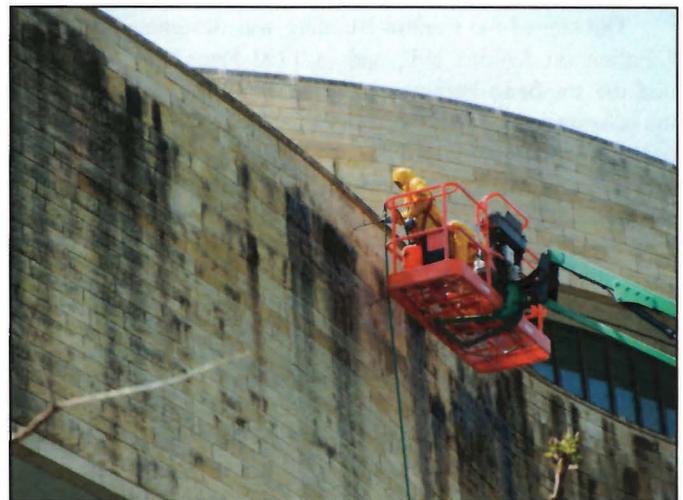
Figure 26. Cleaning biocolonization with a biocide from the *Kasota stone* on the National Museum of the American Indian in April 2011.

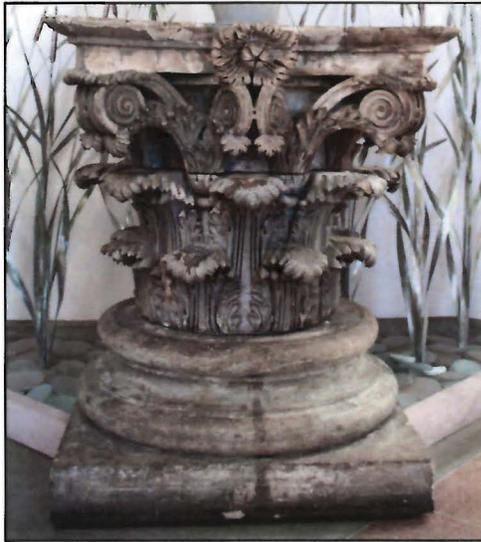
Figure 28. Original *Aquia Creek* sandstone column capital from the U.S. Capitol, on view at the U.S. Botanic Garden.

The U.S. Botanic Garden, established in 1820, formerly occupied the spot at the foot of Capitol Hill now occupied by the Grant Memorial. That building was demolished to provide a clear vista along the Mall's central swath in accordance with the McMillan Plan. The present building (1933), designed by Bennett, Parsons and Frost, was constructed to the south with Salem Limestone. In the northwest room of the building, an original *Aquia Creek sandstone* capital from the west façade of the Capitol is on display (Fig. 28).

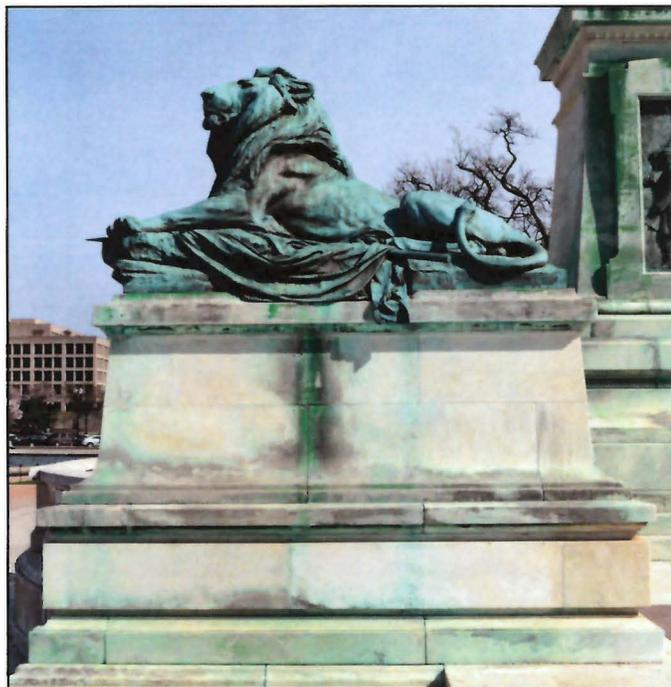
Figure 30. Copper runoff from the Grant Memorial's bronze *Lion* has left disfiguring green and purple stains on the *Vermont marble* base.

Roman Bronze Works: the equestrian statue of *Grant*, four *Lions*, and large groups representing *Artillery* and *Cavalry*. The *Imperial Vermont marble* variety of Shelburne Marble was used for pedestals of the bronze statues (see Stop 8 section for details about the stone). The marble bases were severely stained green and purple by copper runoff from the bronze statues (Fig. 30). A calcite grain from the base shows black (probably tenorite) and green (brochantite) coatings from the copper on its surface at high magnification (Fig. 31).

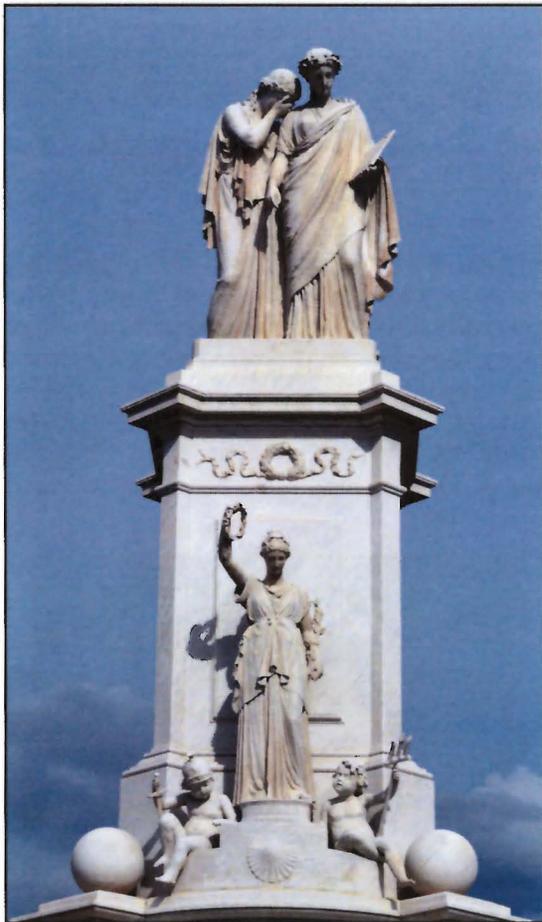
Figure 32. Peace Monument, Carrara Marble, after restoration in 2015.

The Peace Monument (1877), located at the east end of the National Mall to the north of the Grant Memorial, was originally known as the Navy Monument (Goode, 2008). Franklin Simmons (1839–1913) carved it in Carrara Marble in Rome after a rough sketch by Admiral David D. Porter. At the top of the 12-m-high memorial are allegorical figures representing *America* weeping on the shoulder of *History* over the loss of naval defenders during the Civil War. Small boys representing *Neptune* and *Mars* are seated below a figure of *Victory* (Fig. 32).

(maximum crystals 1.5–2 mm), ranging in color from creamy to snow-white (Meccheri et al., 2007). The monument has been repaired many times on account of losses sustained by climbers and severe weathering of the marble (Figs. 32 and 33). In the past 25 years, many extremities have been replaced, and the stone has been strengthened using an ethyl silicate solution with water repellent (Wolanin, 2003).

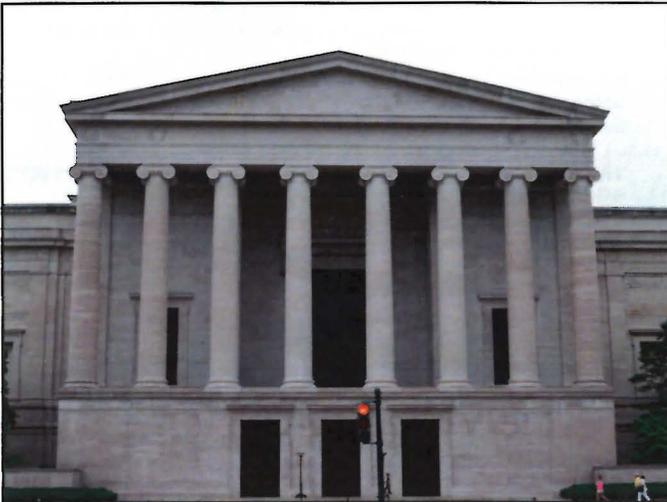
Figure 34. National Gallery of Art West Building, *Tennessee marble*. Note stronger banding on outermost columns.

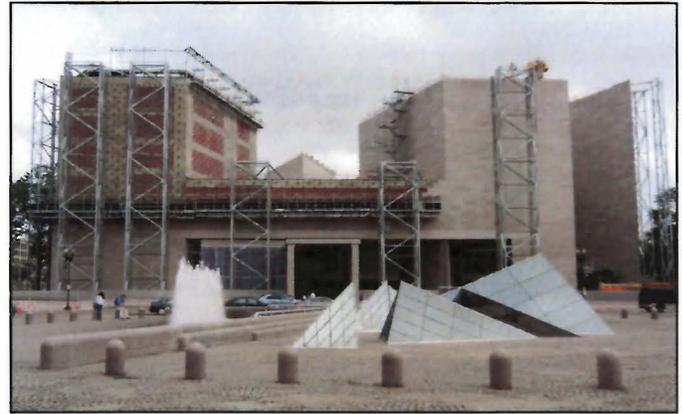
Figure 35. National Gallery of Art East Building during removal of 10-cm-thick blocks of *Tennessee marble* in 2012, subsequently replaced using new anchors.
