# INVESTIGATION OF URBAN ROCK VARNISH ON THE SANDSTONE OF THE SMITHSONIAN CASTLE

## Abstract

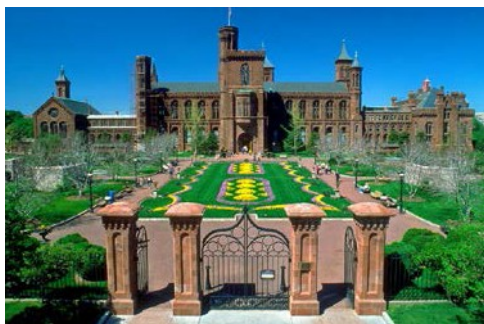
*Figure 1: South facade of the Smithsonian Castle and Enid A. Haupt Garden with the Gateposts in the foreground.*

The Smithsonian Castle on the National Mall in Washington, DC, designed by James Renwick, Jr., was built in 1847-55. Figure 1 shows its distinctive Neo-Romanesque architecture constructed with dark red Seneca sandstone quarried in nearby Maryland (Livingston *et al.*, 2015). Gateposts made out of the sandstone according to Renwick's design were added in 1987 to enclose the Enid A. Haupt Garden.

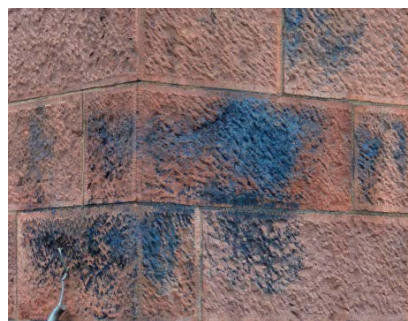
*Figure 2: Patches of rock varnish on the southwest corner of the Smithsonian Castle.*

Recently, visual inspection of the exterior of both the Castle and Gateposts identified patches of very thin adherent layers of bluish black material on the sandstone (see Fig. 2). Its distinctive appearance resembles desert varnish, which is thought to be associated with microbial action (Broecker and Liu, 2001). Nondestructive measurement of the set of patches in Figure 2 using portable X-ray fluorescence (pXRF) showed a high enrichment in manganese (Mn) (Livingston *et al.*, 2014a), which is also a sign of rock varnish. This has led to further research using an array of analytical techniques to characterize the varnish, the sandstone and the environment around the Castle (Table 1).

for a swabbed patch on the southwest corner of the Castle shown in Figure 2. The colony has been identified as a fungus. The closest relative in the Genbank DNA database is *Leotiomycetes sp.* (accession #JQ761063.1). The identification as a fungus is consistent with SEM imaging of the varnish from the gatepost, which shows hyphae that are characteristic of fungal growth (Fig. 9).which shows hyphae that are characteristic of fungal growth (Fig. 9).

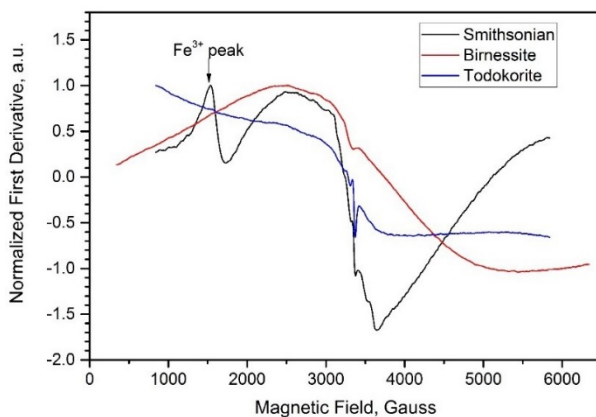
Figure 3: Comparison of the Smithsonian varnish EPR spectrum to Mn oxide mineral standards.

X-ray diffraction (XRD) of the varnish did not yield a usable diffractogram because of poor crystallinity or limited sensitivity given the sample thickness. An electron para-magnetic resonance (EPR) spectrum was obtained from a gatepost sample to constrain the chemical state of the Mn. This was compared to a set of standards of candidate Mn-bearing minerals including pyrolusite, manganite, lithiophorite, manganosite, birnessite and todorokite. Figure 3 presents a plot of the first derivative of absorption versus magnetic field strength for the Smithsonian sample compared to spectra of the most likely Mn minerals, birnessite and todorokite.

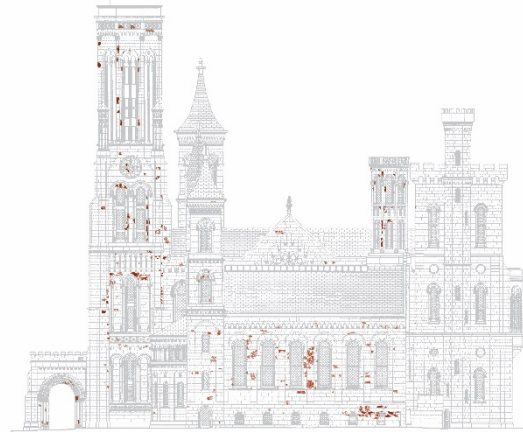
*Figure 10: West elevation of the Castle modified from the Smithsonian's 2002 Master Plan Survey. Varnish patches are highlighted in red.*

In order to better understand the environmental factors influencing the development of the patches, their distribution was mapped by taking a comprehensive series of digital photographic images covering the entire building. Each identified patch was then manually mapped onto digital scale drawings of the elevations of the Castle using Adobe Photoshop, as illustrated in Figure 10. The area of each patch will be quantified, and the resulting data set will be used to investigate possible correlations with solar heating, prevailing wind direction, exposure to vehicular traffic, etc.
