An Unsatisfactory Case of Water Repellents Applied to Control Biocolonization

A.E. Charola¹, J. Delgado Rodrigues² and M. Vale Anjos²

As a result of a multi-year conservation/restoration program for the gardens of the National Palace of Queluz in Portugal, the opportunity to evaluate the long-term performance of conservation interventions on the marble statues that decorate these Baroque gardens was presented.

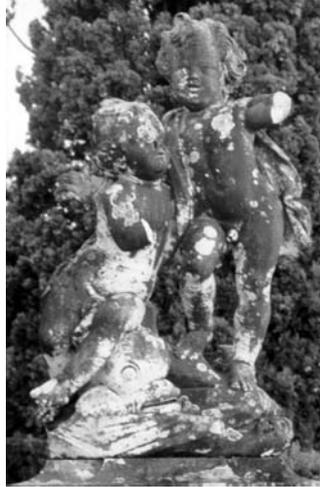
Figure 1: Appearance of a Putti group before the intervention in 1996/7. Note the dark soiling resulting from biocolonization. This same group is shown in Figure 3 some years after cleaning.

Among the first actions undertaken in this project was the creation of a data base of all the stone elements in the garden and to collect as much information about any previous interventions they might have undergone [2]. No records of interventions prior to 1977 exist, which does not necessarily mean that no actions were carried out previously. After 1977, conservation interventions were implemented based on the perceived need. That is, the most soiled statues, or those which had suffered some damage, i.e., from a branch falling on them, were subjected to a conservation or restoration intervention (see Figure 1). As is usual, not all

The bi-faced busts shown in Figure 4, four years after the 1999 intervention, had suffered a previous cleaning in 1995. However, at the time, no water repellent was applied. The resulting soiling from biocolonization, please refer to Figure 1 for comparison, was heavy enough to warrant the 1999 cleaning where the aqueous emulsion was applied. Their appearance four years later show that only one of them could be considered as requiring another intervention.

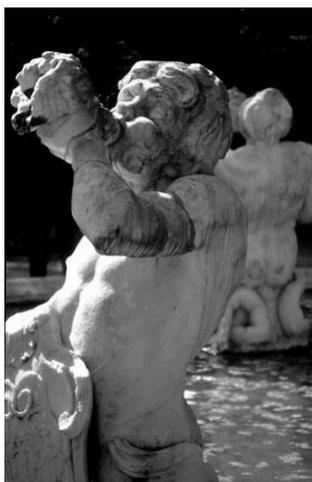
During the documentation phase of the stone statuary subproject, it was observed that some sculptures, which were known to have received a water repellent treatment showed a particular kind of streaking resulting from uneven biocolonization, as shown in Figure 2. This was clearly evident some four years after the intervention at the time the statues were photographed.

The appearance of this unsightly streaking was attributed to the water repellents used since statues that had not been treated with a water repellent showed a more uniform biocolonization.

Figure 2: Particularly noticeable is the streaking under the arm of the Triton resulting from uneven biocolonization. The marble statues are in a fountain that had been cleaned and treated with a water repellent four years previous to the photograph date.

Thus began a thorough examination of those statues that did present this evident streaking and those that did not show it. It was found that apart from the statues in the above mentioned fountain, restored and cleaned in 1998/9, four other figure pairs, cleaned in 1996/7, also showed this occurrence. All of these had been treated by the same conservation firm, using the same water repellent.

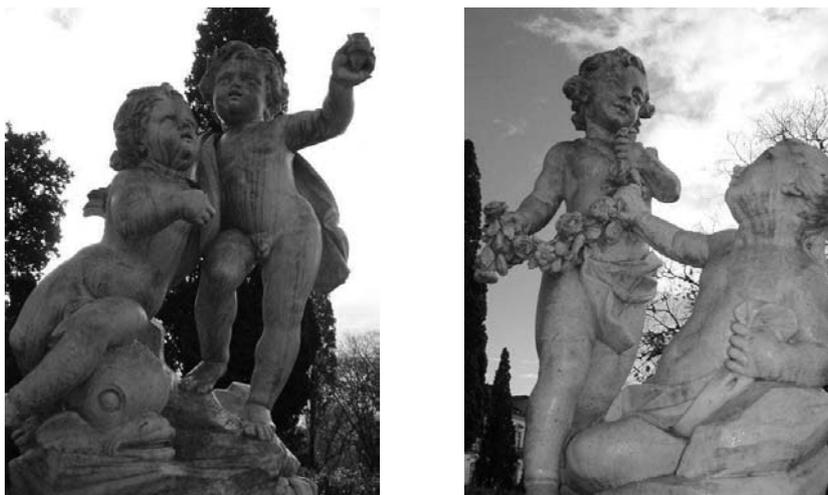
Figure 3: Note the difference in streaking from the putti pair on the left treated in 1996/7 and that on the right, treated by a different conservation firm in 1997. Photographs taken in January 2003. Note the difference in biocolonization distribution, streaked on the left and less streaked though more intense in some areas on the group right.

As mentioned above, the two putti groups (Figure 3) are located close to each other, have similar environmental exposure, were cleaned at practically the same time and the same water repellent was applied by brushing. Nevertheless, a different re-colonization pattern developed, suggesting, by the fact that the second group had heavier colonization on the most exposed areas as occurs normally on untreated objects, that these had received a lower amount of water repellent. This would suggest that the streaking pattern is enhanced when more water repellent is applied.

Interestingly, the four figure pairs belonged to a group of six pairs which decorate a balustrade that limits the formal Malta garden by the palace. The record compilation showed that the other two pairs had been treated by a different conservation firm, using the same water repellent, at about the same time (1997). Curiously, these two pairs showed the streaking effect to a far lower degree, as shown in Figure 3. However, the more exposed areas were far darker from heavier biocolonization.

The data obtained so far suggest that the application of a water-repellent reduces the overall rate of biocolonization. For example, the two putti groups shown in Figure 3 are located in similar exposures and both were cleaned at practically the same time and the same water repellent was applied. However, the one from the second group apparently had less water repellent applied to it and consequently the streaking effect was minimal yet the group showed localized heavier biocolonization supporting the hypothesis that less water repellent was applied to it.

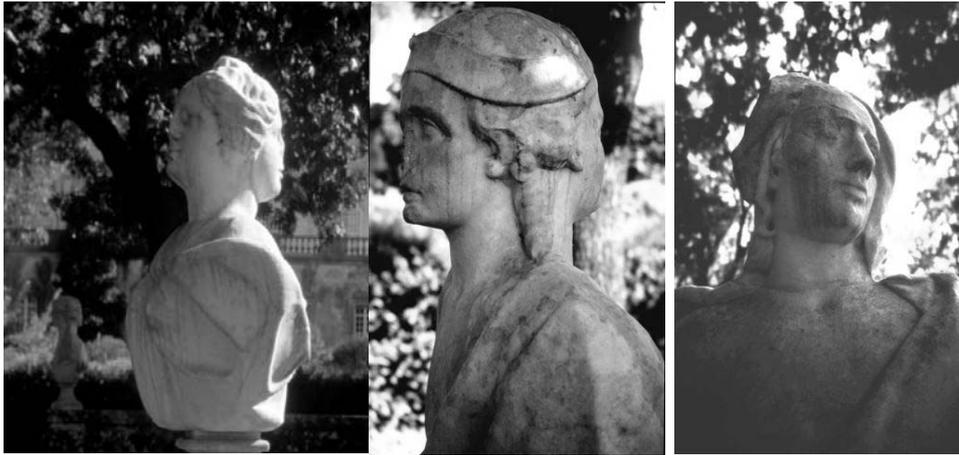
Comparison with the statues treated with an aqueous emulsion showed that these barely had any streaking although, because of their location in a shady area, re-colonization was far more advanced, as shown in Figure 4. The three busts shown belong to a set of four that adorn a balustrade around a fountain located under two trees which shade them to a greater or lesser degree most of the year. These had been treated by the second firm, thus confirming the pattern observed with the putti.

Figure 4: Three bi-face busts to which an aqueous emulsion of an oligomeric siloxane was applied after cleaning in 1999. Photos taken in 2003. Note the difference in biocolonization depending on the location of the busts. From left to right, increasing shade.

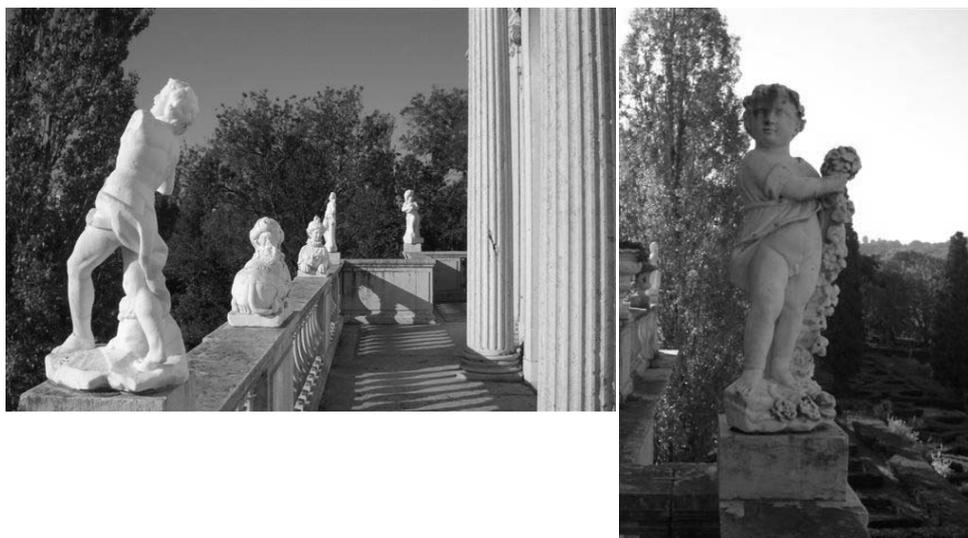
To emphasize the importance of shade in the rate of biocolonization, Figure 5 shows one statue of another set located on a balustrade of a terrace at the Palace with no shade whatsoever. These were similarly treated as the bi-faced busts with an aqueous emulsion of the water repellent applied in 1999. Eight years after the treatment, only minor biocolonization is visible.

Figure 5: Statues on the terrace balustrade treated with an aqueous emulsion of an oligomeric siloxane after cleaning in 1999. On the left, one of these statues shows development of bio-colonization on the more exposed head. Photos 2007.
