PHYSICO-CHEMICAL EXAMINATION OF AGED BRICKS AND "COTTO" TO STUDY THE MECHANISM OF ALTERATION

A.E. Charolà*, R. Koestler*, P. Rossi-Doria**, M. Tabasso***

Bricks and terracotta cornices from Church of S. Cristoforo in the Certosa of Ferrara, Italy, were studied.

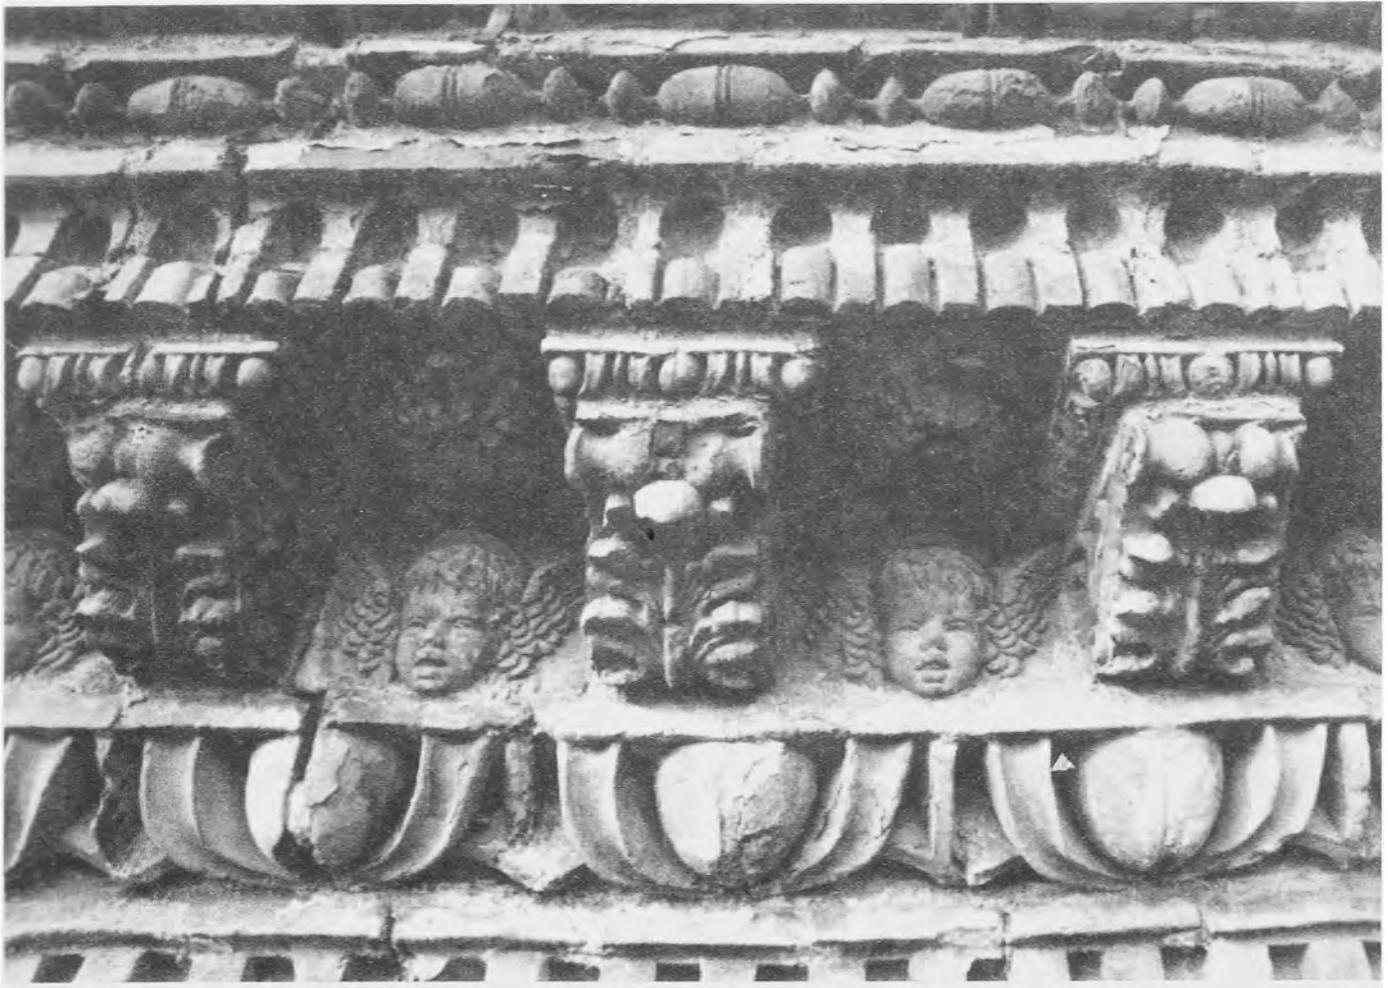
Photo n.1 - Ferrara - Church of S. Cristoforo in the Certosa.
Detail of deteriorated "cotto" cornice.
(Photo by Arch. Cesari, Comune di Ferrara)

The foundation stone was laid in 1452 (Gruyer, 1897); the church has a huge front, lined with symmetrical constructions ending in two cloisters; very elegant terracottas decorate the whole of the buildings. These terracottas are very often in a bad state of conservation (photo n.1) as well as the most of other "cotto" decorations and bricks, so extensively used in the town of Ferrara.

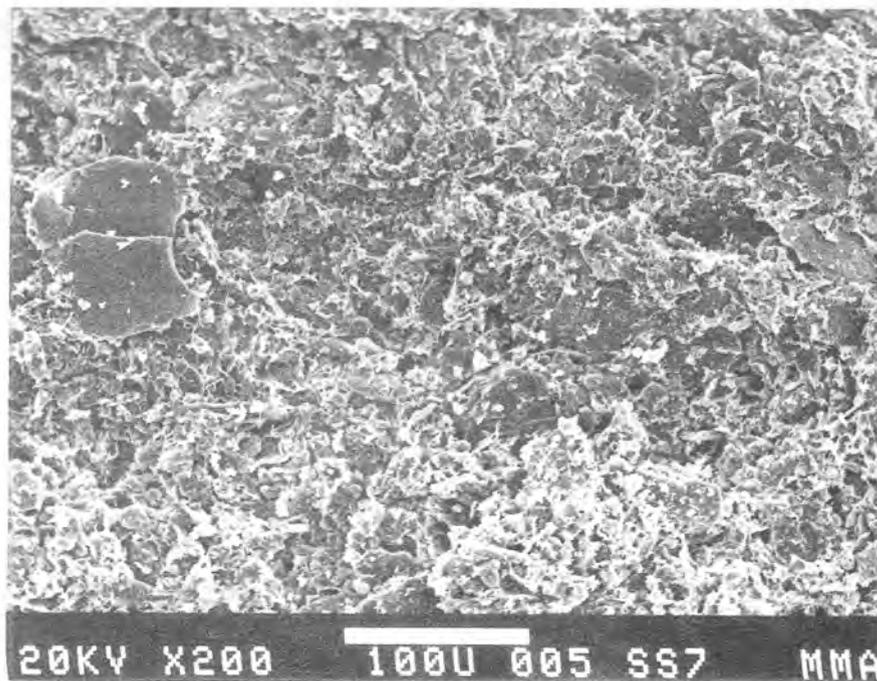
Figure 1A. Sample n.2 - Fracture surface of undecayed specimen of cotto from the cornice.

The samples were examined in fracture surface and from this study evidence can be found for the type of decay that has occurred in the deteriorated specimen. Figures 1A and B exemplify the difference between an undeteriorated specimen (n.2) and a deteriorated one (n.4). What can be observed from these micrographs is that there is a breaking up of the matrix of the "cotto" with consequent flaking and breaking loose of the smaller mineral grains held together by the matrix. How this occurred can be seen from the next series of micrographs.

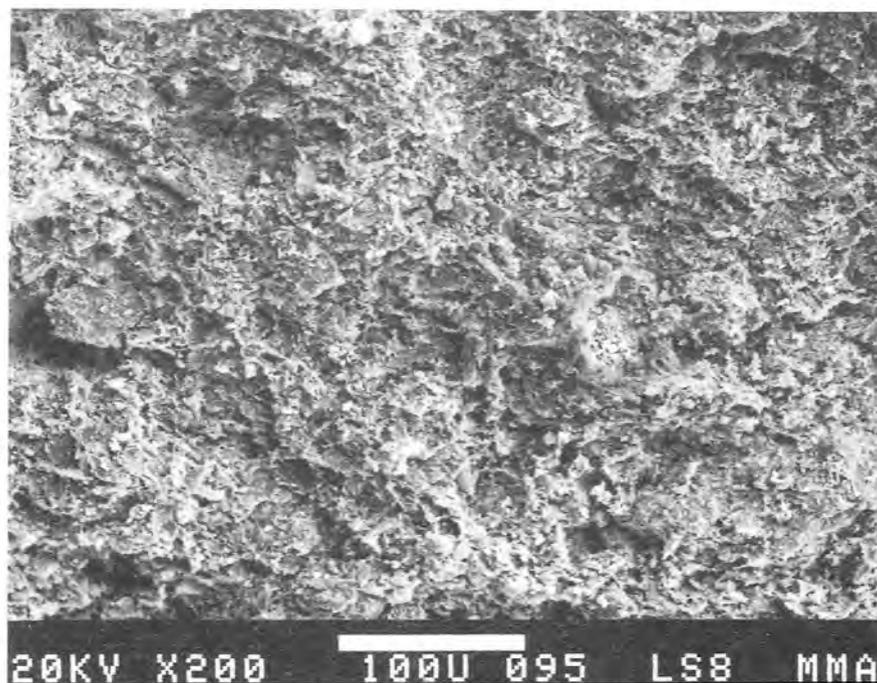
Figure 1B. Sample n.4 - Fracture surface of decayed cotto from the foundation.

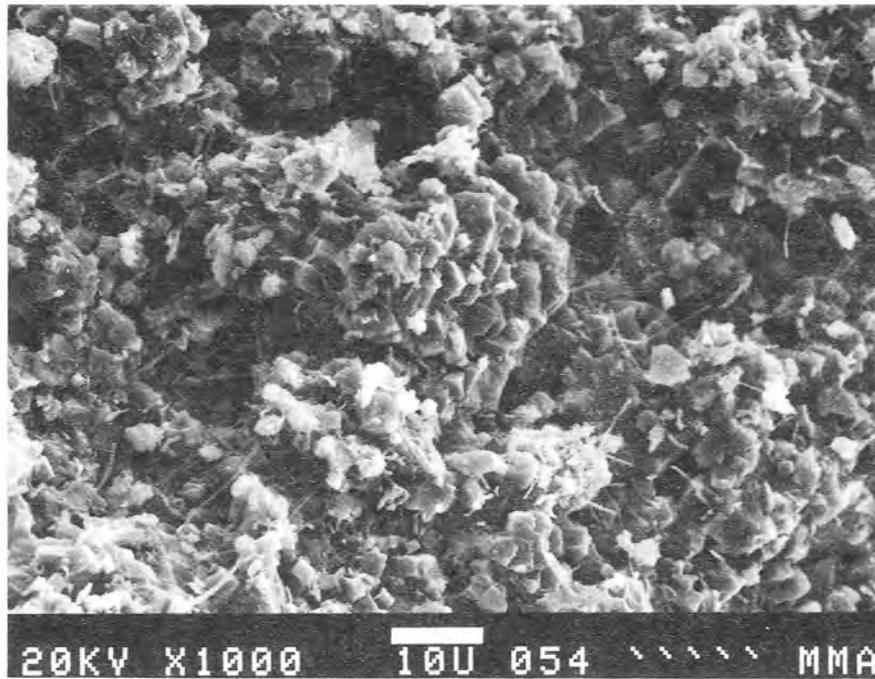
Figure 2A. Sample n.3 - Cotto sample unexposed to atmospheric pollutants showing a mass of calcite and gypsum crystals embedded in the cotto matrix.

In Figures 2A and B, we have a comparison of the unexposed "cotto" sample (n.3) to the exposed but not as yet visibly decayed specimen (n.2). The region compared in this last specimen is a fracture surface close to the exterior, exposed side of the specimen and therefore more open to the action of atmospheric agents. Even a cursory examination of the figures shows the effect of acid pollutants by the etching of the gypsum grains in the exposed sample. Furthermore, the presence of other air pollutants is evidenced by the large amount of fly ash present in this sample.

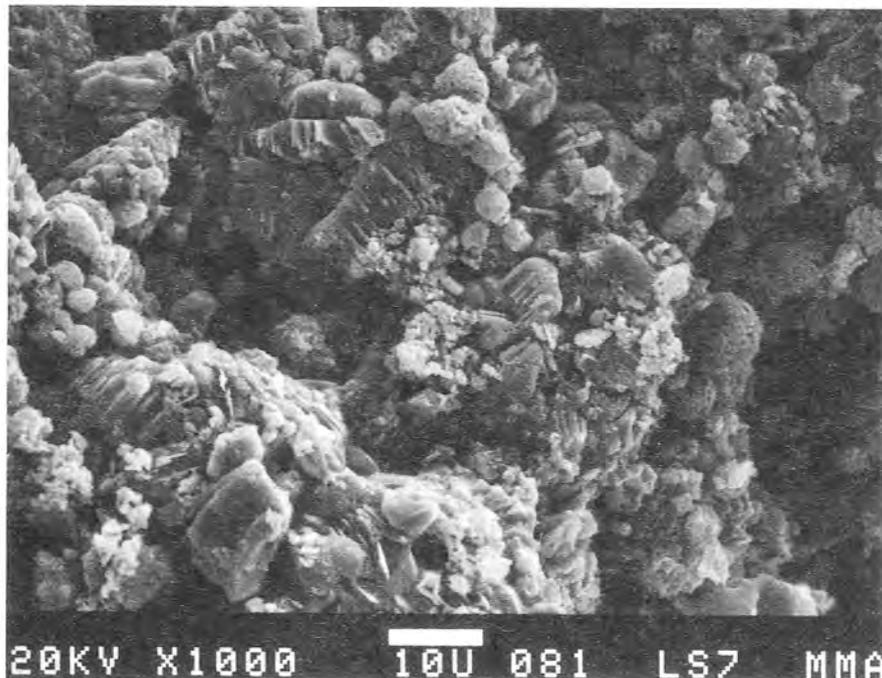
Figure 2B. Sample n.2 - Cotto from exposed cornice sample that was not visibly deteriorated. Note the etching of the gypsum grains.

The main cause of deterioration in the particular case of the "cotto" from the Church of S. Cristoforo della Certosa seems to be an attack by the acid components of air pollutants such as SO_2 . The first step in the attack is against the CaCO_3 present in the "cotto" if it is not covered, and thus protected, by the glassy matrix (see Fig. 2B).

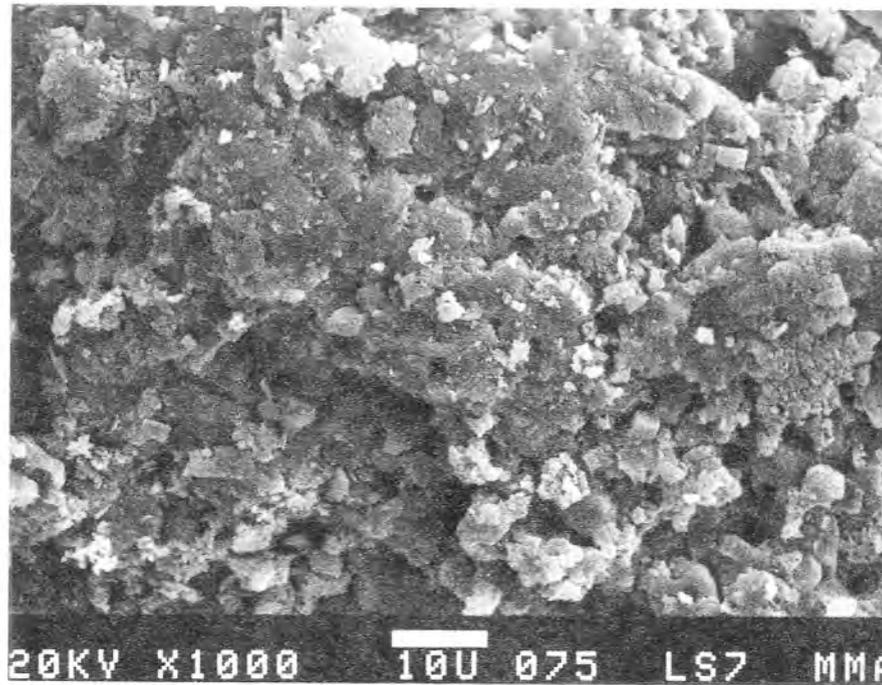
Figure 3A. Sample n.2 - Undecayed cotto showing the characteristic glassy matrix embedding the residual stacked clay particles.

When the "cotto" has been exposed for longer periods of time to the action of acidic air pollutants, the attack will also make itself felt on the glassy matrix, the binding material that holds together the mineral components of the "cotto". Figures 3A and B show a comparison between a sample exposed but not decayed (n.2) and the deteriorated specimen (n.1). In this last specimen it is of interest to note the cracks and general decay of the glassy matrix that surrounds the clay particles. There is a pronounced flaking and loosening up of the embedded quartz and feldspar grains.

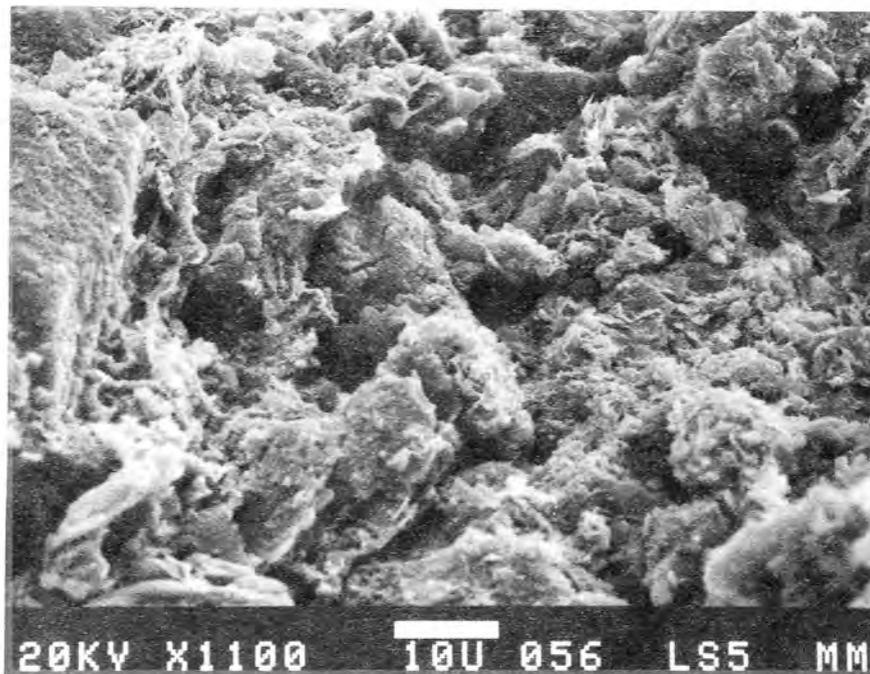
Figure 3B. Sample n.1 - Decayed cotto from cornice. The glassy matrix has been etched away in some parts with the consequent formation of cracks and loosening up of the constituent material.

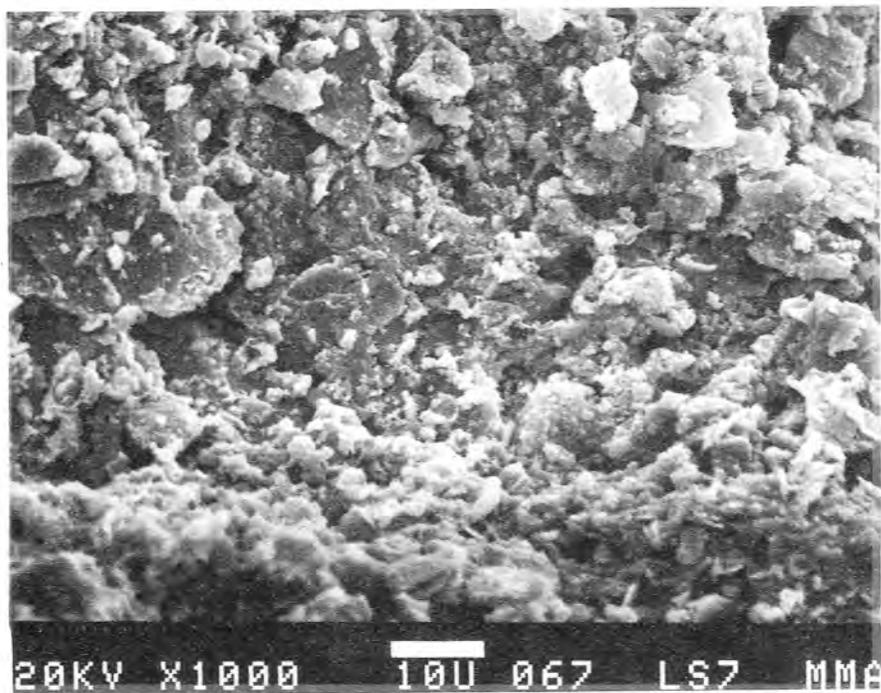
Figure 4A. Sample n.3 - Cotto unexposed to atmospheric agents. The glassy matrix holds together the bonded platy minerals to the other mineral grains.

Finally, Figures 4A and B compare an unexposed specimen (n.3) to an exposed and deteriorated one from the cornice (n.1). The unexposed specimen shows a fairly uniform glassy matrix binding together the fused clay particles and other mineral grains. The decayed specimen shows the deterioration and weathering away of the glassy matrix with the consequent exposure of poorly fused together clay particles.

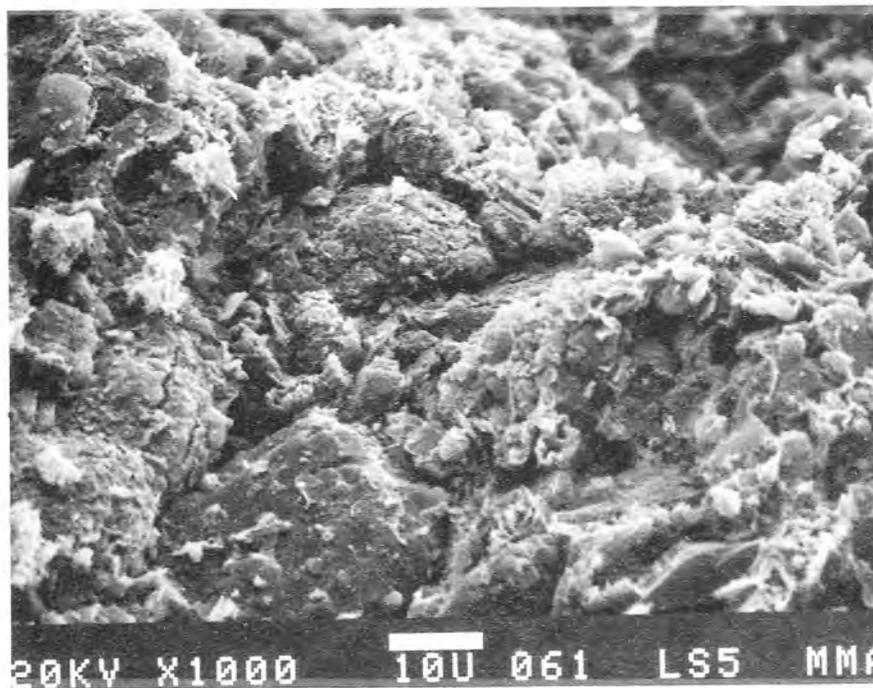
Figure 4B. Sample n.1 - Deteriorated cotto from the cornice. The glassy matrix has broken up in cracks and has uncovered agglomerations of poorly fused platy clay minerals.
