Analysis of the Colour Traces Found on the Cloister of the Jeronimos Monastery in Lisbon

**A. E. Charola¹, L. Aires-Barros², S.A. Centeno³, M. J. Basto² and
R.J. Koestler³**

Abstract

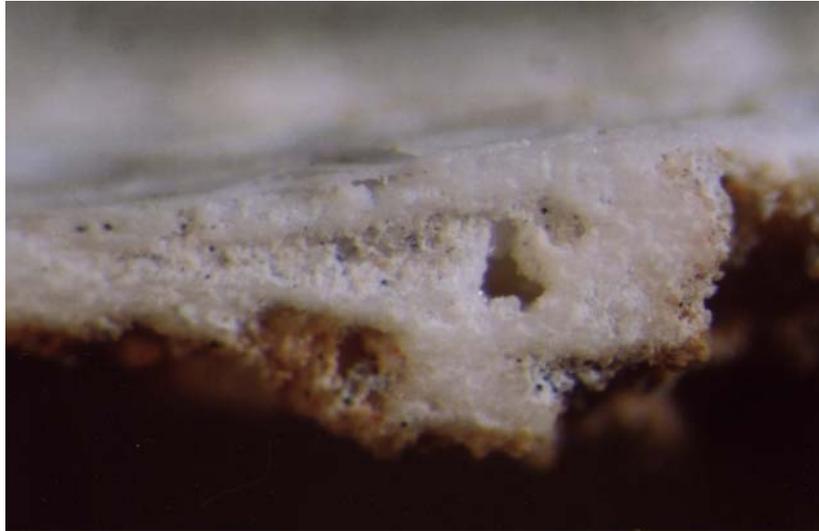
Figure 1: Photomicrograph of a cross-section of sample J10, taken from the stairs that lead to the upper gallery and the choir in the church. The thin orange finish lies above a thicker calcitic layer showing a denser, thin, inner layer, possibly the resulting natural patina of the exposed stone, and a thicker, more porous layer resulting from a limewash application. (34x)

The above conclusion was confirmed through optical microscopy examination of these samples, both in fracture section and in polished cross-section, revealing no significant differences between them [12,13]. Figures 1 and 2, show two different photomicrographic views of sample J10, taken from the stairs leading from the

lower to the upper gallery and into the choir (Coro Alto) of the church. The sample is composed of a thick white layer and a thin orange coating. To be noted is that the white layer can be differentiated into an inner, thin and coherent layer and a thicker porous exterior one. The former could possibly be attributed to the natural surface patina developed by the stone, while the latter one, given its variable thickness and its morphology could be the result of a lime-wash application. In parts (Fig. 2), a distinctive layering can be observed reflecting possible successive limewash applications as well as their exposure to frequent moisture, or infiltrations, to allow the development of the recrystallization process observed. The white layer is between 4 to 10 times thicker than the coloured layer.

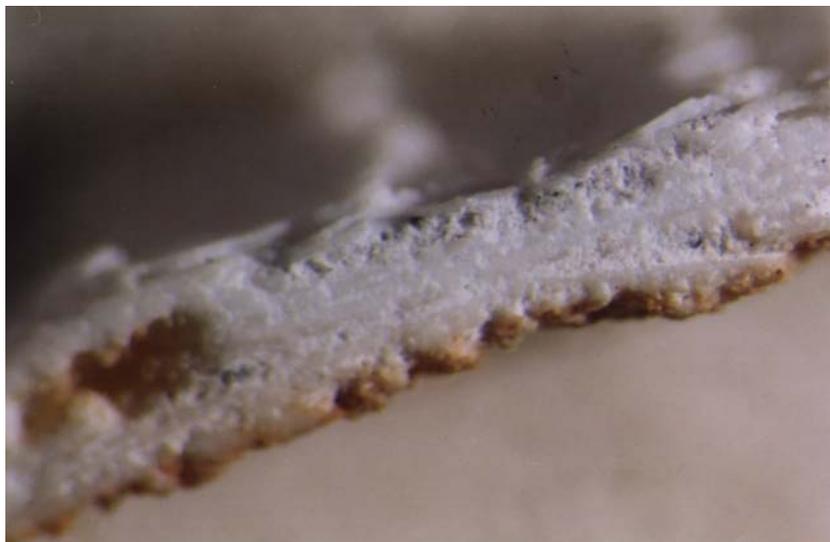
Figure 2: Photomicrograph showing a more general view of sample J10 showing the layered structure of the calcitic stratum suggesting that the limewash was applied in several coats. (24x)

The observed layering on the calcitic layer is similar to that noticed on samples taken from the portal of the church. Their genesis was hypothesized on the basis of water infiltration through lime-mortar joints with a contribution of biological activity in their formation, although their thickness had been a puzzling factor [17]. The presence of a limewash layer, subjected to repeated water infiltrations, would facilitate the formation of such a thick layer, and is consistent with the formation of calcareous concretions or accretions, where re-crystallized layering is observed [13, 18]. It is likely that these deposits on the portal also had an orange layer applied on top (residues of this colouration can still be observed on the walls of the church to date) but these thin layers would be hard to detect under the brownish first layer of air pollution, especially since Fe is one of the contaminants. Analysis of samples not having a black crust but having a brownish colouration were found to have an enrichment in iron and clay minerals in the coloured layer, attributed to the natural weathering of this stone [19]. However, the samples analyzed had not shown a thick calcitic layer as the ones presently analyzed. The fact that the colouration could originate from both natural weathering and intentional treatments has required that further analyses be carried out to be able to elucidate their origin.

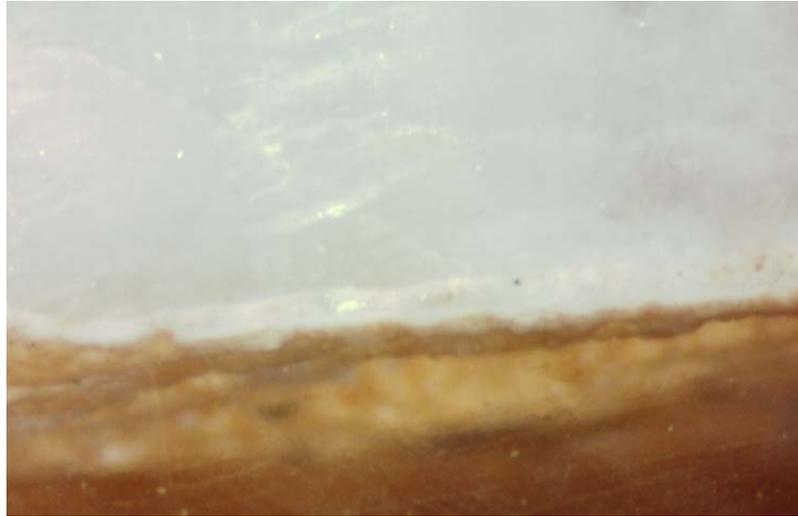
Figure 3: Photomicrograph of a cross-section of sample #7-5, taken from the interior side of the window at the lower gallery. Note that the white layer, even though thin, shows some stratification consistent with application of several limewash coats (28x).

Microscopic examination of sample #7-5 (interior, window at the lower gallery level, in the wall of the staircase leading to the upper gallery) in cross-section, showed the same morphology described above, except that the white layer was far thinner, this being consistent with their location and possible erosion through human touch (Figure 3). The red layer was below 50 μ m thick, while the white layer was around 0.2mm, but although thin, it also showed layering in parts.

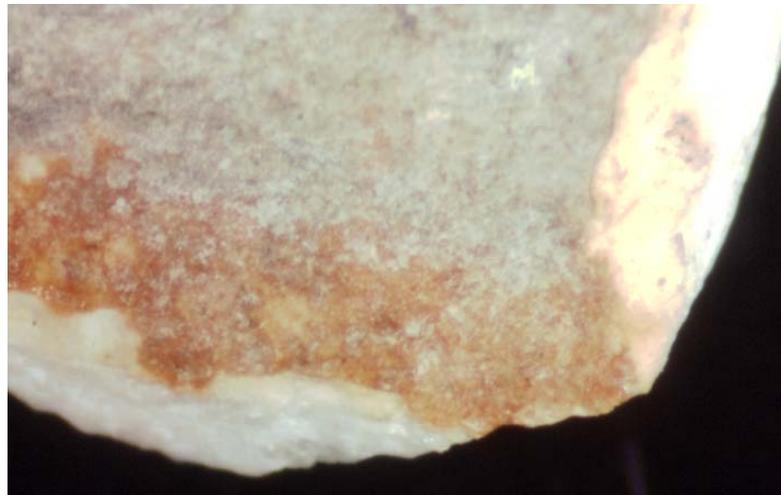
Figure 4: Photomicrograph of sample #5-2, taken from below grade of the interior N wall of the lower gallery. The orange layer has a greyish blue-ochre layer on top of the distinct orange layer. Under this layer, a thicker, white calcitic layer can be seen (14x).

Other examined samples (exterior #7-1, #7-2, #7-3 and #7-7; interior #7-4, #7-5 and #7-6) showed similar morphology with minor variations in layer thicknesses or surface texture. The most distinctive was an interior sample (#5-2) obtained from below grade of the interior N wall of the lower gallery, after some of the paving stone slabs were removed. This sample presented the peculiarity of having a thin greyish blue-ochre finish on top of the orange surface layer as can be seen in Figure 4. From

cross-sections of this sample the thickness of the red layer was found to be about 50 μm , while that of the white one ranges between 0.3–0.5 mm. A more coherent internal white layer could also be observed in parts of this sample, and that ranges in thickness between 50–100 μm .

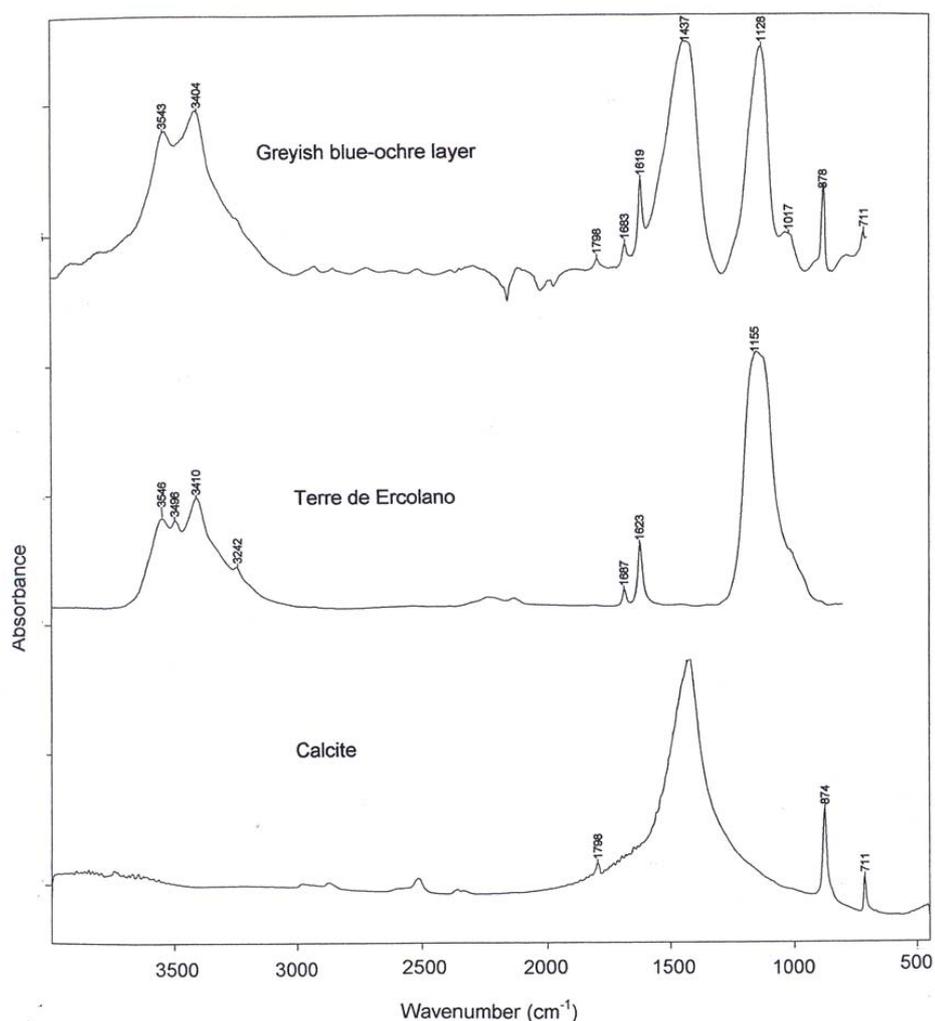
Figure 5: FTIR spectrum of the greyish blue-ochre layer on sample #5-2. The presence of the orange earth pigment, *terre di Ercolano*, was identified. For comparison reference spectra of this pigment and that of calcite are included.

FTIR analysis was carried out on this sample using a Bio-Rad FTS 30 equipped with an UMA 500 Microscope. Materials removed from the different layers of these samples were placed between the windows of a diamond anvil cell and the spectra were recorded with a 4 cm^{-1} resolution. The main objective of these analysis was to identify the origin of the colour layers in these samples. The greyish blue-ochre surface layer on sample #5-2 showed the presence of a red earth pig-

ment, identified by comparison with spectra of reference compounds as *terre di Ercolano*, a mixed orange earth (Kremer 4160), and calcite (Figure 5). The wide variety of the names given to the different red earths, reflect their origin. Venitian red has a scarlet shade, whereas Spanish red has a bluish tone from the impurities of the natural product [20].

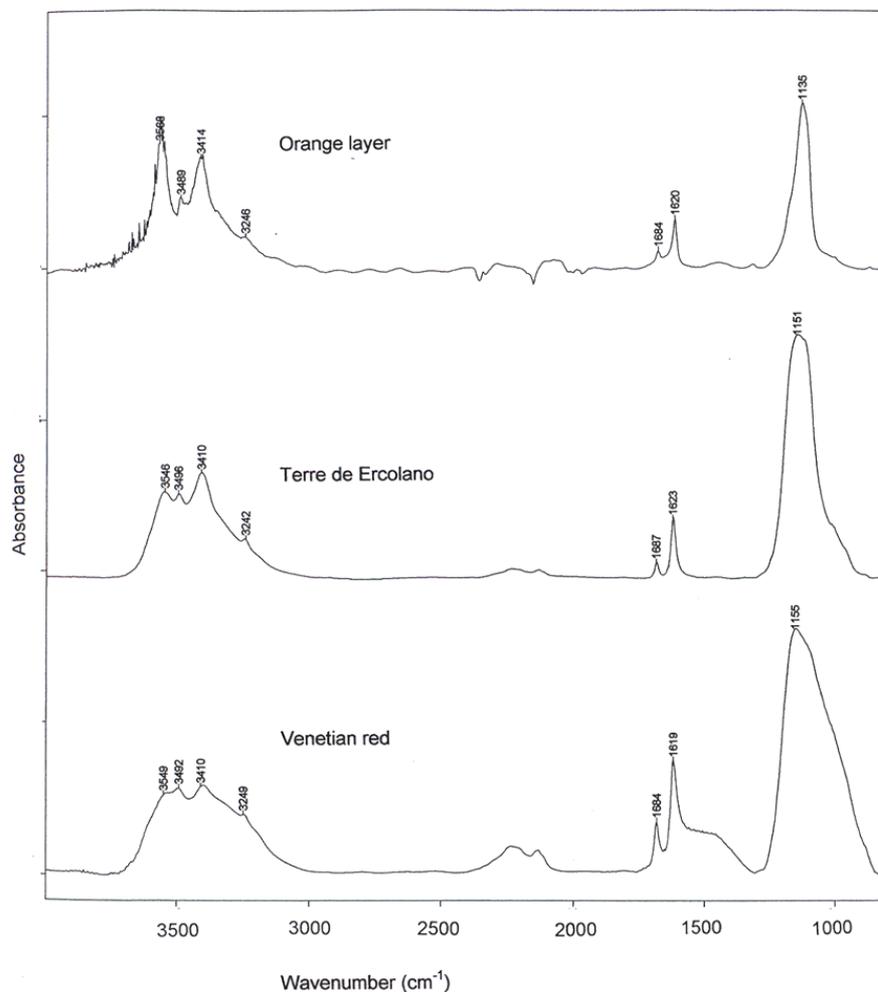
Figure 6: FTIR spectrum of the orange layer on sample #7-4, taken from the upper window of the staircase between the two galleries on the S side. The presence of *terre di Ercolano* was detected. For comparison the spectrum of the Venetian red pigment reference is also included.

A better match was found between the spectra of the orange layer on a small calcareous concretion from an interior sample (#7-4, window, at the upper gallery level, in the wall of the stairs leading to this gallery, S side of the cloister) and that of the *terre di Ercolano* pigment reference. For comparison, the spectrum of a Venetian red reference pigment, described as a mixture of Fe_2O_3 , CaCO_3 , and CaSO_4 (Kremer 4051) is also included in Figure 6.

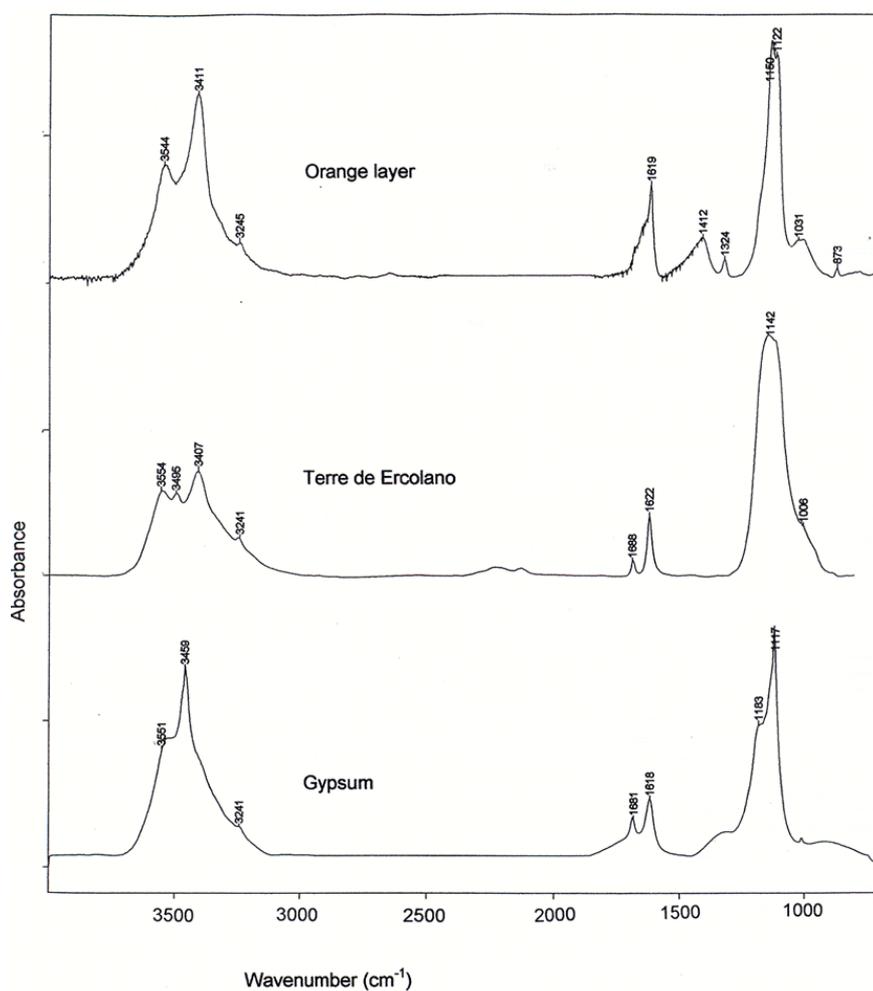
Figure 7: FTIR spectrum of the orange layer on a sample removed from the lower window of the staircase on the S side (#7-5). The presence of the *terre di Ercolano* pigment was detected along with that of gypsum. The spectra of the pigment and that of a gypsum reference samples are included for comparison.

Figure 7 shows the spectrum of sample #7-5 (removed from the interior of the window, at the lower gallery level, in the wall leading to the upper gallery on the S side of the cloister) where oxalates (indicated by the small peak at 1324 cm^{-1}), gypsum and *terre di Ercolano* are present. The higher concentration of gypsum can be accounted for by the relatively protected location of the sample. For comparison, the spectra of the pigment and that of a gypsum reference samples are included.

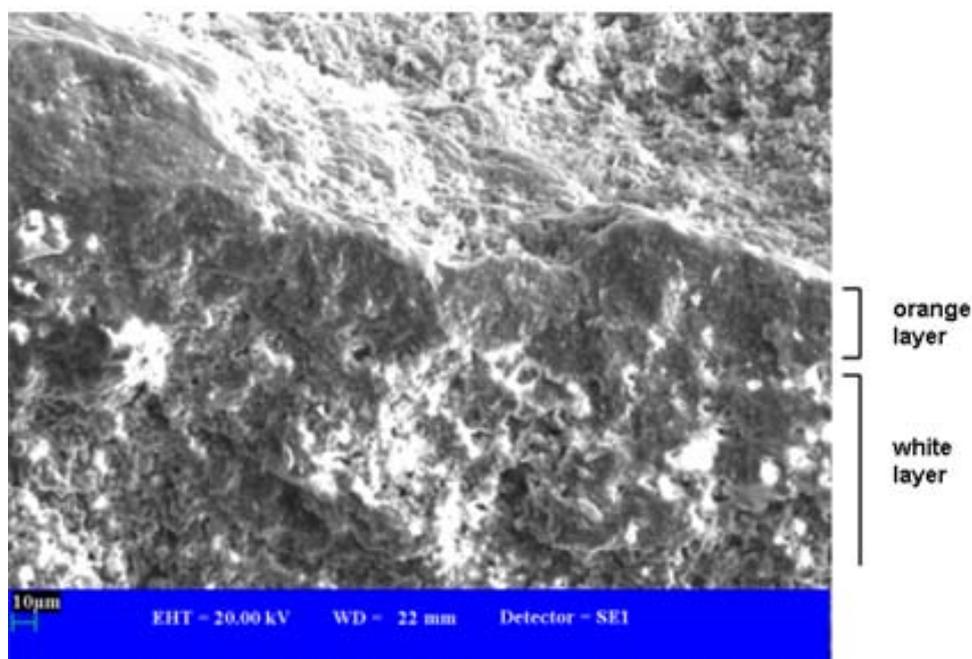
Figure 8: SEM view of the cross-section of the below grade sample (#5-1) showing the orange coloured finish, with the appearance of a wax coating above the porous calcitic layer (300x).

Scanning electron microscopical examination of these samples was carried out with a variable pressure SEM (Leo 1455VP). Sample #5-1 (interior, below grade, of N wall, same location as sample #5-2) clearly showed that the orange layer corresponded to a distinct surface finish that had a similar appearance to that of a wax coating

[21], while the underlying calcitic strata (~0.5mm thick) is very porous and consistent with the hypothesis of a lime-wash application. Figure 8 shows a detail of what appears to be a thin wax coating (approximately some 40-50 μm thick), while Figure 9 shows a back-scattered image of the cross section of this sample.

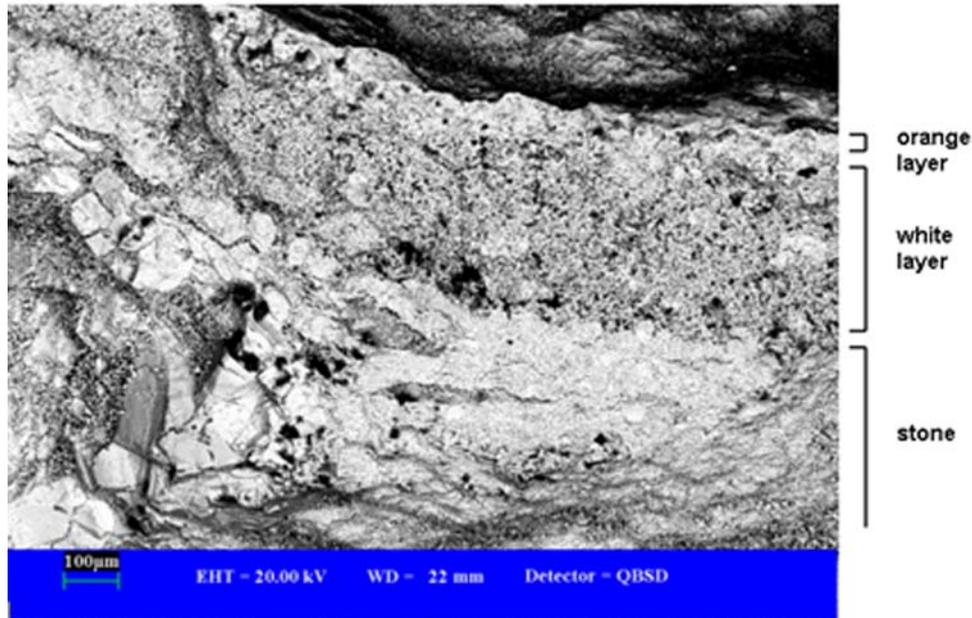
Figure 9: SEM backscattered image of a cross-section of the same sample shown in Figure 8 (#5-1). The thin orange layer is distinctly visible above the thicker white coating that lies on top of the stone, identifiable by the crystals that are best seen at the left side of the picture (75x).

The greyish blue-ochre surface layer proved to be very thin (some ten microns thick) having a layered structure at lower magnification (50X) and a rather granular appearance at higher magnification (500X), that was clearly different from the fairly smooth orange layer at this same magnification. EDS analysis showed that this layer was rich in S (between 4 to 10 times higher than in the orange layer) presumably present as gypsum and consistent with the observed granular appearance, and in C (around 1.5 times higher) present as CaCO_3 and confirmed by FTIR. It also showed that the Si/K ratio was slightly higher in the grayish-ochre layer as compared to the red one, whereas the Si/Na ratio showed exactly the opposite trend. Hence, it would appear, that given the location of the sample, this surface layer was formed by sulfation from air-pollution and later impregnated by run-off from Portland cement as reflected in the higher CaCO_3 content. Finally, the orange layer showed twice the amount of Fe than the grey layer.

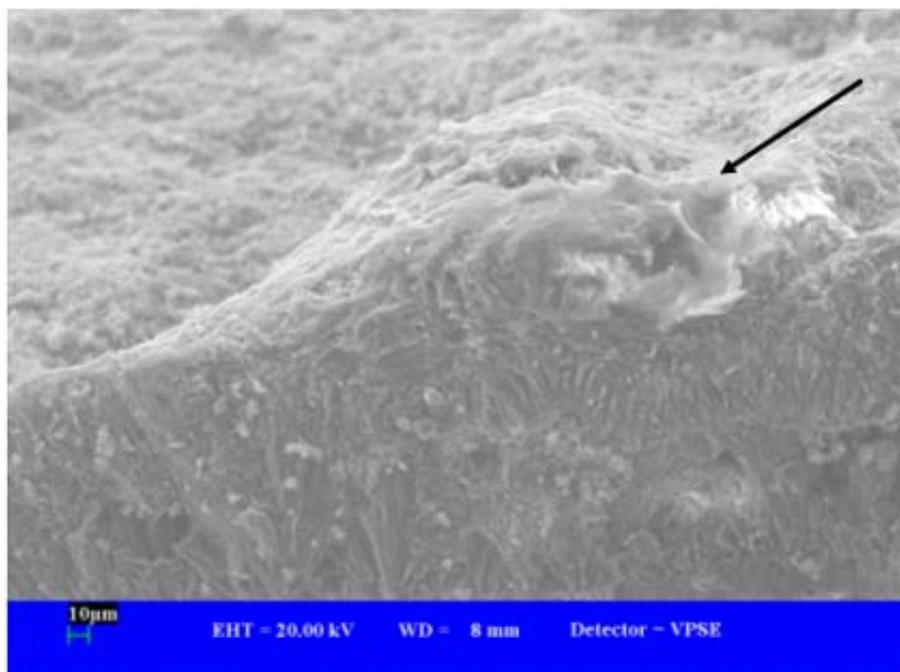
Figure 10: SEM image of a sample removed from the interior window at the upper S gallery level (#7-4). The orange layer has the appearance of an organic coating (see arrow). Note the underlying layered structure typical of calcitic recrystallizations from water infiltrations (600x).

SEM examination of the sample taken from the interior window at the upper S gallery level (#7-4) showed again that the orange layer corresponded with that of an organic coating (Figure 10). In this case, the layer appears much thinner—probably because of its location on the window where human touch may have eroded and smeared it—ranging in thickness between some 10 and 30µm. Figure 10 shows this coating and the layered structure of the underlying calcite strata consistent with the concretionary aspect of this sample, resulting from the recrystallization of successive limewash applications and water infiltrations.

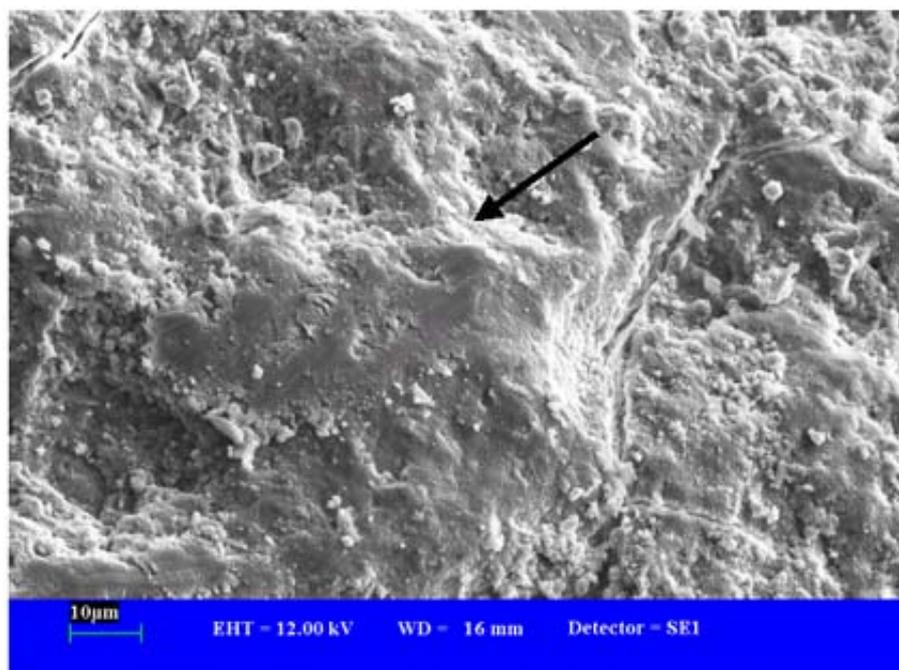
Figure 11: SEM image of an exterior sample (#7-1) taken from the S facade of the cloister. The surface of the sample shows a patchy layer of some organic material, particularly visible in the center of the photomicrograph (see arrow) (2,100x).

For comparison, the SEM of an exterior sample (#7-1), taken from the S façade, shows that in this case the organic layer is even thinner and does not cover the surface uniformly (Figure 11). This is consistent with its exposed outdoor location. Other exterior samples examined by SEM, e.g. a sample from the W exterior façade (#7-7) showed even less traces of the organic material, consistent with its paler colour.

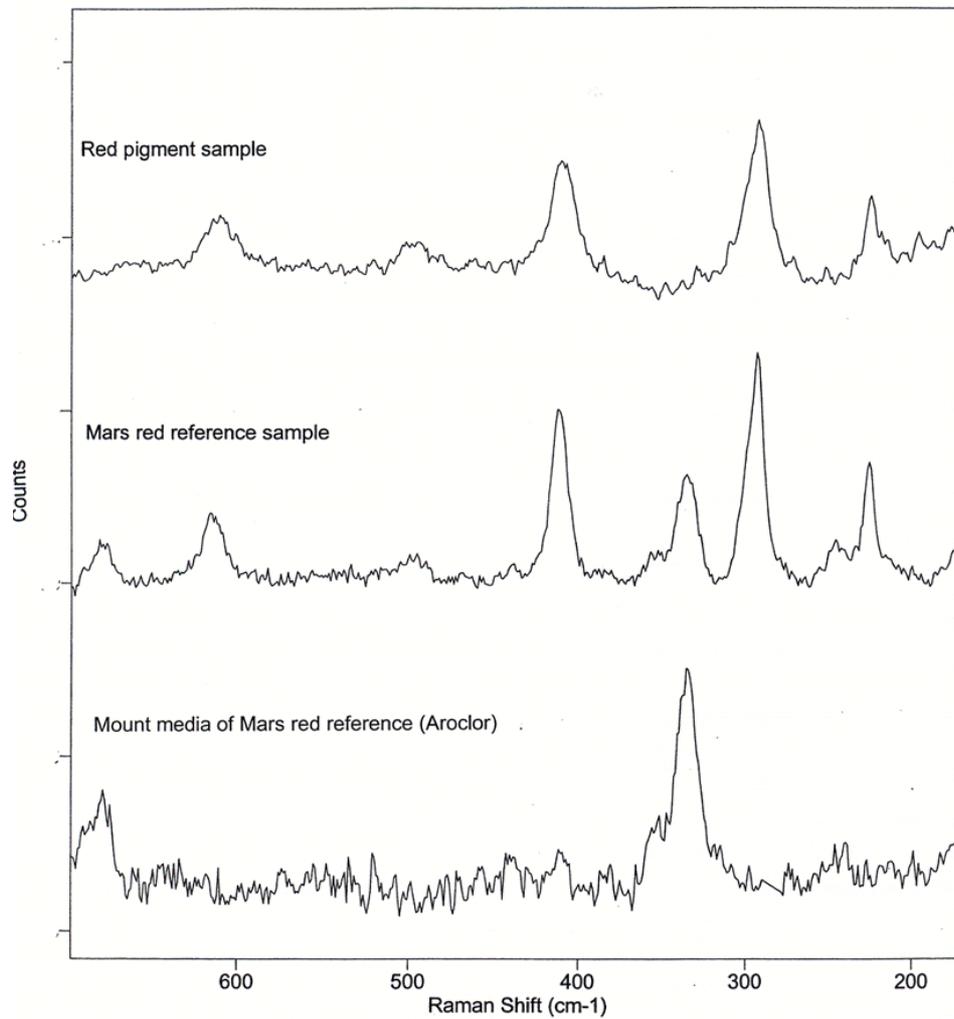
Figure 12: Raman spectrum of the red pigment found in the eyes of the St. Lucia statue (excitation wavelength: 514.5 nm). This spectrum is consistent with that of a synthetic red iron oxide reference (Mars red, Forbes Collection). The spectrum of the reference pigment mounted in aroclor,[®] and that of the mount medium alone are also included for comparison.

Raman spectroscopy was also used to identify the red pigment found in the eyes of the St. Lucia statue. Raman spectra were recorded with a Renishaw System 1000 spectrometer, using a 514nm laser. The laser beam was focused on different areas of the samples with 20x and 50x objective lenses, allowing spatial resolution of about 2 microns. Powers in the order of 1% were used, with accumulation times between 40 to 120 seconds. Calibration was carried out using the 520.5 cm^{-1} line of a silicon wafer. Identification of the materials was done by comparison of the spectra obtained with those of reference compounds. The corresponding spectrum (Figure 12) is consistent with that of a synthetic red iron oxide pigment reference (Fe_2O_3 , Forbes Collection Mars red), that has been manufactured since the mid-nineteenth century [22]. Figure 12 shows the spectrum of the sample, the spectrum the pigment reference from the Forbes Collection and that of the aroclor[®] mounting medium for the pigment reference. The presence of this pigment can be attributed as a prank from the children of the Casa Pia. Only recently (1998), the eyes of the lions at the base of the central column of the south portal of the church had their eyes also painted in red by some vandals.
