Metallurgical Investigation of an Iron Cable Wire in a Gries-Gendell (Severson) Girder

WAYNE L. ELBAN and MARTHA GOODWAY

Cast-iron girders (c. 1854) tensioned with cable rather than rods were discovered more than 20 years ago in Philadelphia. Metallurgical comparison of this girder cable with the wrought-iron cable of the Wheeling Suspension Bridge (c. 1849) in West Virginia revealed interesting differences in the materials.

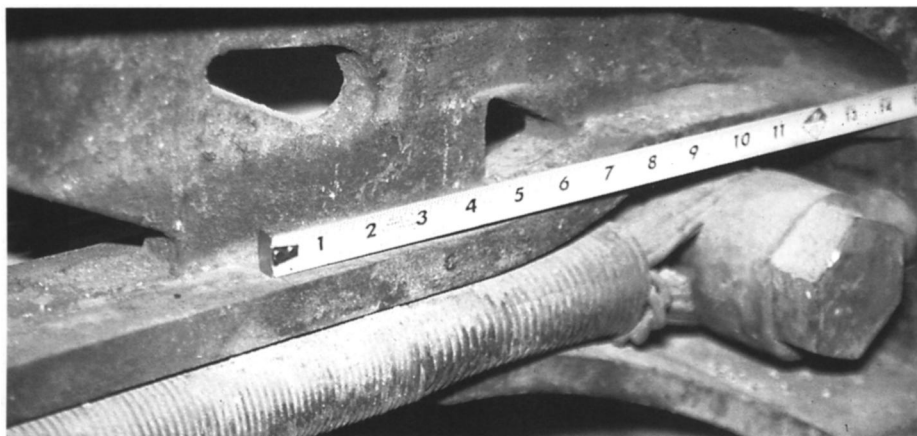
Fig. 1. Continuous wire-wrapped wire cable at one bearing end of Gries-Gendell (Severson) girder in Smithsonian collection. All photographs by the authors.

Figure 1 shows an end portion of an intact girder with one of its two cables visible. The cable consists of parallel wires that are continuously wire-wrapped or selvaged in a highly uniform fashion that suggests machine rather than hand fabrication; the relatively large diameter of the wire around the girder cable seems to preclude manual processes (Fig. 2).⁹ The wrapped configuration represents a significant improvement over the periodic ligatures used on the Wheeling Suspension Bridge main cables, which were assembled only a few years earlier (Fig. 2).¹⁰
