**ATOLL RESEARCH BULLETIN**

**NO. 554**

**THE 2004 INDIAN OCEAN TSUNAMI IN THE MALDIVES:  
SCALE OF THE DISASTER AND TOPOGRAPHIC EFFECTS  
ON ATOLL REEFS AND ISLANDS**

**HIRONOBU KAN, MOHAMED ALI, AND MAHMOOD RIYAZ**

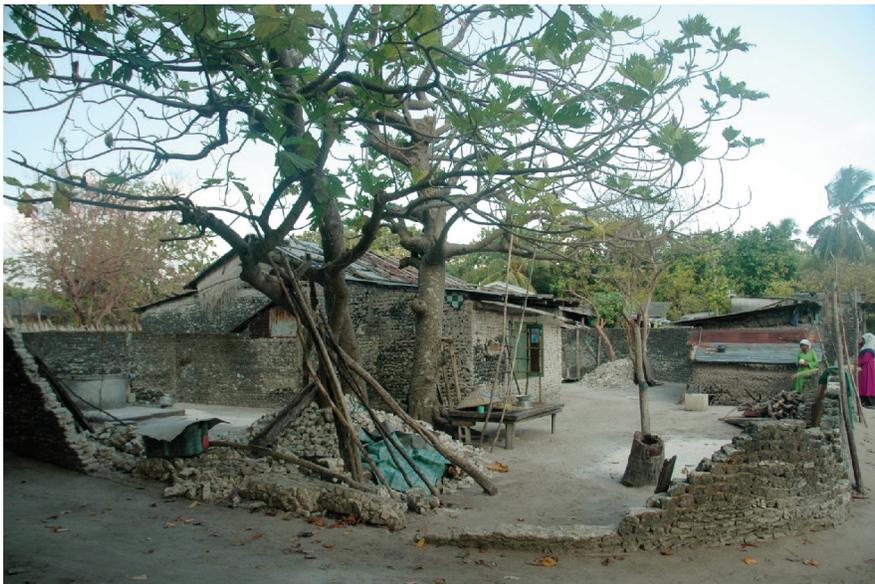
**Photo 3.** A collapsed wall at the lagoon-side on Baarah (February 2005).

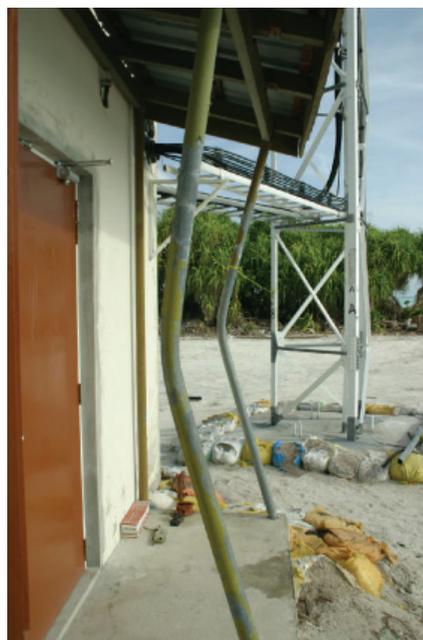
**Photo 10.** Damaged telecommunication facility at the northeastern side of Raiymandhoo.

An antenna facility for mobile phones at the northeastern coast was damaged (Photo 10) and walls were destroyed in a village on the western coast. Most of the island was inundated except for the old graveyard in the center of the island. Nobody was washed out into the lagoon.

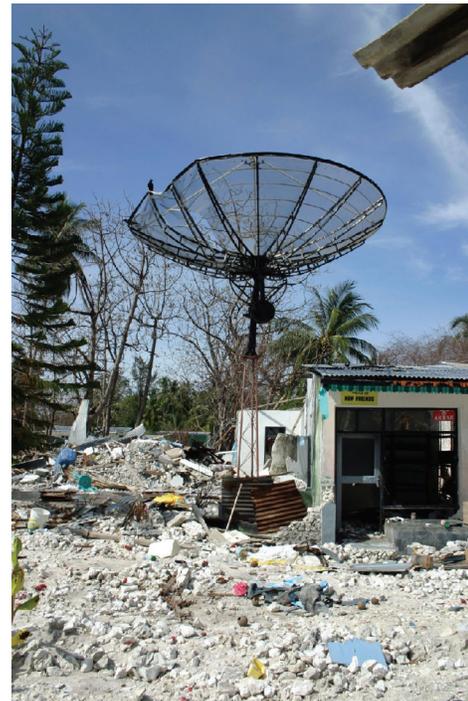
**Photo 13.** Deformation of parabolic antenna on Madifushi (March 2005).

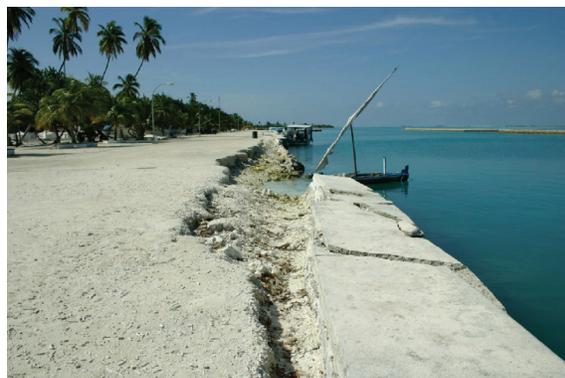
**Photo 16.** Damaged harbor at the western coast of Muli (March 2005).

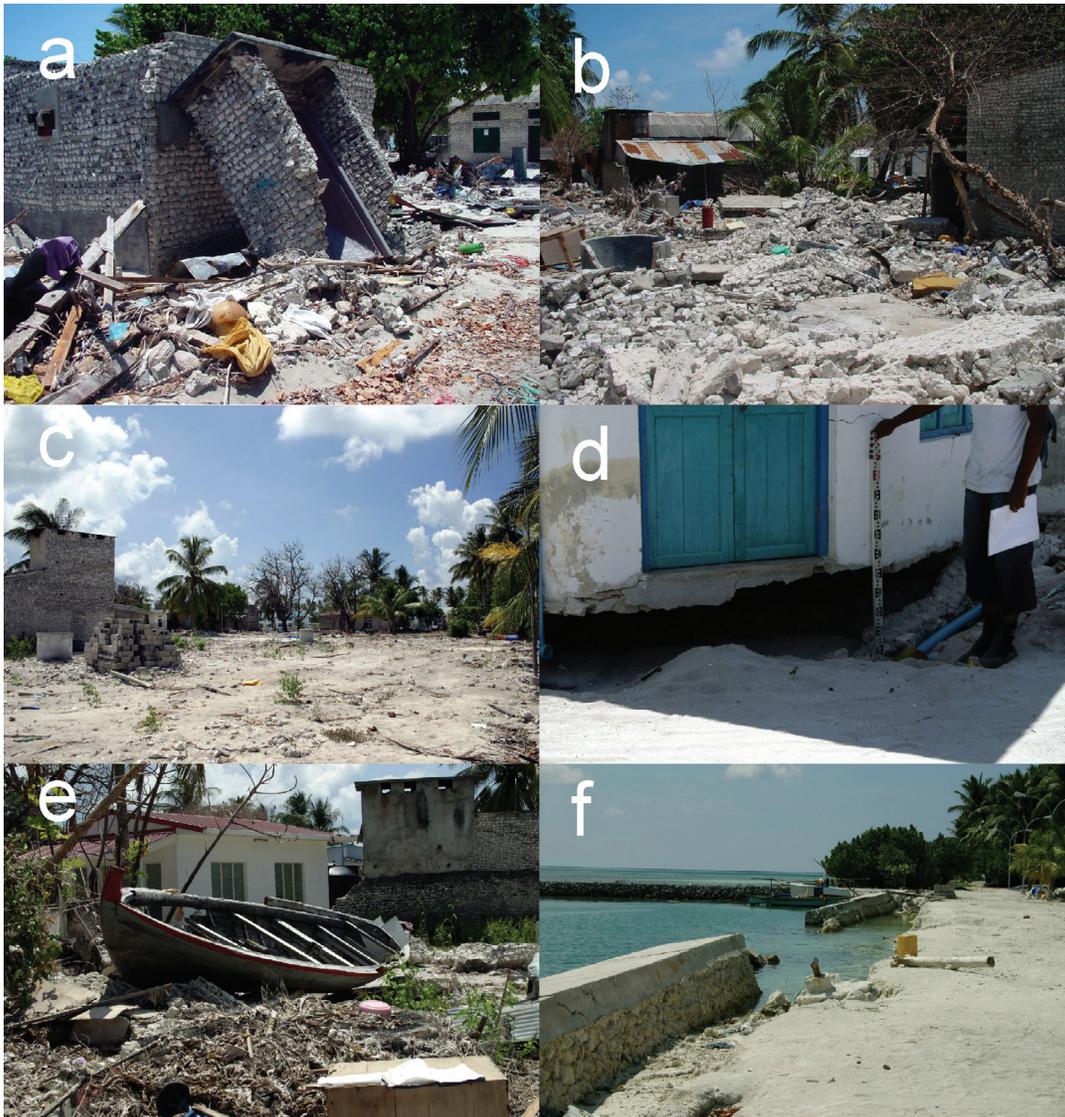
**Photo 20.** Post-tsunami photographs of Vilufushi (March 2005). a-c: destructive damage in the settlement area; d: scouring under a house; e: dhoni run up into the village; f: harbor damage at the western coast.

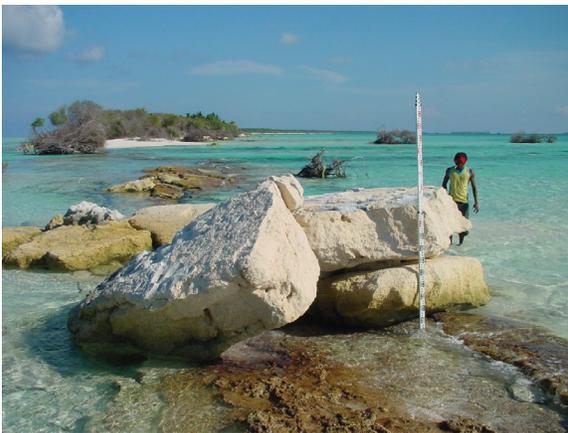
**Photo 21.** Block of beach rocks torn off and piled up on Kalhufahalafushi (March 2005).

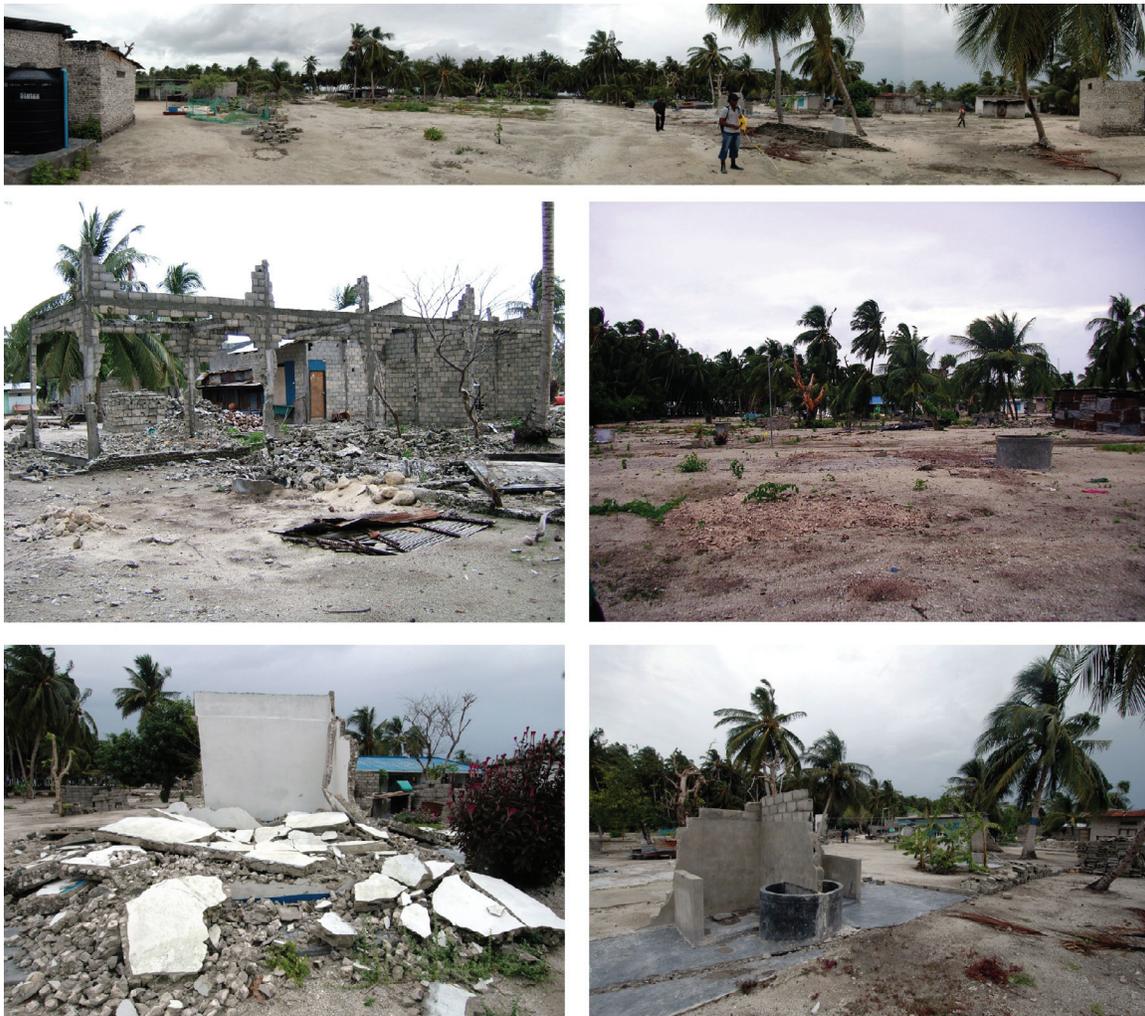
**Photo 25.** Destroyed area near the eastern coast of Maabaidhoo (August 2005).

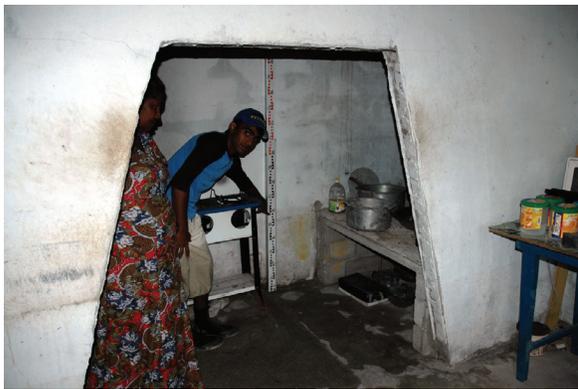
**Photo 31.** Watermark near the oven at the eastern coast of Gan (August 2005).

She was cooking in the annex. She extinguished the flame and ran to the main house just as the second wave came around 10 seconds after the first wave. Along the E-W road, the water reached more than 3 m above the ground and violently flowed through to the western lagoon. However, the water level was above knee height in houses beside the road. A watermark beside an oven in her house is 2.0 m above MSL, which accords well with her recollections (Photo 31).

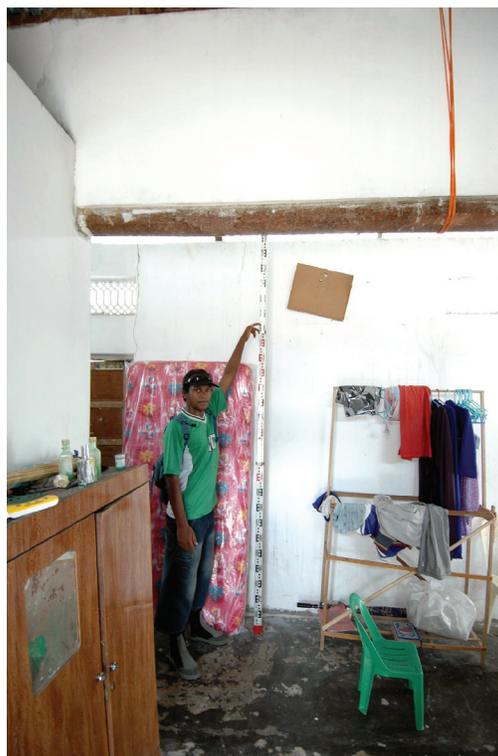
**Photo 33.** Watermark in a house in the eastern area of transect T1 on Fonadhoo (August 2005).
