CONSERVATION APPROACH DIVERSITY TO ADDRESS THE DECORATIVE ELEMENTS IN THE GARDENS OF THE NATIONAL PALACE OF QUELUZ, LISBON, PORTUGAL

*J. Delgado Rodrigues**, Principal Research Officer (ret.),
National Laboratory of Civil Engineering

*A. E. Charola***, Scientific Consultant

Conservation of Stone in Parks, Gardens and Cemeteries

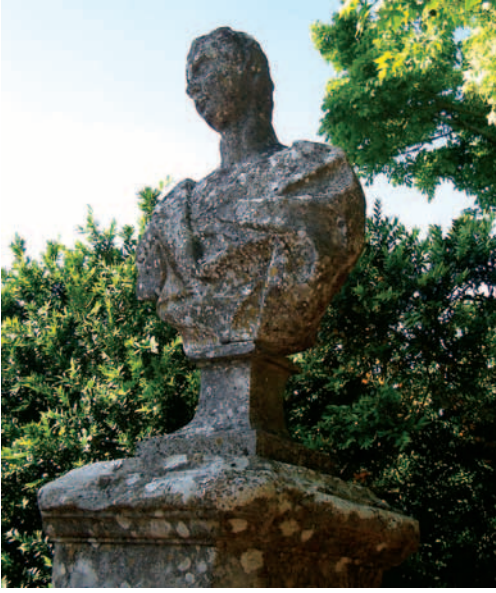
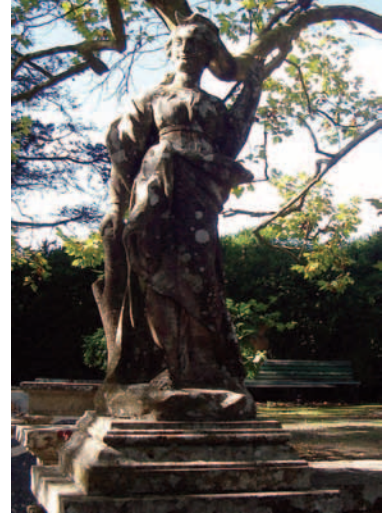
Fig. 2, a, b. Aspects of the heavy biocolonisation in the stone sculptures.

The garden ornaments show typical deterioration as can be expected to occur in a garden environment. Extensive biocolonisation (fig. 2) is the major problem, with lichens being the most aggressive colonizers. There are several species, from foliose to crustose types, and ranging in colour from yellow to white, black, and green. A diffuse darkish biocolonisation is also present. During wet periods, the green algae are clearly visible, especially in sheltered areas that become dark during the dry and hot summers of Queluz. Colonisation has induced the heaviest losses in the sculptures, either directly by micropitting, or indirectly through poor cleaning practices frequently used to eliminate it in the past (fig. 3). The mostly rural environment does not favour the development of black crusts

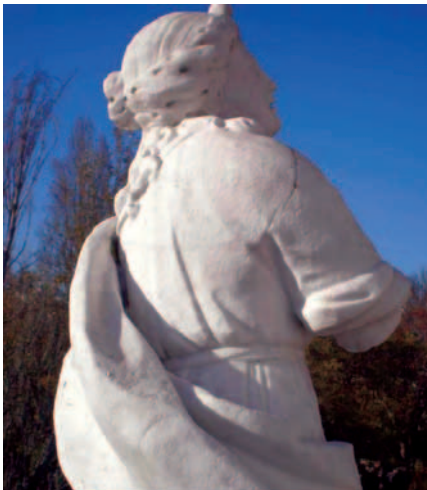
Fig. 3, a, b. Appearance of sandblasted marble sculptures. Micropitting of biocolonisation shows borders smoothed by the cleaning method.

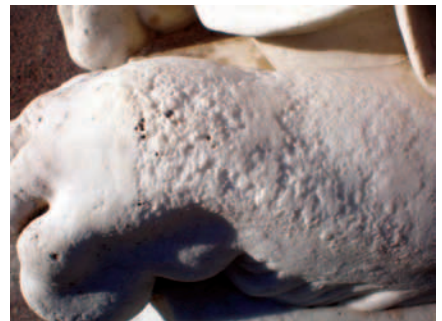
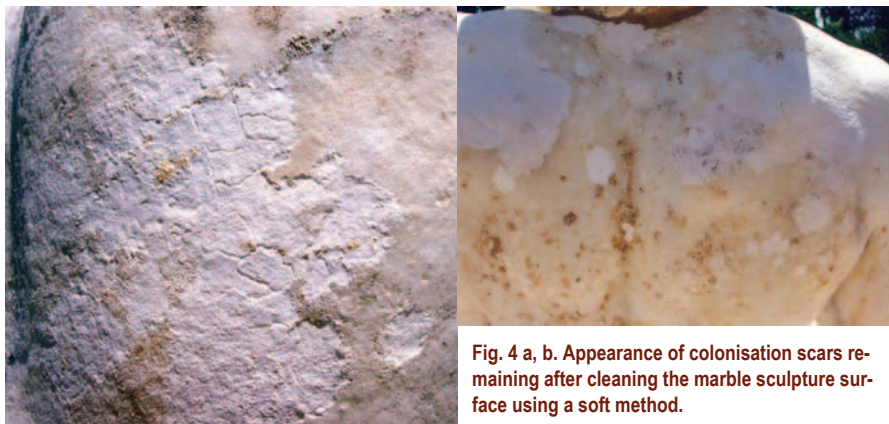
Fig. 4 a, b. Appearance of colonisation scars remaining after cleaning the marble sculpture surface using a soft method.

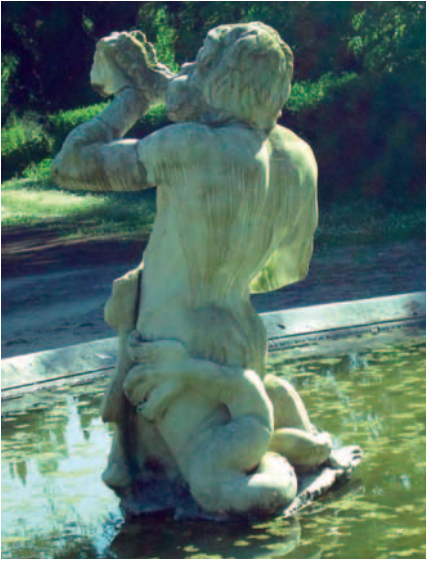
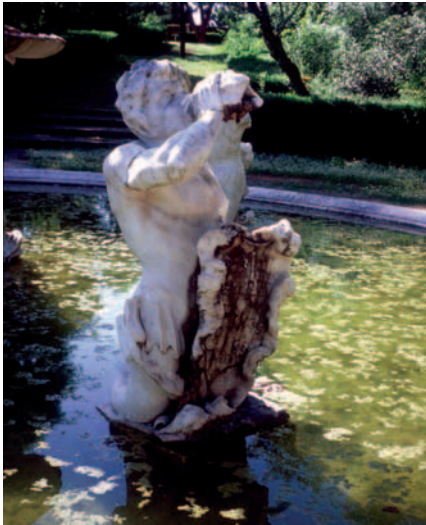
Fig. 5. ◀ a) Biocolonization develops first in the water paths that result from the application of a water repellent to the marble surface of a Triton in the Neptune fountain.

▼ b) Four years after the restoration, the hardness of the water reduced the spray to a dribble that fell over the shield, rather than spraying beyond it. Consequently, the shield is being overgrown by biological colonization.

colonization along the water paths as shown in fig.5 a). This problem has been addressed in detail elsewhere [6].

Another important point is the pressure of the water spray in the fountains. Using the aforementioned example, the Triton figures spout water through conches they carry. Although initially the water spouted beyond the figure itself, as the tubing and nozzles become incrustated by calcareous deposits, the jet tends to fall short and dribbles over the figure increasing the development of algae (fig. 5b).

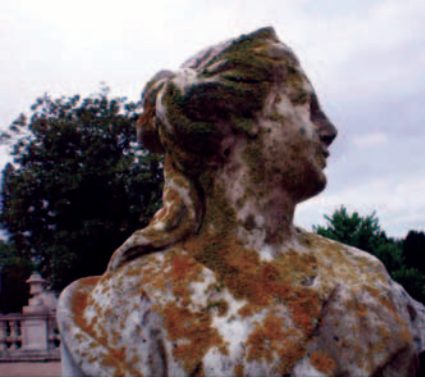
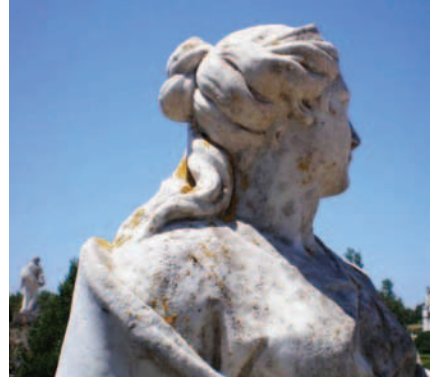
Fig. 6 a, b. Aspects of a marble sculpture before application of a biocide and spontaneous detachment of lichens two months after application..

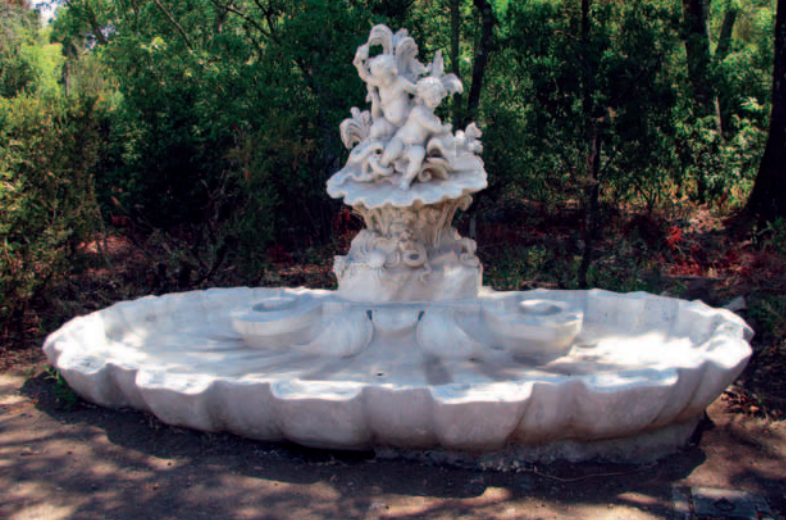
Fig. 7. Small shell-like fountain showing the problem of soil erosion under it (▲), and the Neptune fountain with extensive cracking in the bottom of the basin from roots of nearby trees.

In the particular case of the Neptune fountain, thick roots of nearby trees had caused cracking of in the retaining basin. To address this, a reinforced concrete ring structure had to be constructed around it to strengthen the basin.

maintenance produced a clear lowering of the ground level that is affecting the soil foundation of the fountain basins. This problem was not addressed during the restoration of the fountains (fig. 7) and needs to be integrated within the larger context of the walkways in the park. Recommendations on how to address this rather simple but urgent problem were left to the Palace authorities.
