The New York Public Library: Protective Treatment for Sugaring Marble

A. Elena Charola, Silvia A. Centeno, Kyle Normandin

Abstract

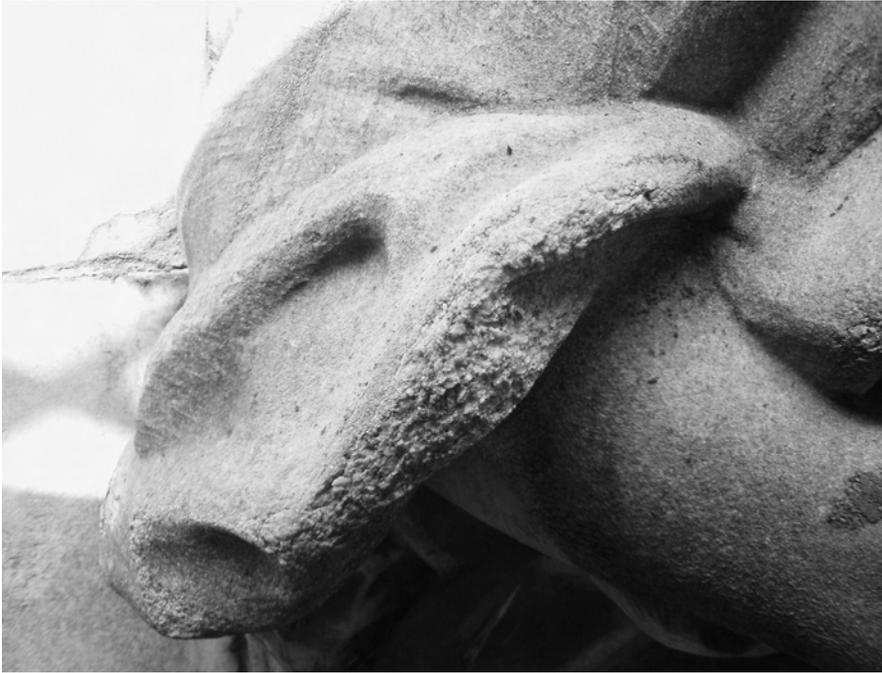
Figure 1 Marble erosion and disaggregation at sculpture relief.

in water can reduce rainwater to an acid pH level of 5.6. Consequently, marble used in outdoor buildings and sculptures in pre-industrial times is already being slowly eroded by precipitation. Except for very pure marbles in which erosion is uniform, marbles that are not highly metamorphosed present uneven erosion. This reflects their heterogeneous structure, in which some areas have larger crystals and others smaller crystals. The rate of dissolution will be proportional to the exposed surface so the erosion occurs faster in the smaller crystal areas because of their higher specific surface; this leaves behind the larger crystals in relief (Figure 1).¹

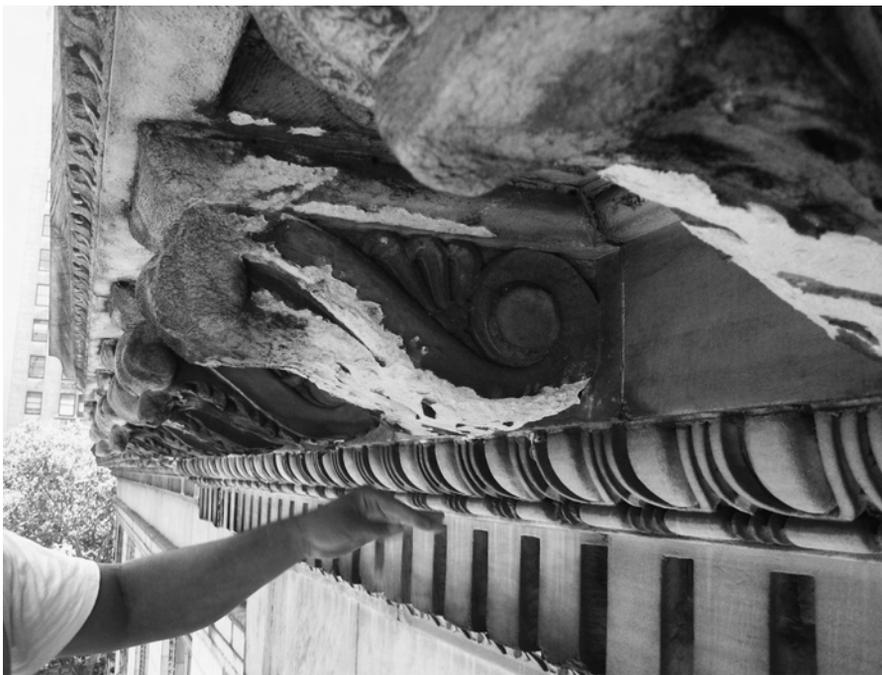
Figure 2 Marble erosion, sugaring and flaking at scroll brackets supporting the cornice.

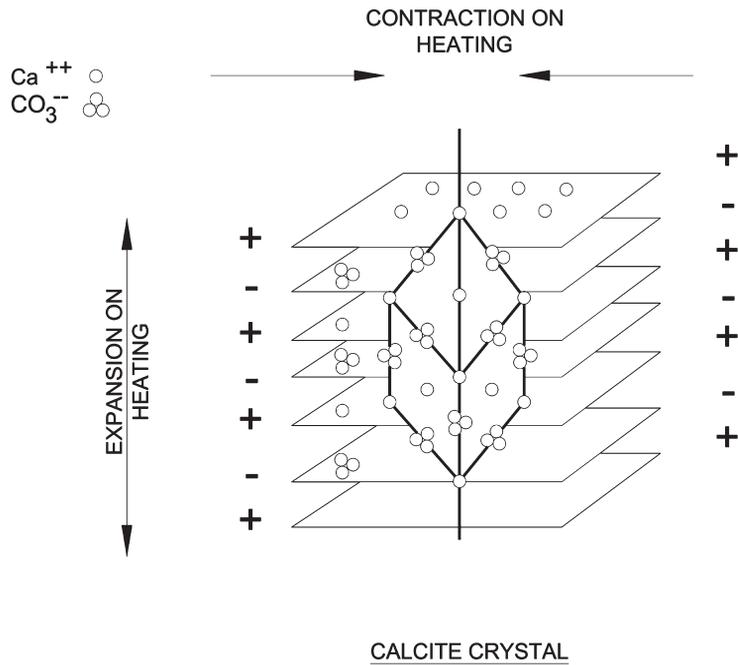
Figure 3 The expansion of a calcite crystal along the c axis and the contraction along the a and b axes with temperature increase (redrawn from Torraca, G., *Porous Building Materials*, ICCROM, Rome, 1981).

Sugaring of marble is also induced by thermal cycling, a result of the anisotropy of the calcite crystal, which has significantly different expansion coefficients along the *c* axis and the *a* and *b* crystal axis. Upon heating, the crystal elongates along the *c* axis while contracting across the other axes (Figure 3). Repeated thermal cycling loosens the texture of the marble, increasing its porosity and in turn accelerating its solubilization in rainwater.

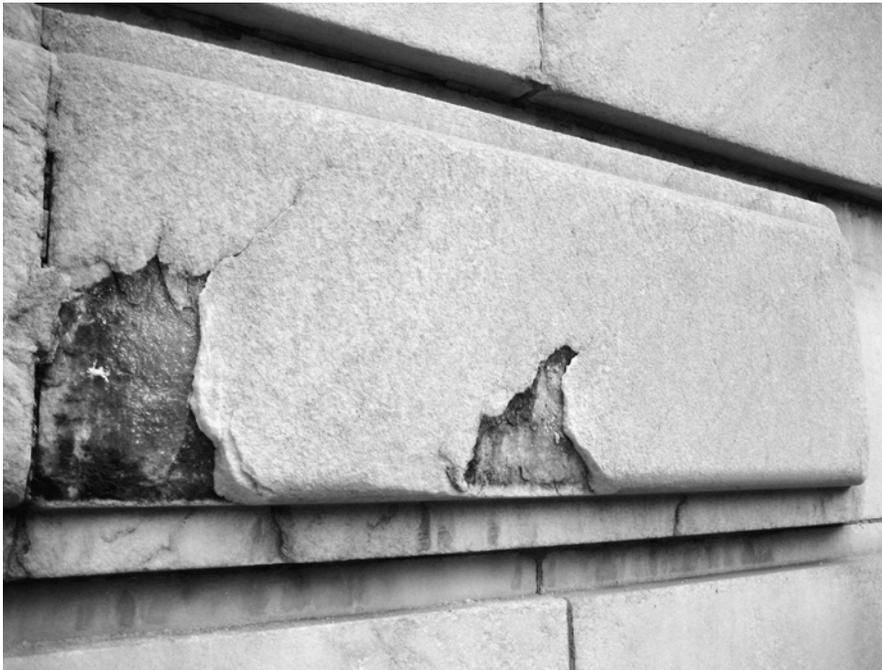
Figure 4 View of surface loss resulting from delamination.

Some cracks were observed beneath the surface, with localized weathering adjacent to them. This suggests that they had been present for a prolonged period of time. These microfractures could be visually observed as planes of incipient delamination (Figure 4).
