Unusual Design Influences a Building's Biocolonization Pattern and Complicates Remediation

Abstract— The Smithsonian Institution's National Museum of the American Indian (NMAI) opened its doors for the first time to the public on September 21, 2004. Designed by Douglas Cardinal, the building stands out from other museums on the National Mall in Washington, D.C., because of its curvilinear shape and the yellow-golden color of its stone, which are intended to recall cliff dwellings of the American Southwest. Biocolonization on the stonework, a consequence of both the building's design and the stone's porosity and facture, has resulted in five cleaning campaigns over the 13 years since the building's inauguration. Such frequent cleaning, three times with the same biocide, is both expensive and potentially self-defeating. Microorganisms tend to become resistant to biocides, and/or new organisms may develop that are even more aggressive. Since a pristine building is preferred by its stakeholders, alternative approaches are being explored to prevent biocolonization. Any alteration of the building's architecture has been rejected, and pressurized water washing is considered inadvisable a

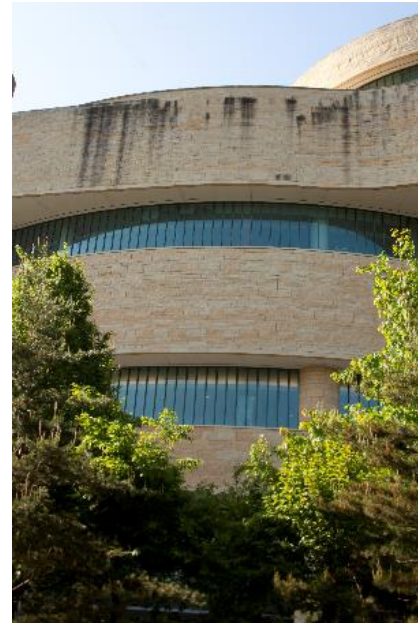
Fig. 2. NMAI, north facade. Sloping capstones contributed to severe black streaking from biocolonization below the Inouye Terrace just six years after the building opened (M. Wachowiak and E. Webb, April 22, 2010).

Architectural features of the NMAI building are responsible for much of its biocolonization, and possible modifications to reduce biocolonization were explored, such as replacement of sloping capstones with flat ones. However, such architectural changes would be both major expenses and unacceptable to the museum.

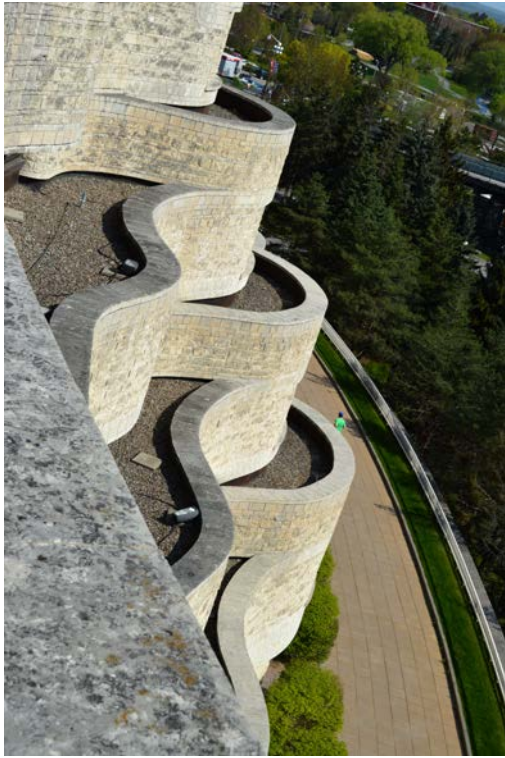
Fig. 3. CMH. Balconies exhibit dark spots on projecting stones. Biocolonization can be seen on the capstone in the foreground at left (May 17, 2017).

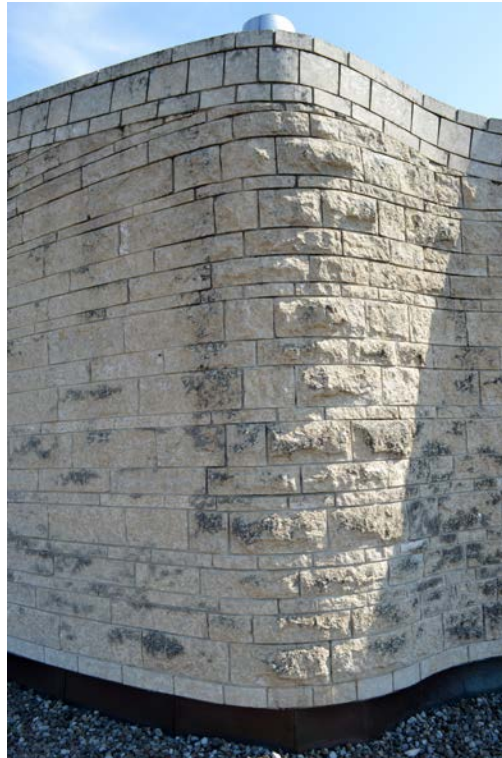
Fig. 4. CMH. Stonework on the roof of the curatorial building shows scattered biocolonization on high relief areas nearly 30 years after the building opened. Since it cannot be seen from the ground (or Parliament), it is unlikely to have ever been cleaned (May 17, 2017).

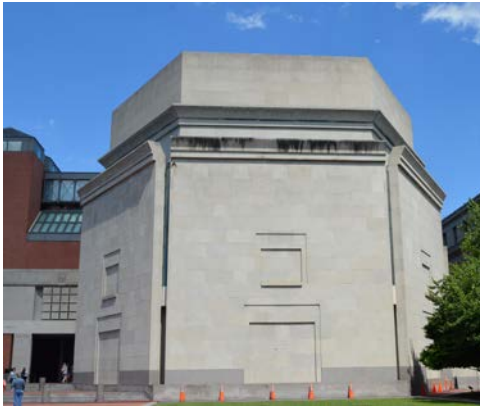
Fig. 5. U.S. National Holocaust Museum (1993). By 2000, the building's Salem Limestone had become disfigured by biocolonization. Following cleaning of the building in 2010, zinc strips installed near the edge of the roof have largely eliminated the problem on flat portions of the façade (June 2, 2017).

Good results reported for inhibition of biocolonization by installation of zinc strips on the gabled roof of the granite Stanford Mausoleum at Stanford University [13, 14] and on Indiana limestone capstones of the Holocaust Museum in Washington, D.C. (fig. 5), led to testing of zinc strips on two Kasota limestone blocks, which proved very effective (fig. 6). Theoretically, zinc ions dissolved in rainwater inhibit biocolonization where the water washes over stonework. Zinc test strips were installed in two locations on the NMAI building in February 2012. After several years they showed localized reduction of biocolonization but have not yet been proven effective in reducing biocolonization on the building's façade because of problems with the test methodology. For an area on the Inouye Terrace shown in Fig. 7, the test period was insufficient because of premature cleaning with the biocide D/2 just two-and-a-half years later in 2014 and then again in 2016. The visibility of the strips on the terrace, which is used both for receptions and by staff, also makes them unacceptable to the museum for further installation there. In the second area where zinc strips were installed atop ledges of roughback blocks, the strips appear to have been only partially effective, mainly because water washes unevenly over the highly textured blocks but also because the strips were placed where they receive less rainfall at the back of the ledges in order to prevent them from being visible. As another test, installation of zinc sheets is scheduled to cover capstones on a sloping balcony and at the top of the building, where they are likely to be most effective. The non-uniform flow of water over the façade's irregular surfaces is likely to result in incomplete inhibition of biocolonization below the capstones, however, since the successful use of metallic zinc in preventing biocolonization relies on the even flow of water down a building's flat ashlar walls, like those of the Holocaust Museum and Stanford Mausoleum. Use of zinc is precluded in other areas; in particular, zinc strips cannot be installed to protect randomly projecting blocks scattered across the facade without interfering with the building's appearance.

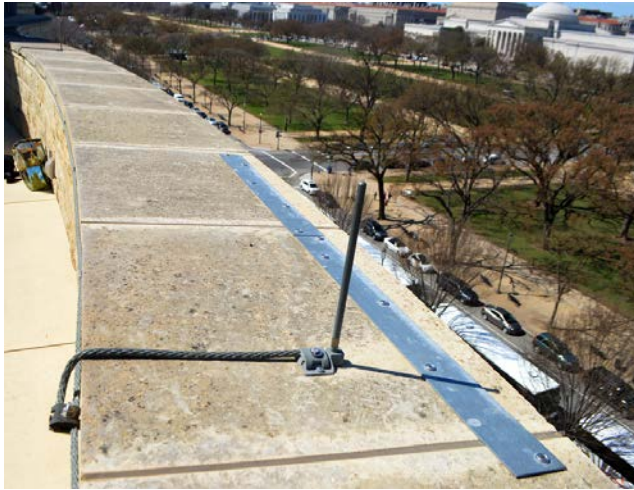
Fig. 7. NMAI, Inouye Terrace. Two years after installation, zinc strips had eliminated biocolonization on outer edges of capstones (March 31, 2014), but their effectiveness on the façade below was indeterminate because of cleaning the following month (and again in 2016). Biocolonization is also absent below the lightning rod from dissolution of copper and near joints where the stone was made water repellent by silicone caulk.

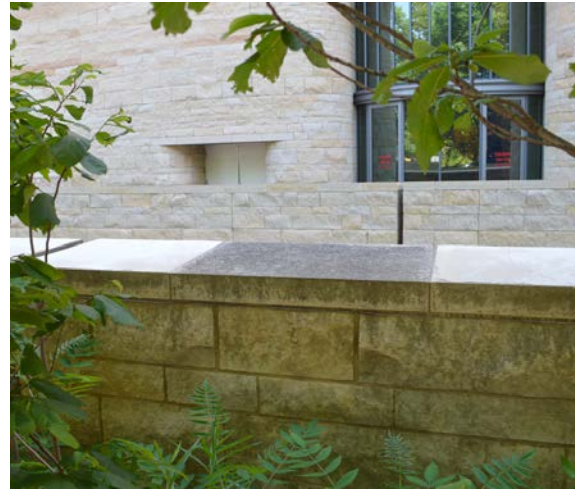
Fig. 8. NMAI, loading dock wall. Hydraulic lime parging containing zinc compounds was applied to the uncleaned pair of capstones on either side of the untreated, dark-colored "control" block at the center less than a year before this photograph was taken on June 6, 2017. The coloration of the parging could be adjusted to better match the stone. The west façade in the background was cleaned in December 2016.

A related method of inhibition being tested on the NMAI building is incorporation of zinc compounds in hydraulic lime parging placed atop five heavily biocolonized capstones on the loading dock wall. Over time the parging itself will eliminate biocolonization on the stone by preventing the sunlight required by the cyanobacteria from reaching it. In addition, the zinc ions should inhibit biocolonization on the parged surfaces and possibly over the long term on vertical façade surfaces below the sloping capstones, where the zinc ions should gradually be carried by rainwater [15, 16]. If successful, the parging might be a suitable alternative for sills and capstones that are not visible from the ground.
