AN ANALYSIS AND TREATMENT OF THE FIRE-DAMAGED MARBLE PLAQUE FROM THOMAS JEFFERSON'S GRAVE MARKER

Abstract

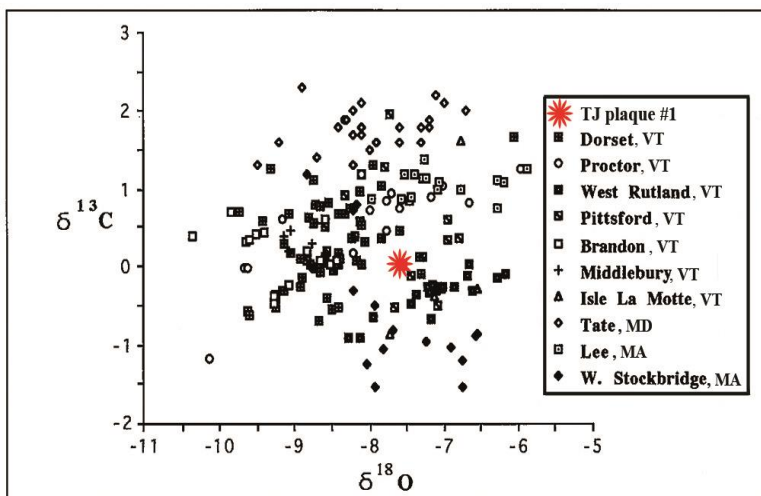
Marble grains on the plaque range from 0.25 to 0.6 mm; accessory feldspar and quartz are found at grain boundaries. In the absence of documents sourcing the marble, it was hypothesized that its small grain size limited possibilities to marble imported from Carrara, Italy, or quarried in Vermont. Carbon and oxygen isotopes for samples from the plaque were compared to reference isotope datasets from Carrara and quarries in the northeast U.S. (Dooley and Herz 1995) and found to best match those of Dorset, Proctor, West Rutland, or Pittsford, Vermont (Fig. 2).

Fig. 2: The stable isotope average for TJ #1 is plotted on a graph showing averages for marble samples mainly from Vermont and Massachusetts, after Dooley and Herz (1995).
