CONDITION SURVEY OF AQUIA CREEK SANDSTONE COLUMNS FROM THE U.S. CAPITOL RE-ERECTED AT THE U.S. NATIONAL ARBORETUM

Emily Aloiz,^{*1} Carol Grissom,² Richard Livingston,³ and A. Elena Charola⁴

Abstract

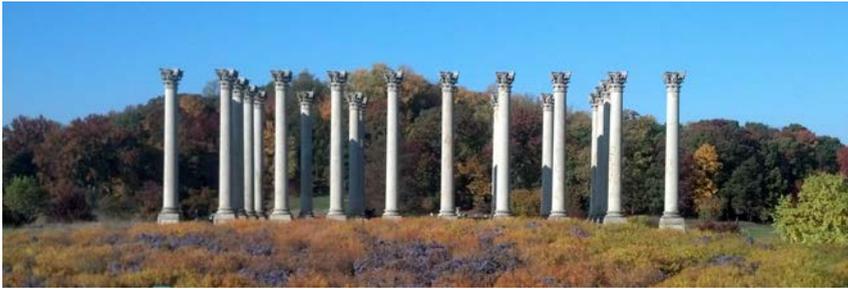
Figure 1: Twenty-two Aquia Creek Sandstone columns from the U.S. Capitol are seen here at their present location in the National Arboretum in Washington D.C.

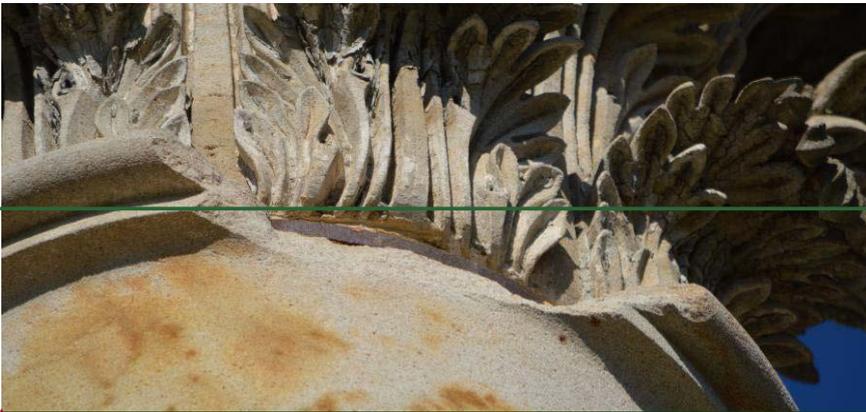
Wrought-iron rings set in lead at the top of each shaft present a second instance of inherent vice. Since the rings are covered by the capitals, it is almost certain that they were installed at the time of original construction, although their purpose remains unclear. Corrosion of the iron has resulted in cracking or loss at 13 of the 22 astragals, as seen in Figure 7.

Figure 7: Detail of stone loss from L13's astragal, revealing its iron ring directly below the bottom edge of the capital.
