## Examination of the Ardagh Chalice—A Case History

In June 1961 the chalice was taken to the Research Laboratory of the British Museum for repair because it had become loose at the joint between bowl and foot. This necessary work was also to provide a convenient occasion to study the chalice, both in order to discover how reliable for modern usage Dunraven's account had been and also to analyze its materials and construction.

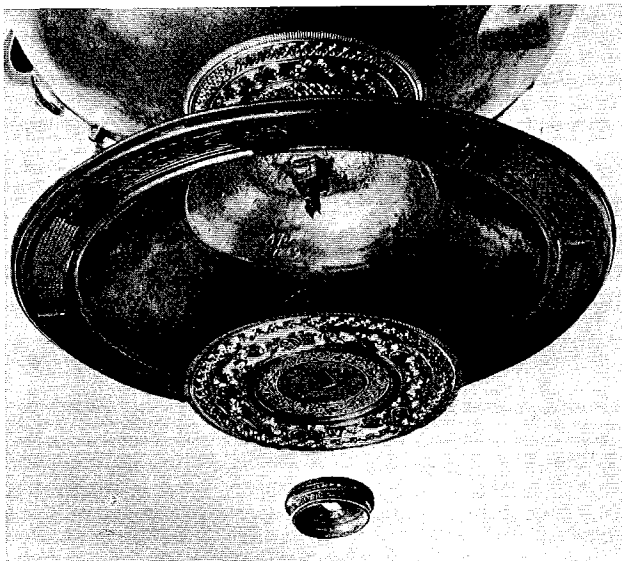
3. Exploded view of crystal mount, under-foot disc, and the end of the central bolt.

square bolt. It also revealed two sharp tags projecting from the end of the bolt. The earlier two deductions now stood confirmed: here were the sharp projections that had torn the silver foil and the square bolt.

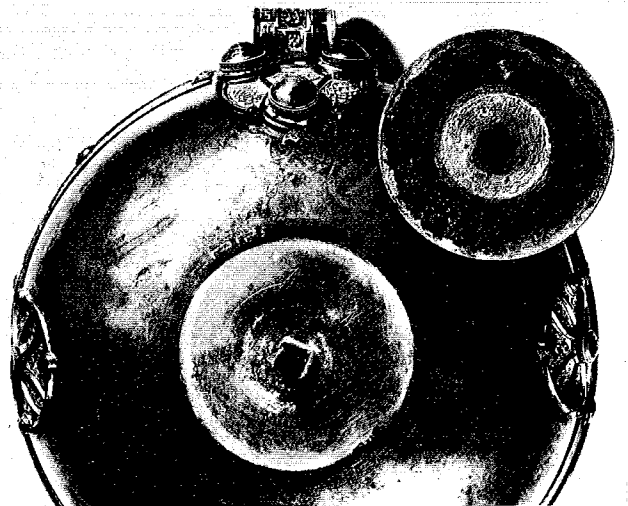
5. The neck assembly removed from the bolt.

The lead was removed very carefully. It was first channelled annularly with a rotary file with care that the file did not approach any part of the chalice. Then the thin wall of lead that had been left against the central bolt was carefully levered back into the annular space made by the file. The neck could then be lifted away from the bowl. In fig. 5 it can be seen with its lead still within it, turned over and laid down alongside the place from which it came. Looking at the inside of the neck you may note that the lead that had lain against the silver bowl is white with corrosion products. Circular turning-marks in these suggest that a lathe had been used. In the periphery of the disc there is a greenish-white deposit that actually represents corrosion products from the bronze of which the disc was made. On the silver bowl may be seen a circle of untarnished silver. This had been protected from the tarnishing gases in the atmosphere by the seal of corrosion products around the periphery of the disc. Toward the center of the clear circle of silver one or two patches of white material adhere firmly. These provide evidence that the expanding corrosion products of lead had been forced tightly against the silver at these places.

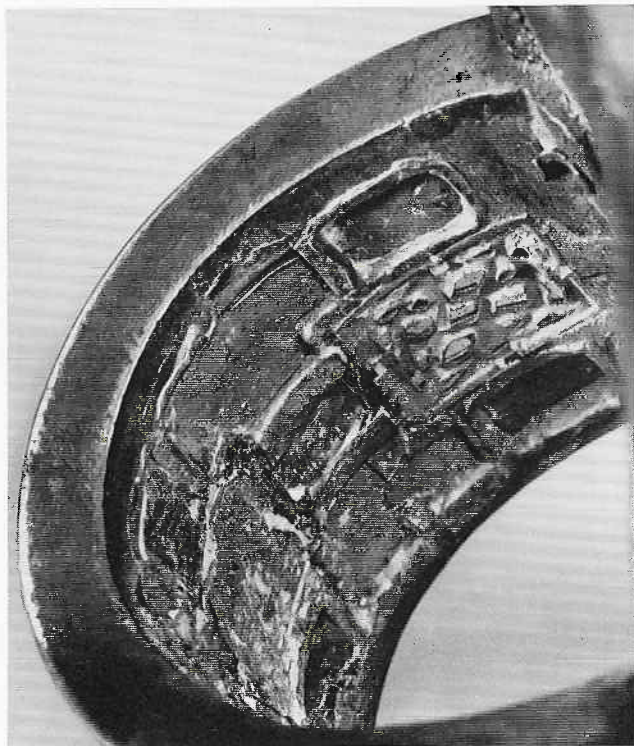
7. The side and exposed interior of one of the handles.

firmed in some objective manner. It was confirmed by an examination of the curvature of the C-shaped flanges on the sides (see fig. 7). Here it can be seen that the "C" is not part of a circle — its radius of curvature varies from point to point. This was quite an important observation because if the handle is not circular, with a readily repeatable curvature, then there is a strong probability that one side of the handle will have a slightly different curvature from the other. It was decided to investigate this.

The trace was then laid against the other parallel flange of the same handle and it was observed that the two curvatures were different. In other words the handle was asymmetric. The trace from the left-hand flange of one handle was then laid against the left-hand flange of the other handle. It was found to fit perfectly throughout its whole length within the width of the traced line — within 0.1 millimeter ( $1/250$  inch). A trace from the right-hand side of one handle was similarly found to match perfectly the right-hand side of the other handle. In other words it could be shown that the two sides of one handle differed from each other but were identical with the corresponding sides of the other handle. This implied that both handles were made from a single pattern by casting. It is most improbable that identical noncircular curvatures would have been achieved so precisely by any other method of fabrication. Other observations were made that rule out other possible forms of construction.

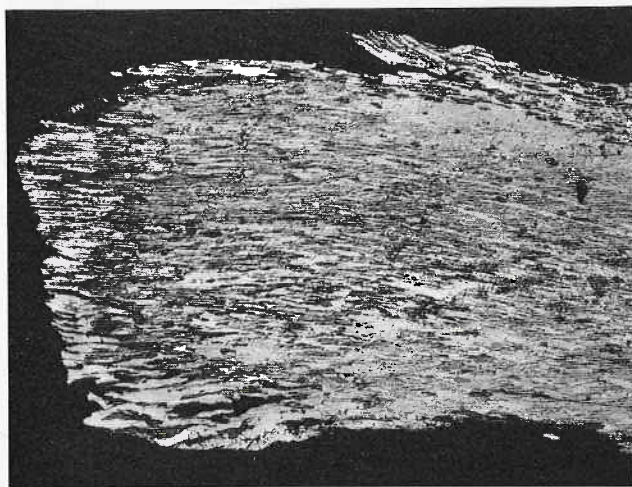
8. A prepared cross-section of a fragment of the silver liner of a handle.

In the photograph the interior of the handle is shown exposed rather unpleasantly because the sheet of silver that covered it had been removed. The next photograph, fig. 8, illustrates the structure of this silver liner. It represents a cross-section through a fragment that has been examined metallographically: polished and examined at high magnification. The smaller dimension of the cross-section shown represents a distance of 0.3 mm ( $1/80$  inch). The metal was examined in order to determine whether it was in fact as ancient as the chalice, about A.D. 800, or whether it represented a piece inserted by Johnson in 1869 — one of the liners appeared at first sight to be more recent than the other. The photograph shows a structure consisting of flattened dendrites. Clearly, the silver had been cast and then reduced in thickness by hammering. This is evidence for a primitive technique of fabri-

cation: modern rolled silver has a quite different structure. Furthermore the silver has become enriched at its surface: the center area of the section appeared pink, consisting of an alloy of silver with much copper, whereas the peripheries of the section are white because they have lost copper and now consist of almost pure silver. The copper-rich phase has been converted during the centuries into the lines of dark mineral that may be seen in between the white crystals of the silver-rich phase, and even these have been lost from immediately beneath the surface at the edge of the fragment, leaving only the white silver-rich metal.

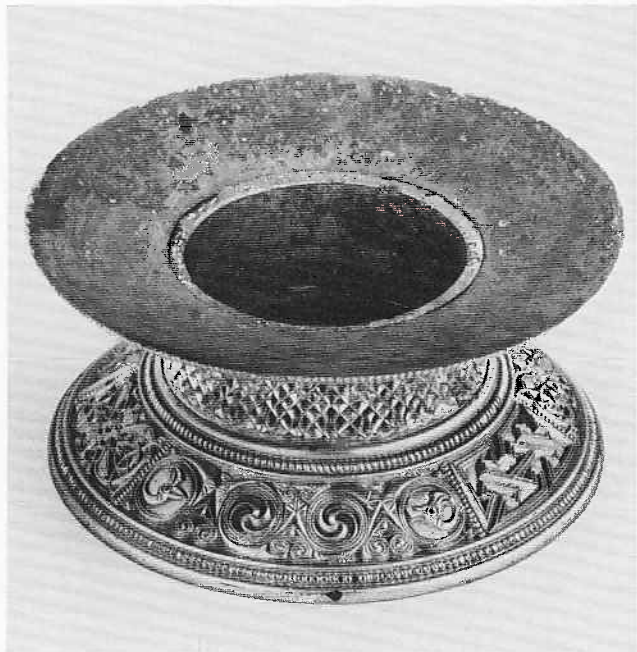
Fig.14 shows the details of the neck assembly. The three components have been decorated externally by the kerbschnitt technique. They fit very closely together: when properly assembled the three could be lifted together as one by grasping the upper ring-mounting alone. The black spot shown at the center of the periphery of the lower ring-mounting represents damage to the gilding. At this point the bronze has lost its protective gilding and has begun to corrode. Damage of this kind was turned to account, as will appear later.

14. The three components of the neck assembly fitted together.

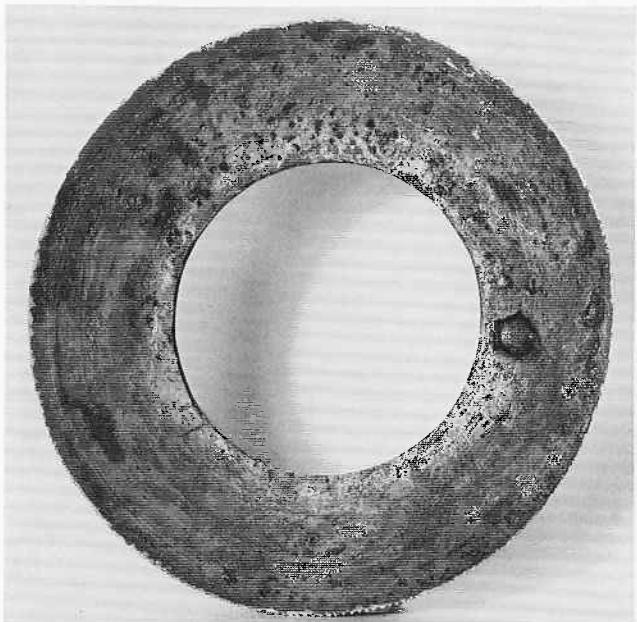
15. The inner surface of the upper ring mounting.

Examination of their inner surfaces revealed that the components had been cast. Fig.15 shows the inner surface of the upper ring-mounting. At about three o'clock a casting flaw is visible, together with many blowholes. At about one o'clock there is also a tiny plug of copper metal that the bronze

founder had inserted in order to fill a particularly deep blow-hole. In fact this plug was found to pass through the entire thickness of the metal to the other side, where it was obscured from casual inspection by the overall gilding. Clearly, this one of the three components has been cast and the other two show similar features. Furthermore, the inner surface has been either turned or stoned down: the circular markings from this process are clearly visible around the rim.

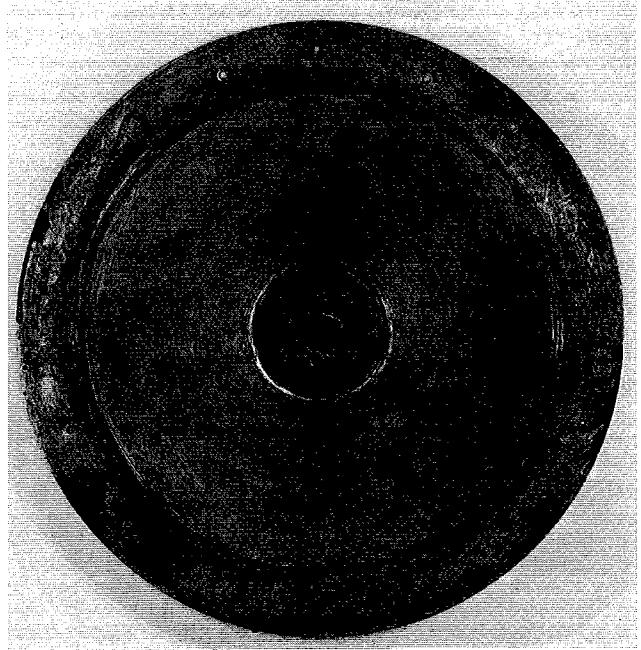
18. View of the foot-cone, decoration removed, from above.

both the straight lines of the grid and, between these, their shadows. The curves of these shadows indicate quite clearly that the slightly concave top has been deformed along the axis of the two side slots in which the iron key was discovered lying loose. It was also observed, in confirmation of this finding, that the whole foot-cone had been distorted slightly along this same axis. It had been "squeezed in." In fact, at the time when the chalice was reassembled temporarily for exhibition at the British Museum, at a time when the significance of this distortion was unrecognized, a pair of tiny pads had to be inserted between foot-cone and lower ring mounting in order to compensate for the distortion and to obtain a rigid structure. Those pads may be seen in fig. 25.

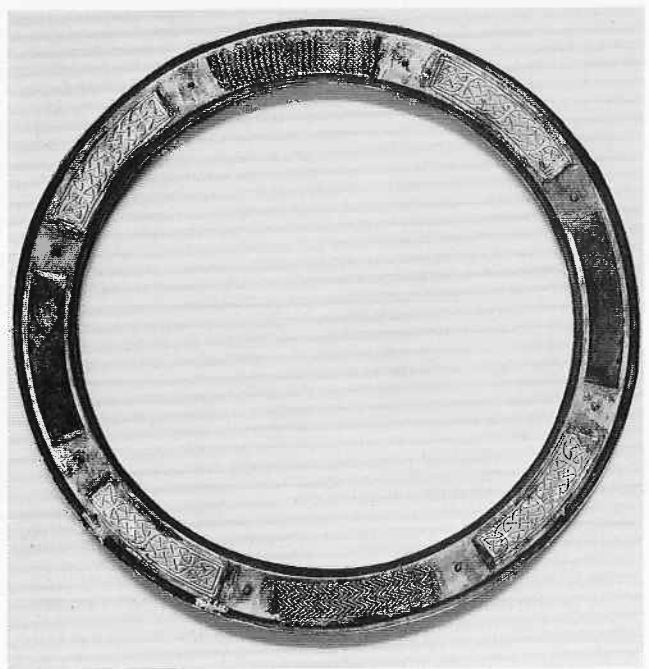
30. The inside of the lower foot-girdle after the panels were reassembled.

and to find at the ends of certain panels minute identification scratches, hitherto unsuspected, that ran off the ends of the panels onto the adjacent silver of the foot-girdle. In this way it could be shown quite conclusively that these panels had been in these particular positions at the time when someone else, perhaps Johnson, marked and dismantled it. This demonstration was further justification for the policy of making detailed photographic records of parts of the structure that would be hidden after reassembly.

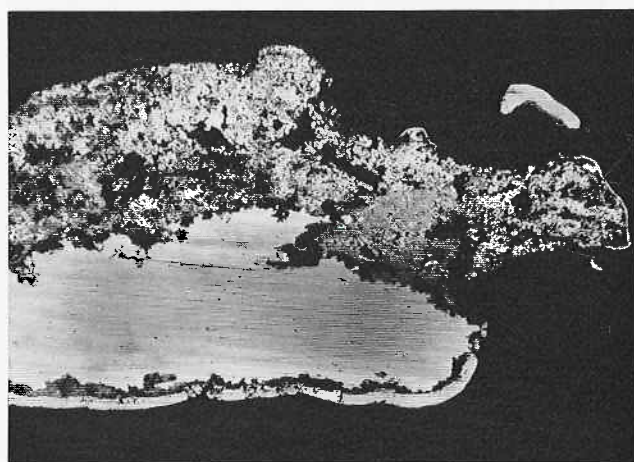
33. A cross-section of a fragment of one of the gilt openwork bronze panels in the upper foot girdle, unetched. The length of the part of the fragment shown was about 0.9 mm.

Fig. 33 represents a cross-section of a fragment of one of the panels, a fragment found attached only by a thread of metal. The white area of the picture represents unetched polished metal. The upper area of darker material contains mineral corrosion products. These minerals no longer have the usual appearance of such corrosion crusts. The panel appears to have been cleaned by dipping in acid, presumably by Johnson, and to have been altered by this. Other points of interest are, first, the thick white line on the surface that appears at the bottom of the photograph — this is original gilding about 0.02 mm thick (less than  $\frac{1}{1000}$  inch); second, a thin white line on the right hand side. This is newer gilding, perhaps by Johnson, 0.002 mm thick, similar in thickness to the gilding found on the catch-disc beneath the crystal shown in fig. 24.

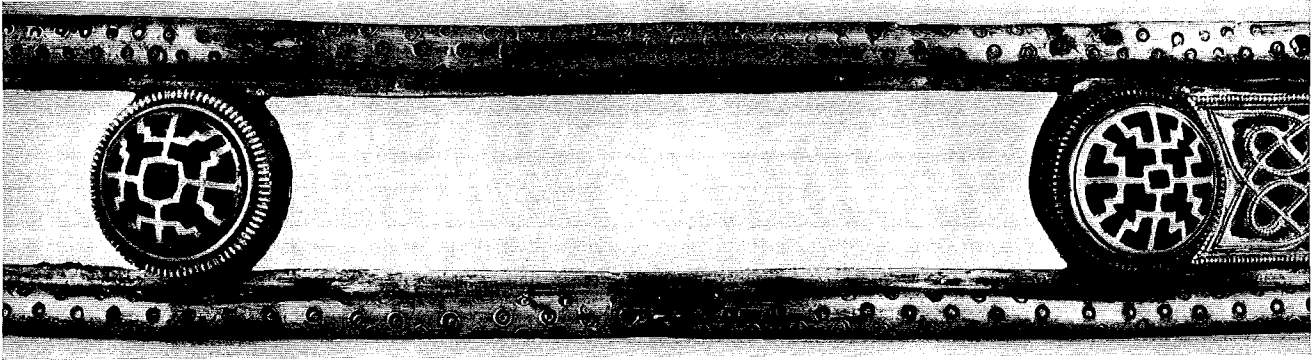
In fig. 37, in the upper length of a short portion of the girdle, there can be seen to the right of the left-hand stud, a length of inserted silver that is very much whiter than neighboring metal. In fig. 38 the same length of silver and its parallel fellow when seen from the back have clearly been soldered into place with hard solder. Next, consider the panels that were set in the long apertures in the girdle. They consisted of three types; one, shown here (fig. 39) and later described as of "C-pattern," was zoomorphic. The panel was made up in three layers, first the lines of the design ridged up in gold in the pressblech manner with the intervening background cut away; second, lying along the top of the ridges, soldered on, was a treble layer of beaded wires, only the top row being visible in the photograph at first sight but all three being clearly present on close examination; third, backing the open-work pattern was a plate of gilt copper, taken away for the purpose of making this photograph. Of especial interest in fig. 39, in the lower left hand quadrant, are two cones of twisted wires, the left-hand one broken off. Details of their method of construction will be presented later. Around the panel, beyond the bordering beaded wire, was left a narrow flange that would have prevented the panel from falling through the containing aperture in the original design. Although beaded wire was mostly used, certain details of the design have been filled in with twisted wire.

37. Frontal view of a short length of the curved bowl girdle between studs known as III 1 and I 6.

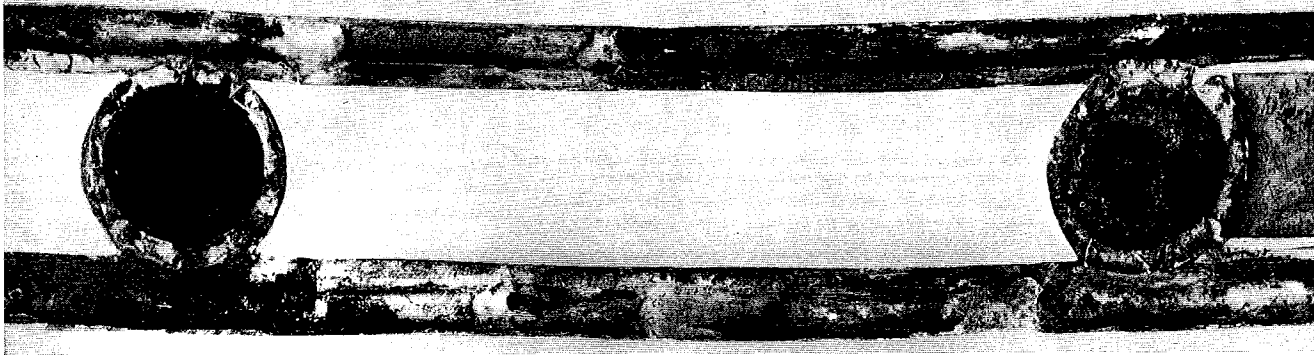
38. Interior view of same length as shown in fig. 37.

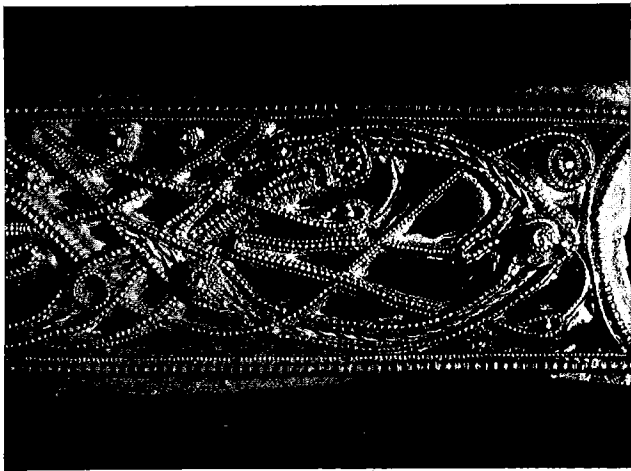
39. Detail of portion of zoomorphic panel from bowl girdle, type C.

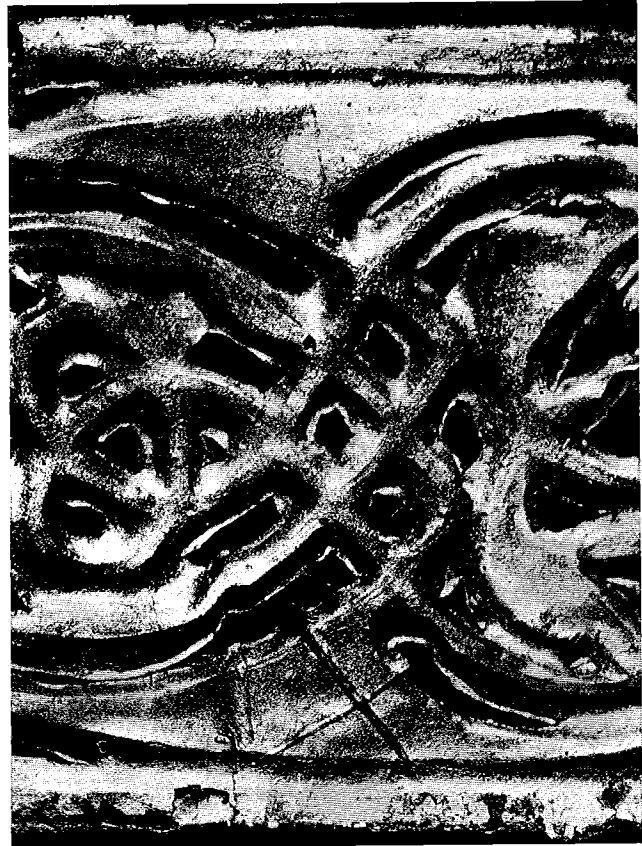
Fig. 40 present a view of part of the back of this same panel that supports the belief in a pressblech manner of construction. Even the sharp edges of the die against which the gold sheet was pressed can be discerned here along the lengths of the hollows. There is also visible a numeral, X, scratched at the top. This and similar numerals caused much perplexity, as

40. Detail of the back of the panel shown in fig. 39.

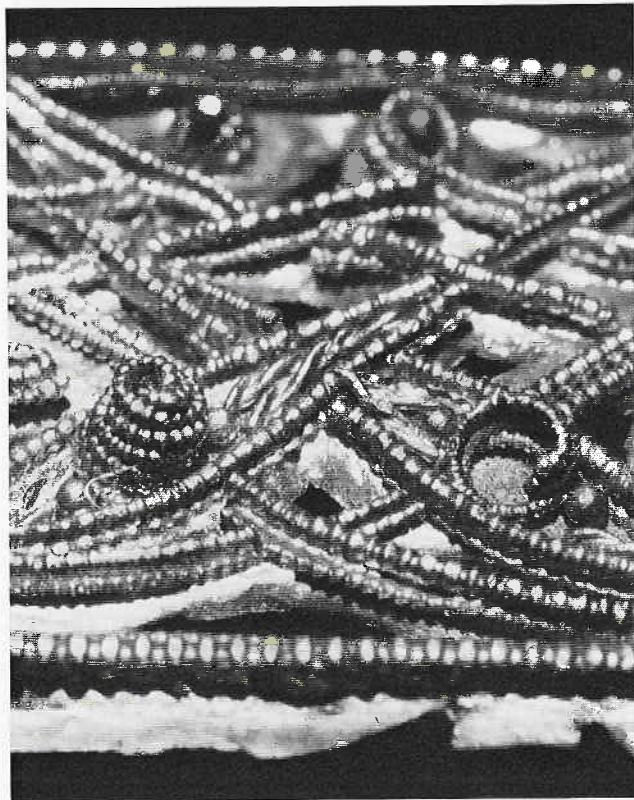
41. Close-up view of the pair of cones shown in fig. 39.

will be discussed later. Fig. 41 is a close-up view of the pair of cones made of twisted wire described above. They have clearly been made by coiling up a pair of beaded wires. Fig. 42 shows another pattern of panel, one that has been described as type A — an ornithomorphic design. This is fabricated in a manner identical with that of the other panels. Notice also that the overall visual effect is very similar to that of the preceding panel, type C. This observation became of considerable importance when the question of arranging the panels arose at the time of reassembly. The third design of panel, fig. 43, type B, consisting of knot-work, has a quite different visual effect and stands out quite clearly from a group of all three types.

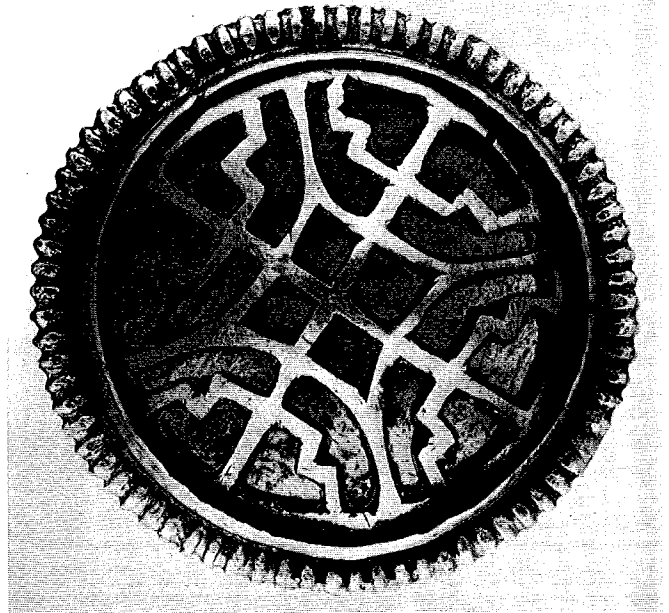
Fig. 50 illustrates the central stud in the roundel on the other side of the bowl. A certain amount of damage had been done here, with the result that where the central silver grille had been torn away the glass of the stud had been exposed. The stud contains both red and blue glass. It could be seen that the red glass has been inserted into spaces in the grille and that the blue glass in a plastic condition has been pressed in behind it in order to fill all of the remaining cavities.

The damage here appears to have been done by someone in search of information. A less destructive method of examining a stud would have been to push it slightly forward in its mount so that the edge of the silver grille was exposed. The thickness of the exposed edge could then have been measured by means of a microscope. In fact, on preliminary examination a stud was found that had been pressed forward in this manner. Advantage was taken of this to measure the thickness of the grille, 0.1 mm ( $1/250$  inch). There does exist, however, a general method of examination that is completely nondestructive. The next photograph, fig. 51, illustrates another stud, photographed while it was immersed in toluene so that the glass can be seen clearly without the confusion introduced by surface scratches. Here the actual thickness of the peripheral

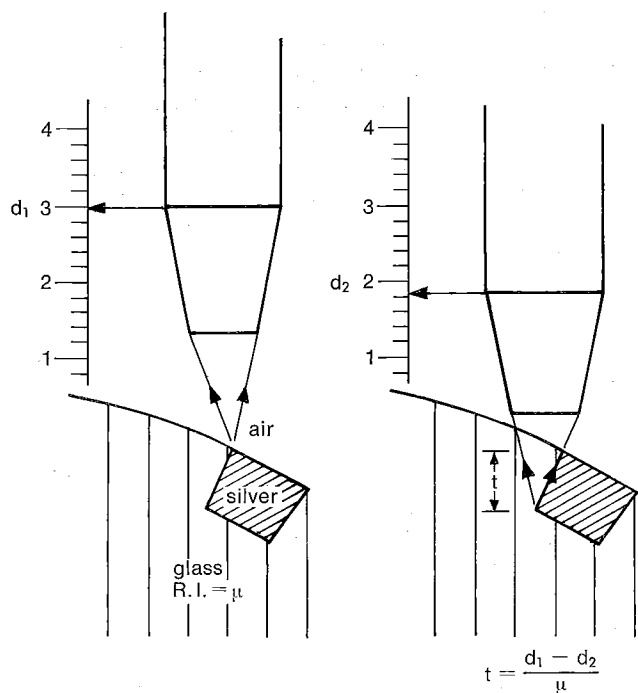
52 Method of measuring the approximate thickness of the silver grille without damage to the stud.

edge of the silver grille can be seen. In these circumstances it was not difficult to focus a suitable microscope first of all on the upper edge of the grille and then on the lower edge (fig. 52). By measuring the travel of the microscope between these two positions the thickness of the silver may be estimated. Details of the method are indicated in the illustration. A suitable factor has to be applied to compensate for the refractive index of the glass, but this need not be known very precisely.

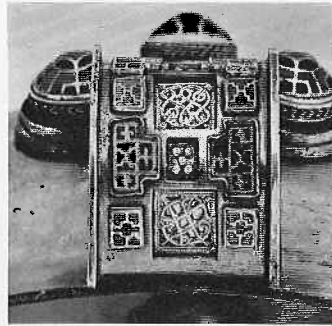
57. Some of the decorative studs in one of the handles.

Fig. 57 presents the decorative studs set in one of the handles. Here a central vertical row of gold filigree panels is flanked on two sides by mirror-twin pairs of rectangular studs. All of the studs except those two across the middle of the field of view have silver grilles in their faces. The two exceptions have grilles made of red glass. Unfortunately the red has corroded extensively. Certain of the studs were made of pale blue transparent glass (two of these may be seen on edge on the curve of the handle). These were both backed by silver foil, but only one of the two foils was embossed. It was necessary to photograph this from inside the handle, for the benefit of posterity, while the silver liner of the handle that normally ob-

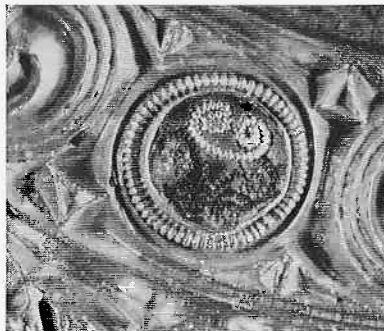
59. A blue glass stud from the under-foot disc that retains only one of its three gold beaded-wire decorations.

Fig. 59 shows yet another kind of stud: one of the five found in the underfoot mounting. Only two of the five still retained any of the gold beaded-wire decoration, and in this photograph only one of the coiled wires remains, but the shapes of the other two are retained in the glass stud. These indicate conclusively that the glass was pressed around the beaded wires while it was in a viscous condition. A little thought about this design will indicate that the shapes of these three coiled beaded wires were perfectly adapted to the method of construction of the stud. Placed back to back inside a hemispherical mold the three would slide to the bottom and align themselves symmetrically in contact while the viscous glass could be pressed in to fix them in place.

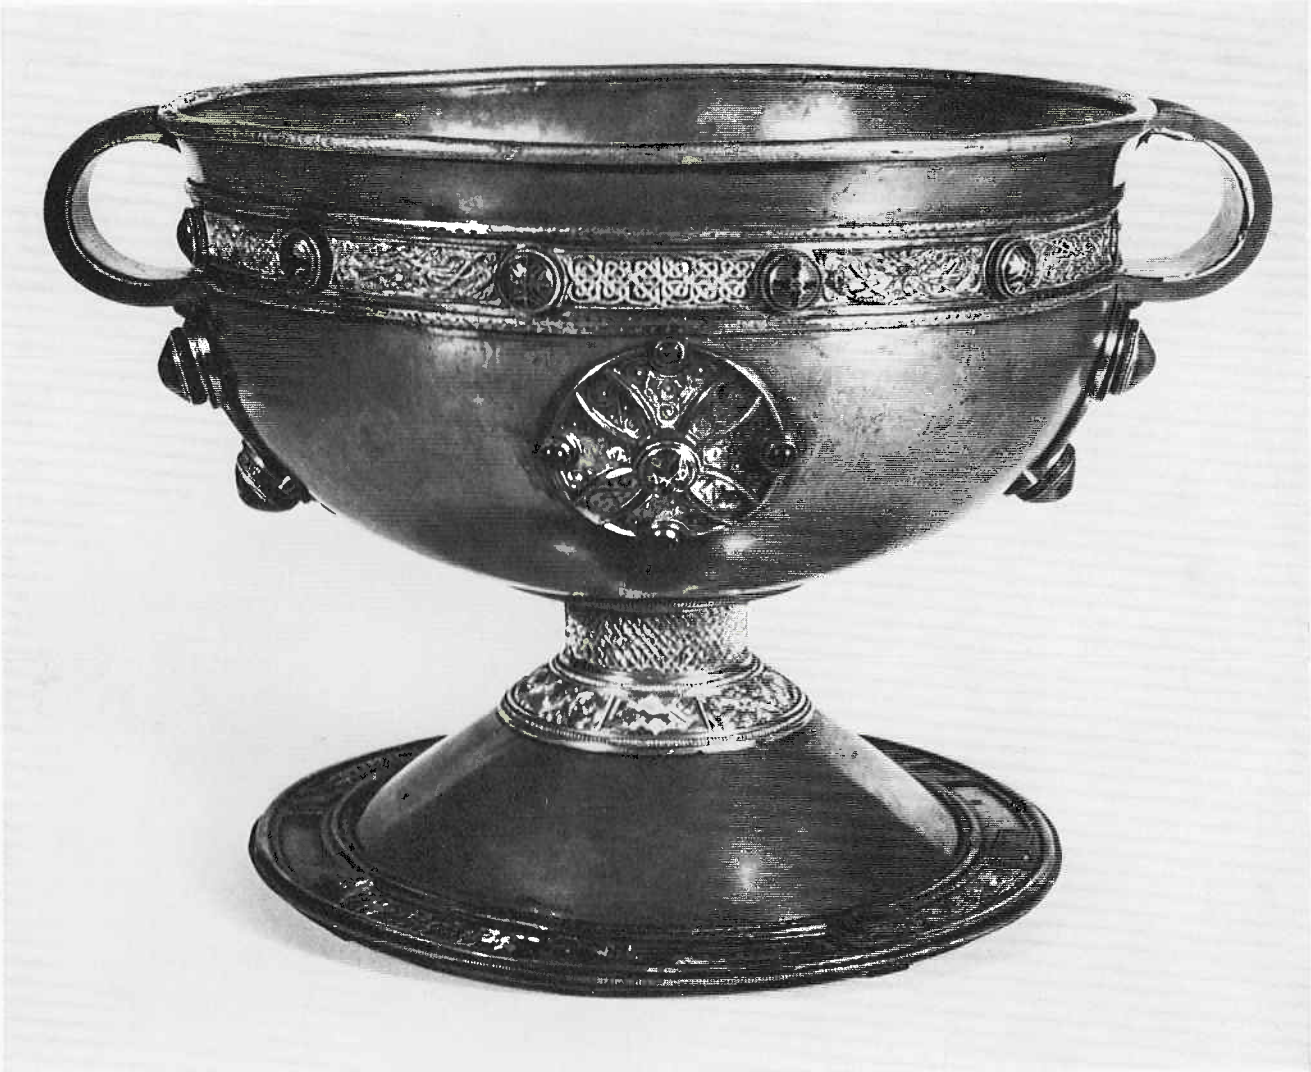
67. The other side of the chalice as it was received.

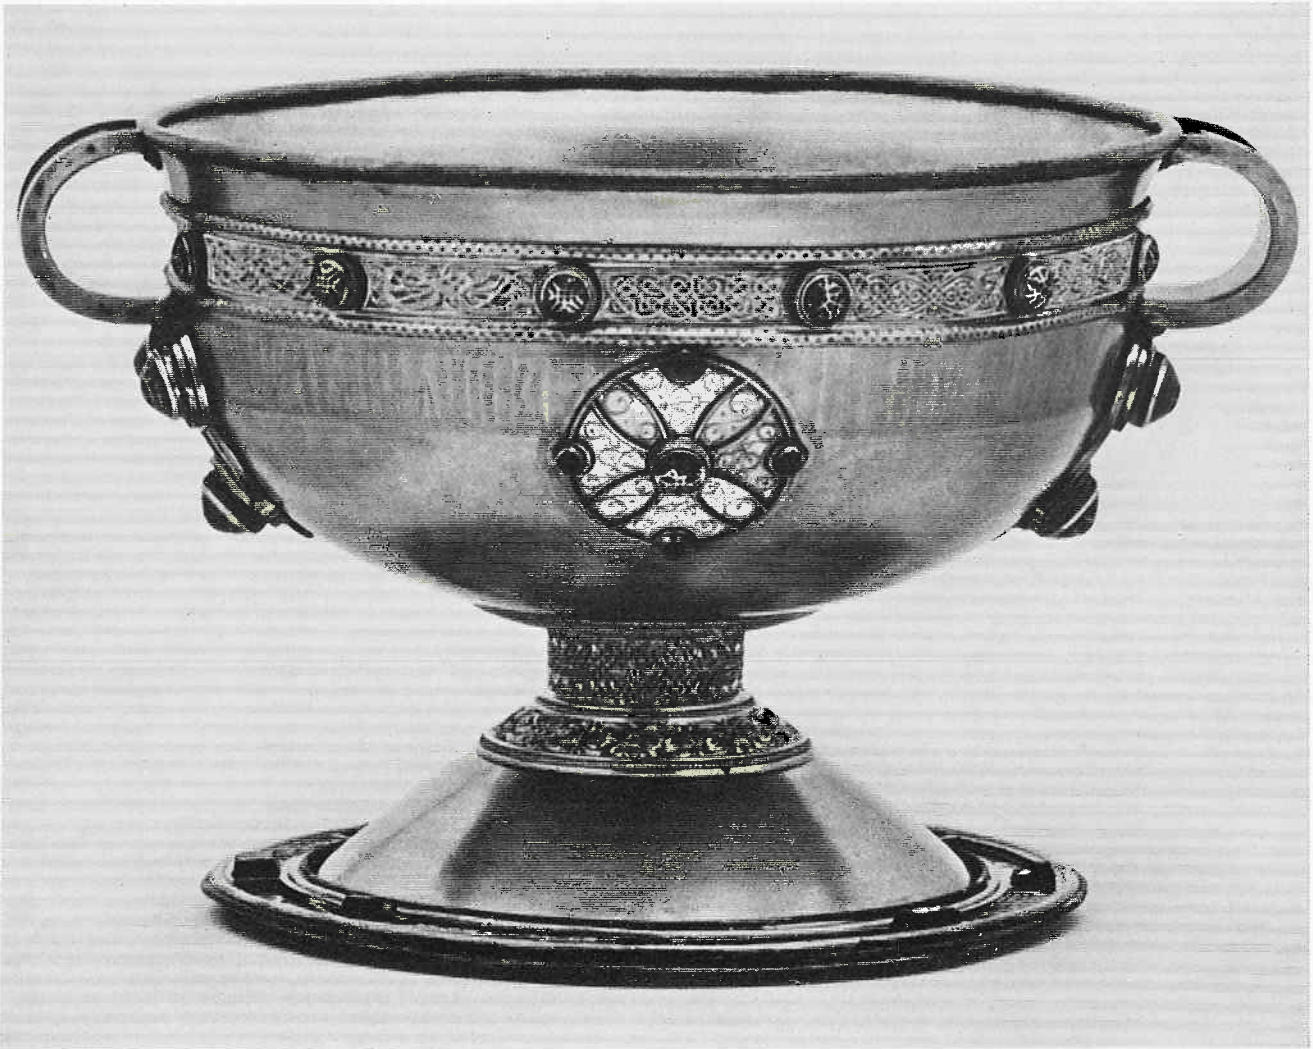
68. One side of the cleaned and reassembled chalice.

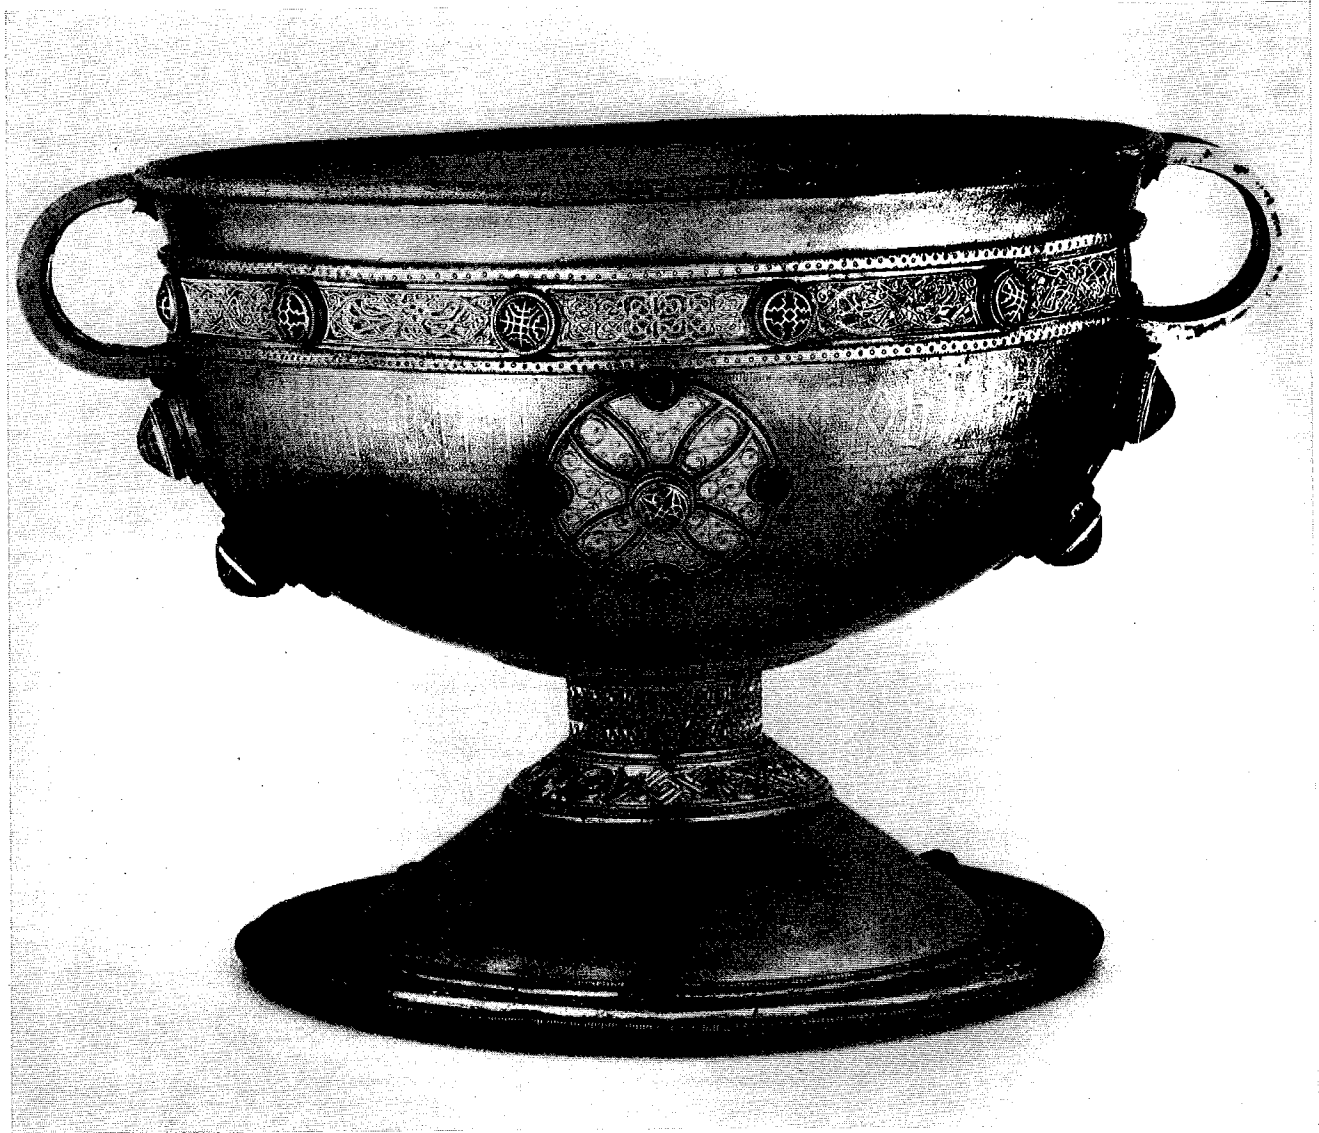
69. The other side of the cleaned and reassembled chalice.
