A Question of Technique: Condition Issues Associated with Layering Structure in Richard Diebenkorn's Ocean Park Series

ABSTRACT

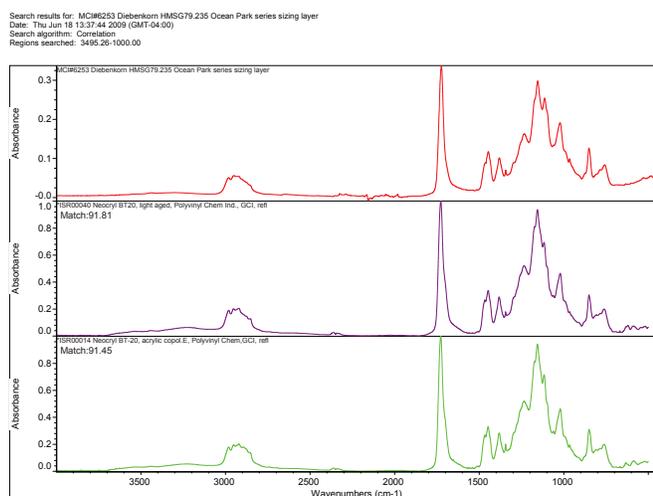
Cross sections from *Ocean Park No. 111* indicate that the unpigmented resin layer described earlier was applied directly to the entire surface of the canvas, presumably as a size to protect the fabric support. Another possibility is that Diebenkorn wanted to create a smooth surface on which to work, as the resin completely masks the canvas texture. Fourier transform infrared (FTIR) analysis of a sample of the resin layer taken from a tacking margin identified it as an acrylic; specifically, a poly-ethyl acrylate-methyl methacrylate copolymer (pEA-MMA) such as Rhoplex. Rhoplex AC-33 is a likely candidate as the material was widely used by artists during the 1970s and 1980s. Figure 3 shows the spectra of a sample from *Ocean Park No. 111* compared to that of Neocryl BT-20, a bulk pEA-MMA resin. The shape of the C-H stretch region, around 2800-3100 cm^{-1} , is an indication of an acrylic resin, as is the location of the carbonyl peak at 1732 cm^{-1} and the shape of the fingerprint region. Pyrolysis-Gas-Chromatography-Mass

Figure 3. Comparison of the FTIR spectrum for the clear synthetic material in *Ocean Park No. 111* and two spectra for bulk ethyl acrylate methyl methacrylate acrylic emulsion (Neocryl BT-20 from DSM NeoResins).

Spectrometry (Py-GC-MS) verified the identification of the sample as a pEA-MMA resin.

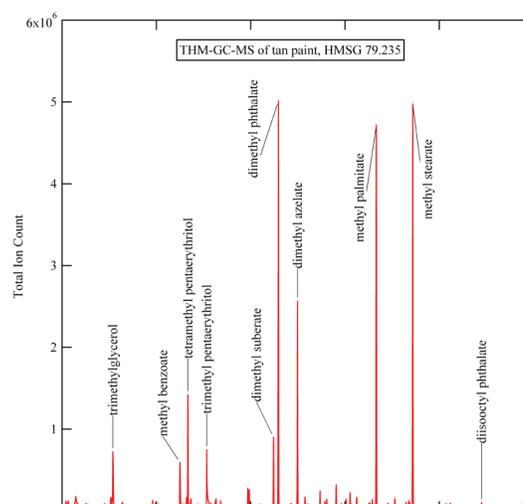
FTIR and Py-GC-MS analysis identified the paints that Diebenkorn used as oil-modified alkyds. Peaks identifying the pentaerythritol backbone of an alkyd are clearly visible in the pyrogram from a sample of the tan paint taken from the surface of the painting (fig. 4). In several of the paint samples identified as alkyd paints, there also seems to be a peak at $\sim 1160\text{ cm}^{-1}$ that suggests there is some free oil as part of the paint composition that may indicate an added artist's oil medium or paint. Additionally, the identification of pigments and the absence of filler materials characteristic of alkyds indicate that the artist occasionally alternated alkyd paint layers with artists' oil paints.

Figure 4. Pyrogram for a sample of tan paint taken from the surface of *Ocean Park No. 111* with the characteristic peaks noted.

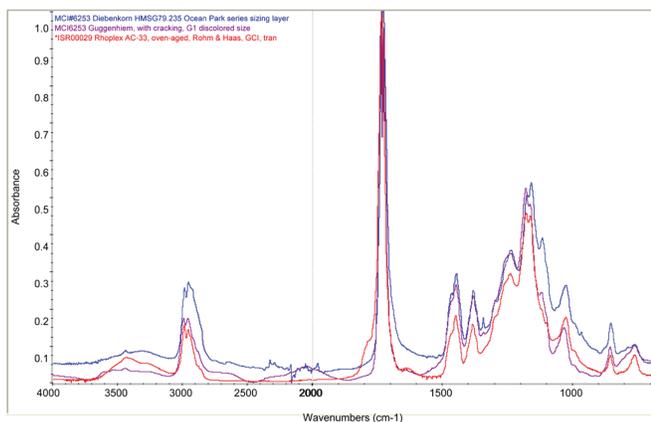
The unpigmented acrylic resin size layers found in both *Ocean Park No. 111* and *Ocean Park No. 96* were compared using FTIR. Figure 10 shows their spectra compared to aged Rhoplex AC-33. As shown, the three materials share the same characteristic peaks. Furthermore, samples of the resin size material taken from two additional Ocean Park paintings were identified as poly(ethyl acrylate-methyl methacrylate).[2]

Figure 10. Comparison of FTIR spectra for the synthetic preparatory material from *Ocean Park No. 111* and *Ocean Park No. 96* to aged Rhoplex AC-33.

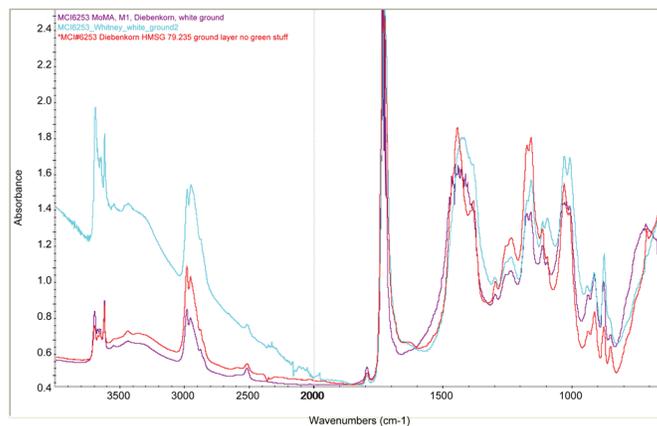
The grounds of *Ocean Park Nos. 111, 115*, and *125* were all identified as acrylic gesso. Figure 11 shows their comparative spectra. Interestingly, the grounds of *Ocean Park No. 115* and *Ocean Park No. 125* were commercially primed while that of *Ocean Park No. 111* is an acrylic that the artist applied by hand based on the fact that the ground does not extend over the tacking margins. As mentioned previously, the preliminary white paint layer from *Ocean Park No. 96* is probably an oil-based alkyd based on pigment and filler composition.

Figure 11. FTIR spectra for ground samples from *Ocean Park Nos. 111, 115, and 125*. The comparison illustrates the similarities of the acrylic ground layer in the three paintings.

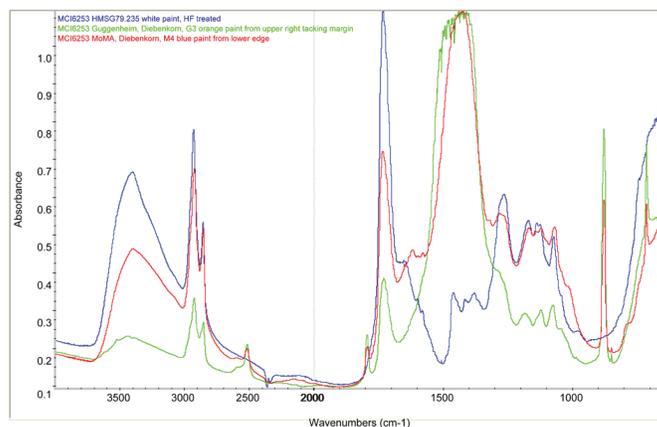
comparison of the FTIR spectra of paint samples from *Ocean Park Nos. 111, 115, and 96*. All three show a broad peak from 1260–1280 cm^{-1} , typical of alkyd paint binder (Ploeger, Scalzone and Chiantore 2008). The alkyd peak at between 1260 through 1280 cm^{-1} in the spectrum of a paint sample from *Ocean Park No. 96* is partially obscured by the large calcite peak. Very small peaks or shoulders were visible in a number of the paint samples from the three paintings at 1600 and 1582 cm^{-1} , indicating the presence of phthalates, one of the components of an alkyd paint. The location of the carbonyl peak at 1732 cm^{-1} instead of 1740 cm^{-1} for oil based paint found in all of the spectra is also indicative of an alkyd binder. Py-GC-MS analysis of four samples from *Ocean Park No. 111* confirmed the presence of oil-based alkyd paint.

Figure 12. FTIR spectra of alkyd paint samples from *Ocean Park Nos. 111, 115, and 96*.
