SMITHSONIAN INSTITUTION  
BUREAU OF AMERICAN ETHNOLOGY  
BULLETIN 92

# SHABIK'ESHCHÉE VILLAGE

A LATE BASKET MAKER SITE  
IN THE CHACO CANYON  
NEW MEXICO

FRANK H. H. ROBERTS, JR.

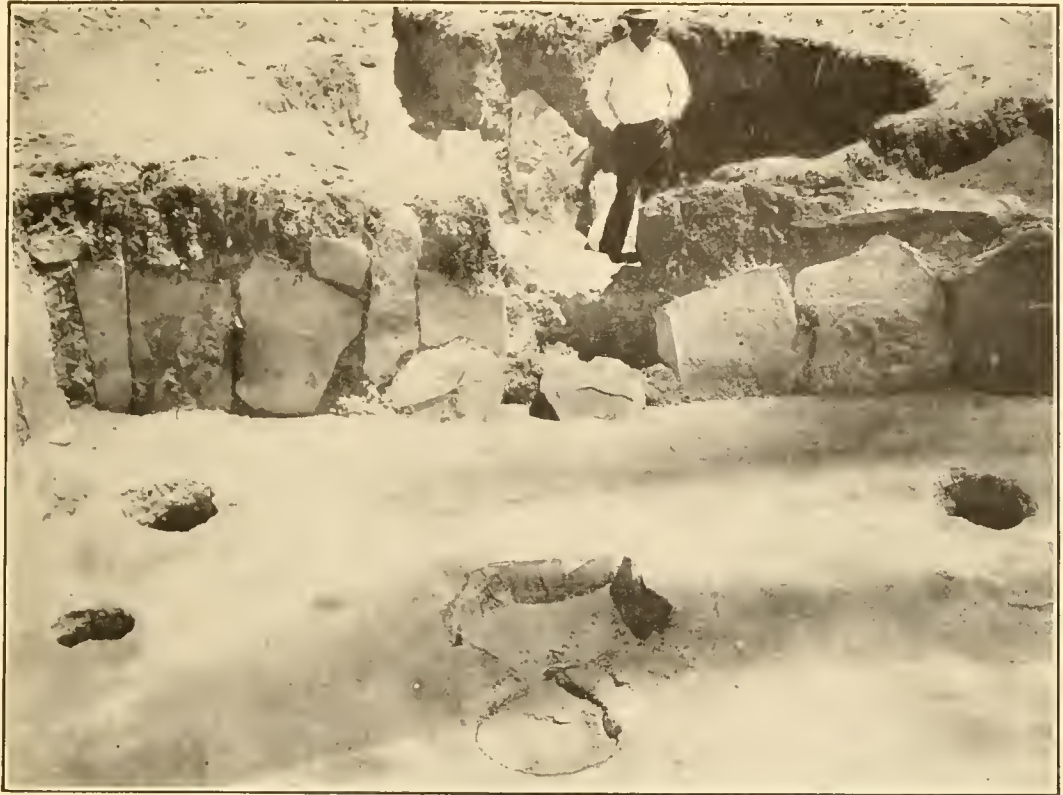
*a*, House A

A good example of the rectangular dwelling was found in house A. (Pl. 2, *a*; fig. 1.) All that remained was the excavation, but there was sufficient evidence in the débris-filled interior to indicate what the structure had been like. Large slabs had been used to line one and portions of two other sides of the excavation, the remainder having had the plaster applied directly to the native earth.

In the floor, about 2 feet (60.96 cm.) from each corner, were four holes containing fragments of decayed wood; the remains, no doubt, of posts which had supported the upper walls and roof. Judging from the size of the holes the posts must have averaged about 10 inches (25.4 cm.) in diameter. These roof supports had been placed approximately in the directions of the four cardinal points of the compass.

Near the center of the room of house A was a rectangular fire pit lined with small stone slabs with the tops flush with the plastered floor. It was well made but quite shallow. Close to the fire pit, in almost the exact center of the room, was a small oval hole filled with clean sand. Just what its purpose was is not clear. There was a similar feature in a majority of the houses. It is possible that it represented the same thing as the small hole found in about the same position in the floors of later-day kivas. The latter, called the sipapu, symbolized the mythical place of emergence through which the Hopi, Zuñi, and other southwestern Indians believe their ancestors passed on their journey from the underworld to the surface of the earth. It may well be that in the days when Shabik'eshchee village was inhabited each house had its own shrine, whereas in later times it was deemed essential only to the ceremonial house, the kiva. A more practical explanation would be that it was merely a place to set vessels where the heat from the fire would keep their contents warm. The rounded bottoms of the containers would necessitate some support to keep them in an upright position, and a hole filled with sand would admirably serve such an end. Because of the small

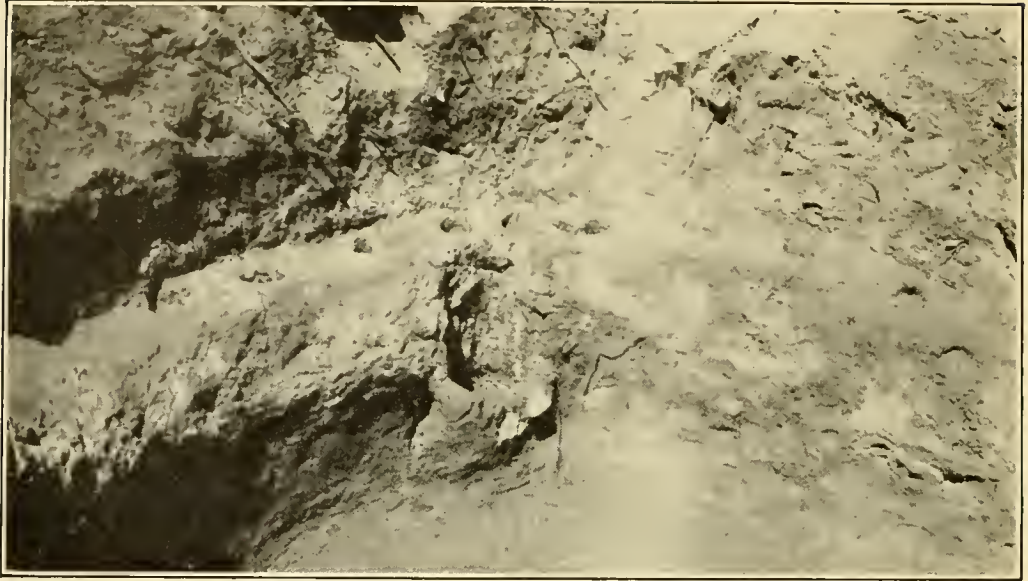
*a*, Bench at top of wall, showing holes for roofing poles

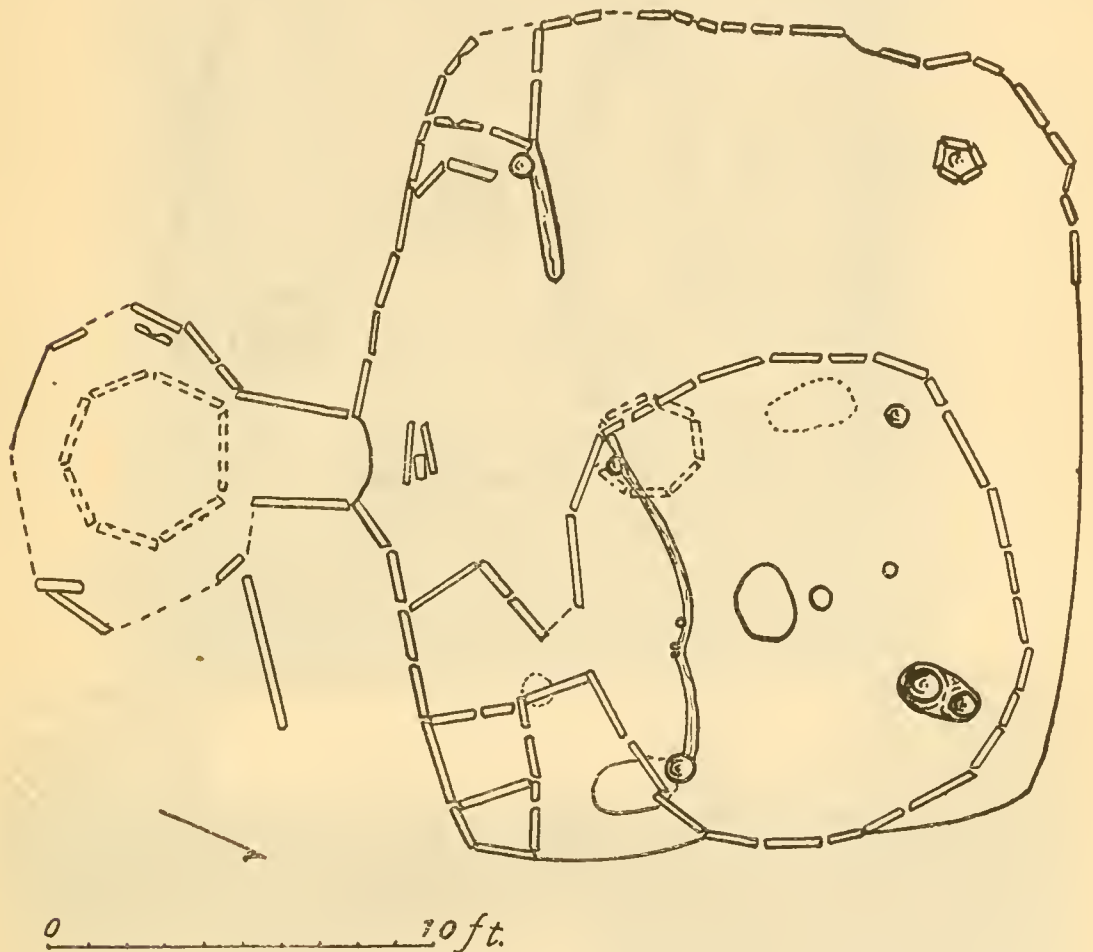
FIG. 7.—Plan of the F House group, showing both structures in complete relationship

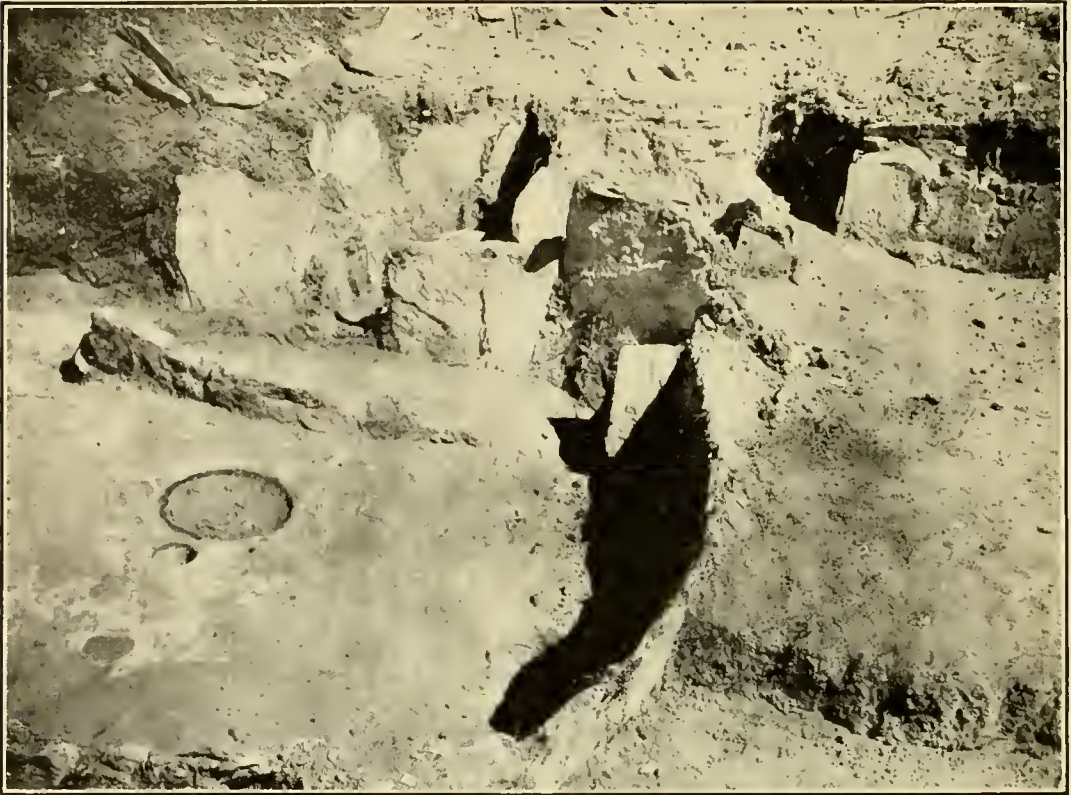
*a*, House F-1 during excavation. Rough masonry may be noted at sides of doorway. House F in left foreground

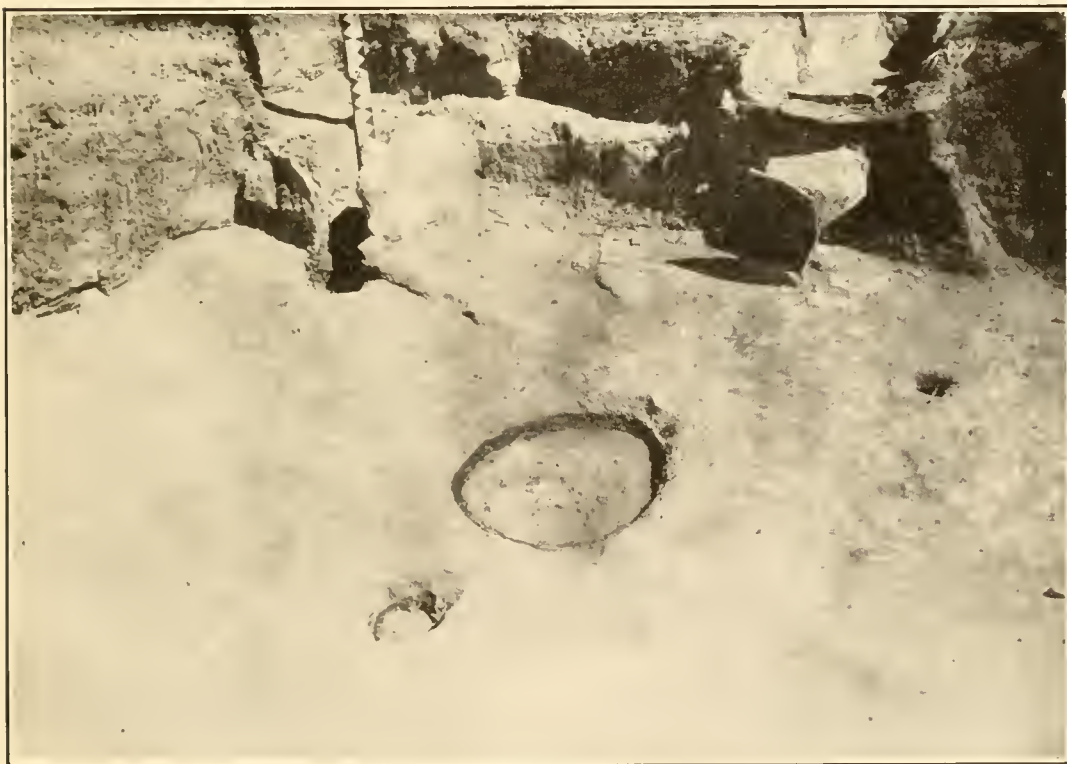
*b*, House N

House N measured 12 feet 6 inches (3.81 m.) by 14 feet 6 inches (4.4196 m.). There seemed to have been some difference between the wall heights on the north and south sides of the room. The north slabs were 1 foot 6 inches (45.72 cm.) high on the average, while those on the south side had been 2 feet (60.96 cm.). The tops of many of the slabs on the south side had been broken off.

The sipapu was  $8\frac{3}{4}$  inches (22.22 cm.) in diameter and 8 inches (20.32 cm.) in depth. From the edge of the sipapu to the edge of the rim around the fire pit was  $8\frac{3}{4}$  inches (22.22 cm.). The raised rim averaged 5 inches (12.7 cm.) in width and  $2\frac{1}{2}$  inches (6.35 cm.) in height. The fire pit was roughly circular in form and measured 2 feet (60.96 cm.) on a north and south diameter and 2 feet  $3\frac{3}{4}$

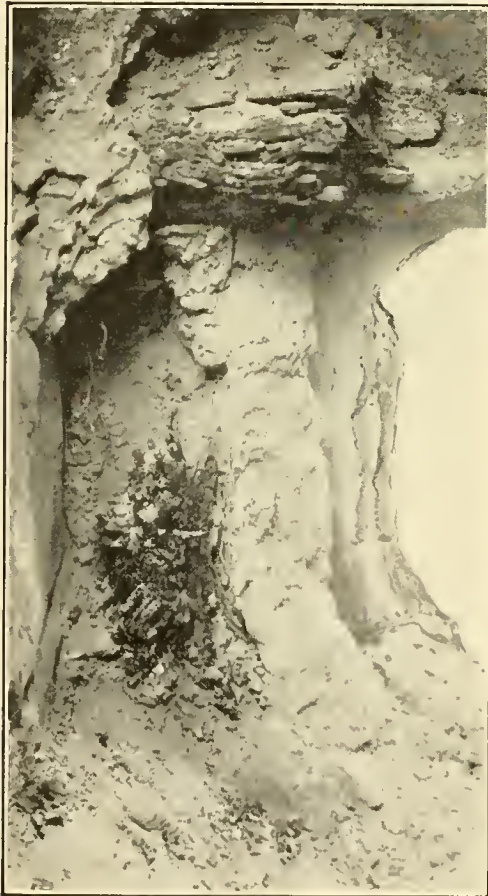
b, Doorway from passage side. Note timbers for passage covering, also plaster reducing size of doorway

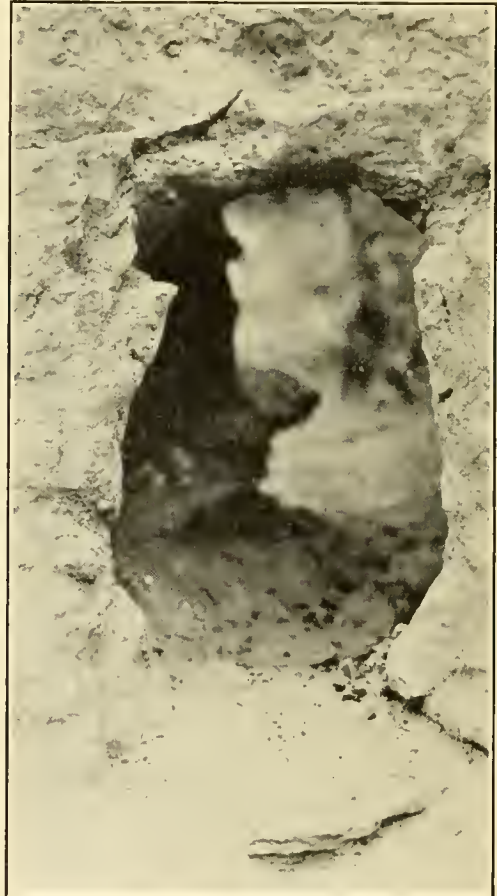
c, Doorway from room side. This picture shows the manner in which the original opening was later reduced in size by use of plaster

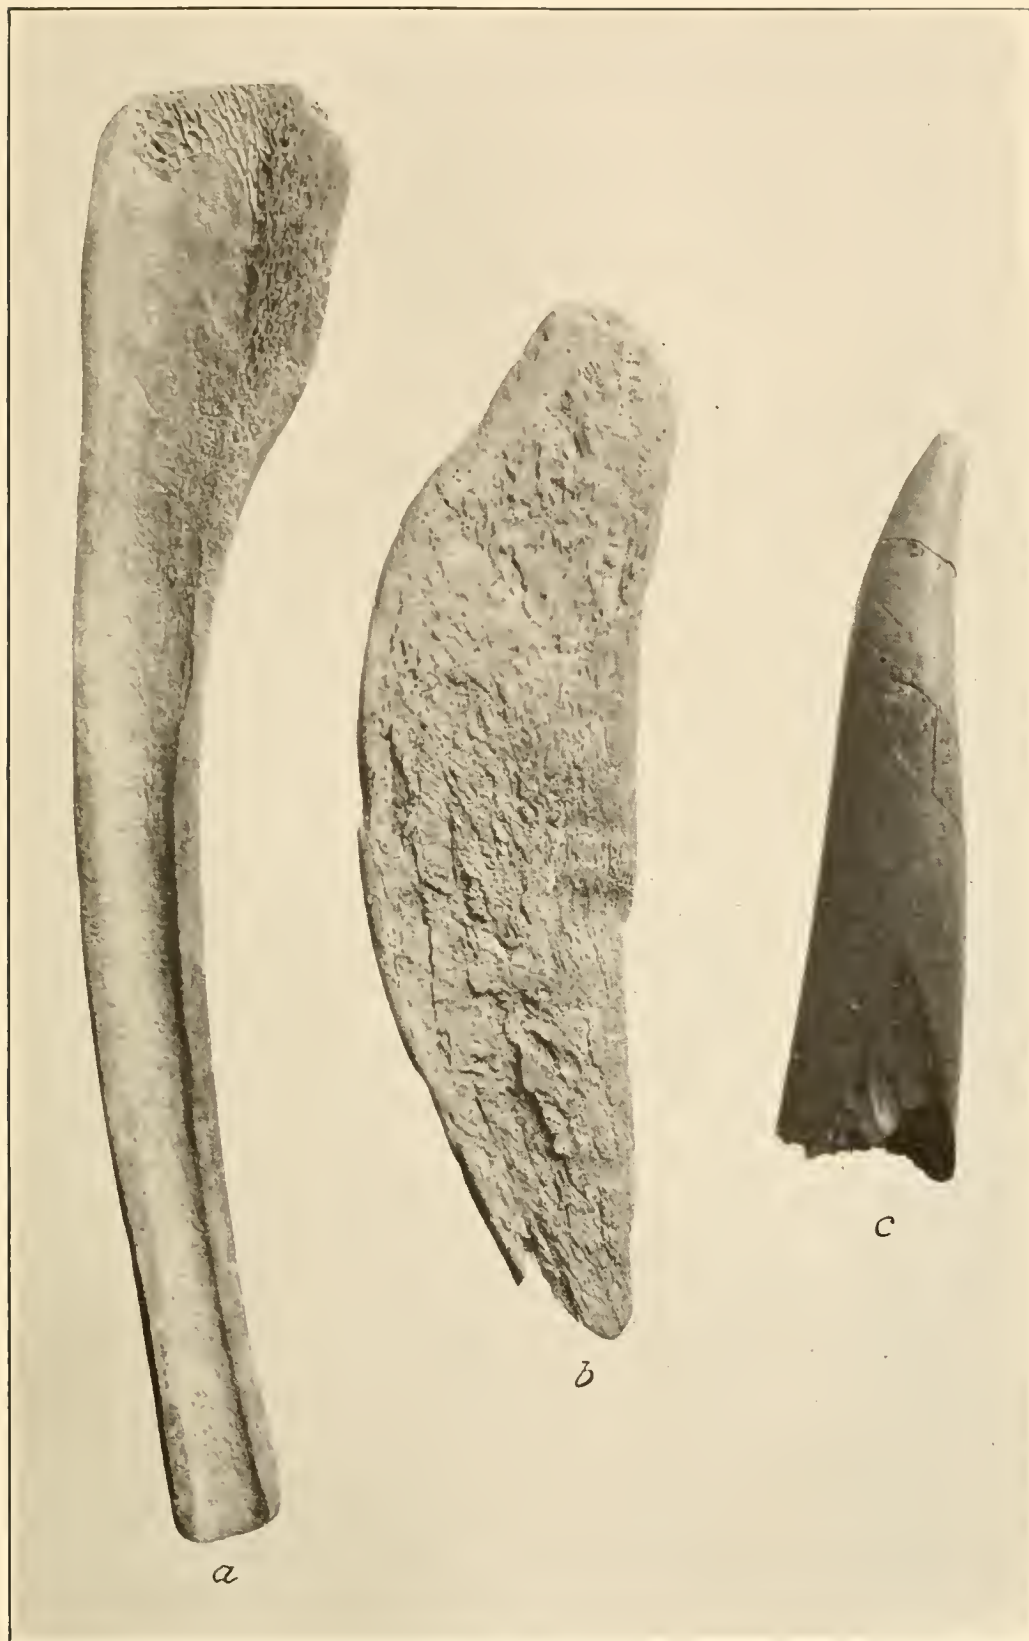
**BONE IMPLEMENTS**

*a*, Spoon spatula, 10 inches (25.4 cm.) in length. *b*, Scraper or dressing tool. *c*, Flaker

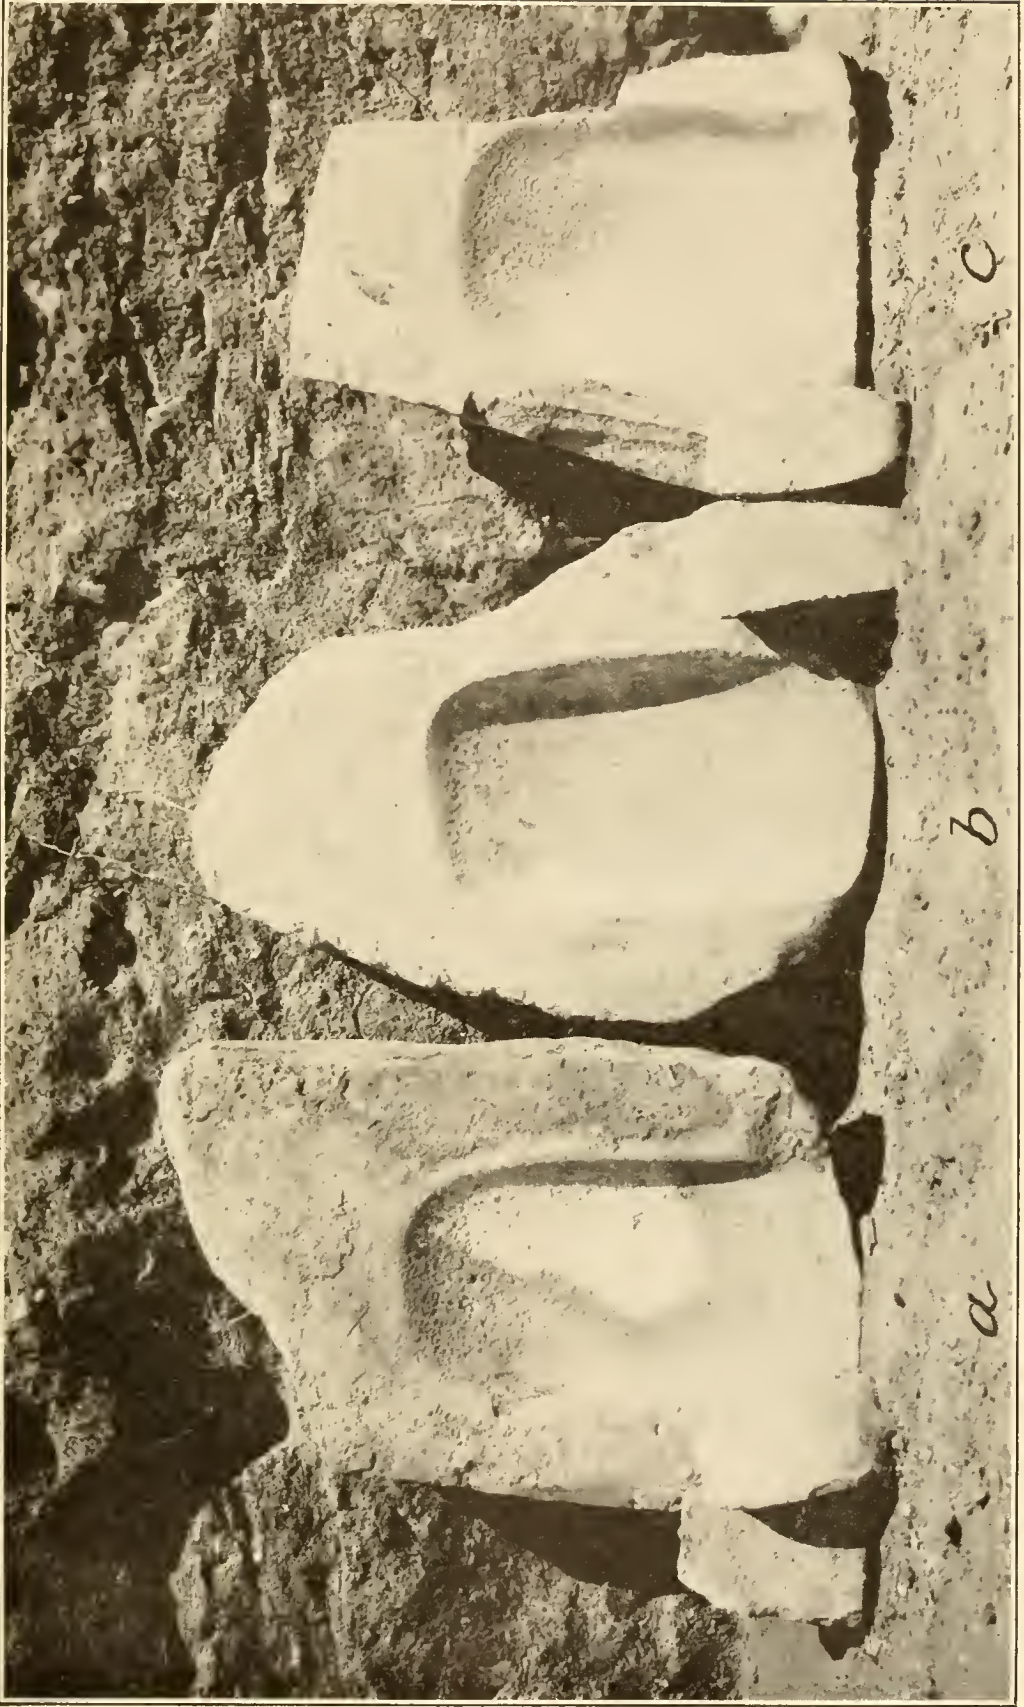
STONE OBJECTS, METATES

The metates or milling stones were all of the same general type and quite characteristic in form. (Pl. 26.) They were made from comparatively thin slabs of sandstone, and except for the groove or

trough pecked down the center of one side were unmodified. Because of the thinness of the rock from which they were made, it was not possible to work out a very deep groove. The life of a single metate would not be very long, either, because the trough could only be pecked and roughened a few times before the bottom would become too thin for use. In many cases a small hole was worn completely through the bottom of the groove. The rapidity with which this type of metate would wear out probably accounts for the large number of them found among the slabs used to line the excavated portions of the houses.
