SMITHSONIAN MISCELLANEOUS COLLECTIONS
VOLUME 147, NO. 1

THE ARCHITECTURE OF PUEBLO BONITO

NEIL M. JUDD

CITY OF WASHINGTON
PUBLISHED BY THE SMITHSONIAN INSTITUTION
JUNE 30, 1964

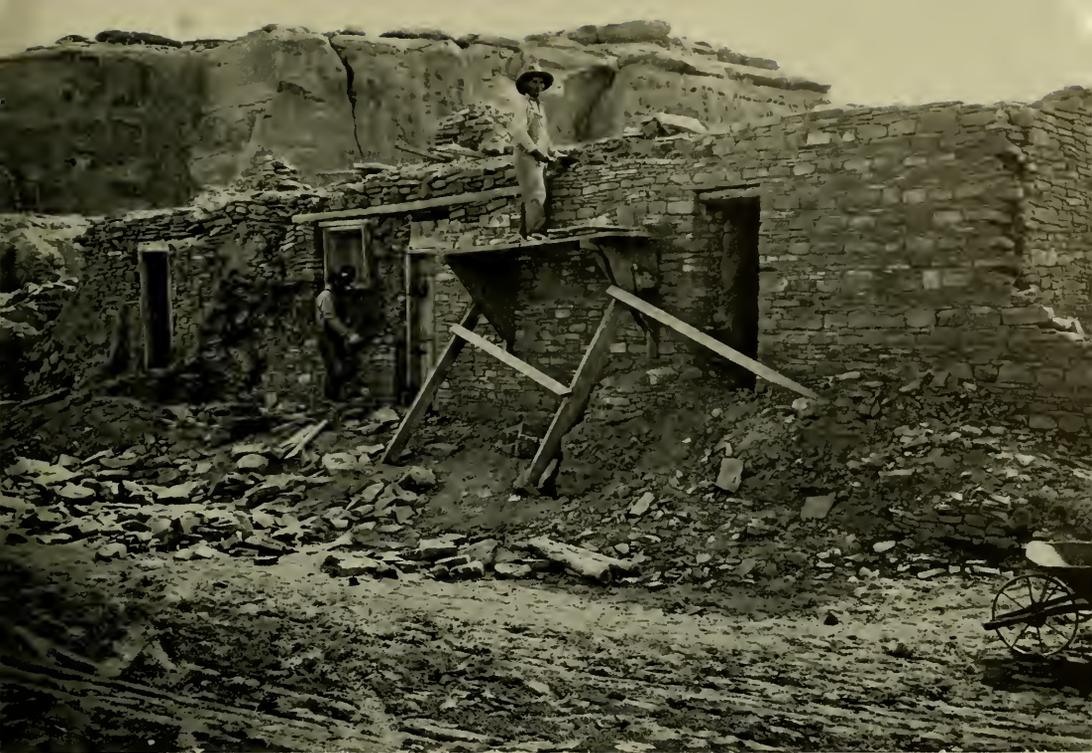
PLATE 4

Upper: Rooms 122-124, rebuilt by Richard Wetherill, were repaired by the Pueblo Bonito Expedition for laboratory use.

Lower: An apparently unfinished wall in the southwest corner, East Court, overlay older structures. Above, the exterior of Rooms 150-152 with ancient repairs.

were revamped and reroofed for occupancy. These same rooms were later utilized by the School of American Research (Hewett, 1921, p. 12), and they were still habitable when we repaired them for laboratory use in 1925 (pl. 4, upper).

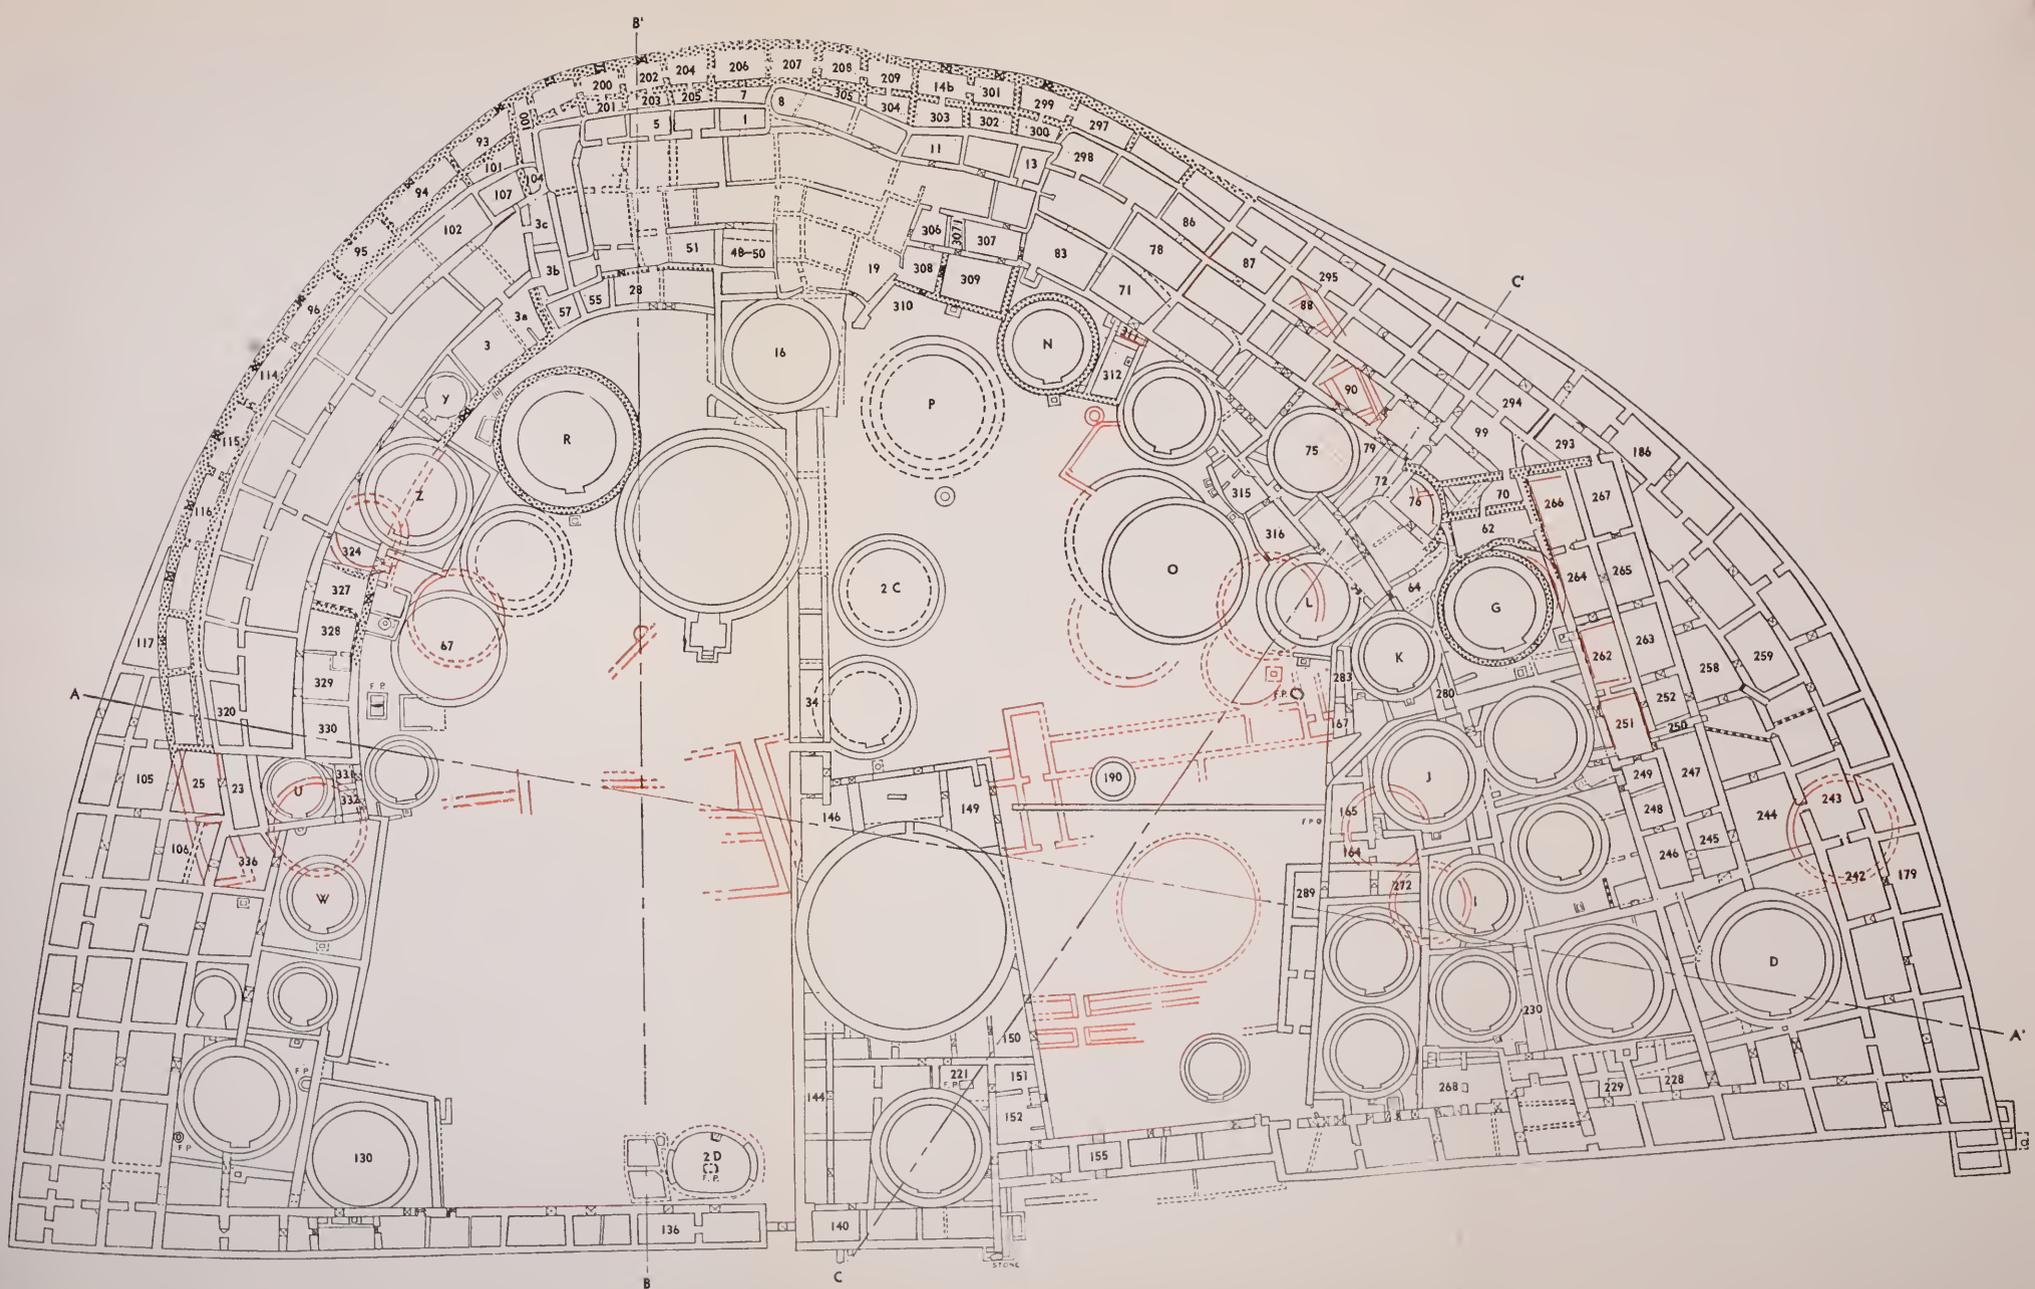
FIG. 4.—Ground plan showing the initial Late Bonitian addition to the pueblo with abandoned second-type walls and known foundations.

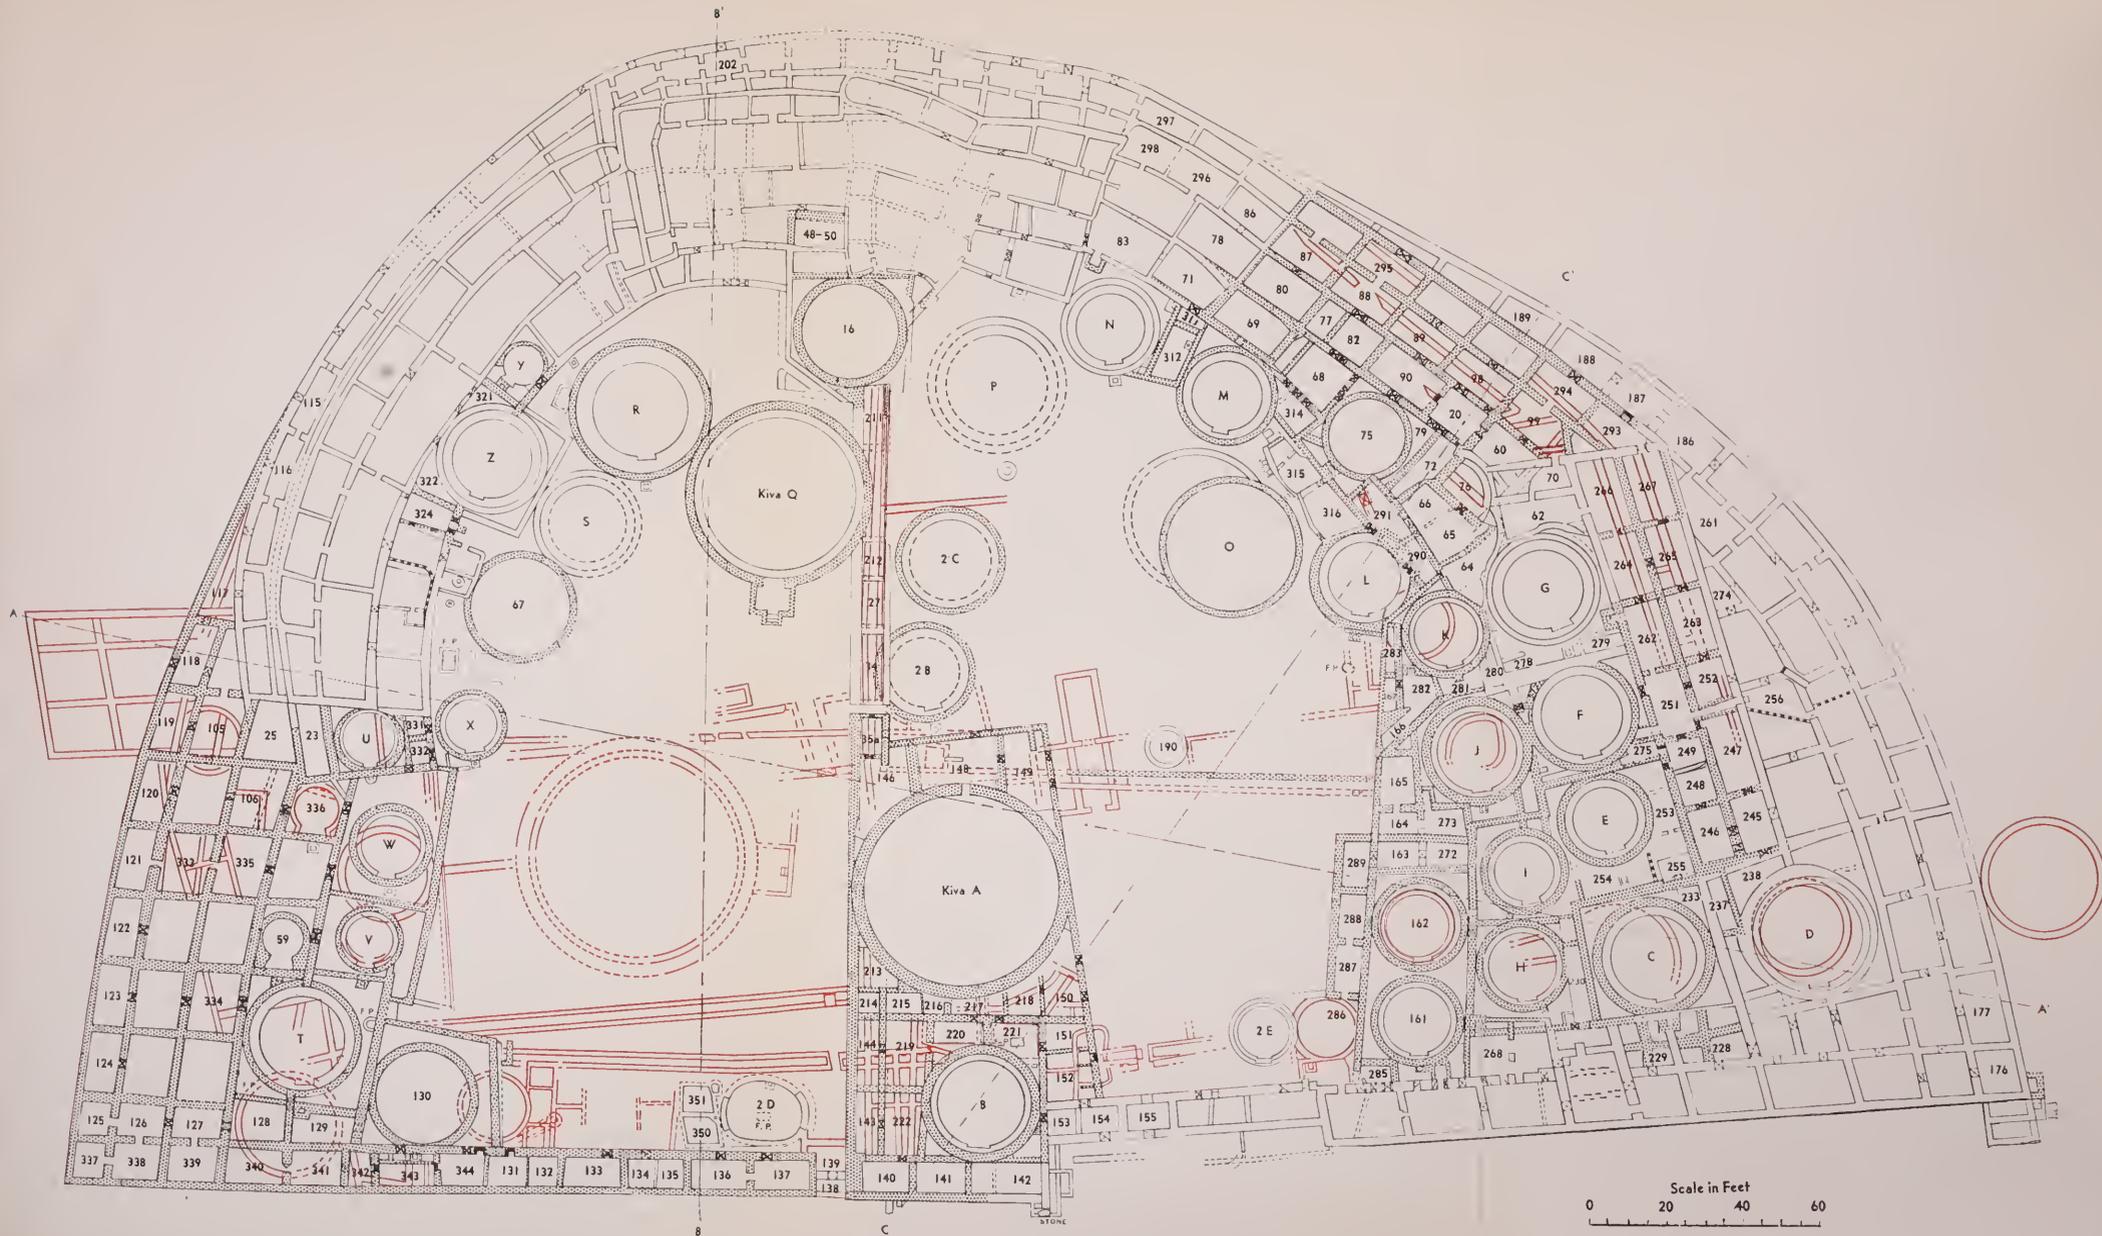
FIG. 5.—Ground plan showing extent of the second Late Bonitian addition with known subfloor walls and foundations for third-type masonry.

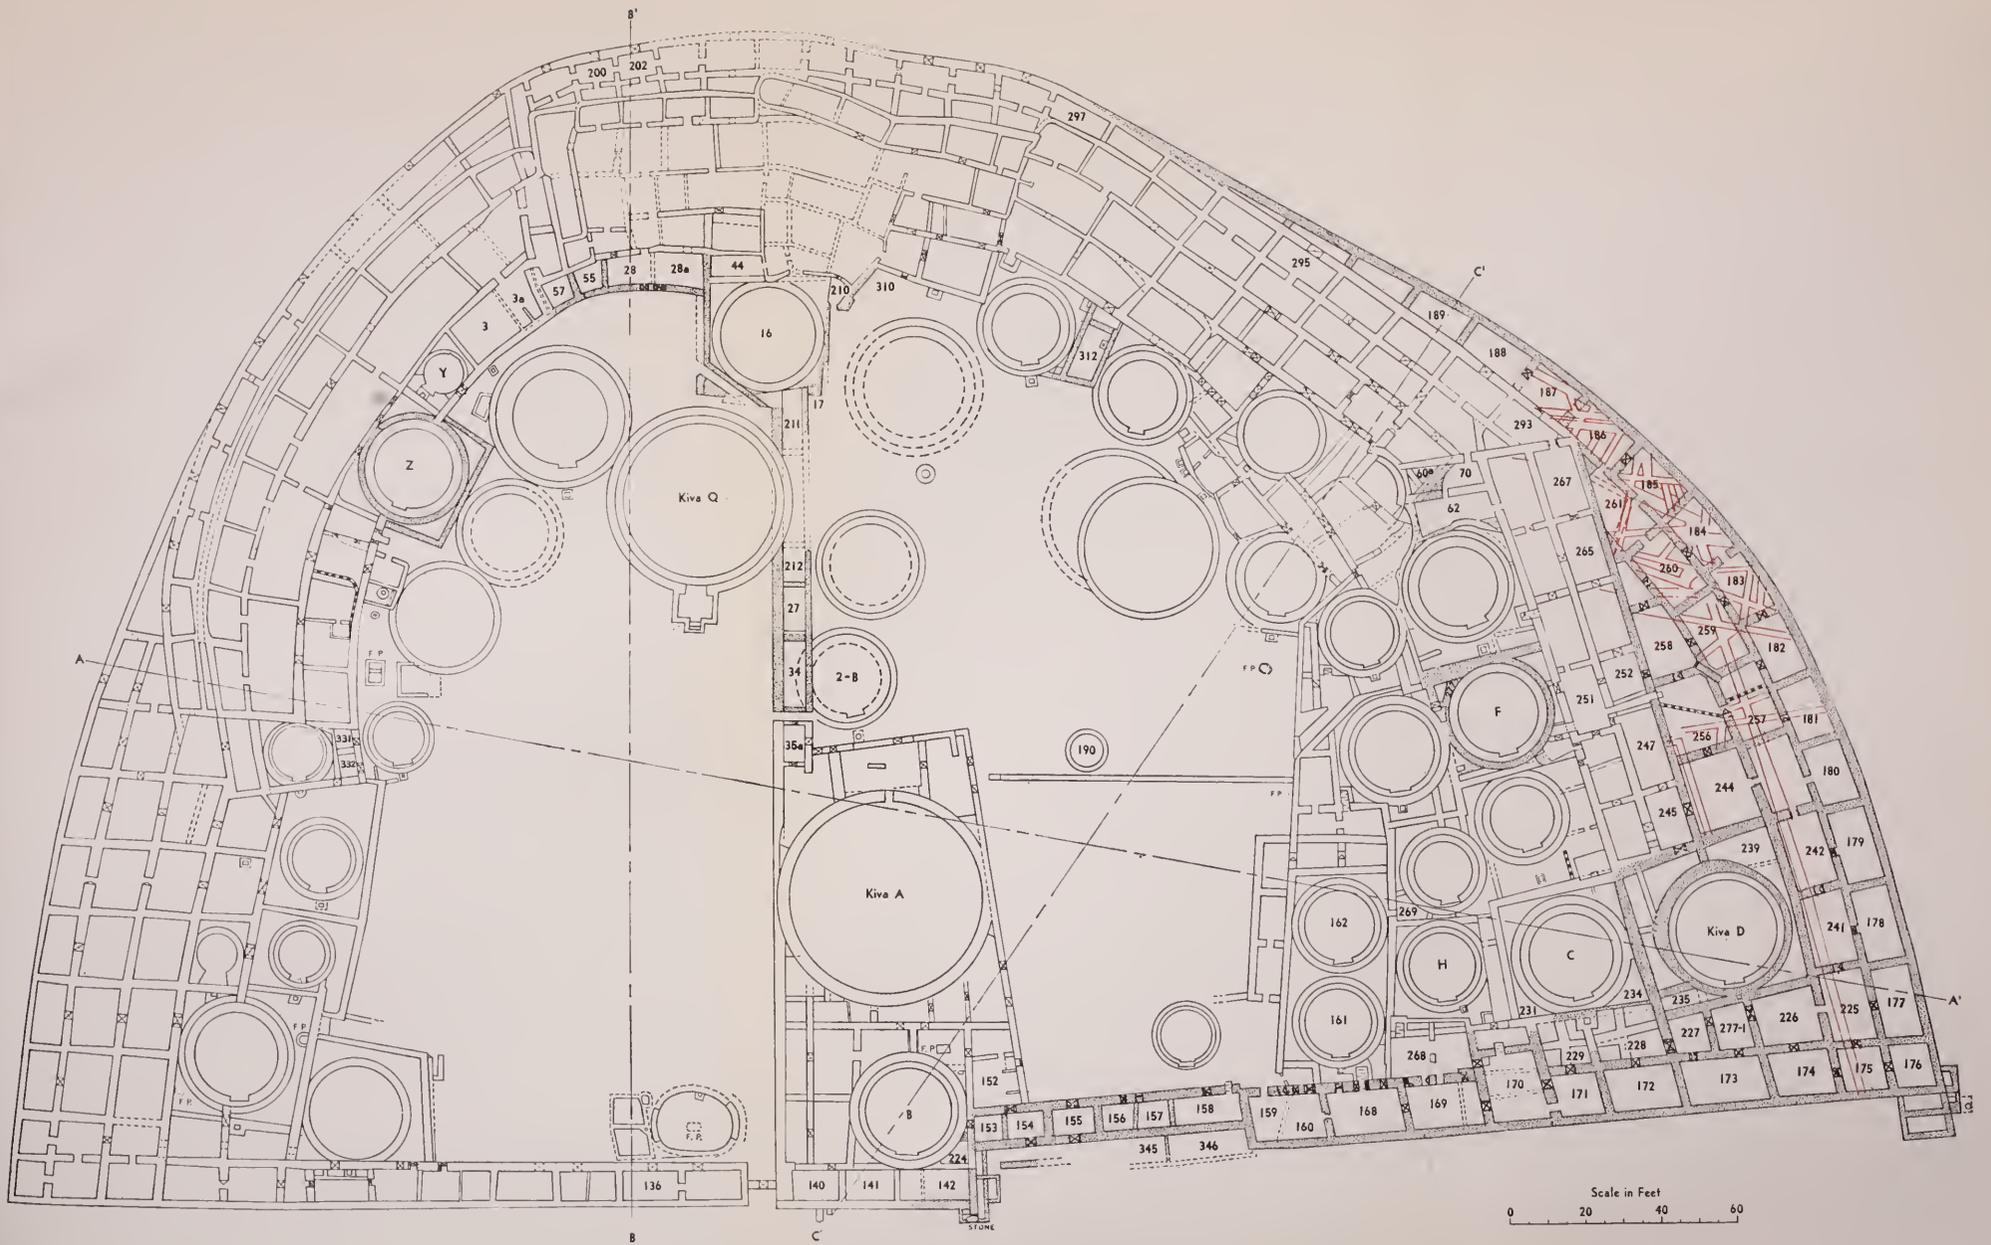
FIG. 6.—Ground plan showing final additions to Pueblo Bonito and known subfloor foundations for fourth-type masonry.

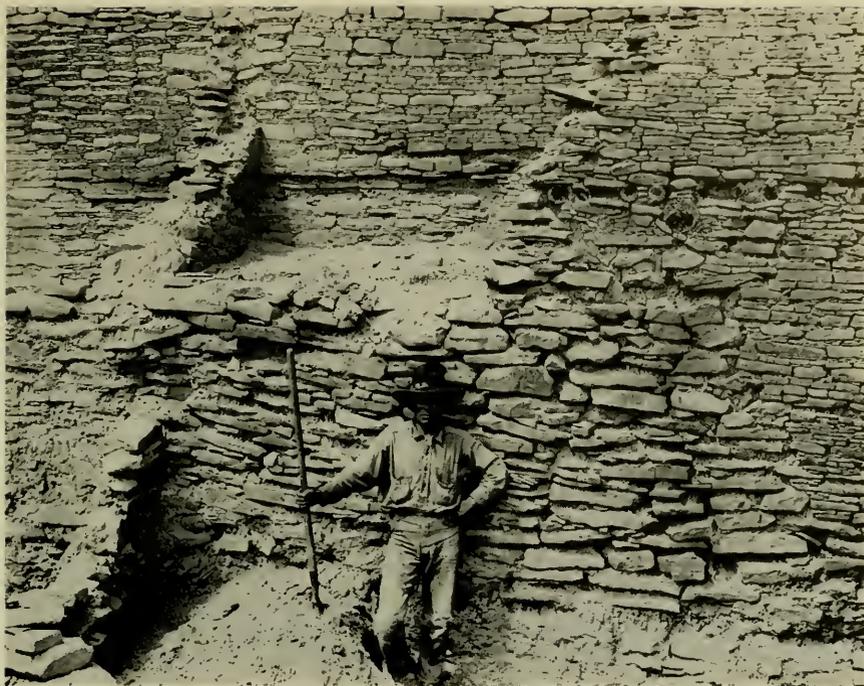
Third-type replacement of first-type masonry, north wall of Room 86B. Second-type interior, room north of 296B, at upper left.

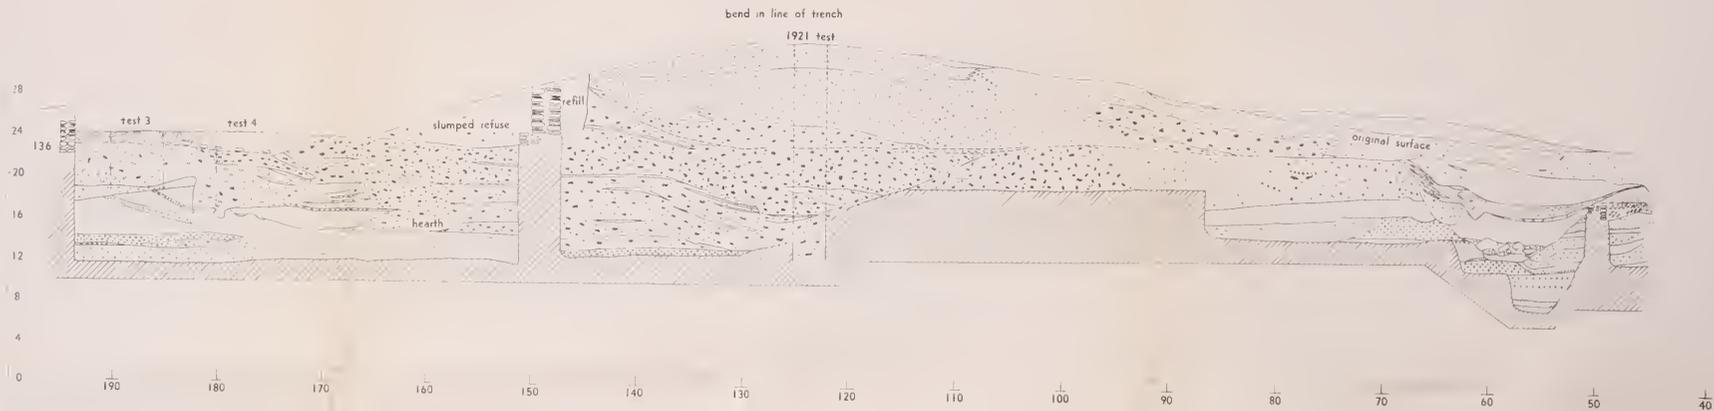
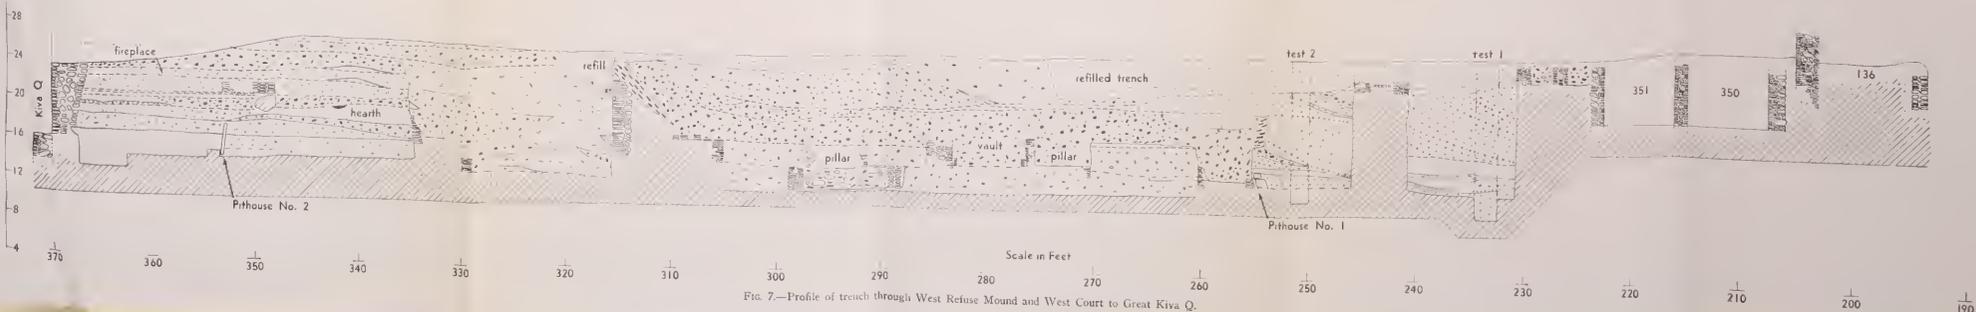
FIG. 7.—Profile of trench through West Refuse Mound and West Court to Great Kiva Q.

The broken floors of two more BM. III or P. I pit-dwellings were revealed by our 1925 exploratory trench 11 feet 9 inches below the West Court surface or approximately 6 feet below the present valley surface south of Pueblo Bonito (fig. 7). In both instances sandstone slabs on end, packed between and held upright with mud, marked floor limit. Another early house remnant, including a 16-inch-high section of stone-topped adobe wall, was bared on a silt surface 6 feet 3 inches below floor level in Room 241. The builders of Pueblo Bonito probably were unaware of these and like remains deep beneath their foundations.

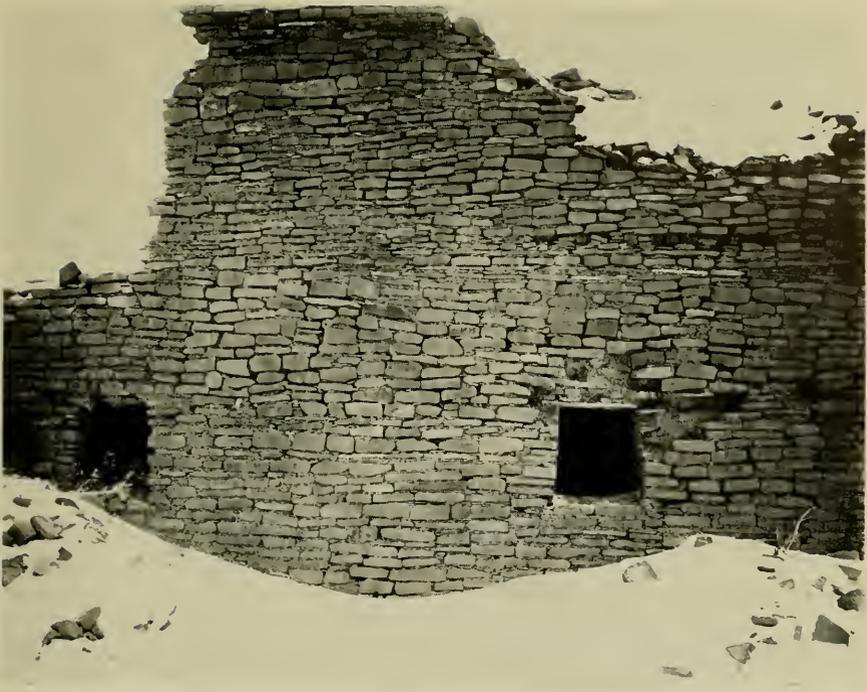
Ceiling poles of the Hyde Expedition's "old dark room" extended through its north wall: open door of Room 200, at left.

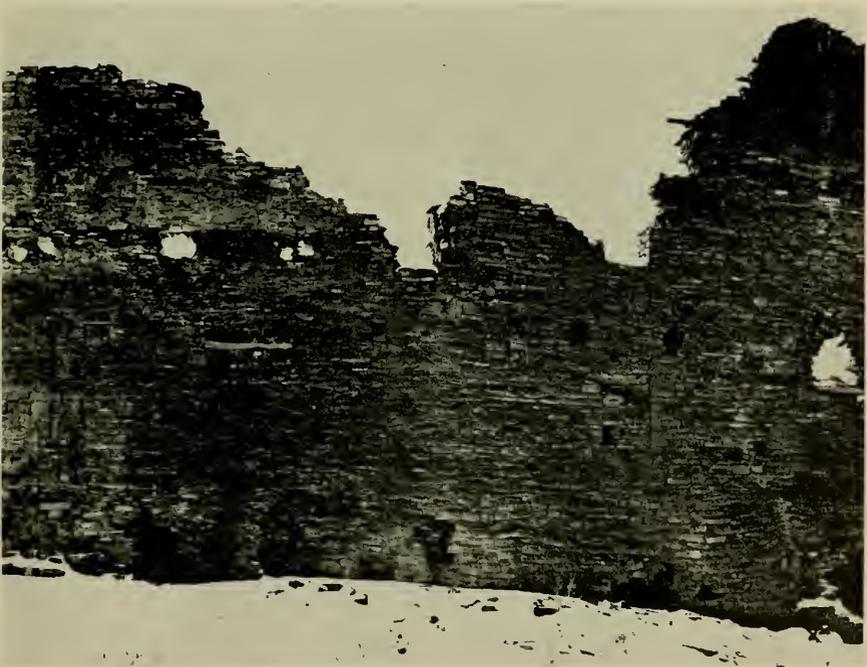
Empty beam holes in Room 299B (right center) are about 2 feet lower than those of Room 297B, next on the left. At lower right, the broken north door of Room 301.

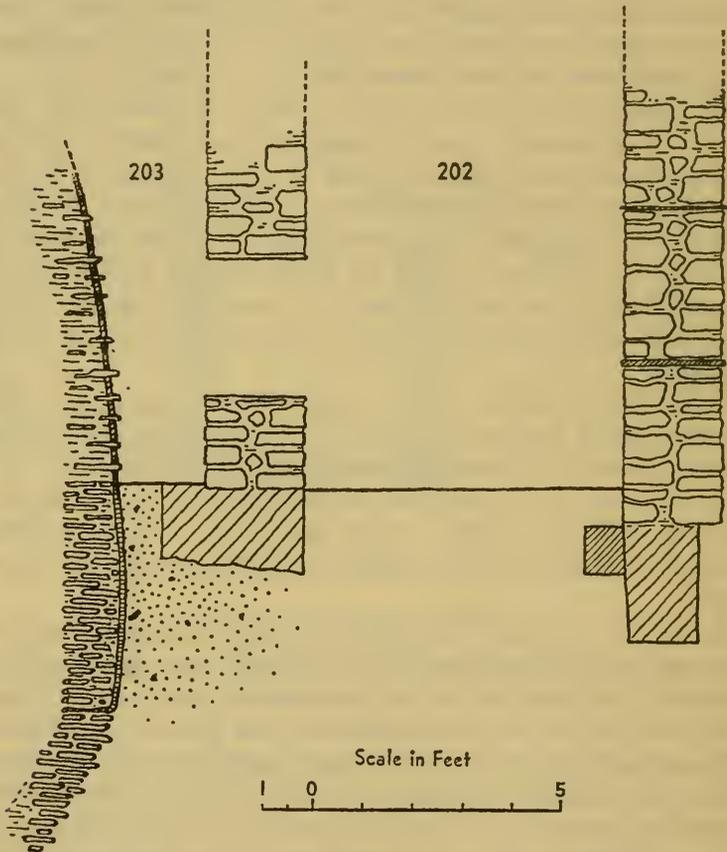
FIG. 10.—Diagrammatic sketch showing relationship of Late Bonitian Rooms 202-203 to Old Bonitian Rooms 4-5.

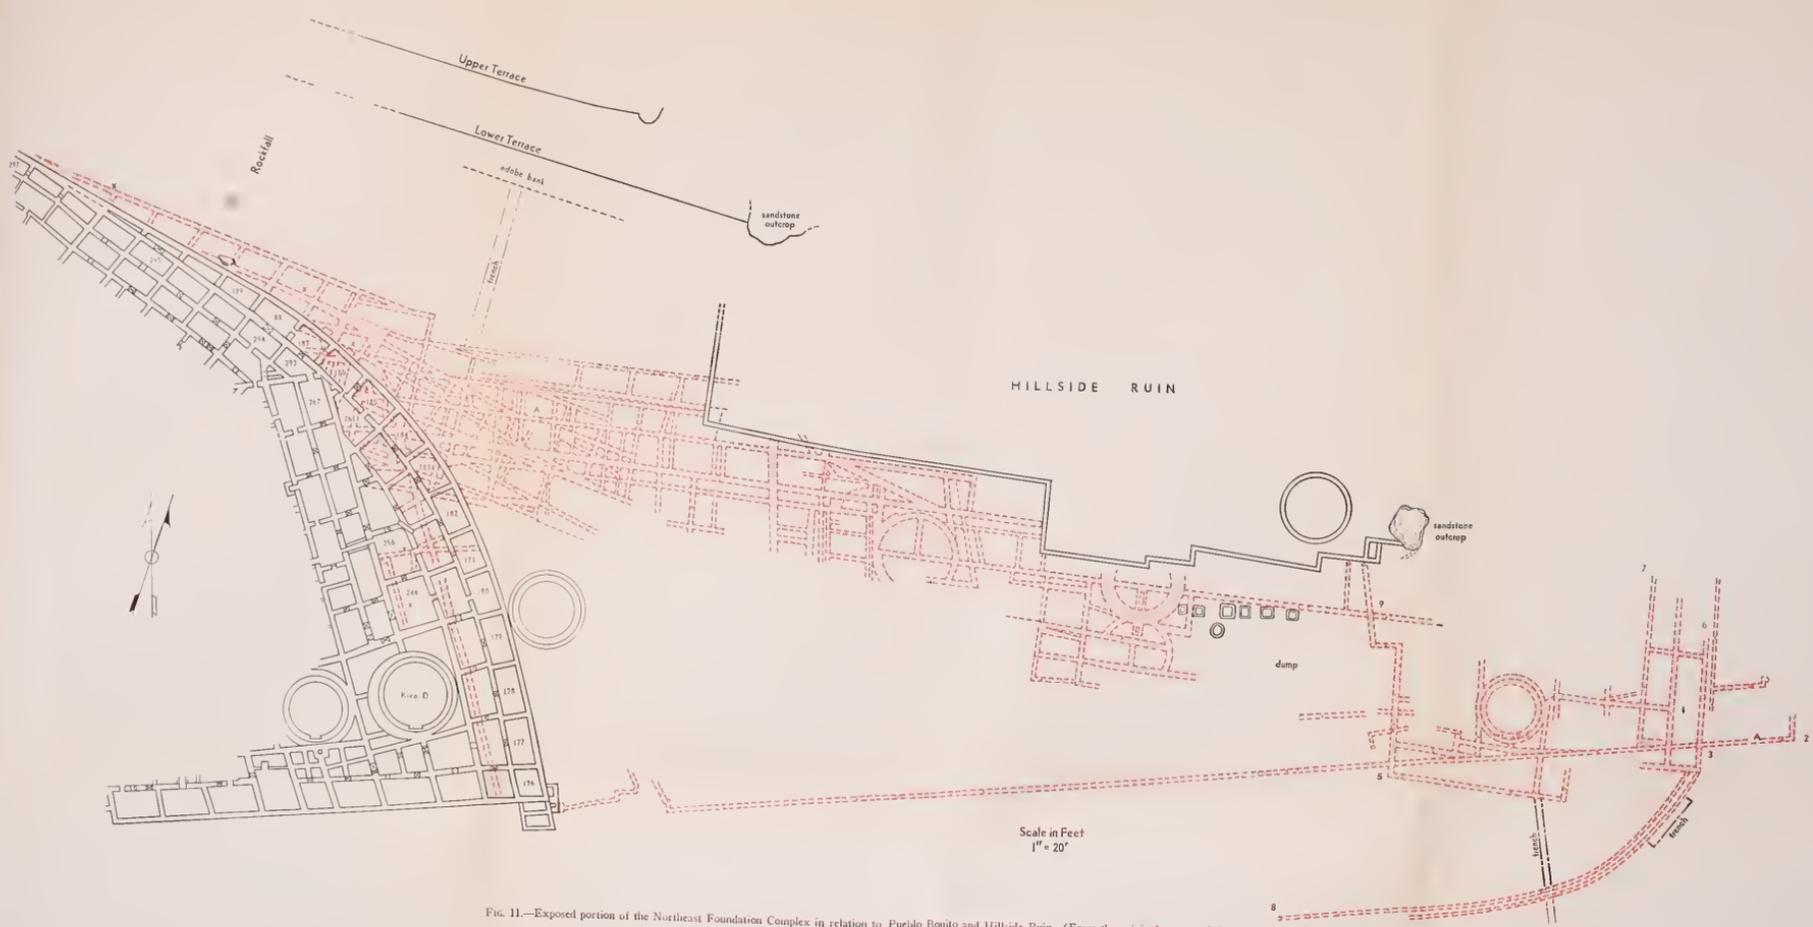
FIG. 11.—Exposed portion of the Northeast Foundation Complex in relation to Pueblo Bonito and Hillside Ruin. (From the original survey of Oscar B. Walsh.)

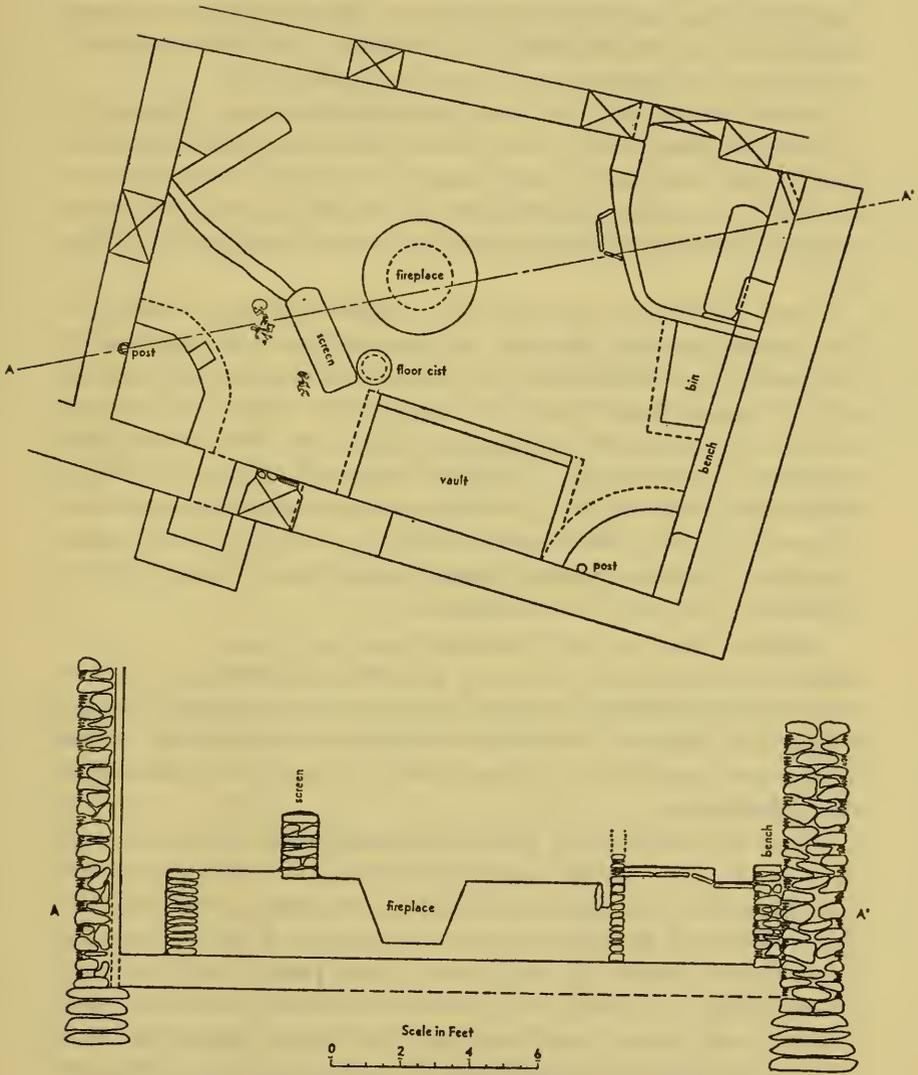
FIG. 12.—Late Bonitian Room 309 and cross section.

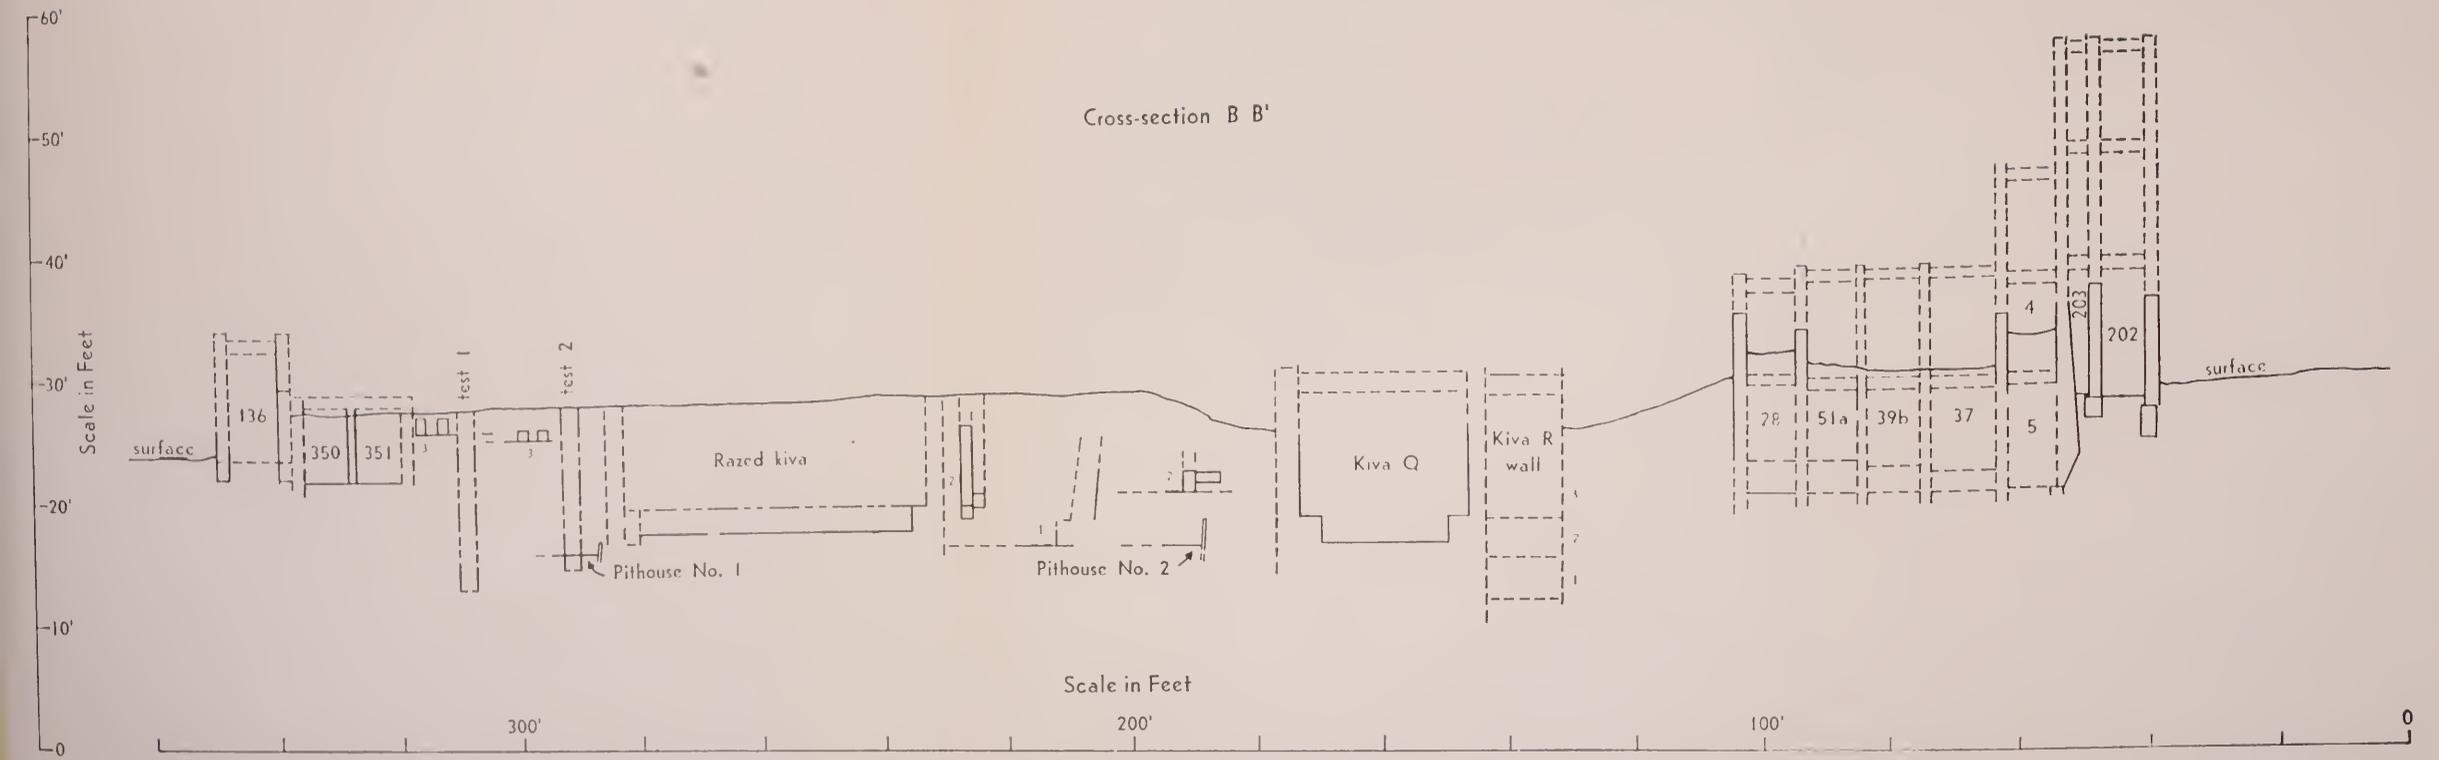
FIG. 14.—Cross section B-B' from Room 202 to surface outside Room 136.

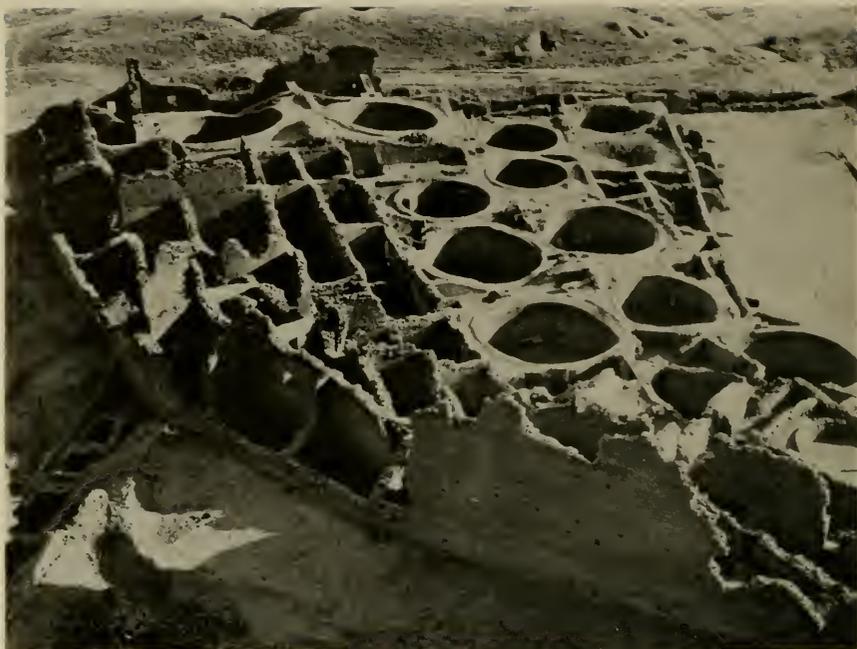
The Late Bonitians' third and final addition to the pueblo overlies units of the Northeast Foundation Complex. National Geographic Society repairs appear in the 4-story wall at right. (Photograph by E. L. Wisherd, 1923.)

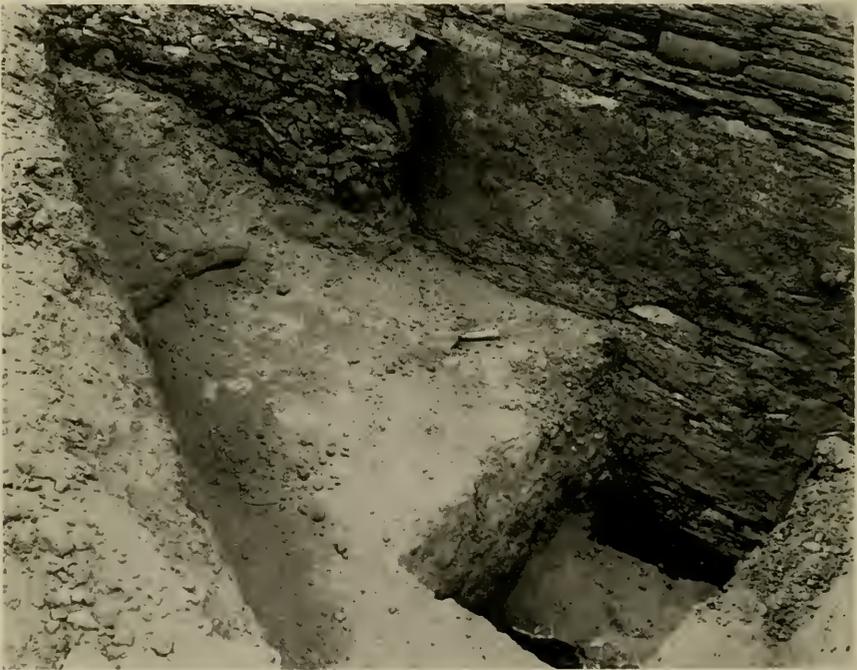
The Northeast Foundation Complex began as a thin wedge against the plastered second-type exterior of Room 297.

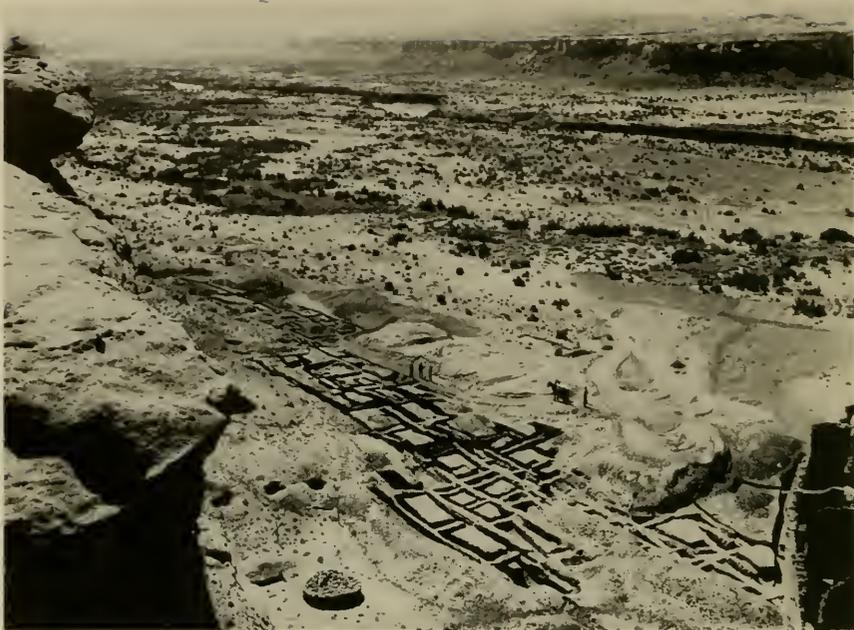
View of the Northeast Foundation Complex from the Braced-up Cliff. In left foreground, stones piled for wall repairs; beyond, 3 tests against west side of Hillside Ruin.

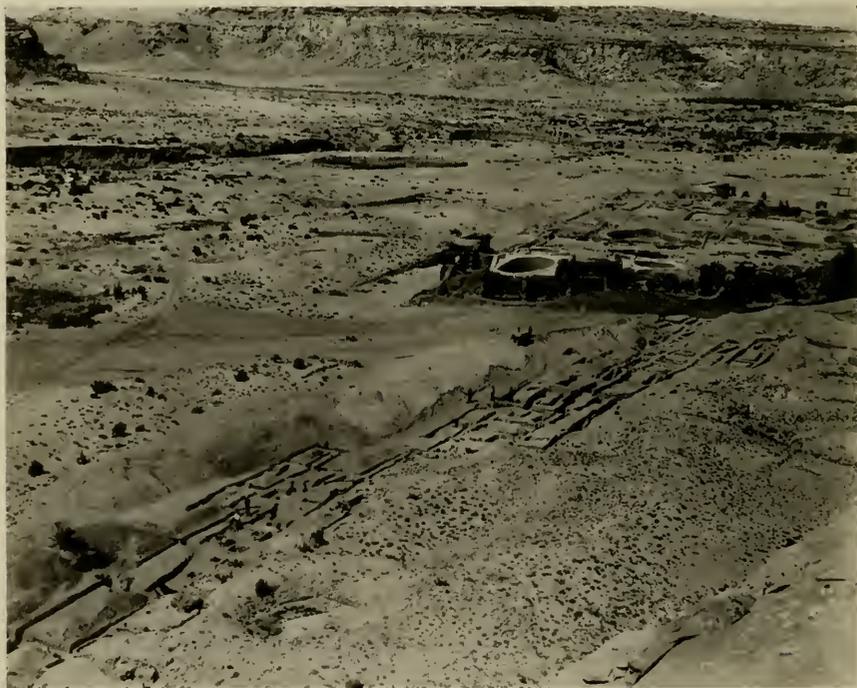
The Northeast Foundation Complex from the northeast cliff. Pueblo Bonito in the background, with National Park Service cementwork around Kivas D and F.

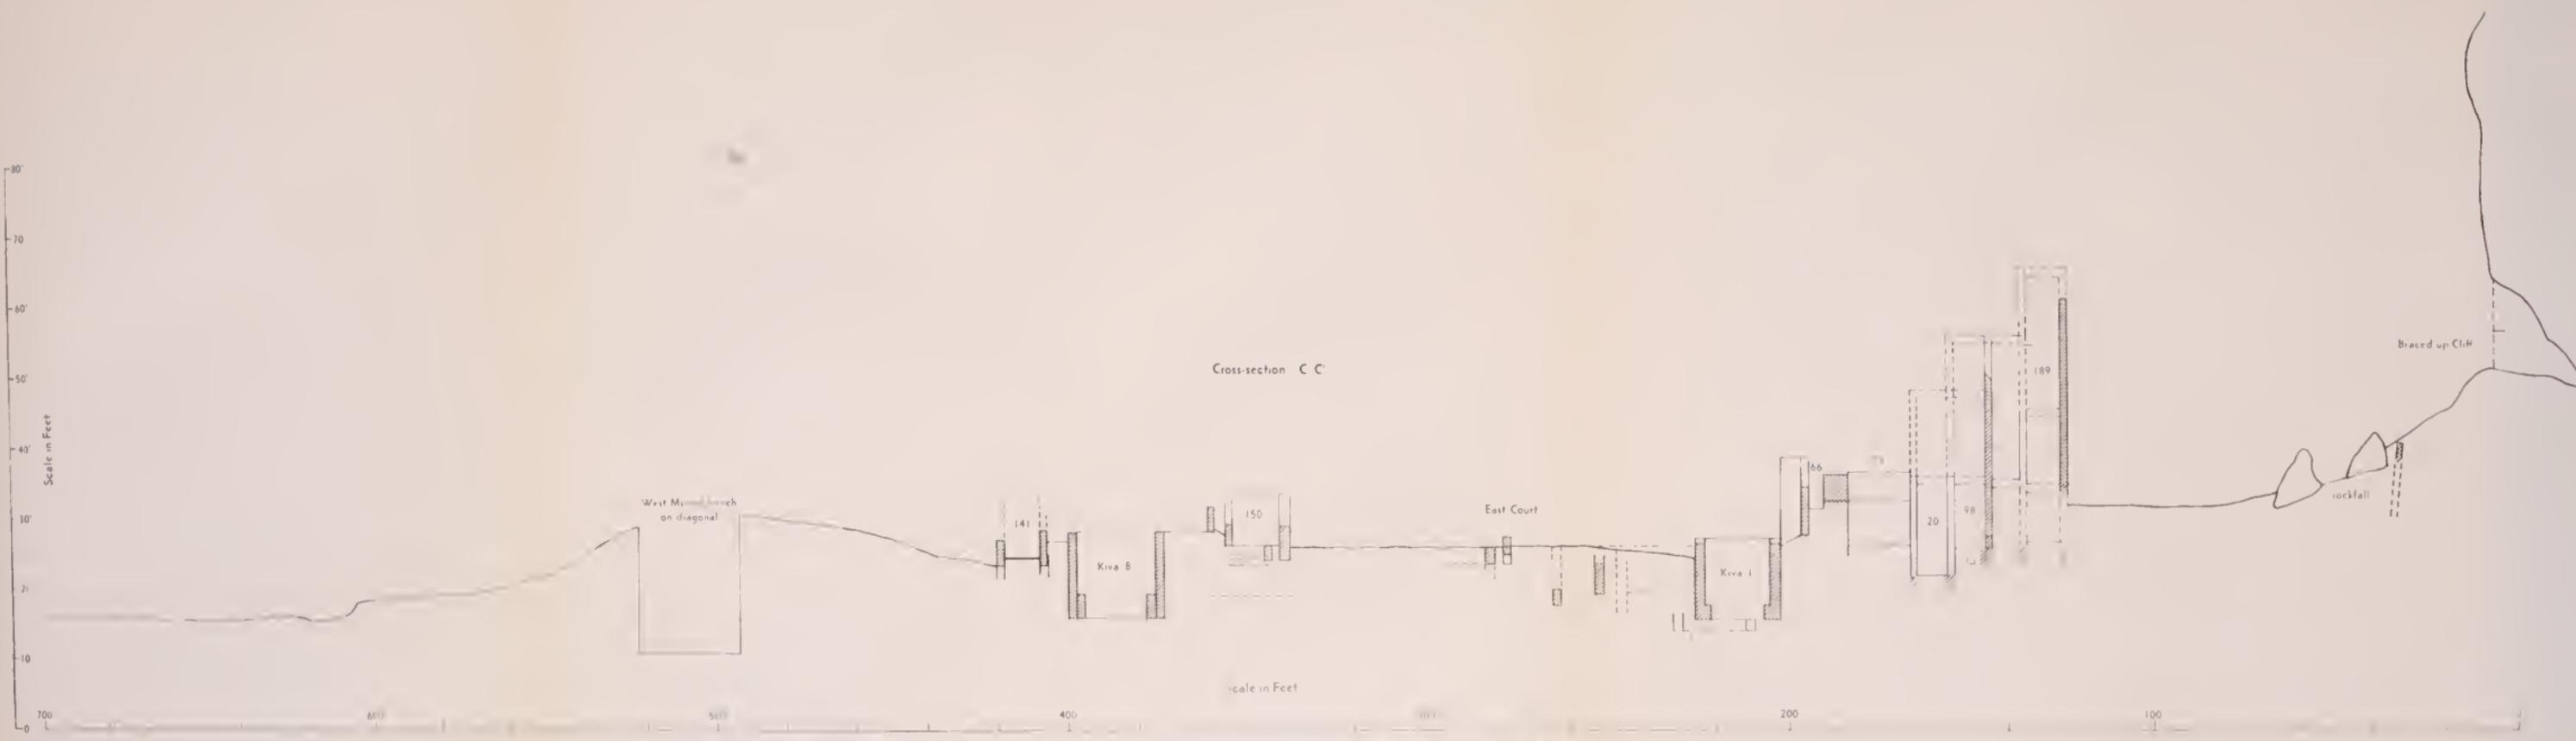
FIG. 15. Cross-section C-C from the Braced-up Cliff through Room 141 and the West Mound trench on a diagonal. Subterranean structures indicated by dashed lines. (From the original survey by O. B. Walsh.)

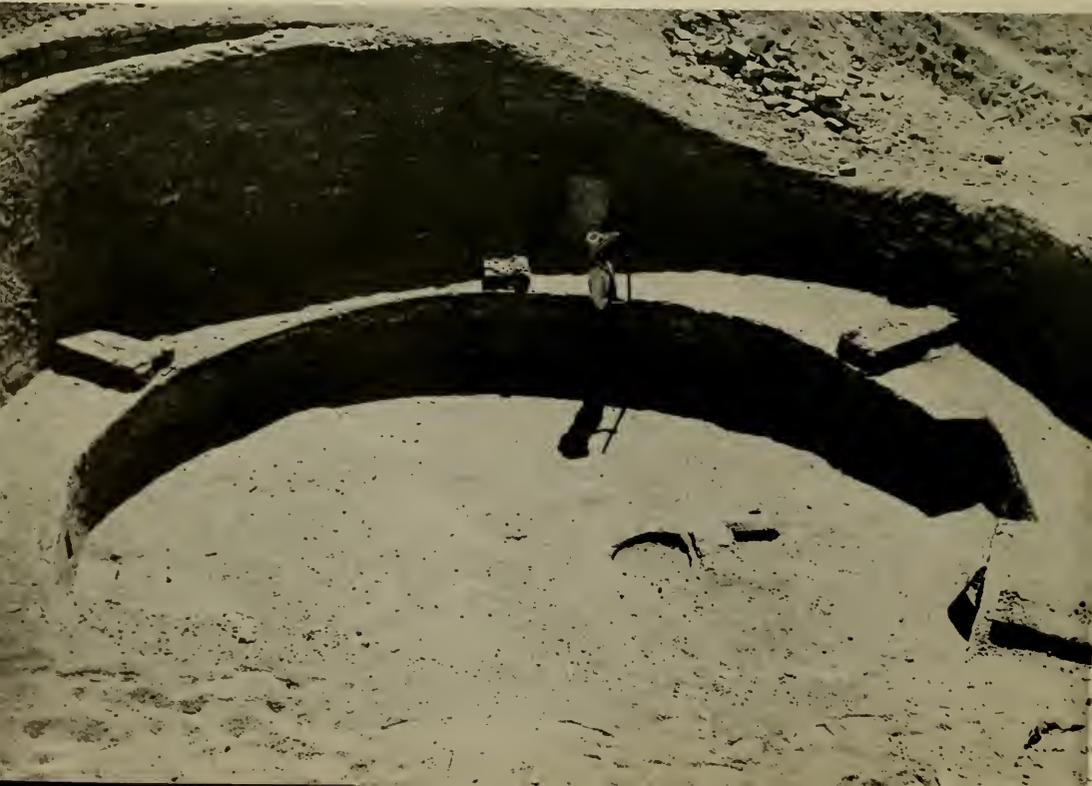
Lower: Fireplace, ventilator, and south bench recess of Kiva R with Pilasters 1 to 3 beyond and
ceiling pole offset at upper left.
(Photograph by O. C. Havens, 1924.)
