SMITHSONIAN MISCELLANEOUS COLLECTIONS
VOLUME 147, NO. 1

THE ARCHITECTURE OF PUEBLO BONITO

NEIL M. JUDD

CITY OF WASHINGTON
PUBLISHED BY THE SMITHSONIAN INSTITUTION
JUNE 30, 1964

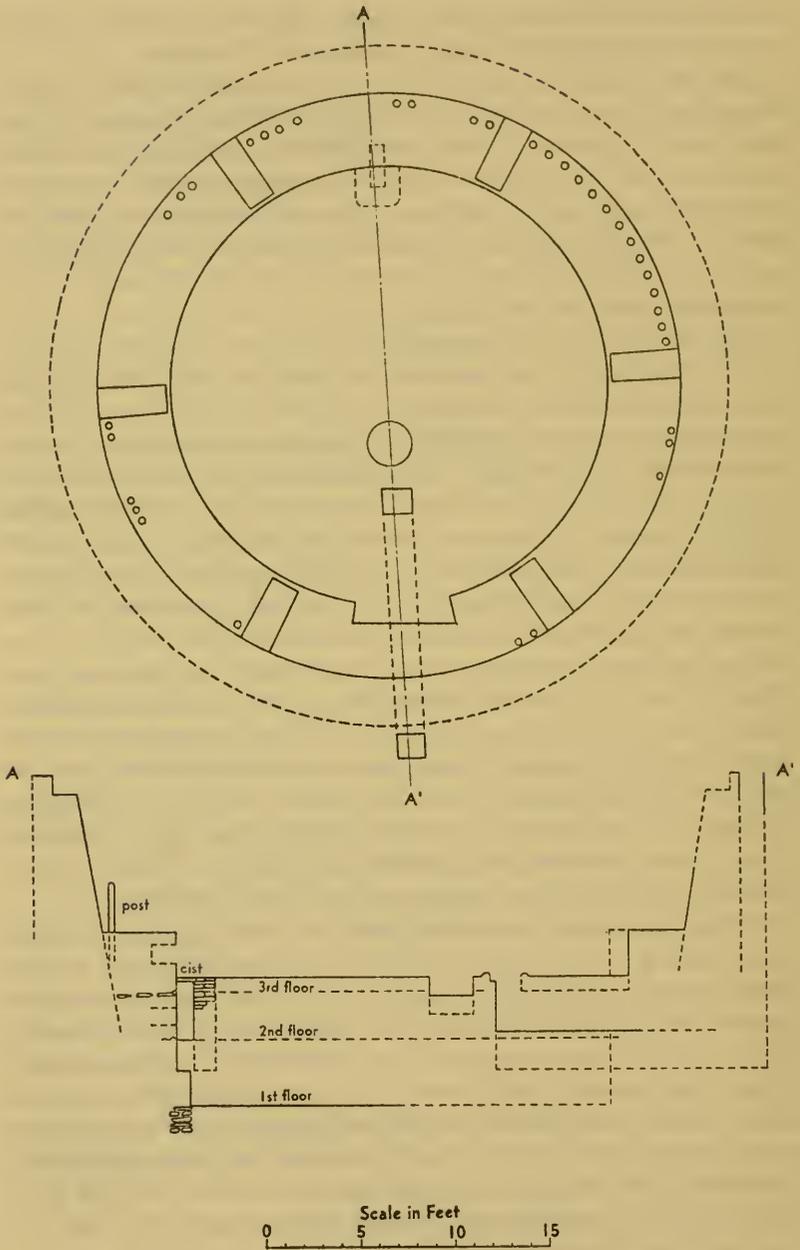
FIG. 22.—Kiva R with cross section, A-A', showing relationship of its predecessors.

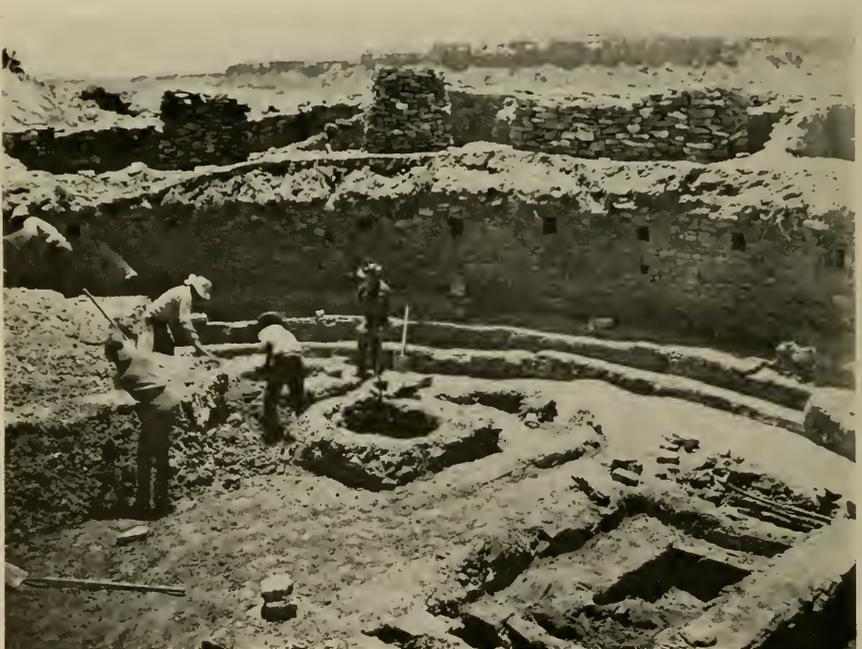
The south pillars, vaults, and other features of Great Kiva A were buried under water-soaked sand and silt.

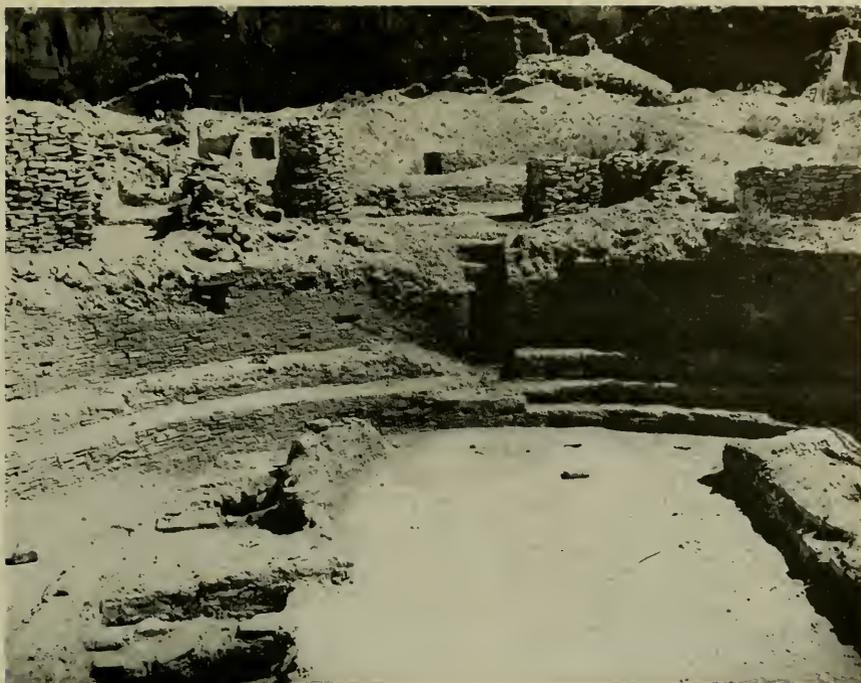
Two masonry pillars and adjoining vaults occupy the north floor of Great Kiva A.
Above, stones piled for wall repairs.

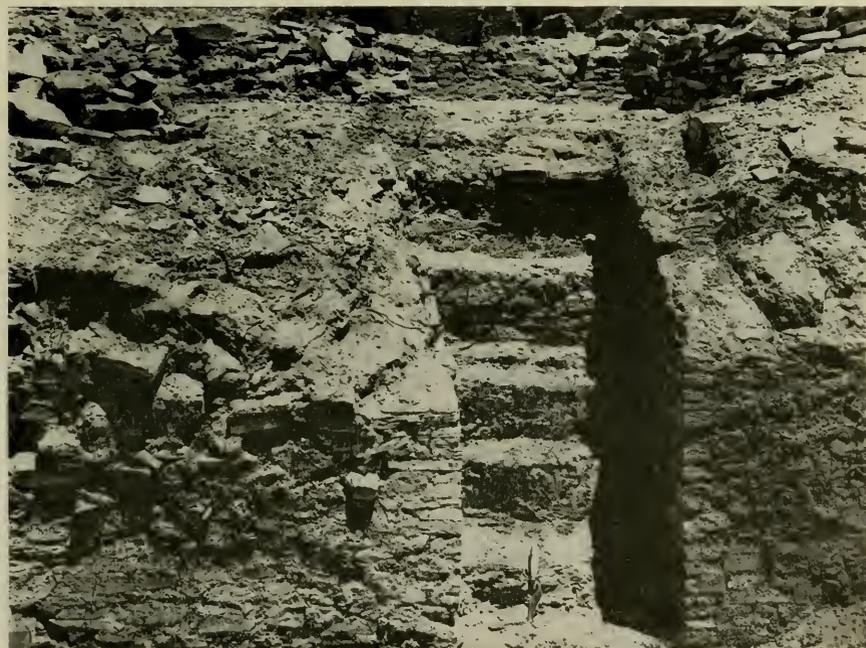
Five masonry steps with wooden fore-treads led from the north benches of
Great Kiva A to Room 148.

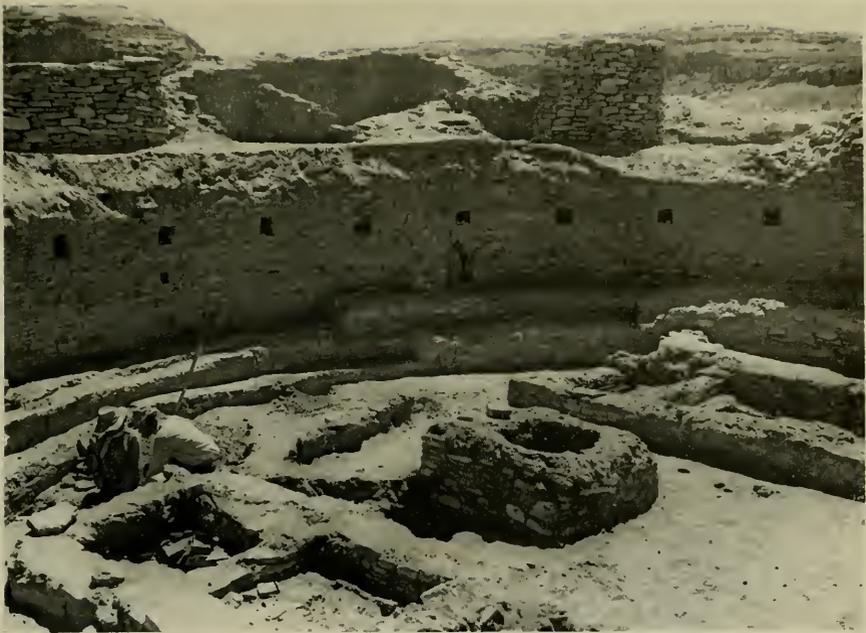
Great Kiva A from the north, showing fireplace, deflector, south pillars, east and west vaults. Stones for wall repairs are stacked in Rooms 217-218.

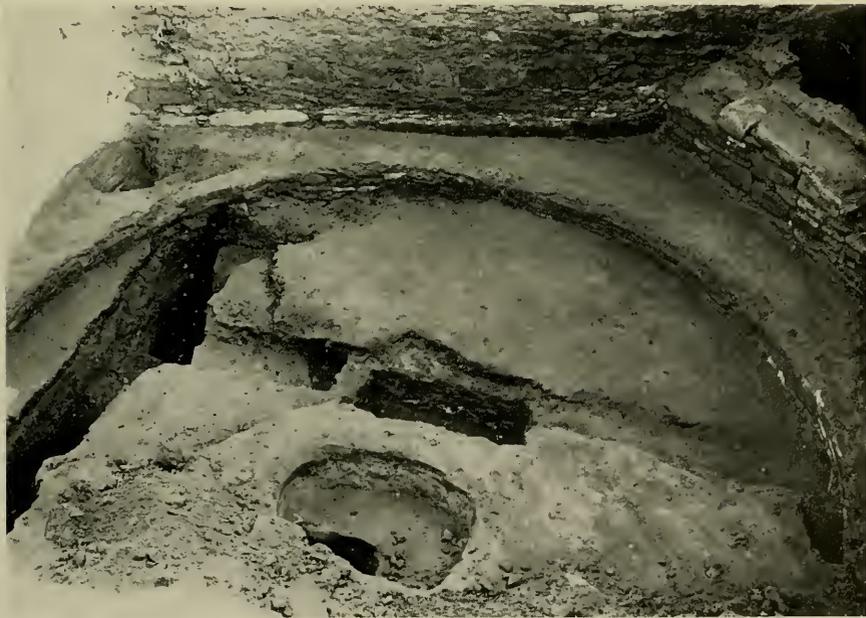
The floor of Room 336 concealed older, partially razed walls and was itself covered by an intermural kiva, subsequently demolished.

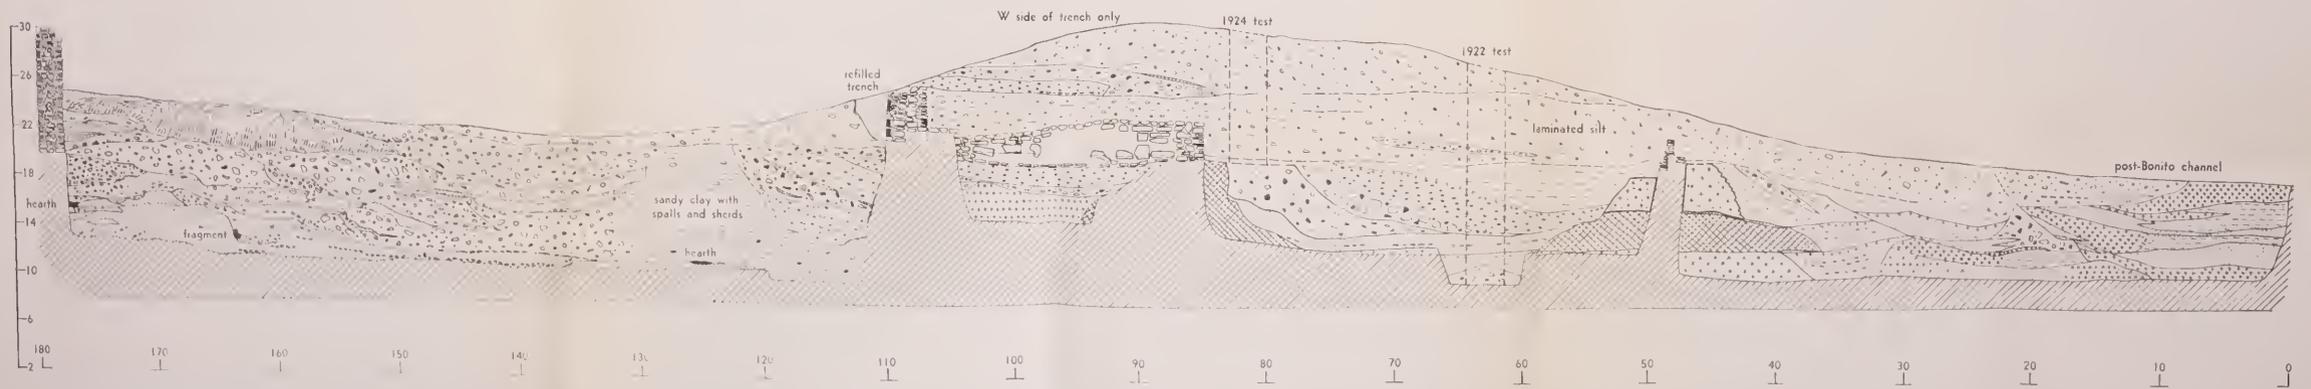
FIG. 24. The "Far Fast Trench" (upper); the "Middle Trench"; and the "East Mound Trench" from the post-Bonito channel to the foundations of Room 171.

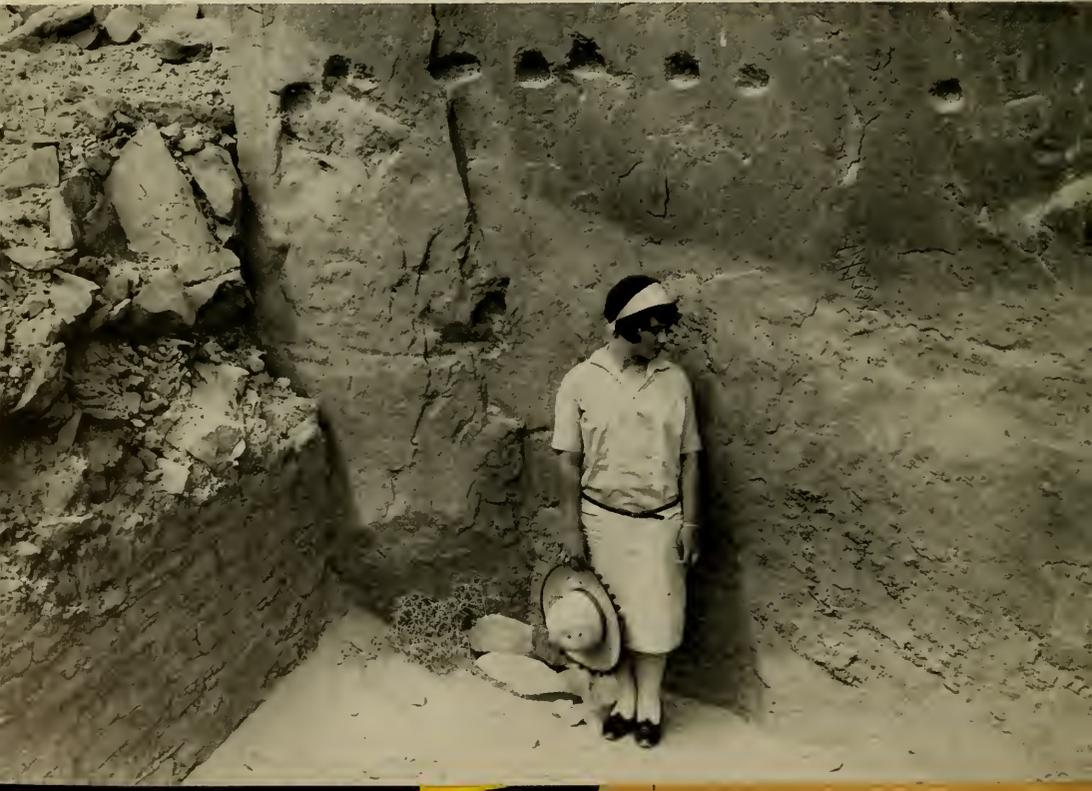
This little P. III house has since been destroyed but beneath it, as seen in 1920 and later, layered alluvium extended to right and left, the patient deposits of floodwaters flowing over a grassy plain (Bryan, 1954, pl. 6, upper). In Chaco Canyon where the gradient has always been a modest one, summertime floods formerly advanced slowly and dropped their silty burden on the way.
