# Chapter 4

## Weathering and Deterioration

Michael Steiger and A. Elena Charola, Sect. 4.5 by Katja Sterflinger

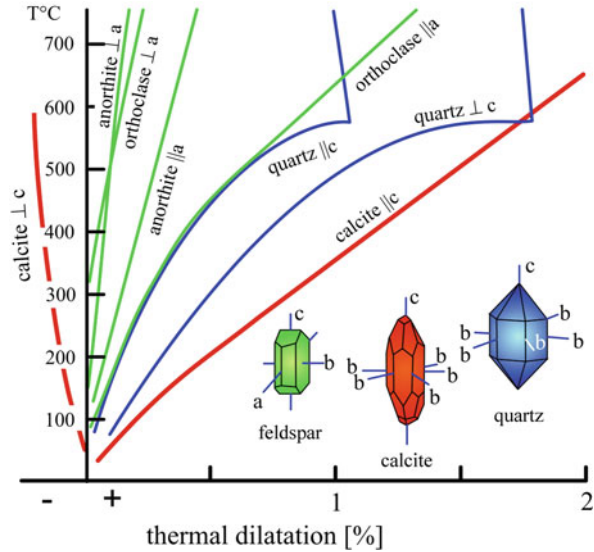
**Fig. 4.2** Linear expansion changes for some minerals as a function of temperature. Adapted from Winkler 1994

these minerals while Fig. 4.2 shows the linear expansion changes they undergo with temperature.

As can be seen from Table 4.2 calcite is the only mineral that upon heating expands in one direction while contracting in the other (Figs. 4.2 and 4.3); and, upon cooling it will contract along the *c* axis while expanding along the other ones. Therefore, calcite marbles are the most susceptible to thermal cycling that leads to granular decohesion of the stone matrix, i.e., the so called “sugaring” deterioration pattern that has been long known (Kessler 1919, Franzini et al. 1983). This is mostly the result of the thermal stress induced along grain boundaries that leads to their failure and even to grain fissuring (Fig. 4.3).

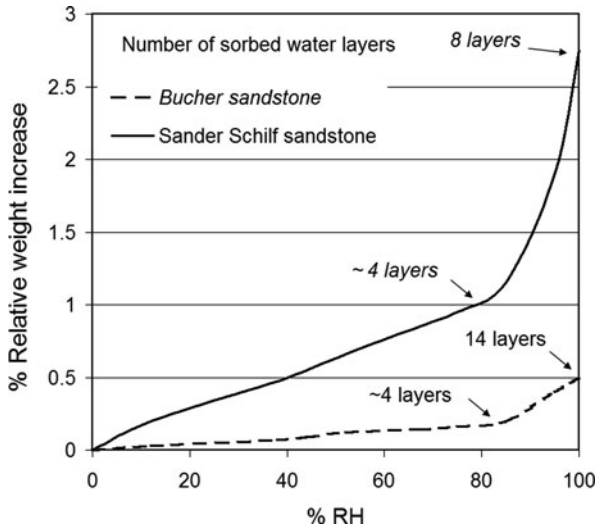
**Fig. 4.6** Water sorption curves for the coarse-pore Bucher and mixed-pore Sander Schilf sandstone that also contains more phyllosilicates. Adapted and simplified from Sneath 1984. The number of sorbed water layers was calculated based on the amount of sorbed moisture that in turn reflect the specific surface area of the stones (2.63 and 14.8 m<sup>2</sup>/g, respectively). Note that at the inflection point of the curve (approx. 80% RH) both stones had absorbed the same number of water layers

The influence of the presence of clays and of smaller pores is immediately evident in the hygric water absorption of sandstones shown in Fig. 4.6 where the moisture absorption of the coarse-pore (most have 100  $\mu\text{m}$  radius) Bucher sandstone (95% quartz, 5% kaolinite) and the mixed-pore Sander Schilf sandstone (55% quartz, 10% feldspars, 5% chlorite, illite and muscovite plus 35% lithic fragments) with fine pores around 0.05  $\mu\text{m}$  and coarse pores around 50  $\mu\text{m}$  radius is shown.

The inflection point of the curves falls around 80% RH, and at that point both stones had only absorbed approximately 4 water layers, this corresponds to an approximate thickness of 1 nm, indicating that these sized pores are already filled with water. It is at this point that the moisture content in the stone starts to induce hygric swelling as discussed previously for the Schöttmarer sandstone (see Fig. 3.47, Sect. 3.5).

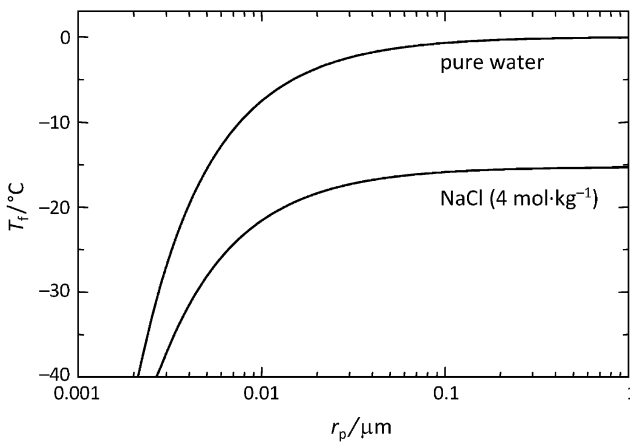
**Fig. 4.11** Freezing temperatures  $T_f$  in water and aqueous NaCl as a function of pore size in a saturated porous material. Adapted from Steiger (2006b)

In a porous material there is no uniform temperature at which the pore water freezes. Apart from the concentration of dissolved salts, the freezing temperature is also affected by pore size. A small ice crystal, i.e., a crystal growing in a small pore has a higher chemical potential and, therefore, a lower freezing temperature than a large crystal. Figure 4.11 depicts freezing temperatures of pure water and of a NaCl pore solution. It is obvious that there is a strong depression of the freezing temperature with decreasing pore size. Therefore, in a porous stone pure water starts to freeze in large pores and at temperatures only slightly below 0°C. In small pores (<0.1 μm), water only freezes at significantly lower temperatures, as shown by the

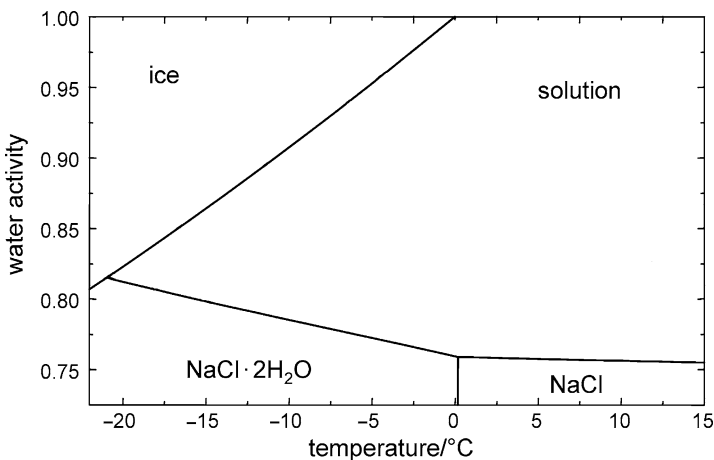
**Fig. 4.12** Phase diagram of a sodium chloride solution. Concentration of sodium chloride increases with decreasing water activity. Adapted from Steiger (2004)

The graph is valid for a salt-water system. In a porous body this may vary as a function of the pore diameter. The freezing temperature depression of a salt solution

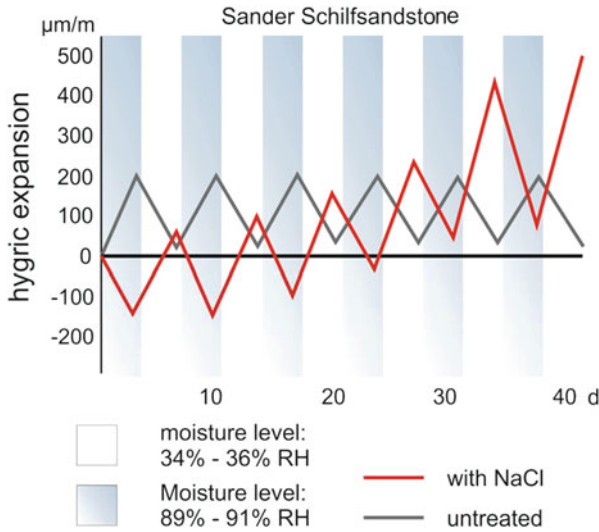
**Fig. 4.13** Hygric expansion for a Sander Schilf sandstone sample and for one pre-treated with a NaCl solution. Adapted from Snethlage and Wendler (1997)

Hygric expansion is mostly relevant for phyllosilicates, in particular clays, as discussed in a previous section (Sect. 4.2.2). However, their swelling behavior in the presence of salts changes significantly as already pointed out by McGreevy and Smith (1984). To illustrate this point, the following experiment, similar to that discussed by Sneath and Wender (1997) is described, using the clay containing Sander Schilf sandstone, already discussed in a previous section (Sect. 4.2.2). One sample of the stone was first impregnated with NaCl, a second sample served as control. Both samples were dried to ambient conditions (30% RH and  $20^{\circ}\text{C}$ ) prior to subjecting them to RH cycling between 35%RH and 90%RH. The behavior of these samples is shown in Fig. 4.13.

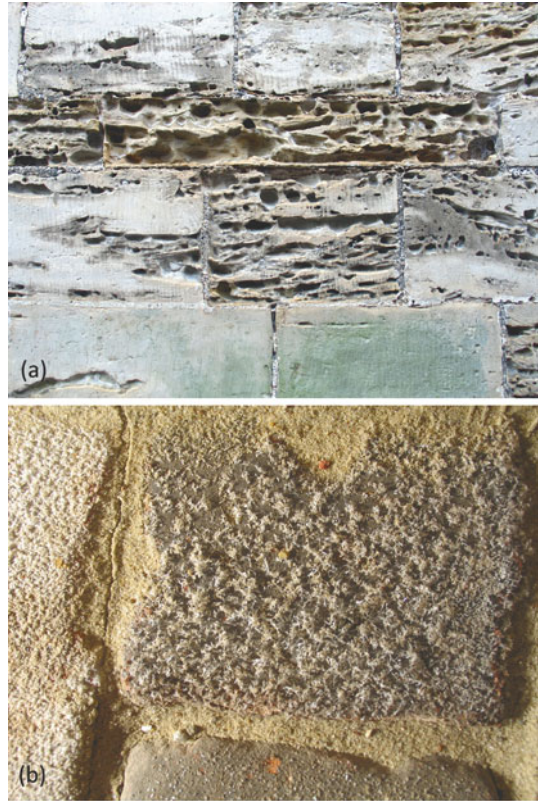
**Fig. 4.16** Salt induced deterioration: **(a)** alveolarization (Kromborg Castle, Copenhagen, Denmark); **(b)** salt efflorescences on sandstone flagstones (Marienkirche Salzwedel, Germany); Photos: Hans-Jürgen Schwarz, Ri-Con, Hanover, Germany

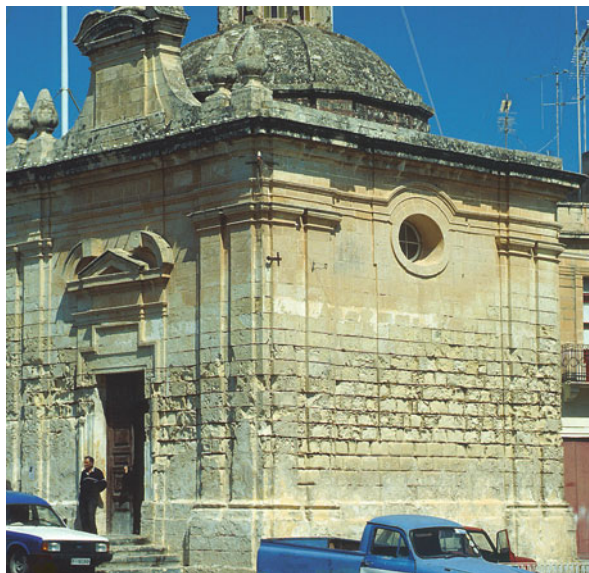
**Fig. 4.17** Sea salt induced deterioration at Santa Marija Ta' Cwerra church (Malta); Photo: B. Fitzner, Geological Institute, RWTH Aachen University

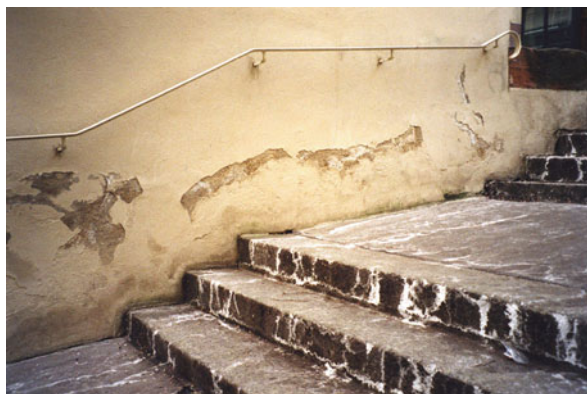
**Fig. 4.18** Efflorescences of deicing salt on a stairway in downtown Basel. Reproduced with permission from Siedel (2009)

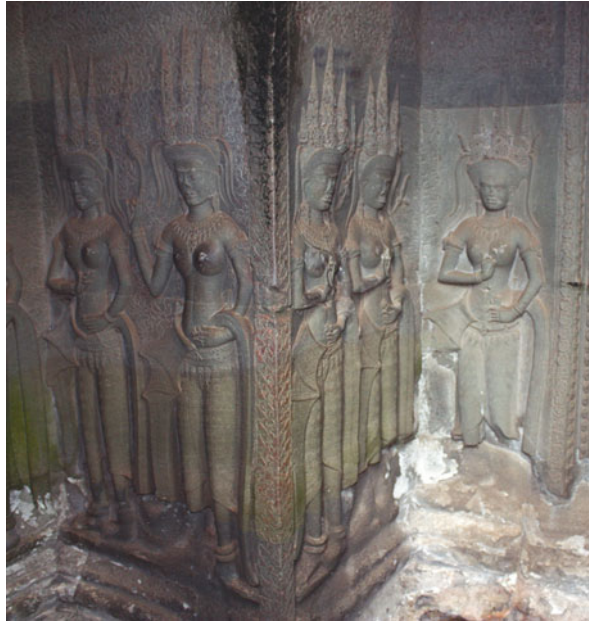
**Fig. 4.20** Salts partially originating from bat guano at Angkor Wat (Cambodia)

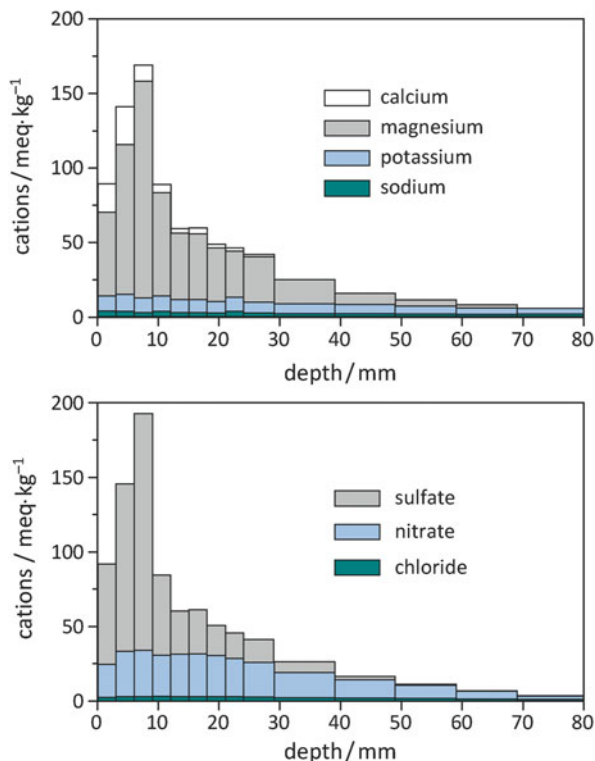
**Fig. 4.22** Salt profile in sandstone from Schloss Weissenstein, Pommersfelden. Adapted from Steiger (2003)

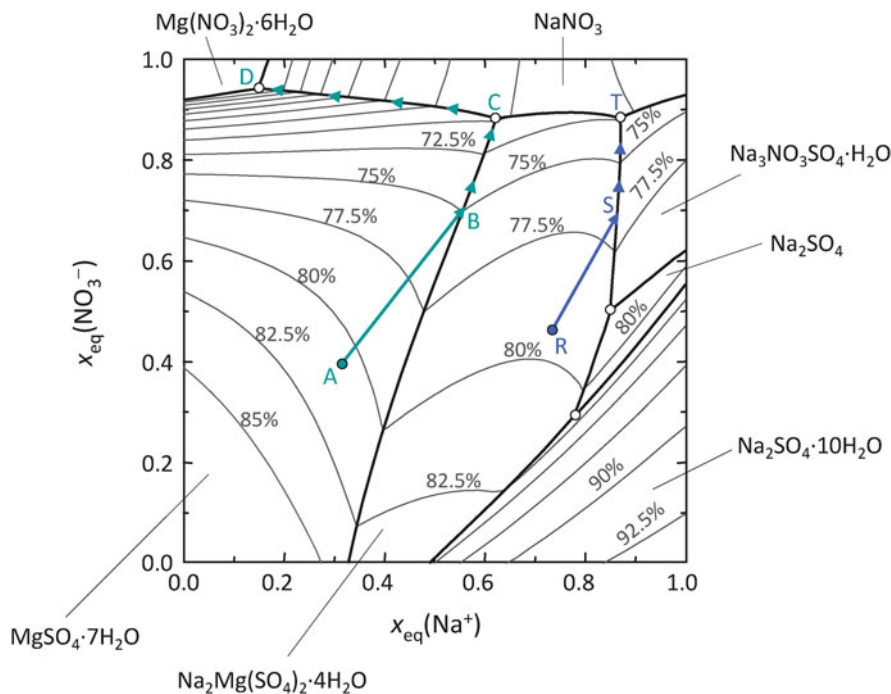
**Fig. 4.29** Solubilities and saturation humidities in the system  $\text{Na}^+ - \text{Mg}^{2+} - \text{NO}_3^- - \text{SO}_4^{2-} - \text{H}_2\text{O}$  at  $25^\circ\text{C}$ . Adapted from Steiger et al. (1998)

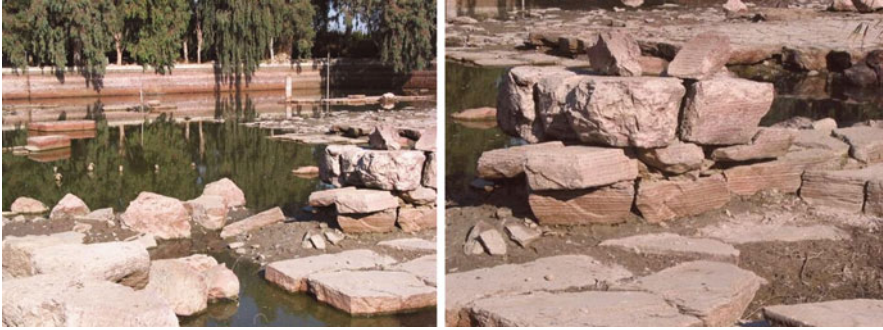
**Fig. 4.30** Ephesus, Turkey: the rosy stain on white calcareous limestone is caused by bacteria forming blooms in the brackish water of the pond overlaying the subterranean parts of the Artemision

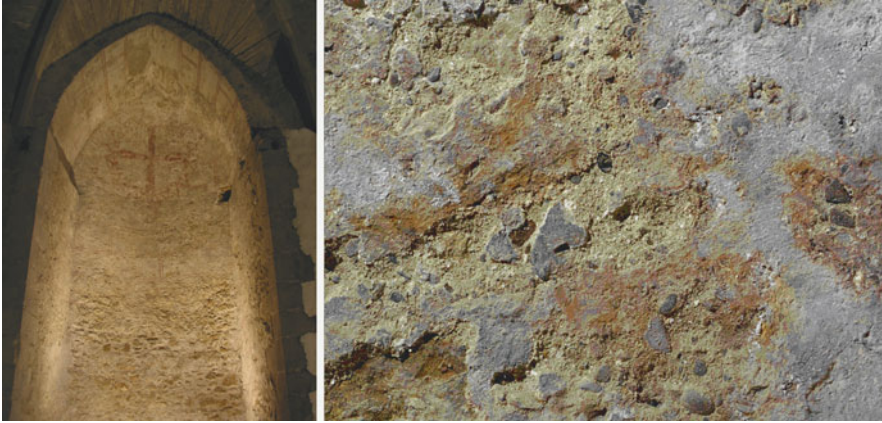
**Fig. 4.32** St. Virgils chapel (Vienna, Austria): halophilic bacteria and archaea cause a rosy stain on the salt attacked stone surface of the Medieval monument

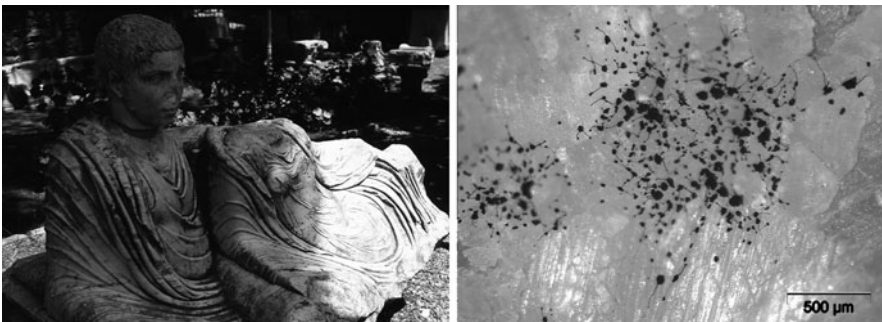
**Fig. 4.33** Side, Turkey: black micro-colonial fungi on a marble surface

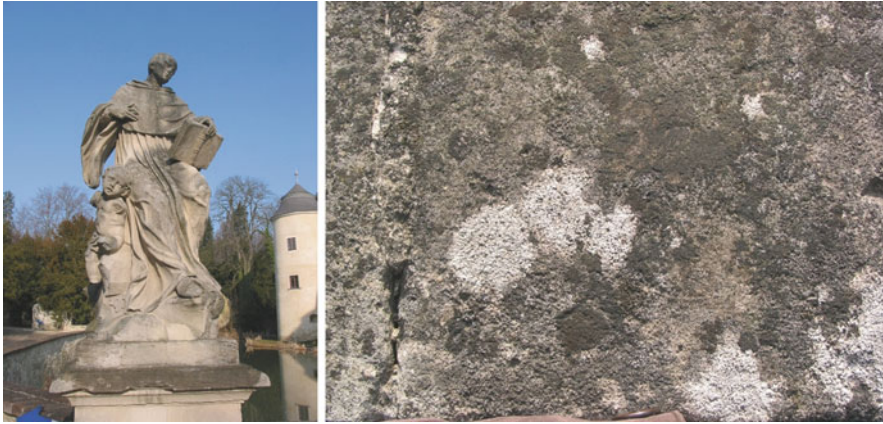
**Fig. 4.34** Lichen crusts growing on calcareous sandstone and forming a landscape-like pattern
